27 December 2021

TROPICAL CYCLONE RAI-21

PRELIMINARY SATELLITE-DERIVED INDUSTRIAL SITES IMPACT ANALYSIS IN CEBU & NAGA

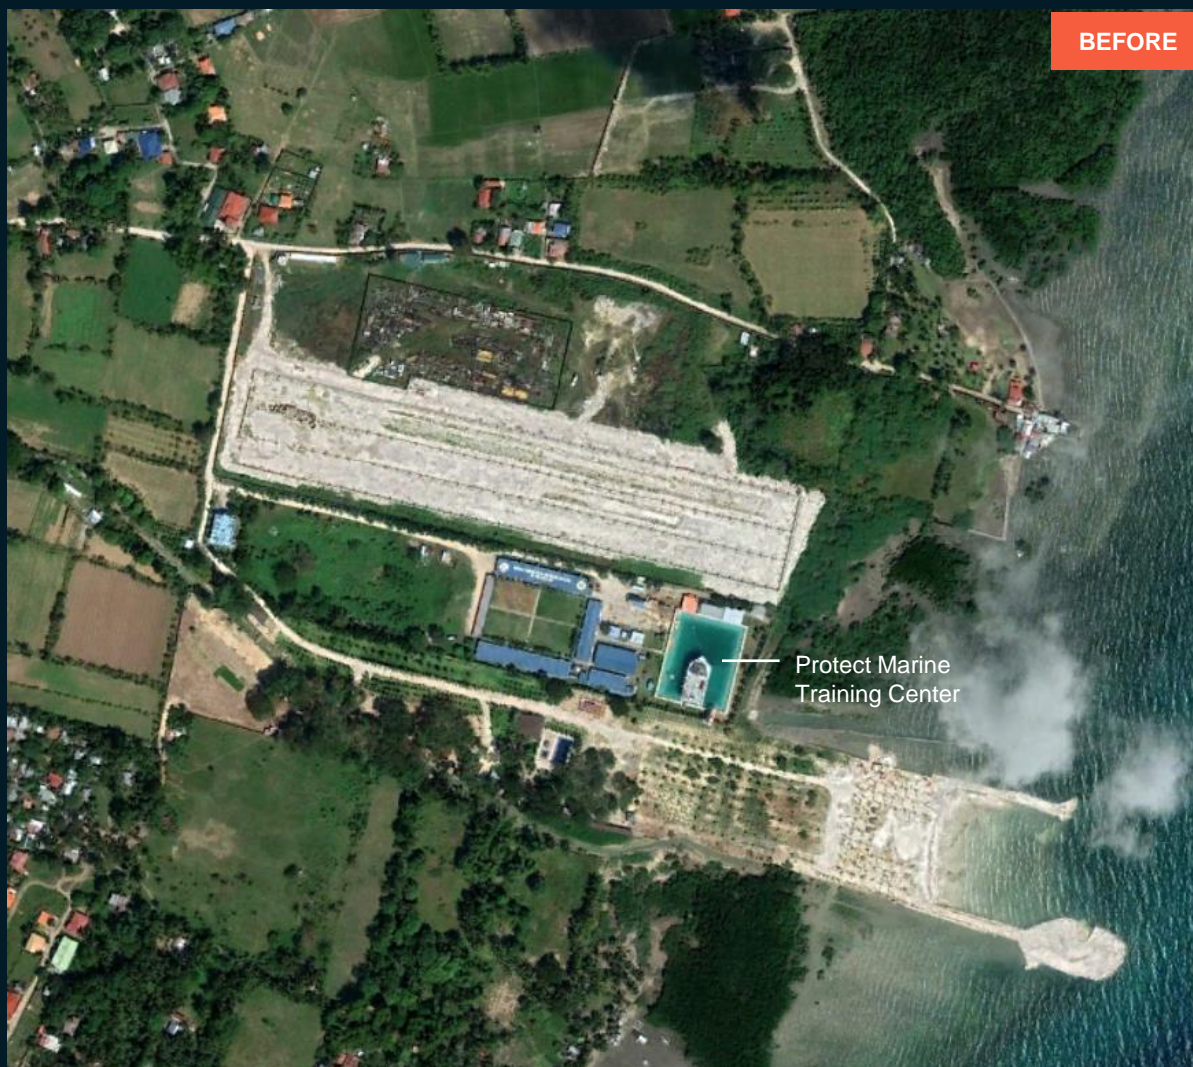
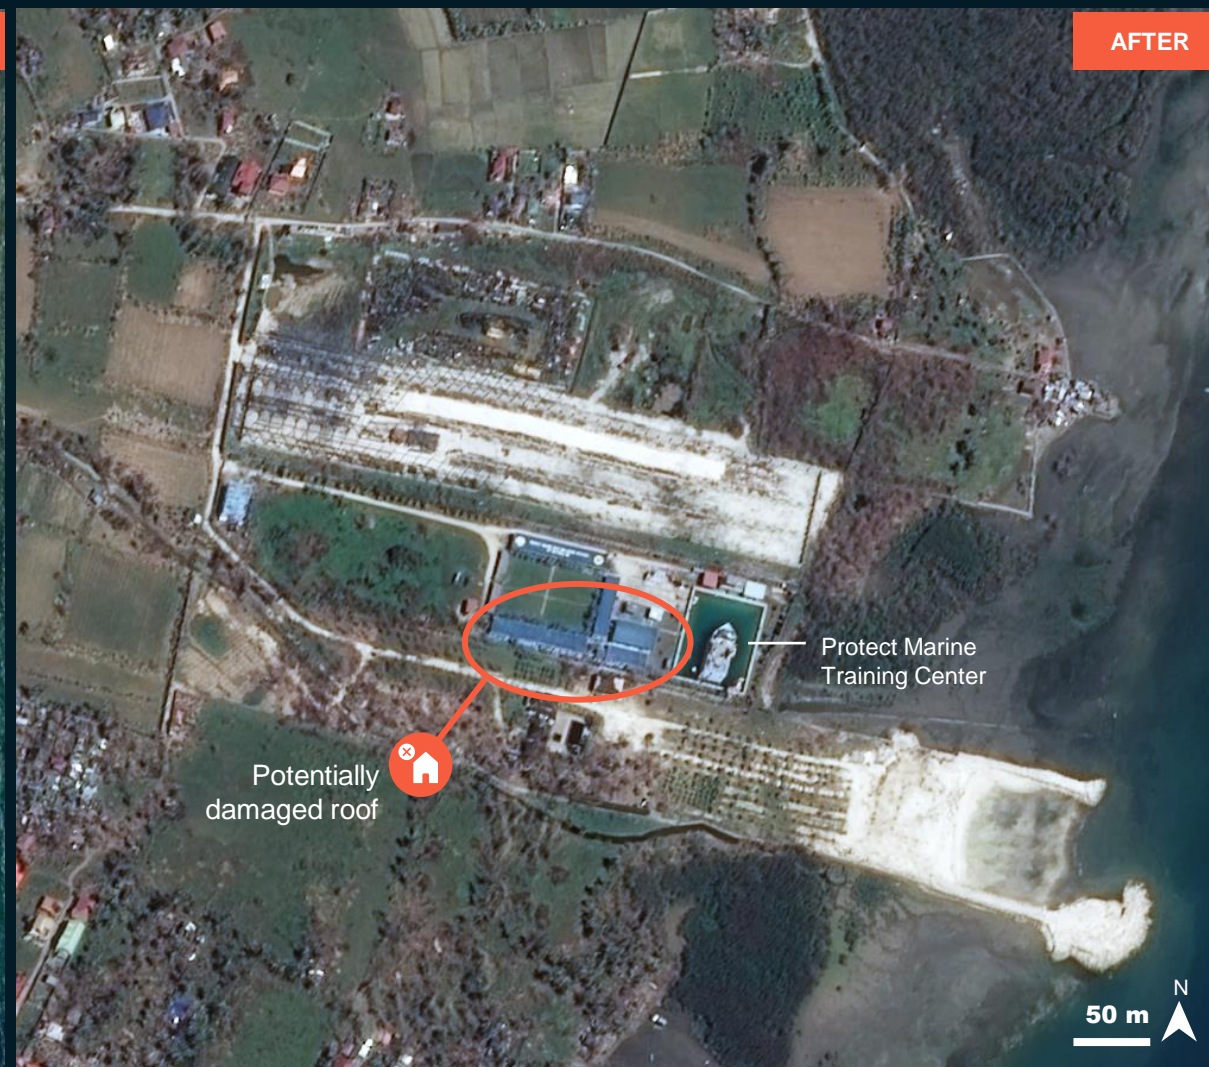
AOI 1-1 : PROTECT MARINE TRAINING CENTER, CARCAR CITY, CEBU, REGION VII (CENTRAL VISAYAS)

Potentially damaged roof

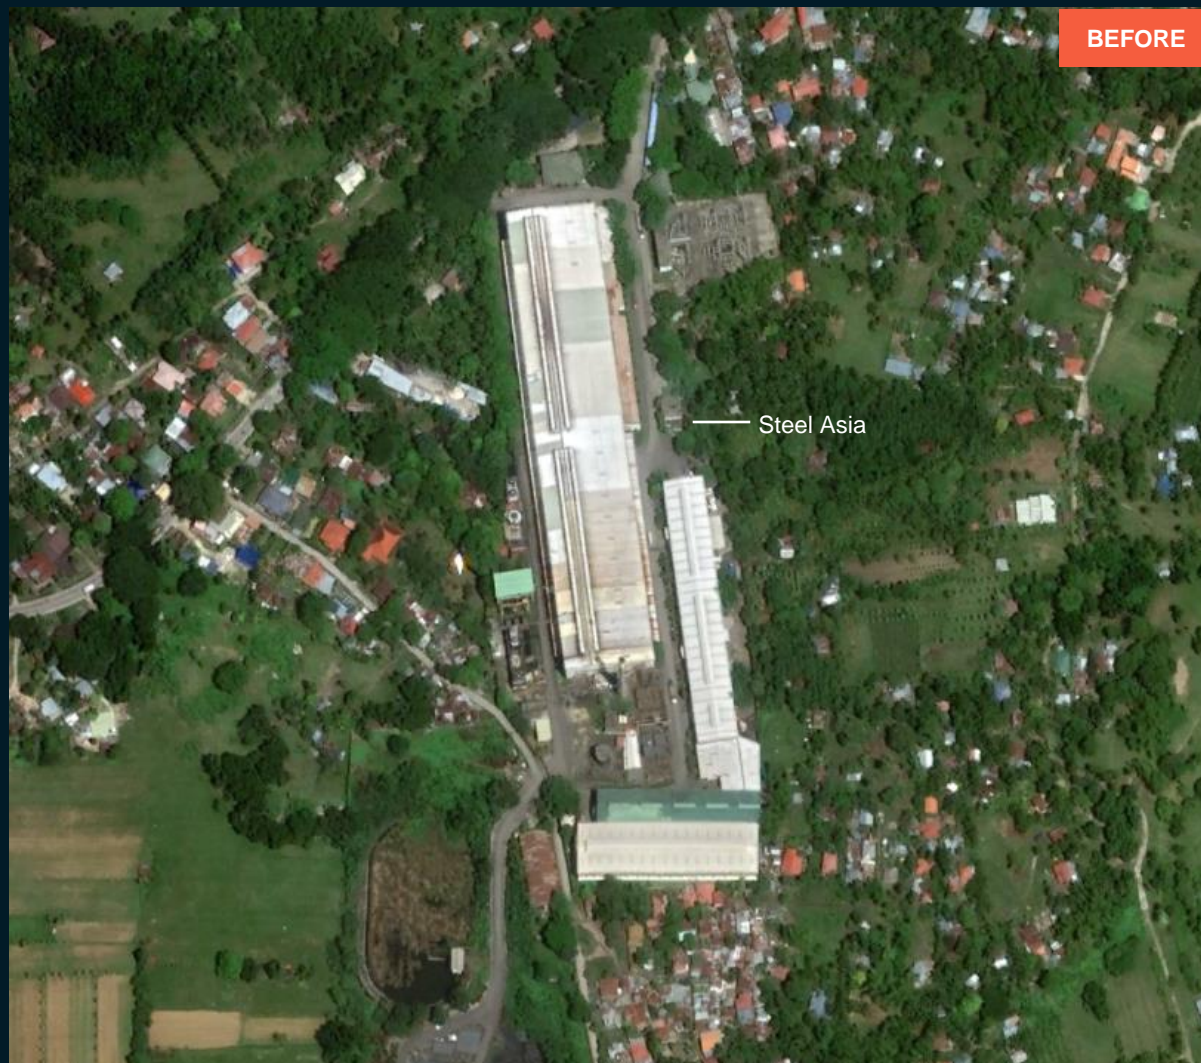
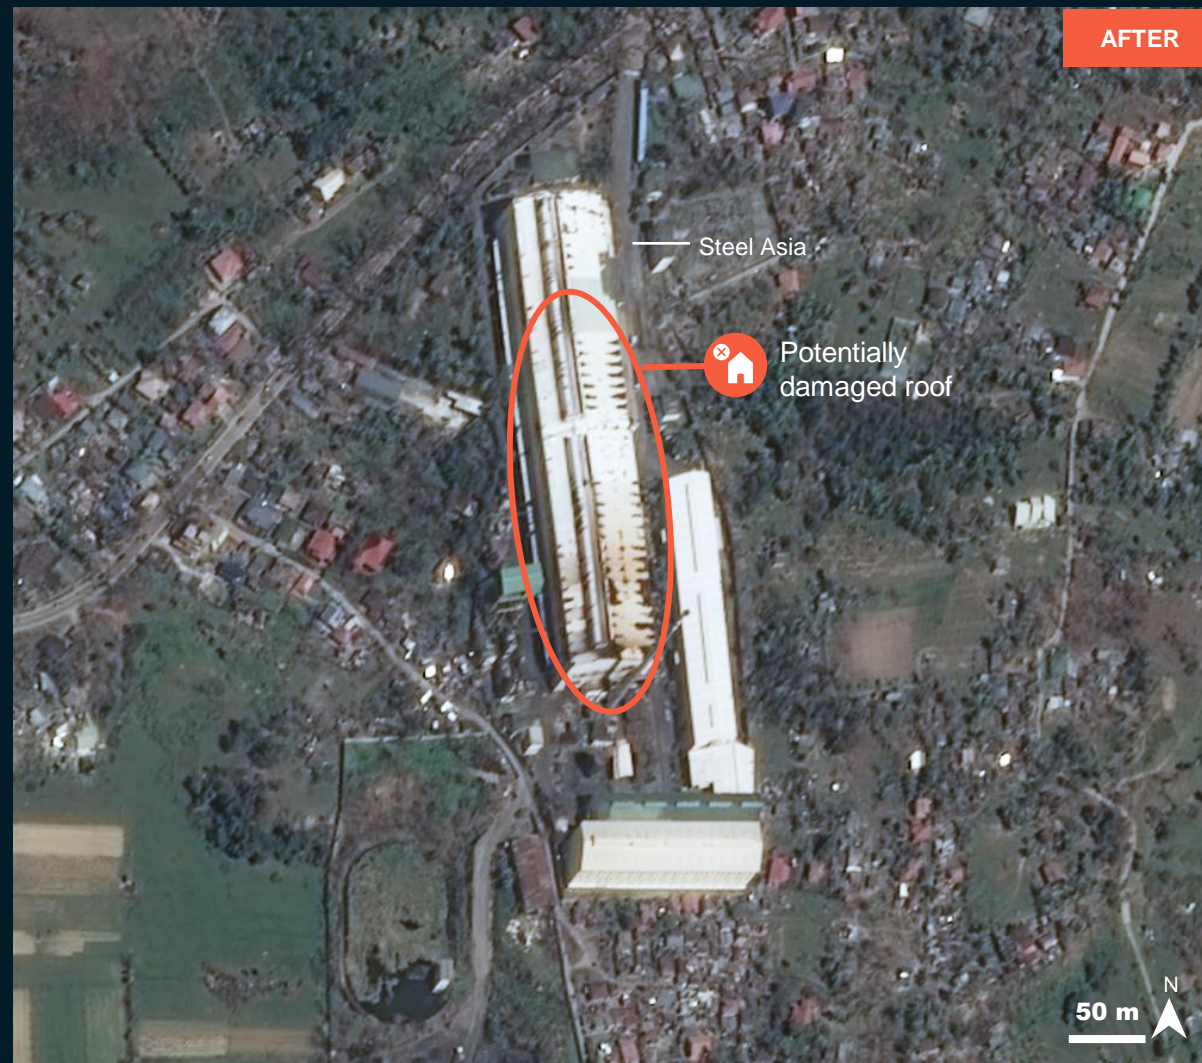
AOI 1-2 : STEEL ASIA, CARCAR CITY, CEBU PROVINCE, REGION VII (CENTRAL VISAYAS)

Potentially damaged roof

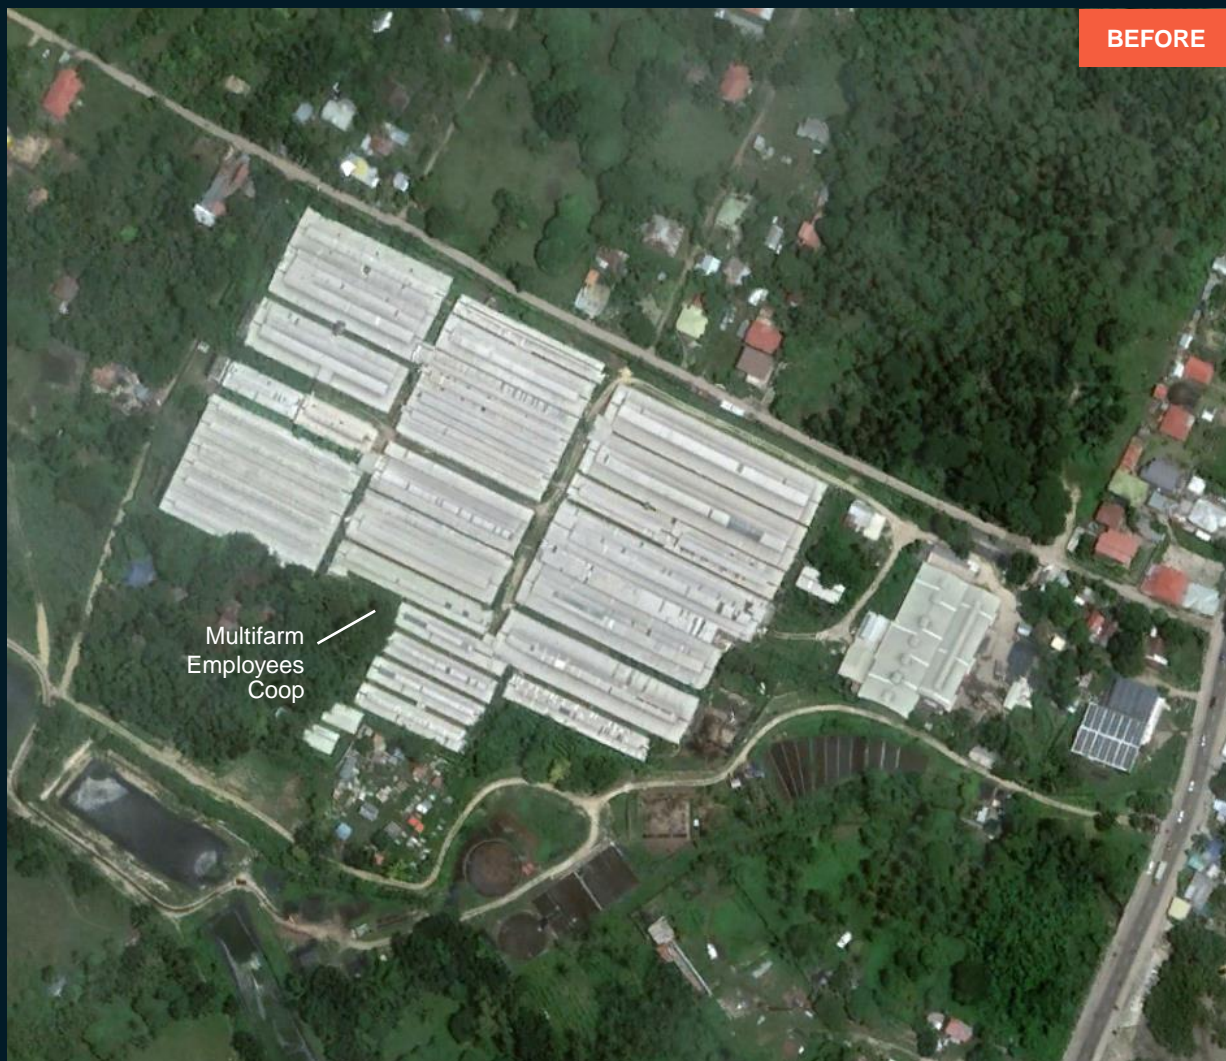
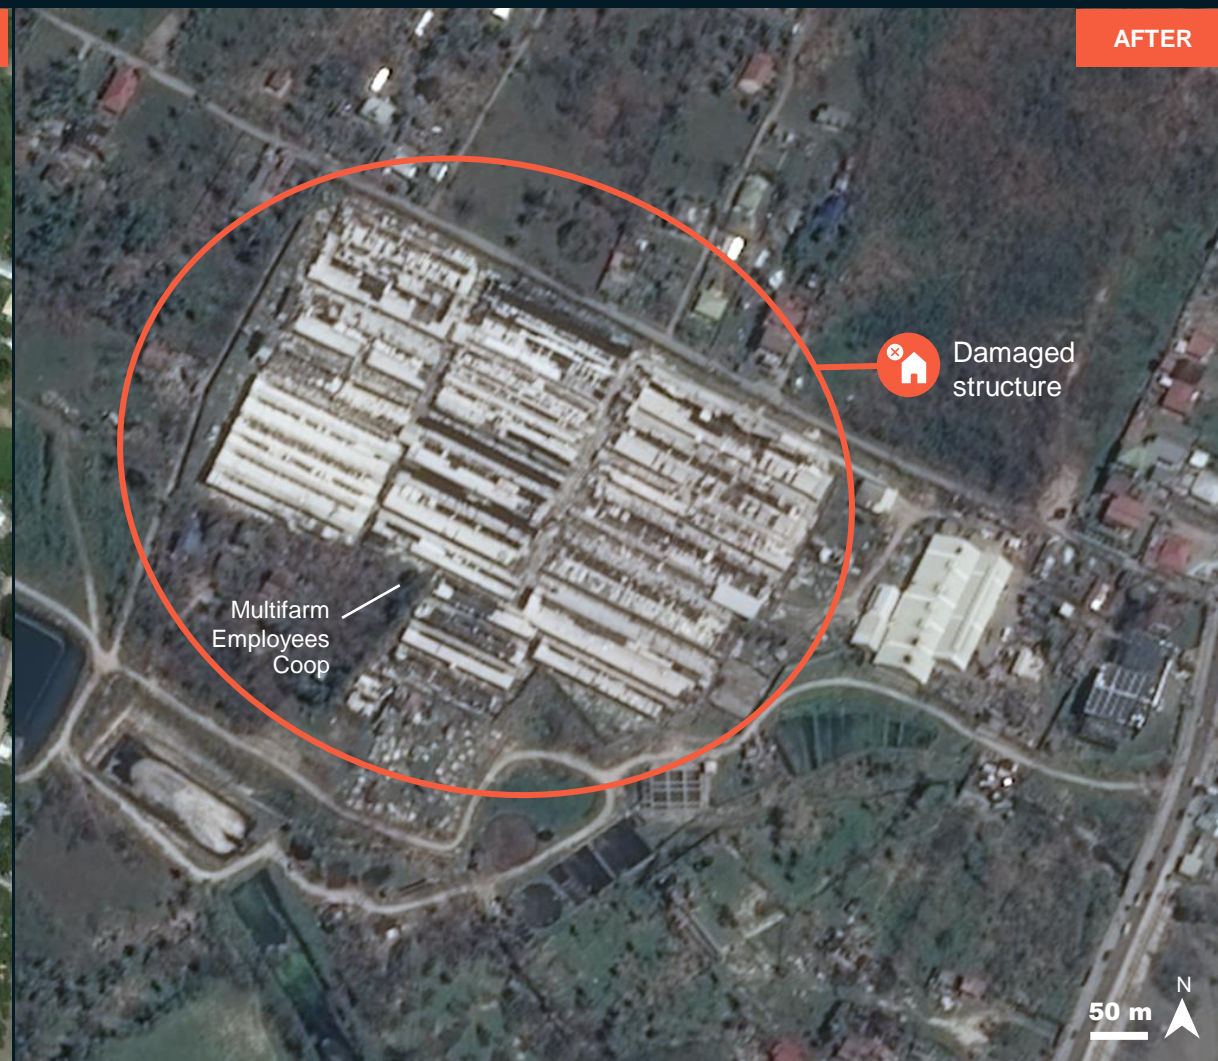
AOI 1-3 : MULTIFARM EMPLOYEES COOP, SAN FERNANDO, CEBU PROVINCE, REGION VII

Widespread damaged structure

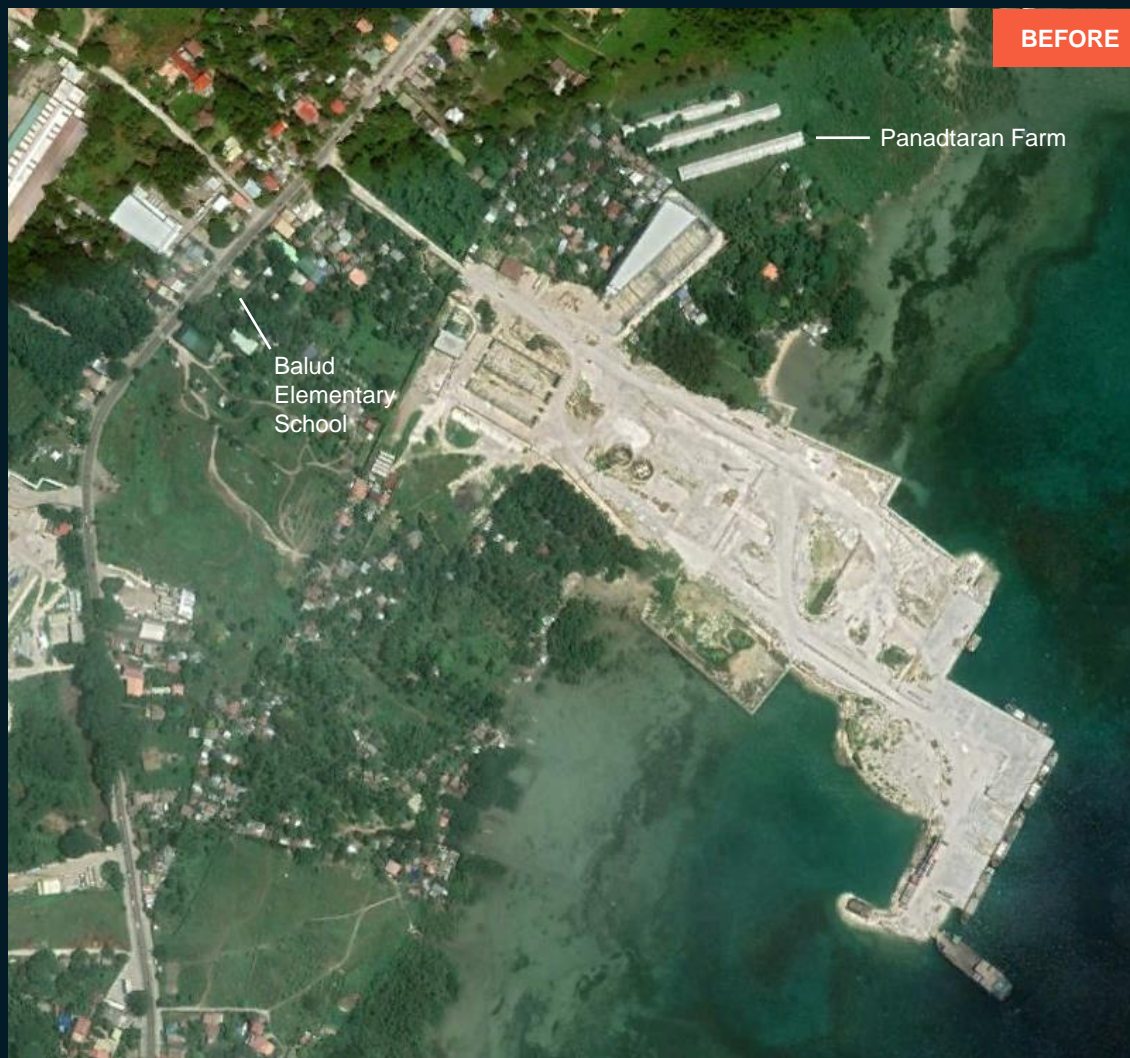
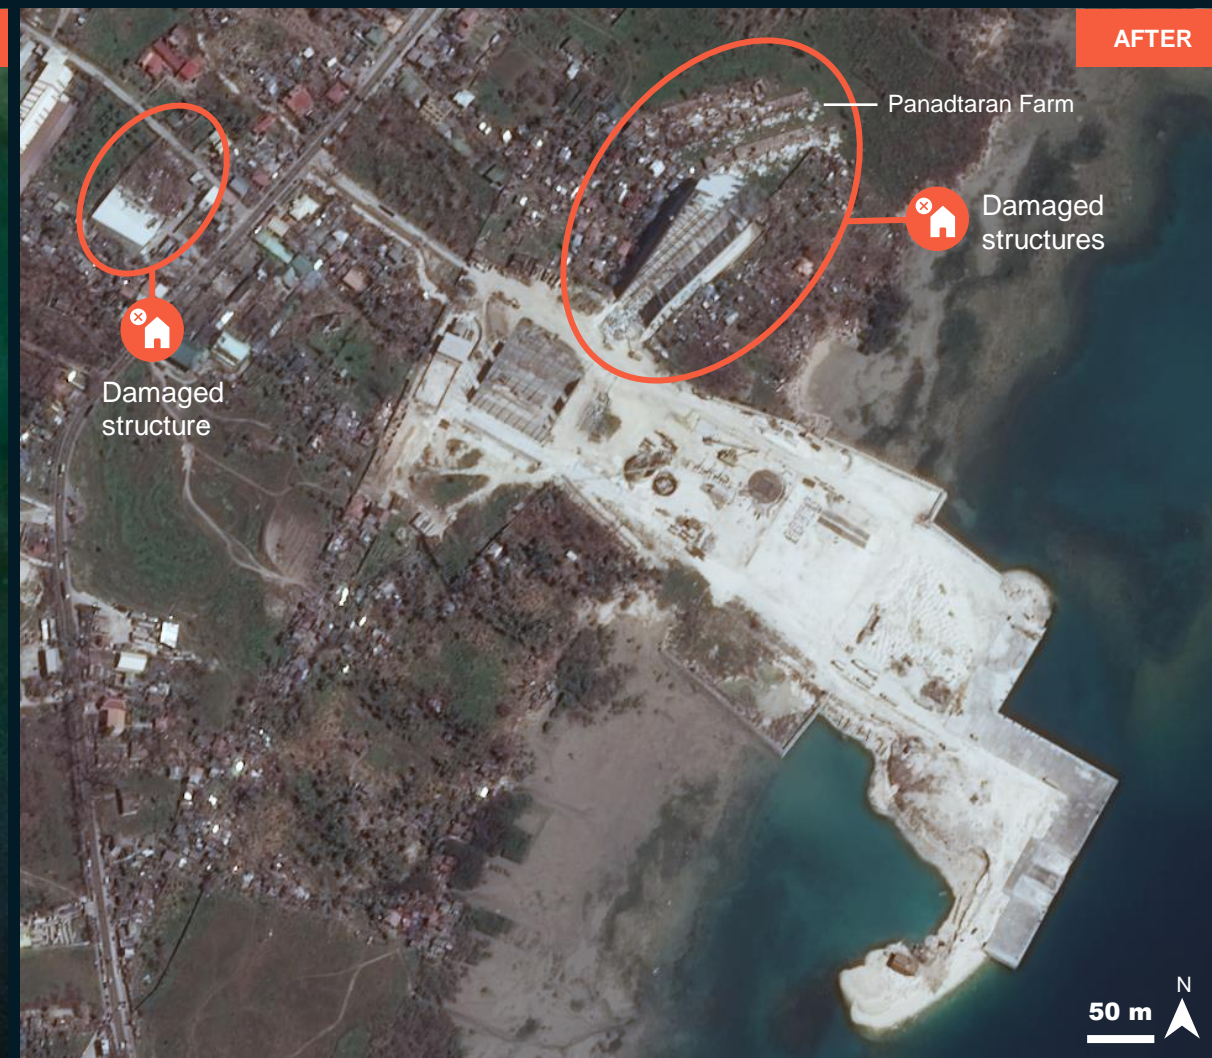
AOI 1-4: PANADTARAN FARM, SAN FERNANDO, CEBU PROVINCE, REGION VII (CENTRAL VISAYAS)

Damaged structures

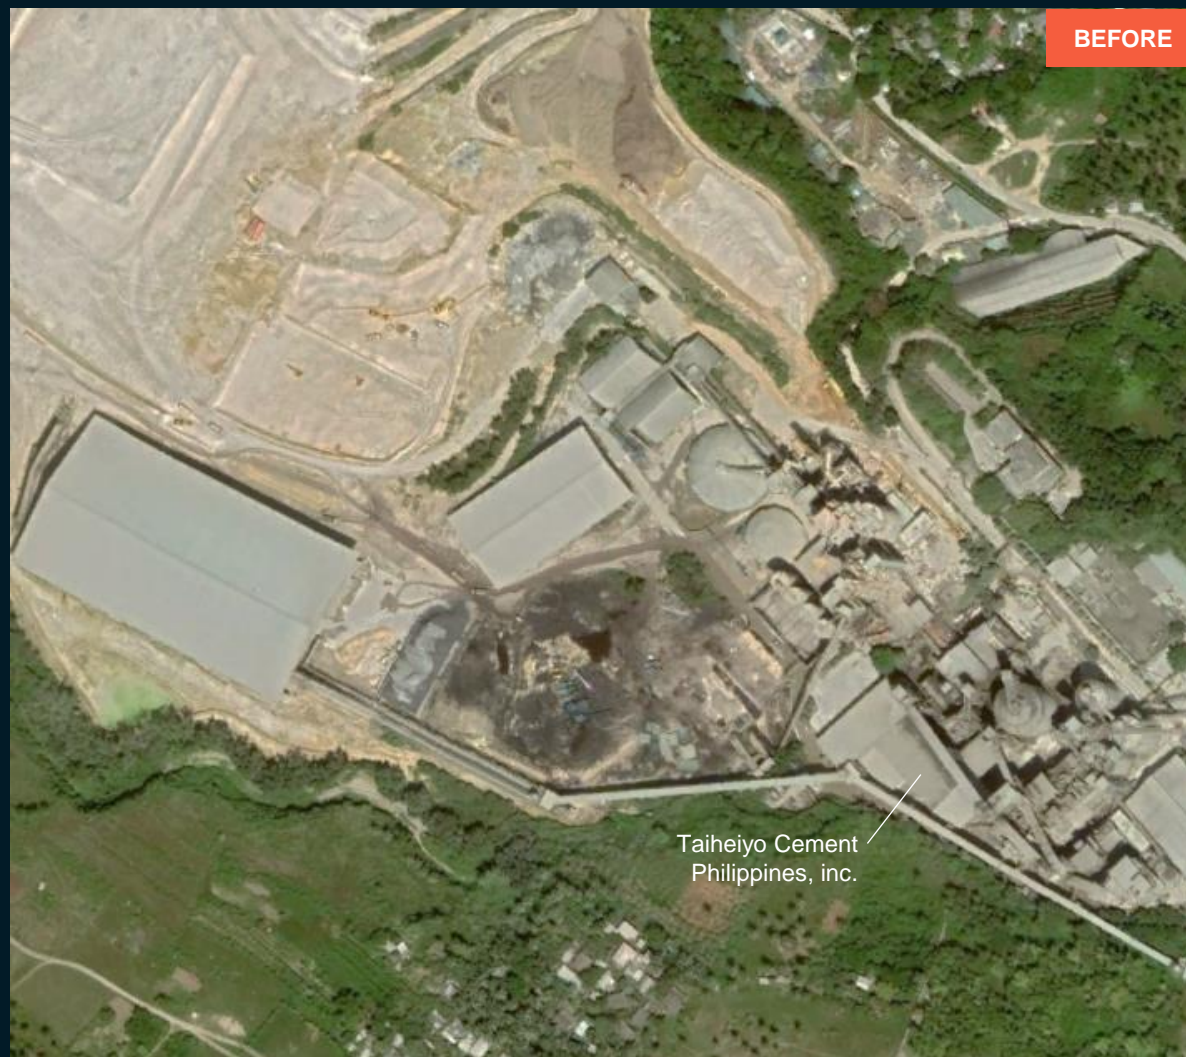
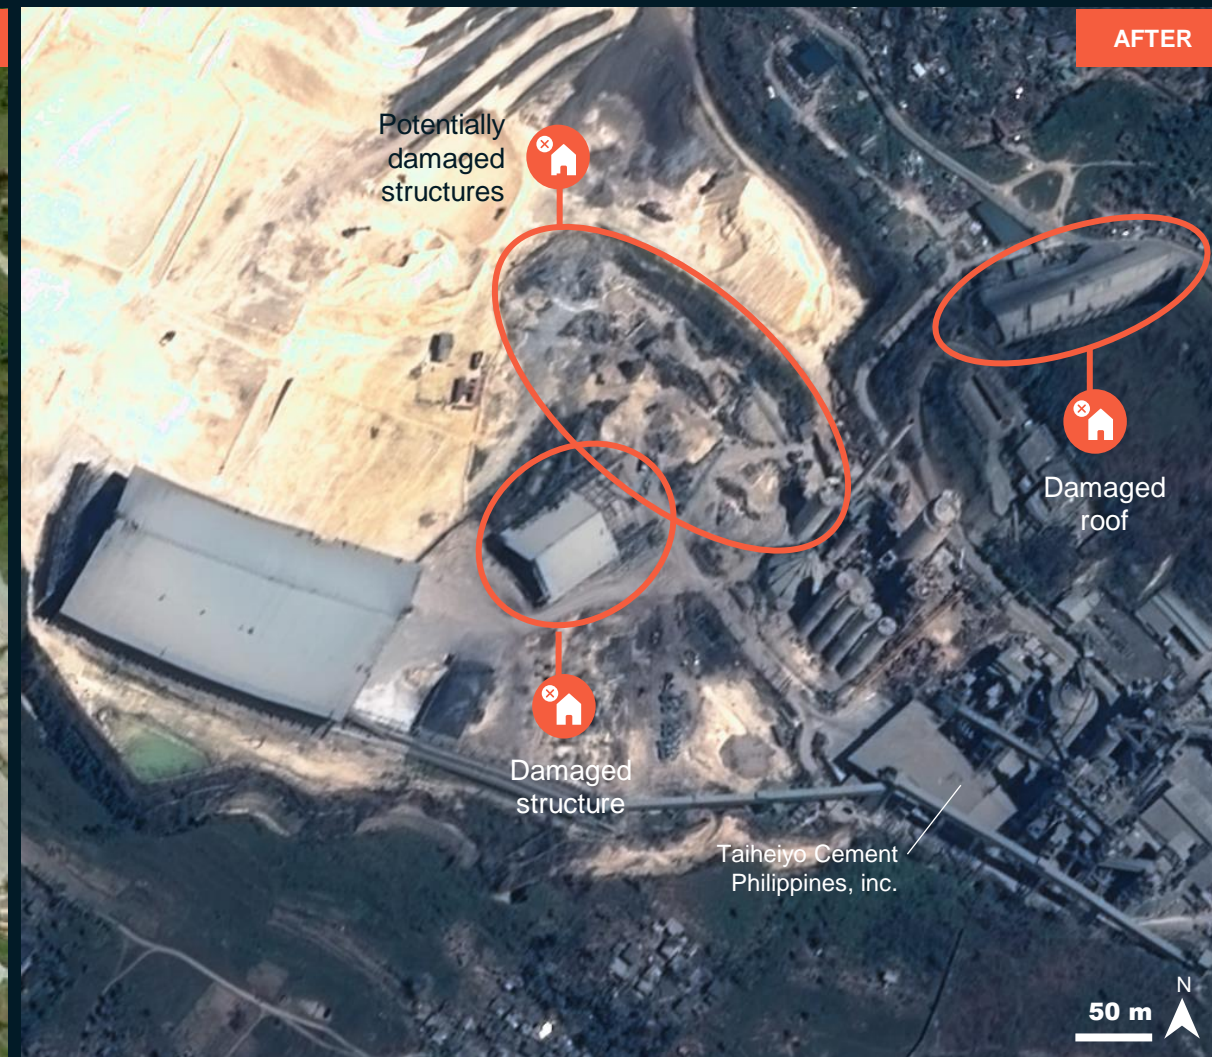
AOI 1-5 : TAIHEIYO CEMENT PHILIPPINES, INC. SAN FERNANDO, CEBU PROVINCE, REGION VII

Damaged structures and roof in the industrial factory

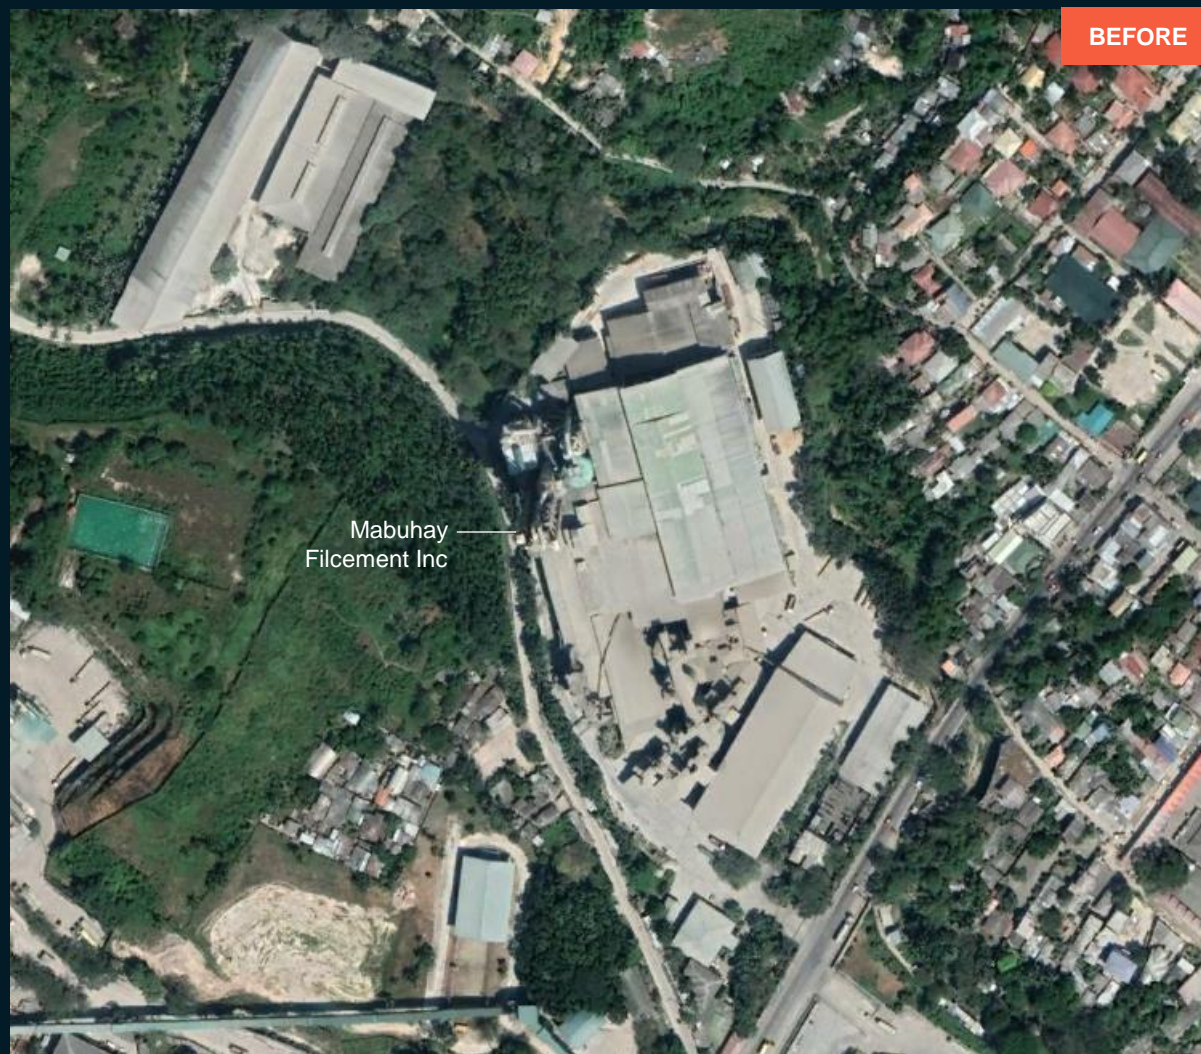
AOI 1-6: MABUHAY FILCEMENT INC SAN FERNANDO, CEBU, REGION VII (CENTRAL VISAYAS)

Damaged structures and roof in the industrial factory

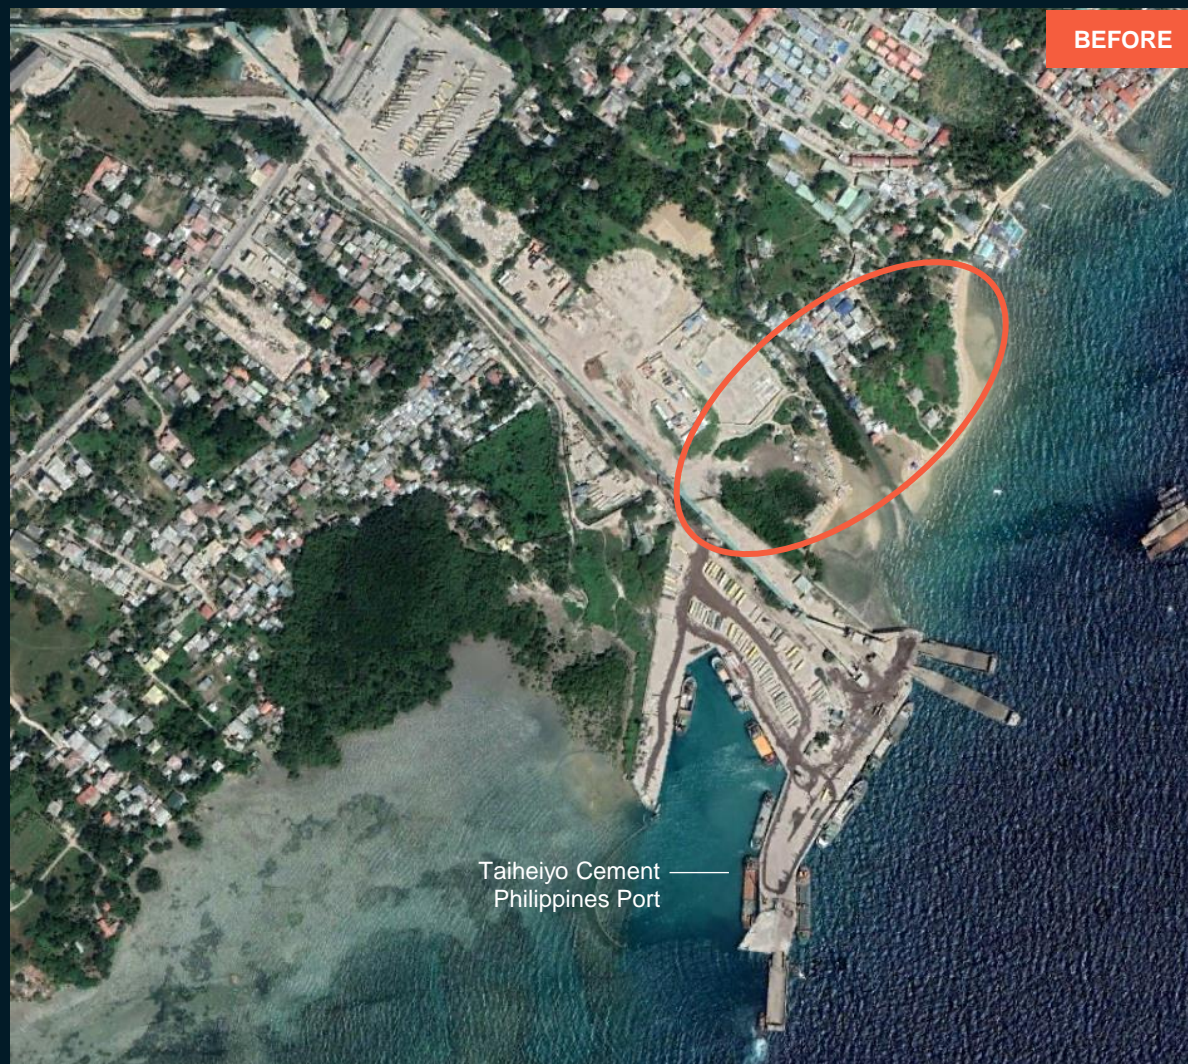
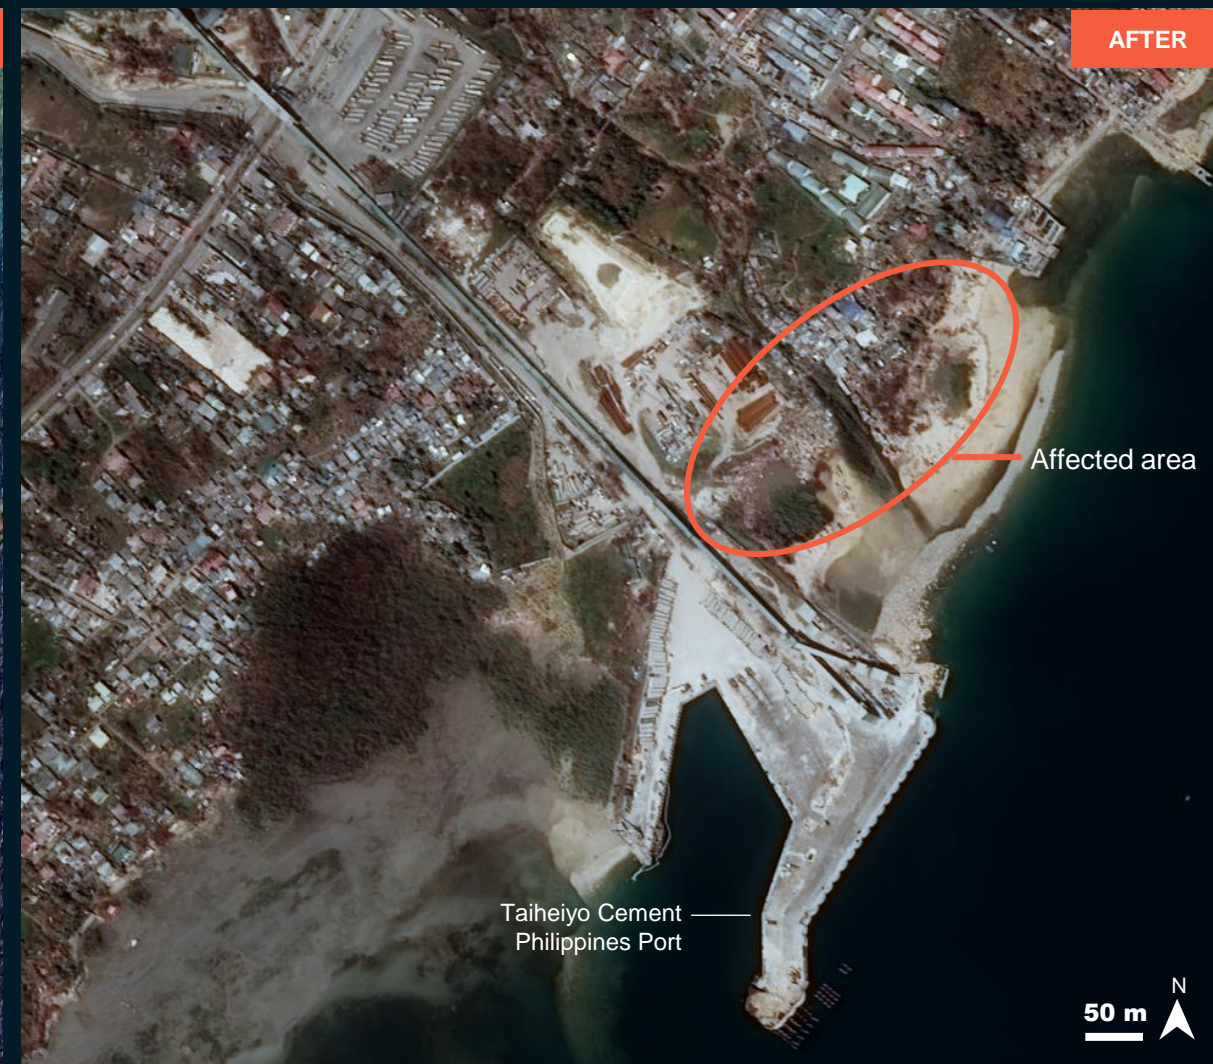
AOI 1-7: TAIHEIYO CEMENT PHILIPPINES PORT SAN FERNANDO, CEBU, REGION VII (CENTRAL VISAYAS)

Affected area along the shoreline

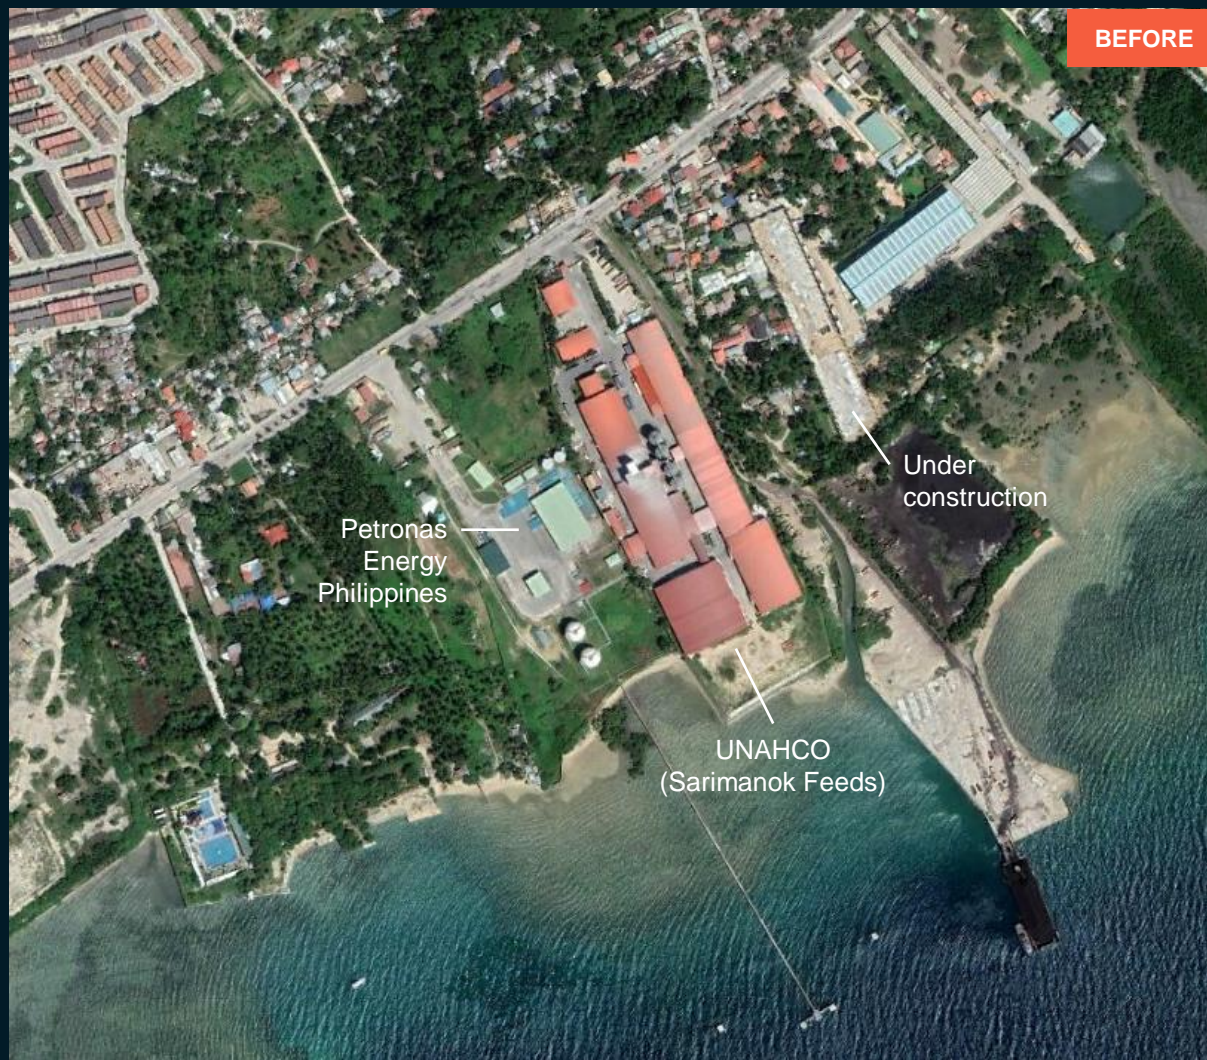
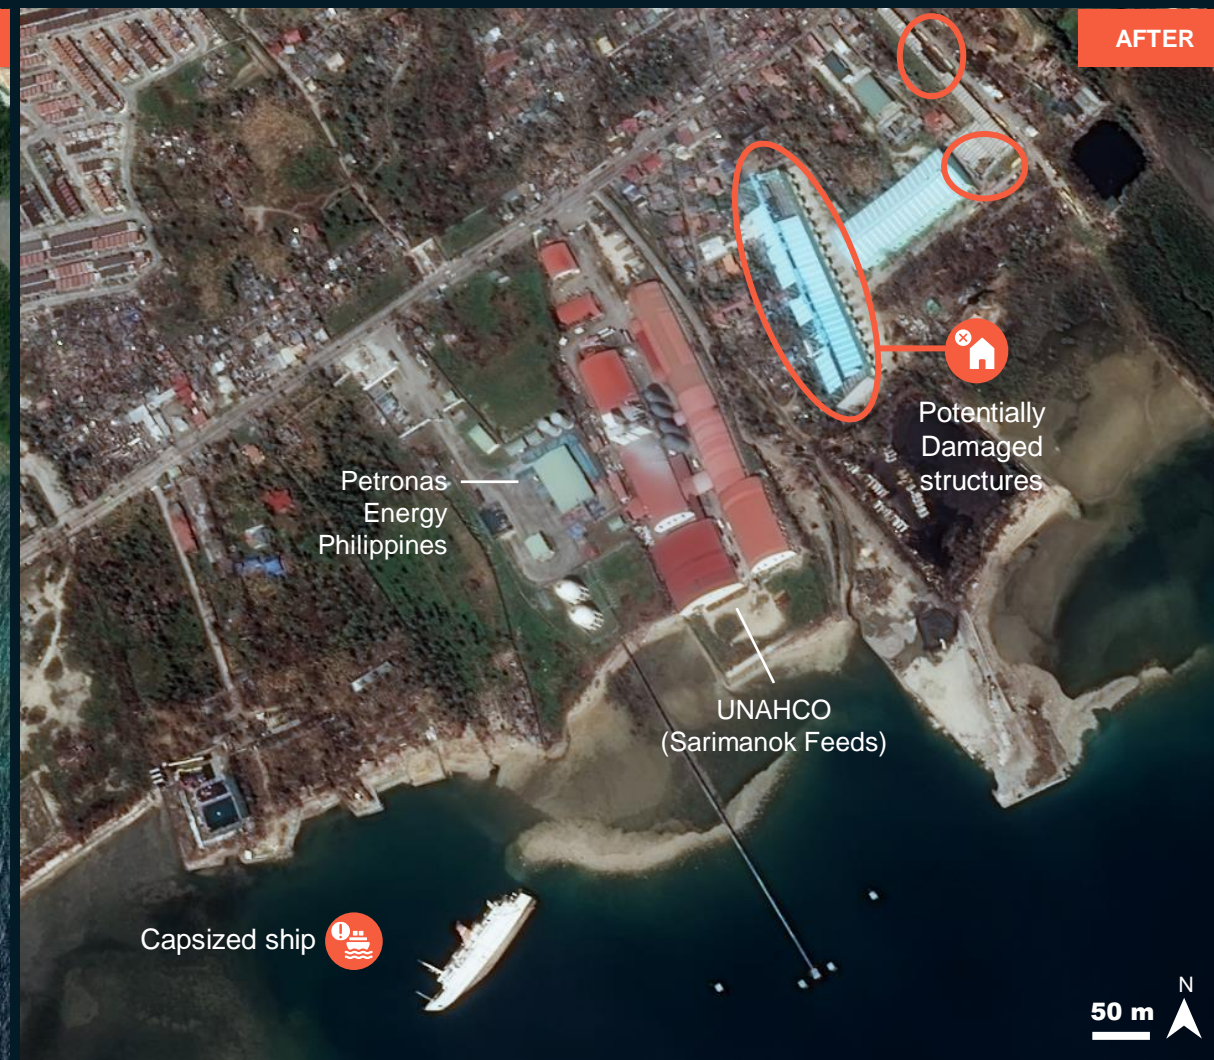
AOI 1-8: UNAHCO (SARIMANOK FEEDS), GUANZON BEACH SAN FERNANDO, CEBU, REGION VII (CENTRAL VISAYAS)

Damaged structures and capsized ship

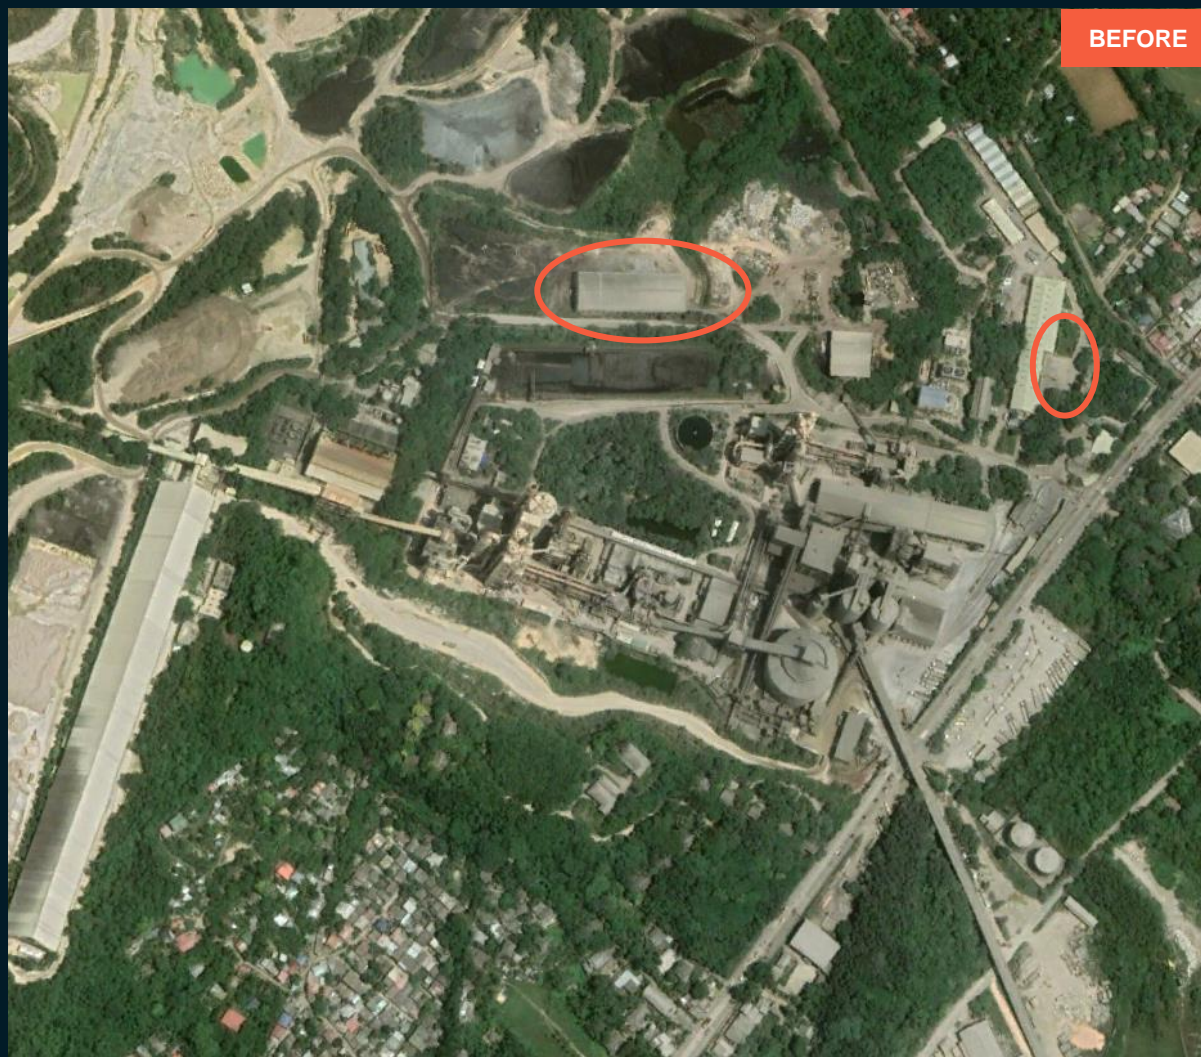
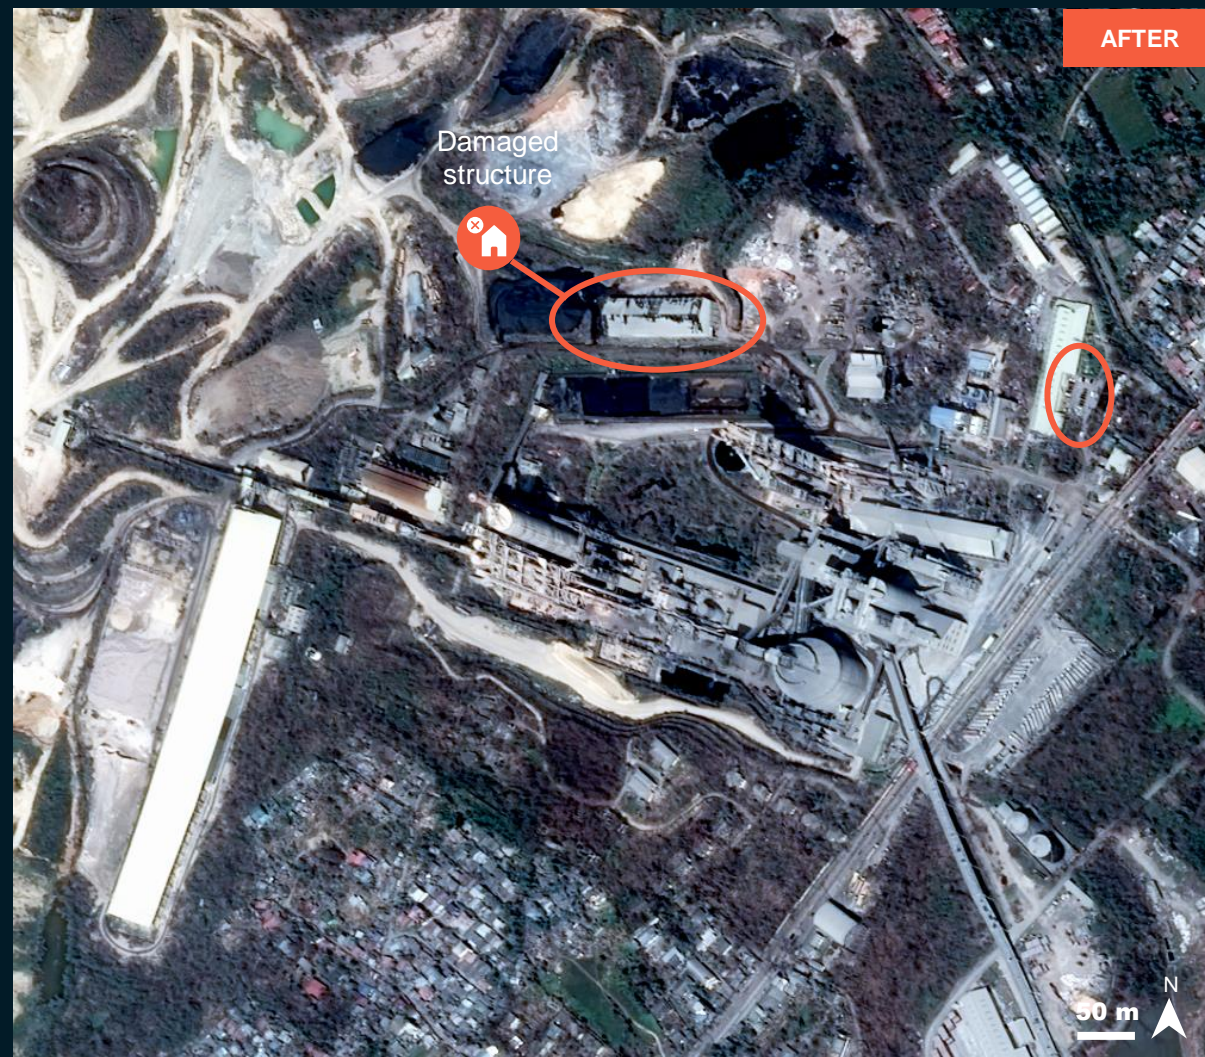
AOI 1-9: CITY OF NAGA, CEBU, REGION VII (CENTRAL VISAYAS)

Damaged structures in the industrial factory
