27 December 2021

TROPICAL CYCLONE RAI-21

PRELIMINARY SATELLITE-DERIVED INDUSTRIAL SITES IMPACT ANALYSIS IN CEBU & NAGA

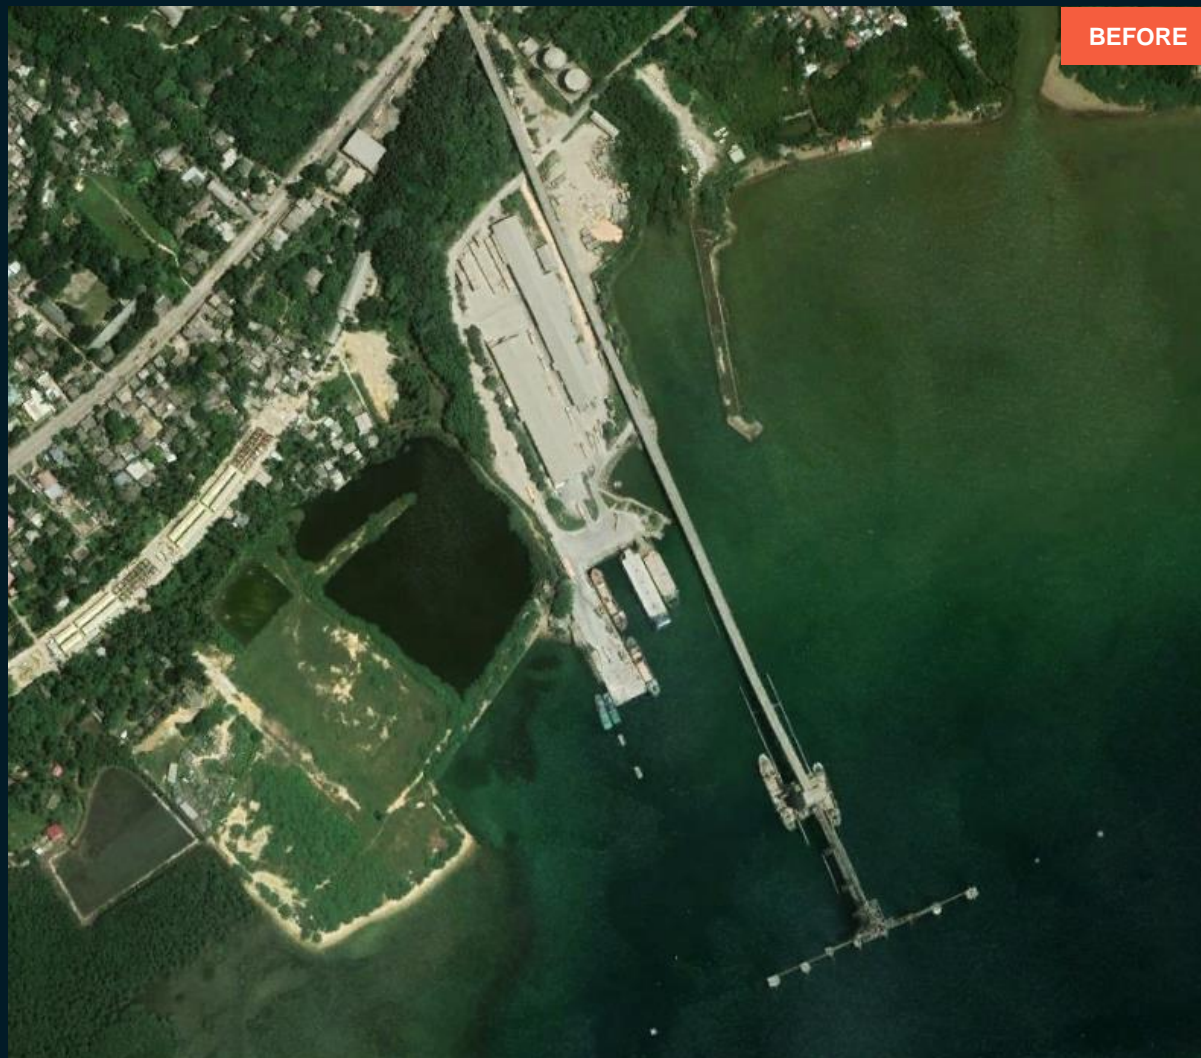
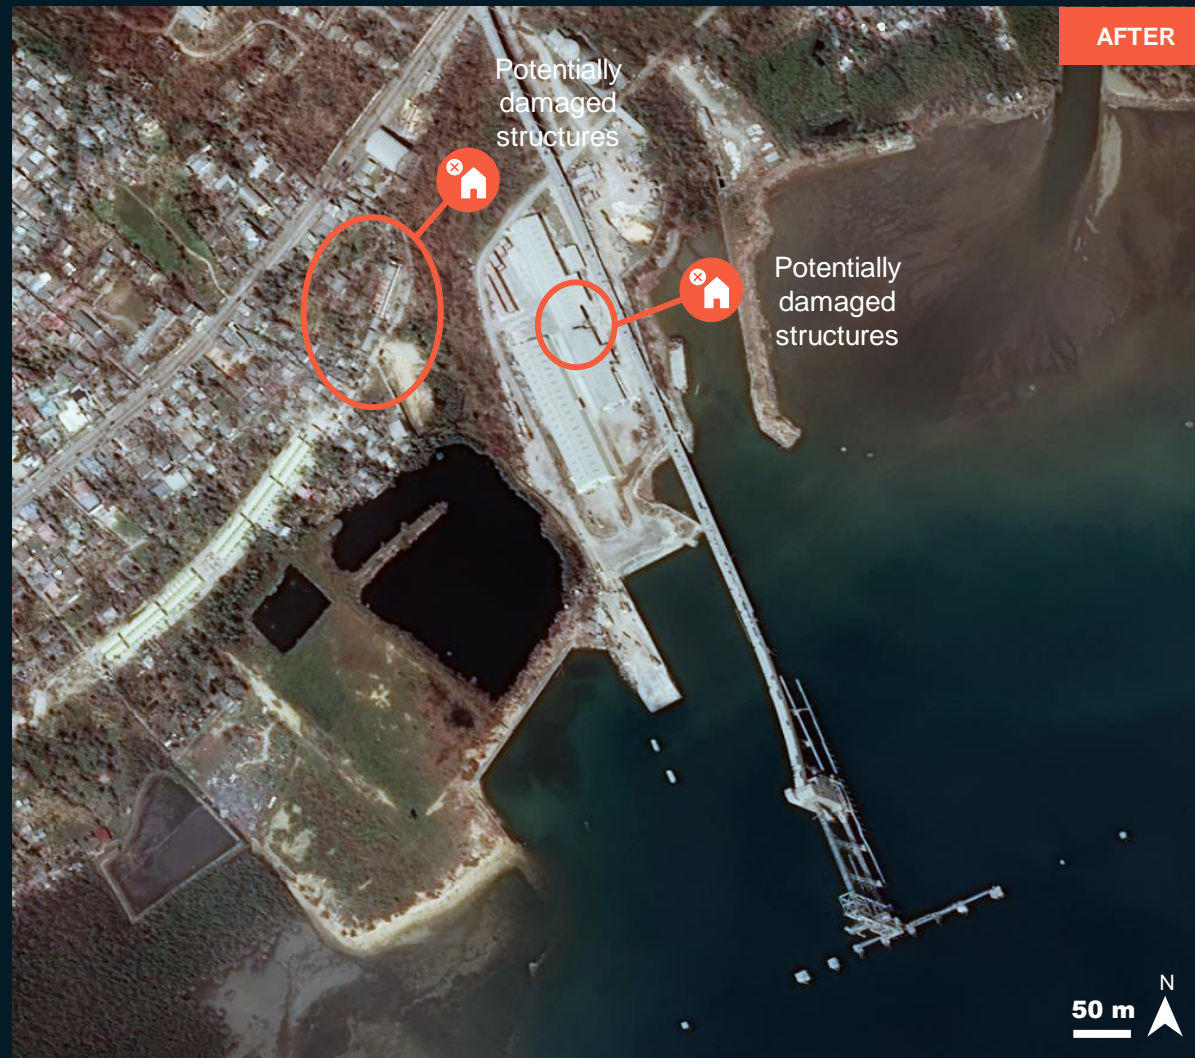
AOI 1-10: CITY OF NAGA, CEBU PROVINCE, REGION VII (CENTRAL VISAYAS)

Potentially damaged structures in the port

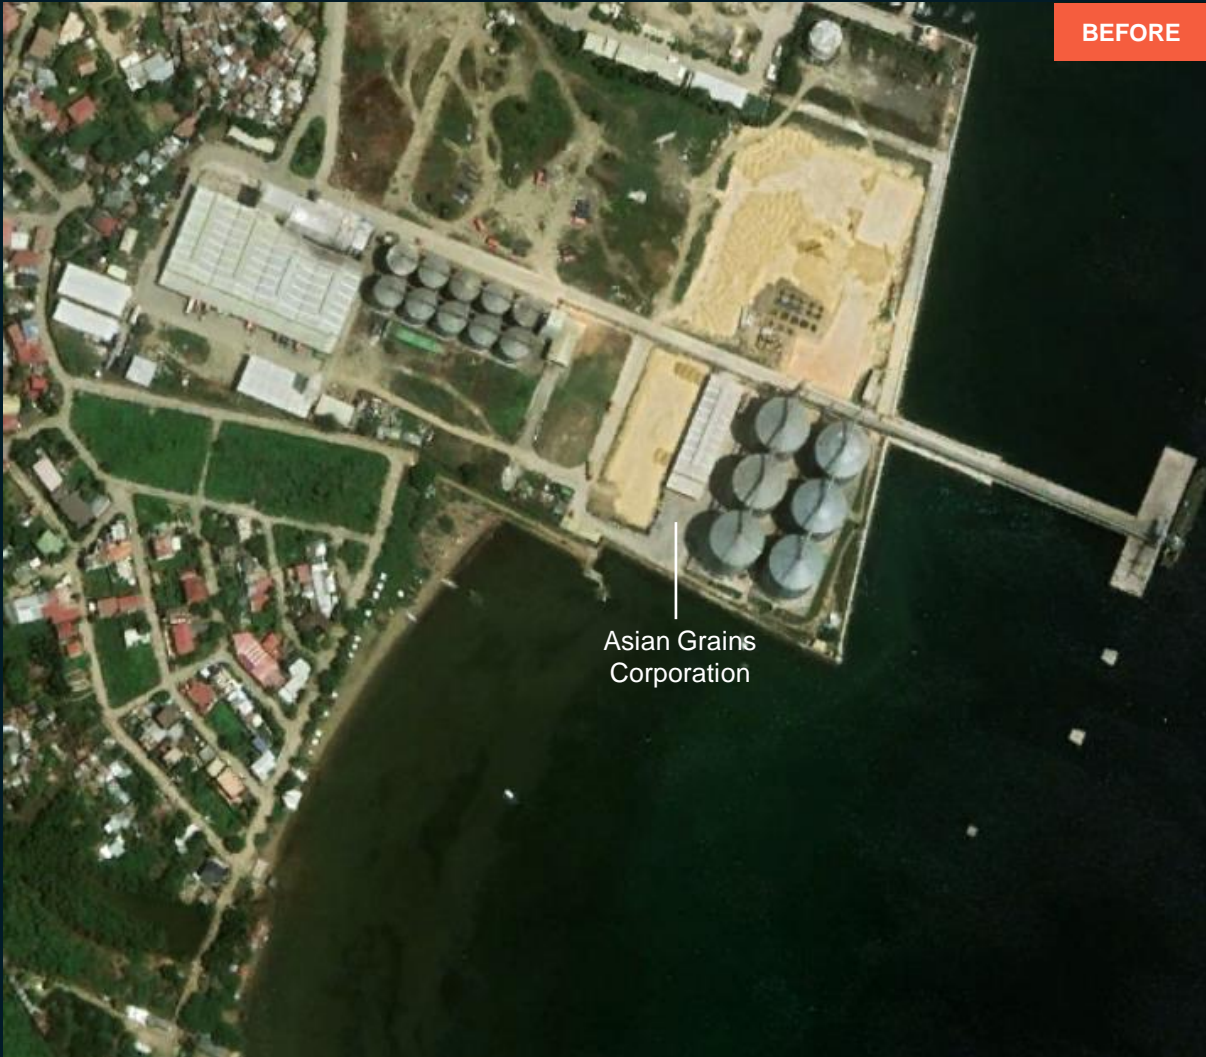
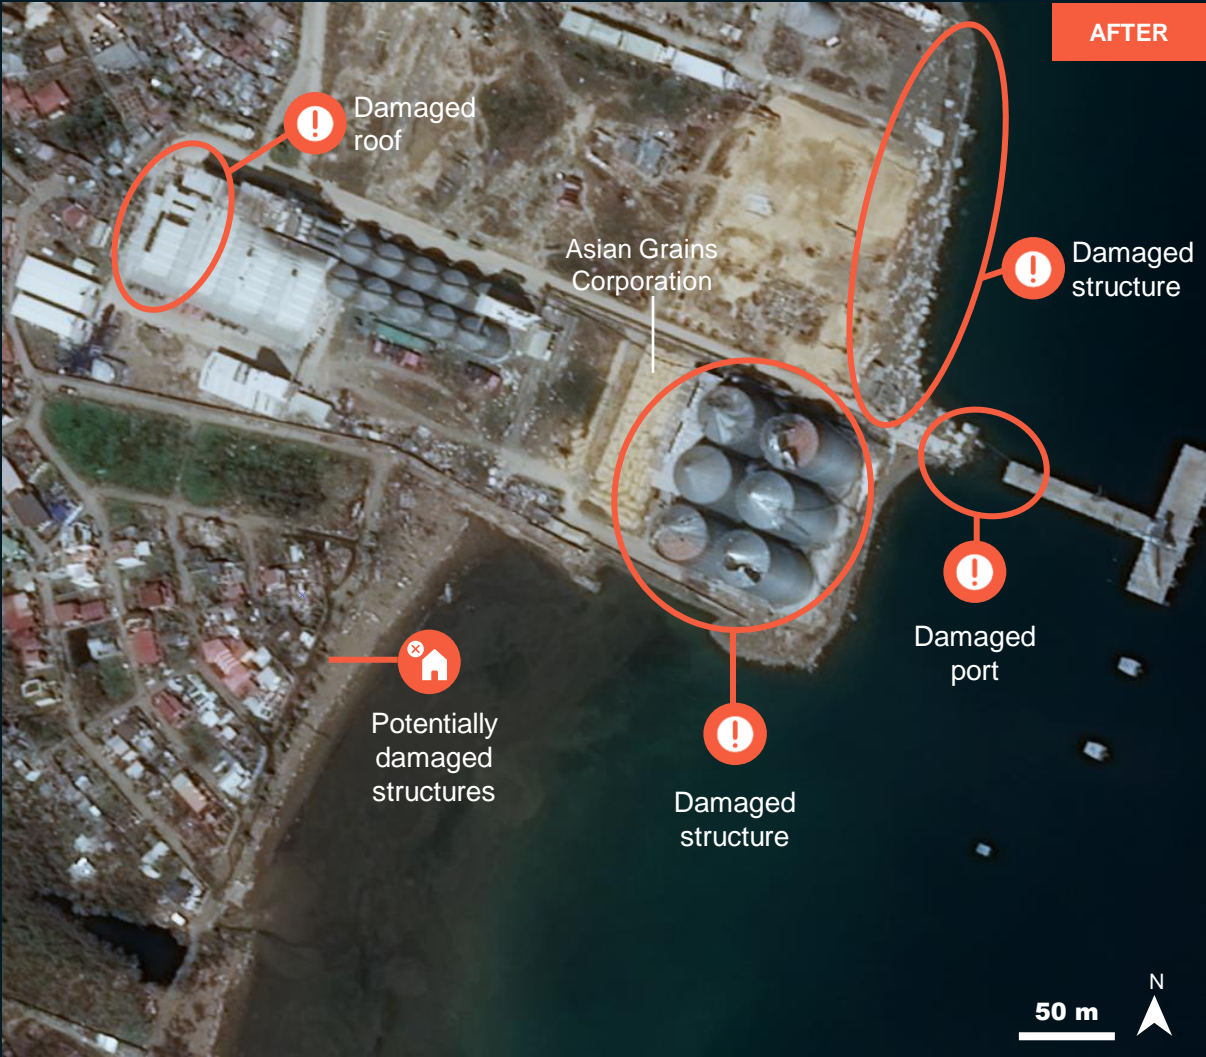
AOI 1-11: ASIAN GRAINS CORPORATION, CITY OF NAGA, CEBU PROVINCE, REGION VII

Damaged industrial infrastructures

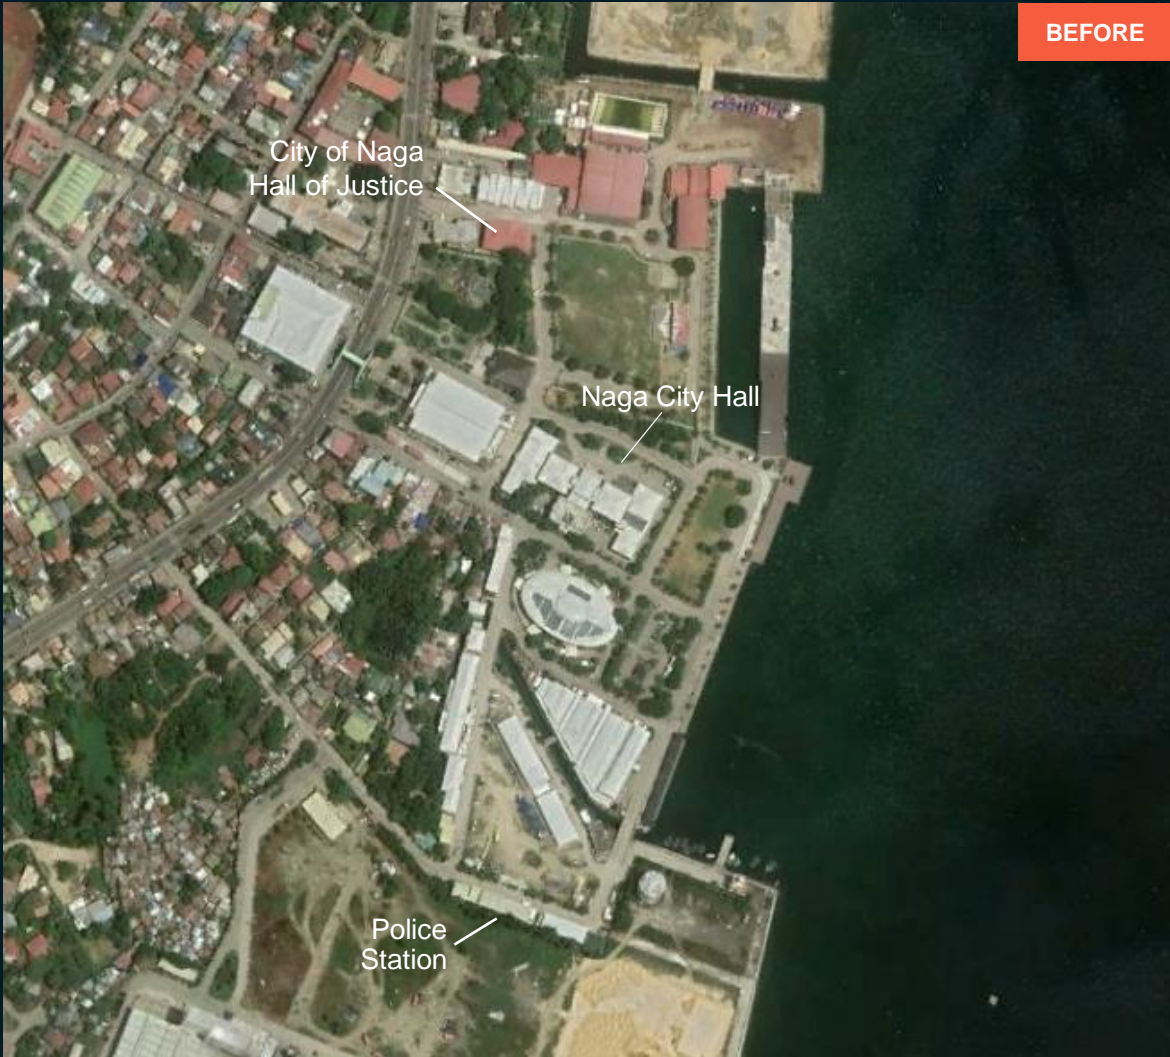
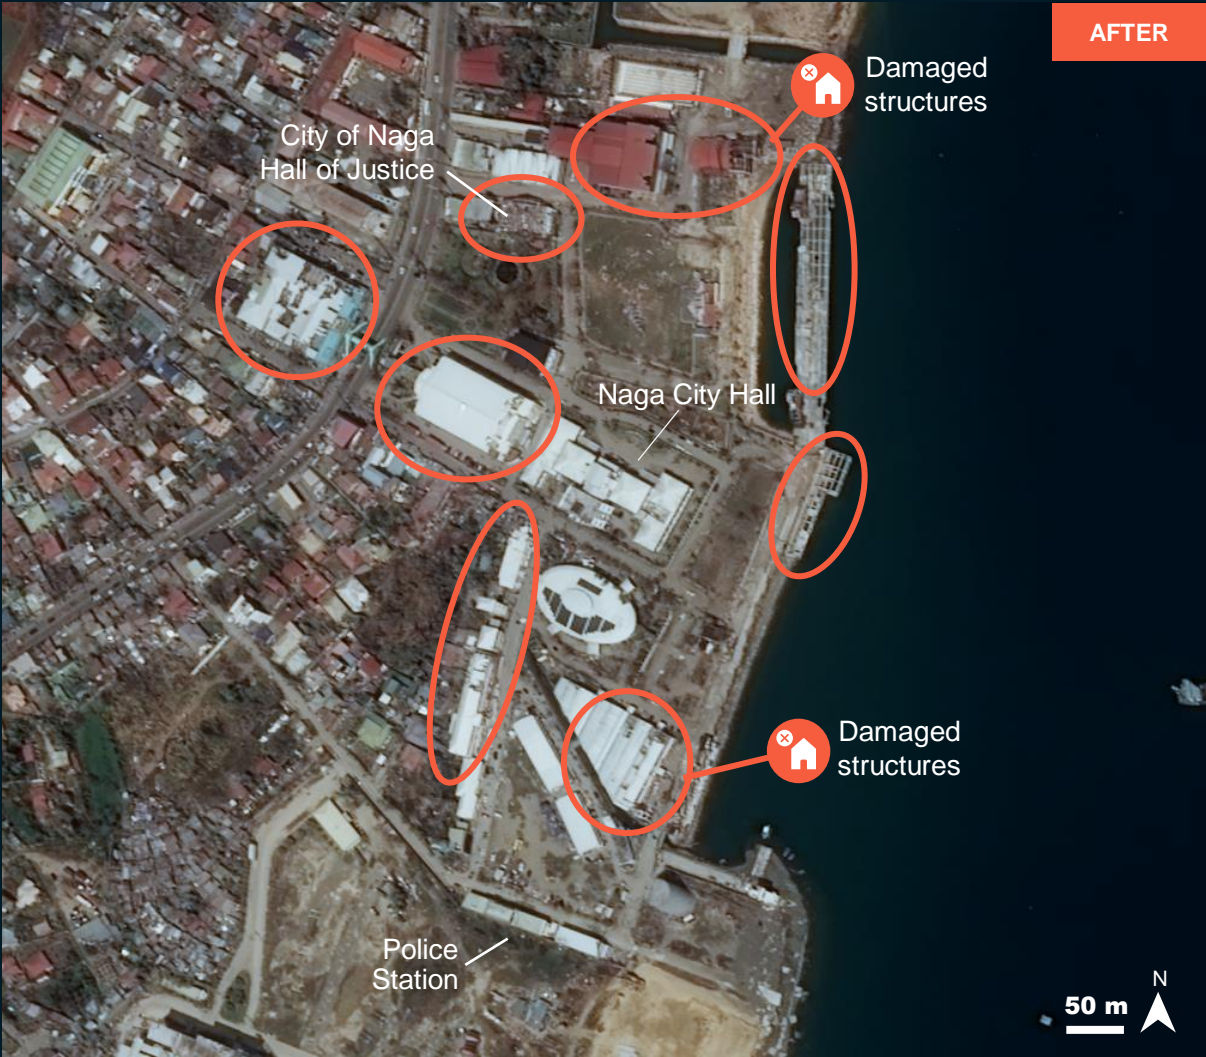
AOI 1-12: CITY OF NAGA, CEBU, REGION VII (CENTRAL VISAYAS)

Damaged structures

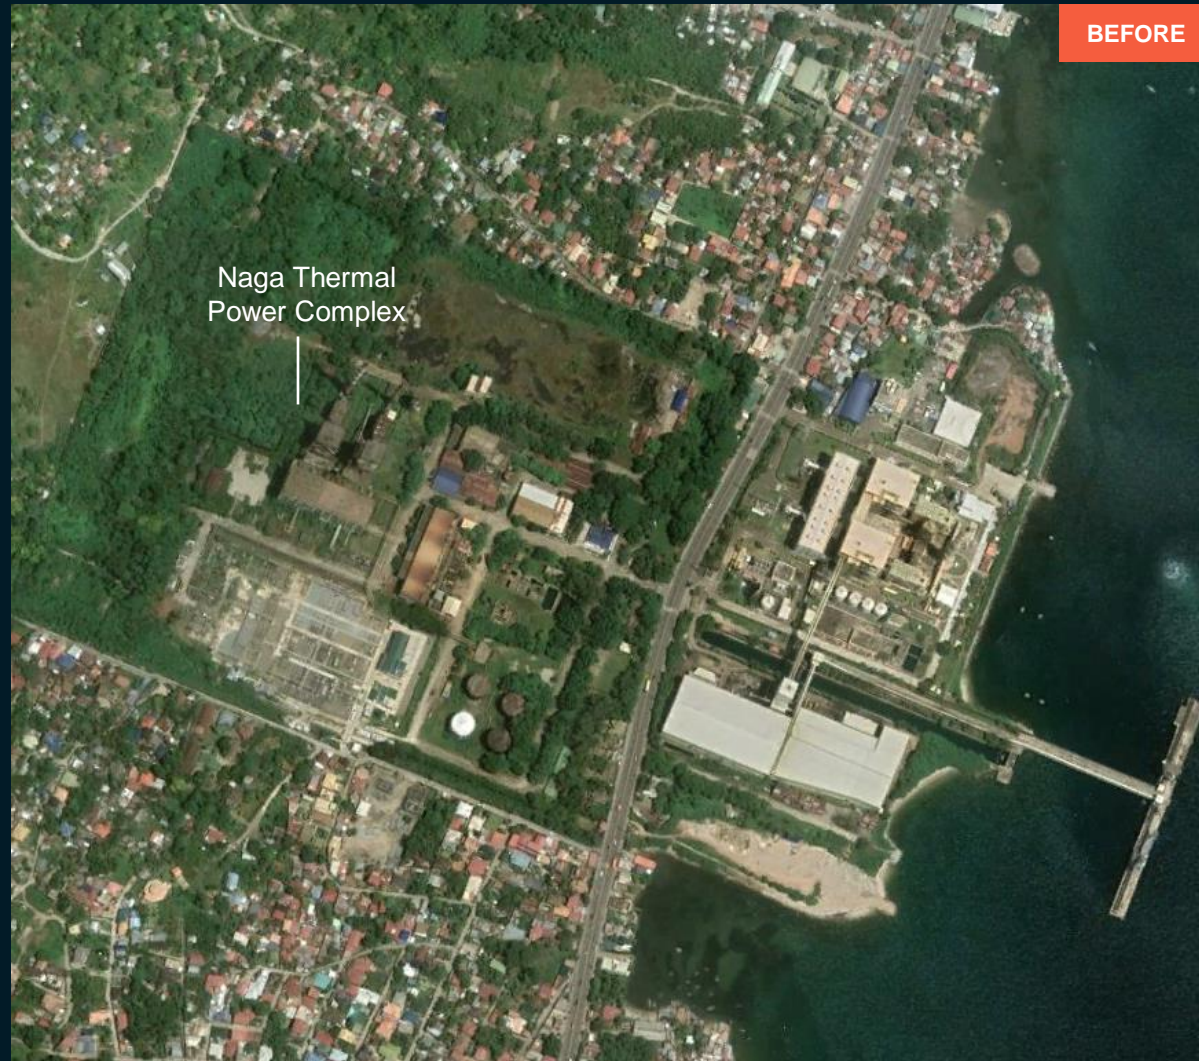
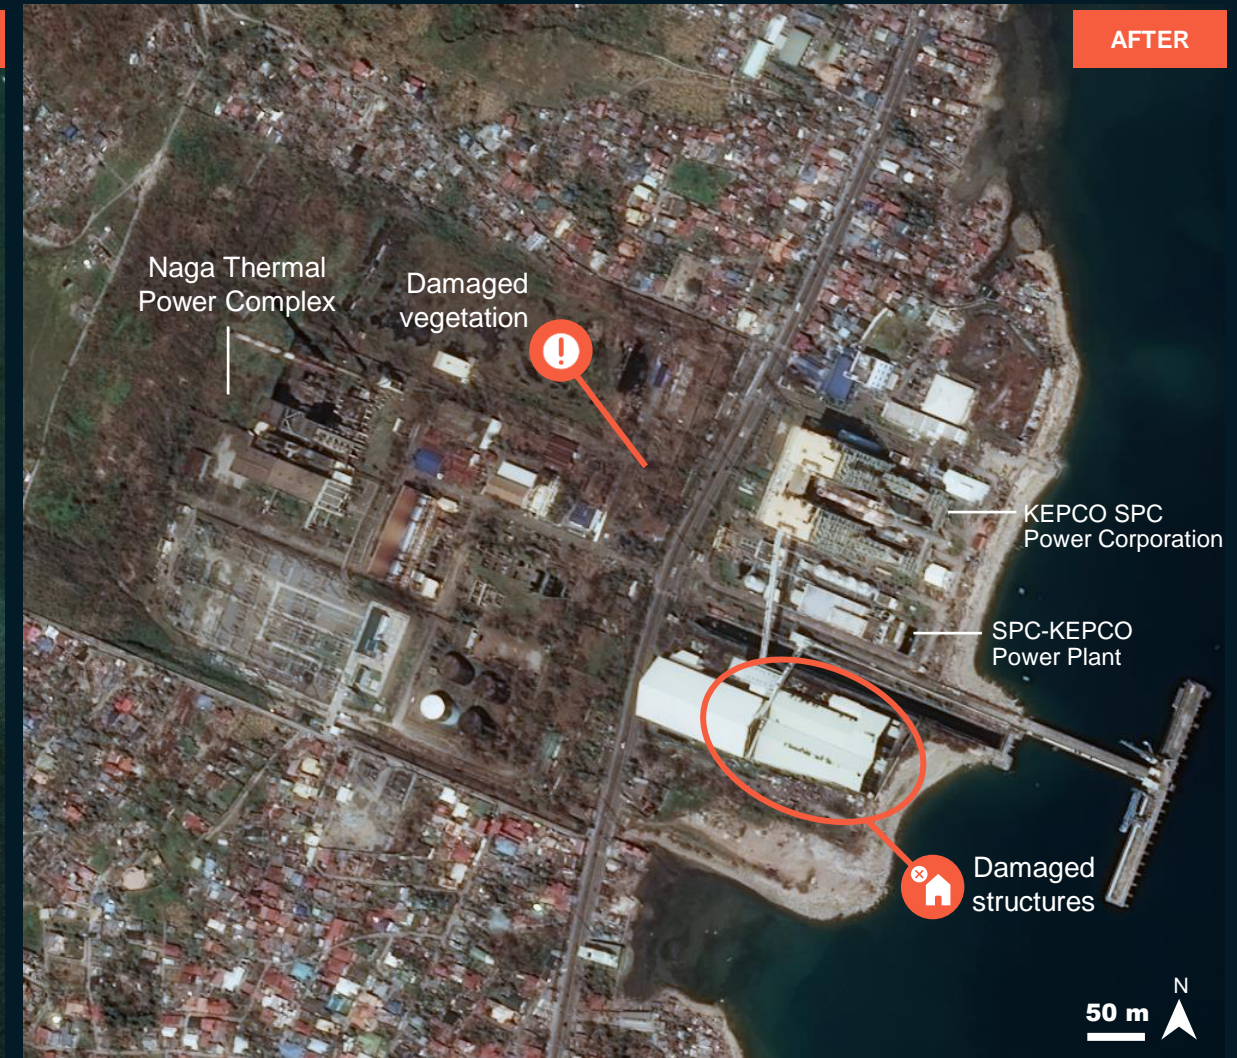
AOI 1-13: NAGA THERMAL POWER COMPLEXCITY OF NAGA, CEBU, REGION VII (CENTRAL VISAYAS)

Damaged structures and vegetation in the power plant site

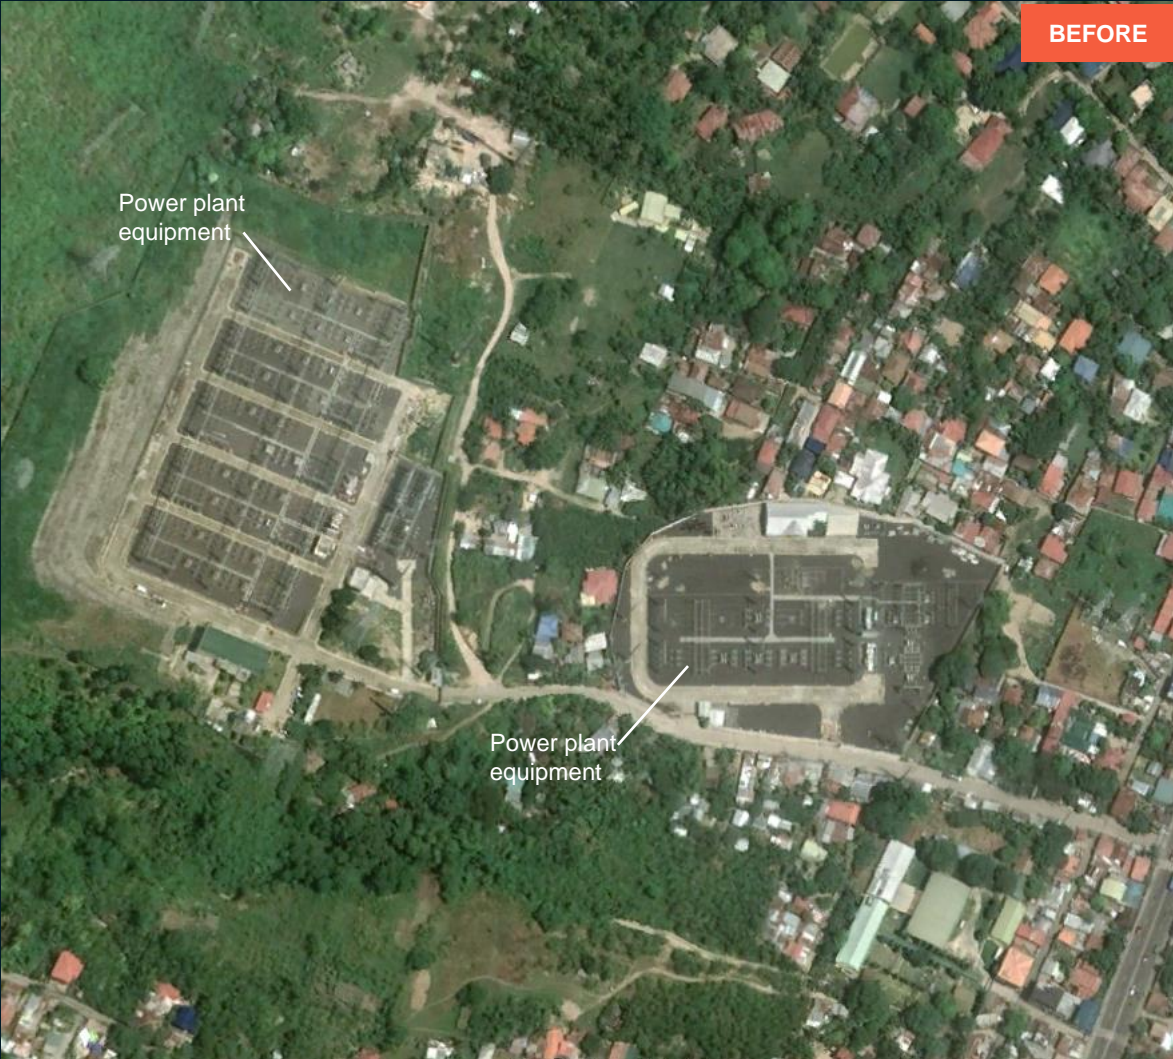
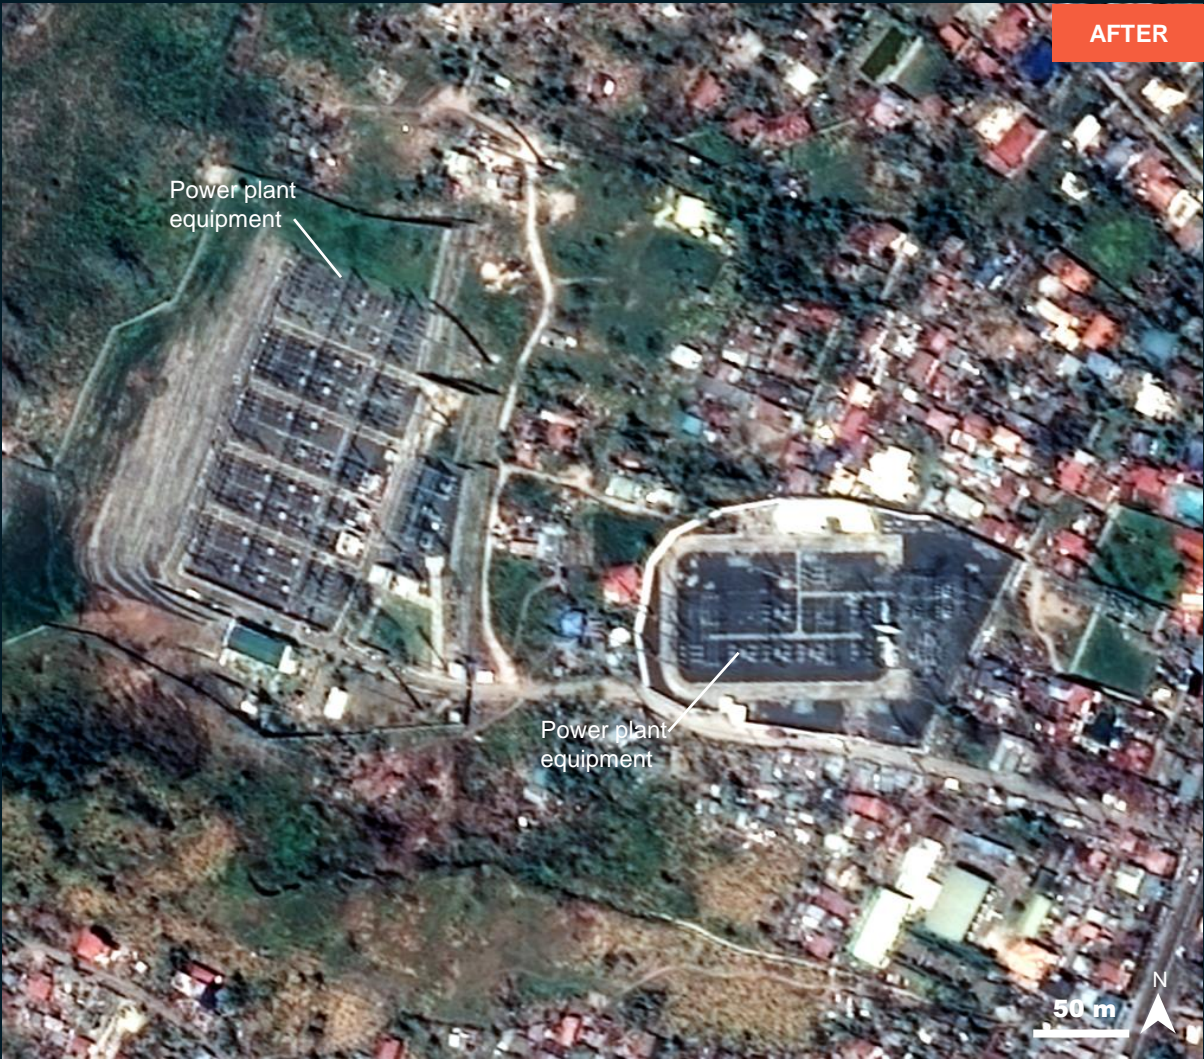
**AOI 1-14: CITY OF NAGA, CEBU,
REGION VII (CENTRAL VISAYAS)**

No damage

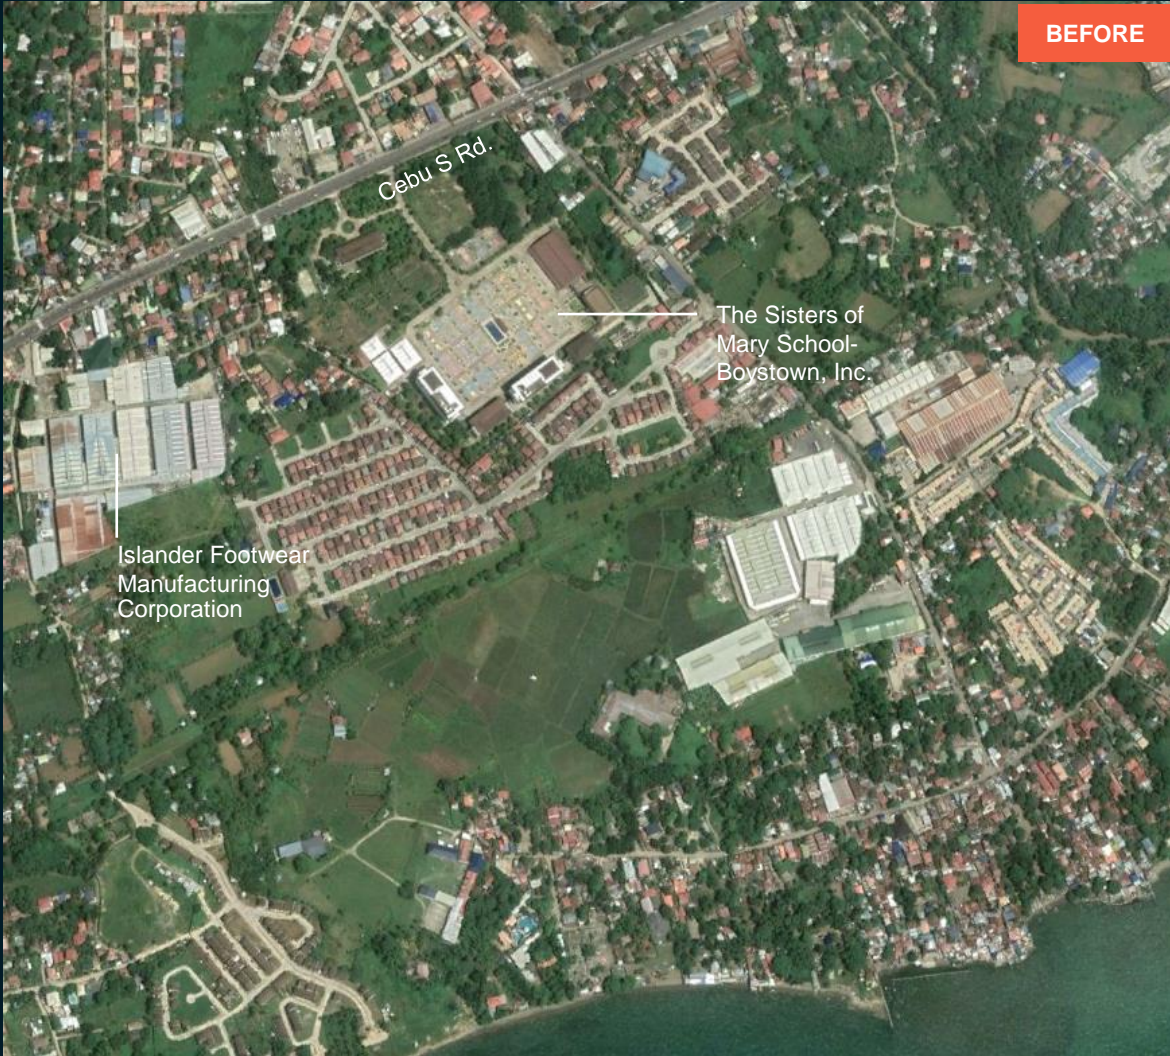
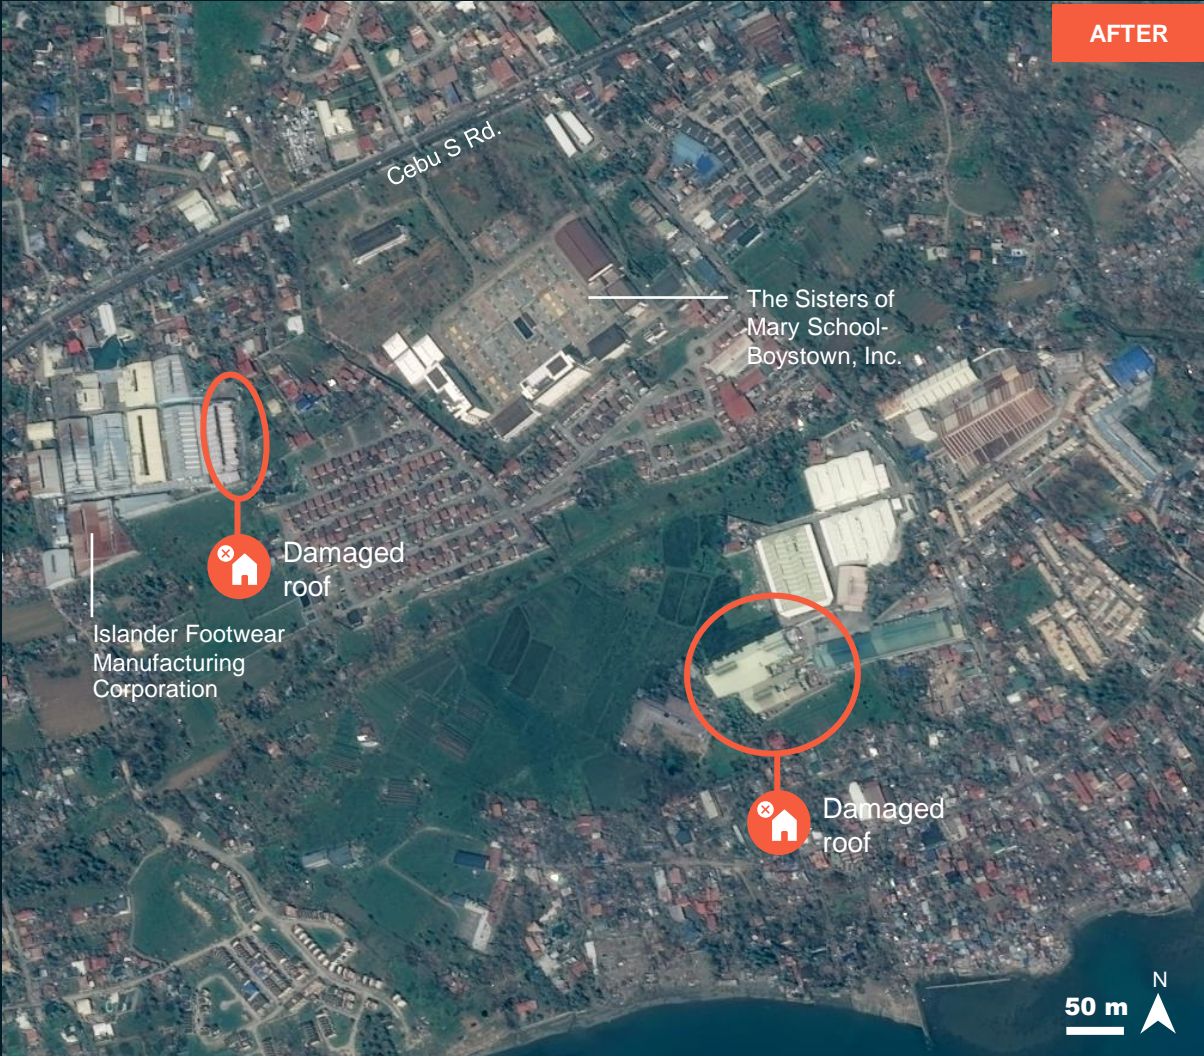
AOI 1-15: TUYAN, CEBU PROVINCE, REGION VII (CENTRAL VISAYAS)

Damaged roof

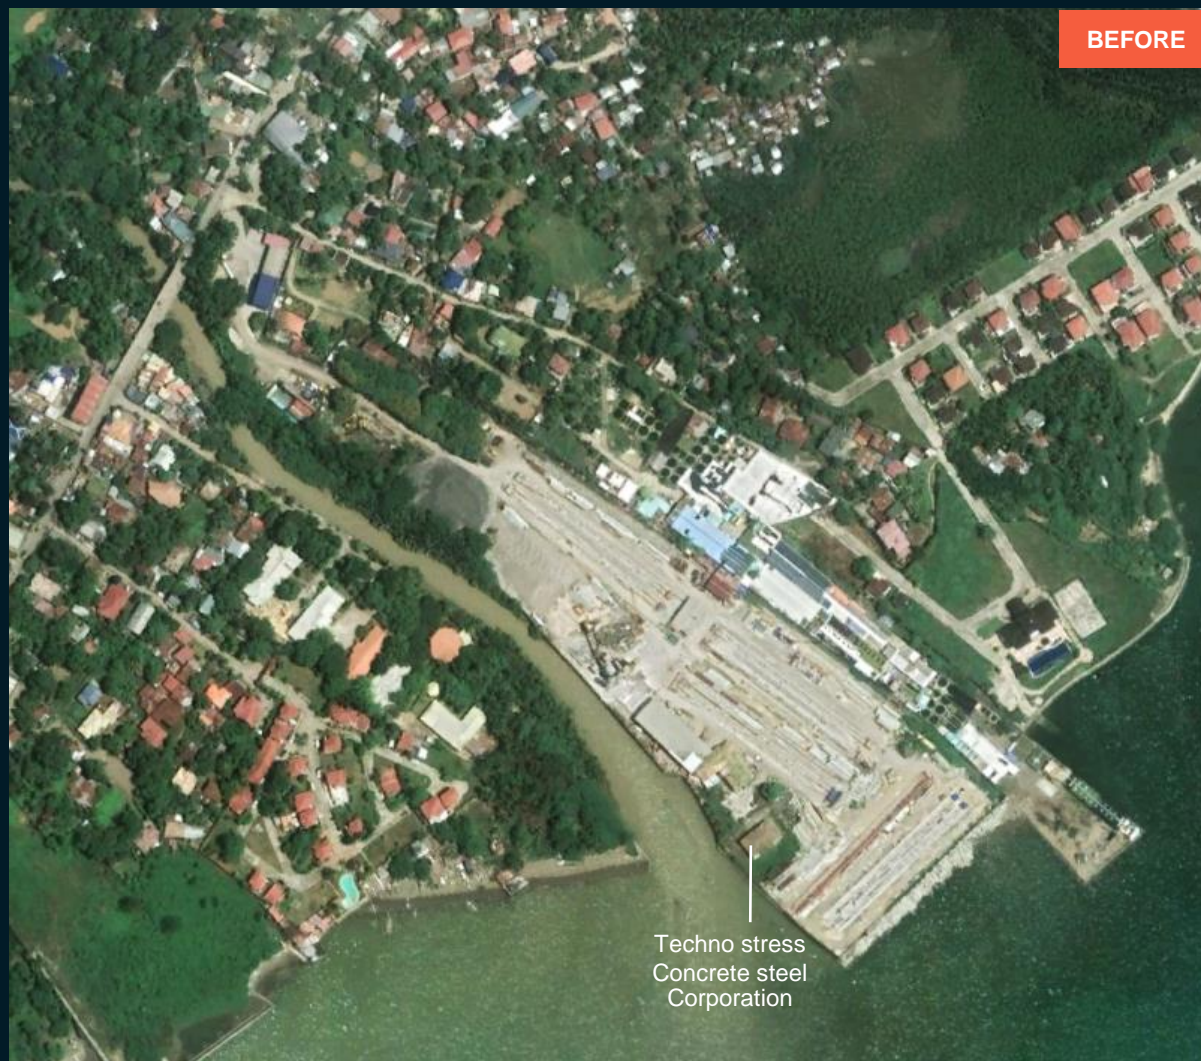
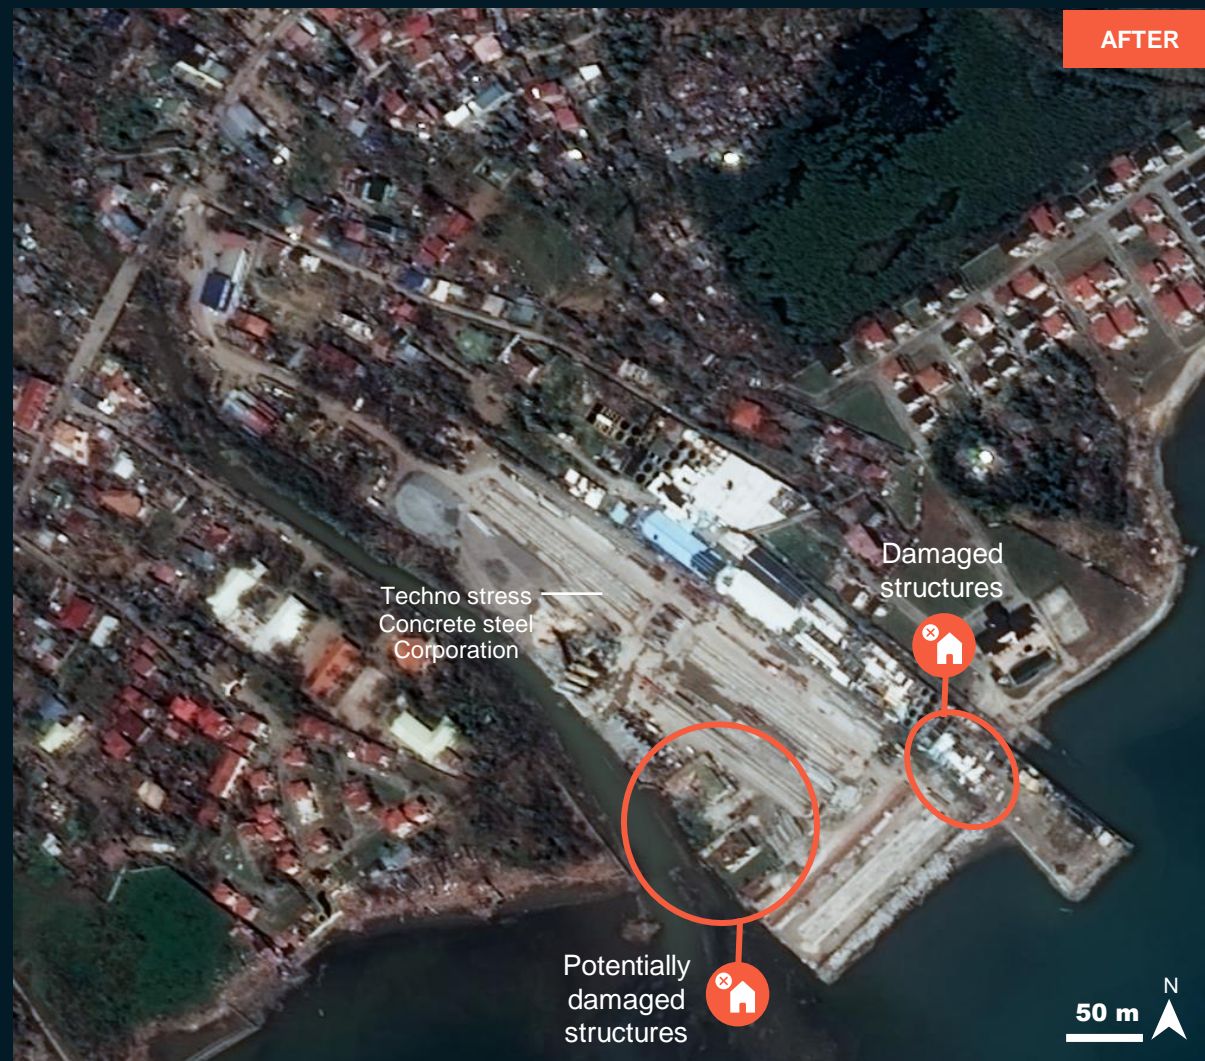
AOI 1-16: TECHNO STRESS CONCRETE STEEL CORPORATION CEBU PROVINCE, REGION VII (CENTRAL VISAYAS)

Damaged structures in the port

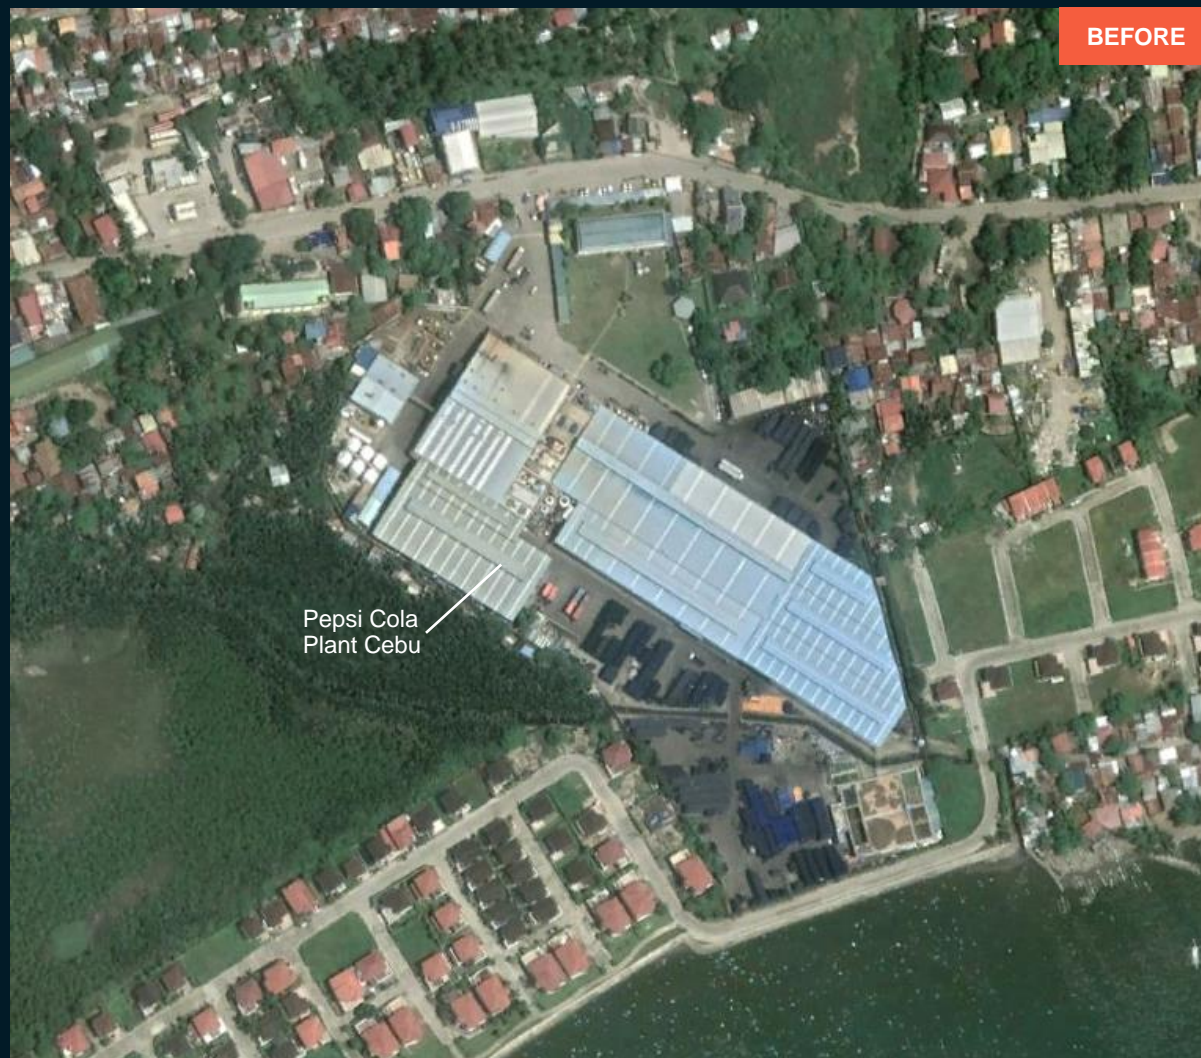
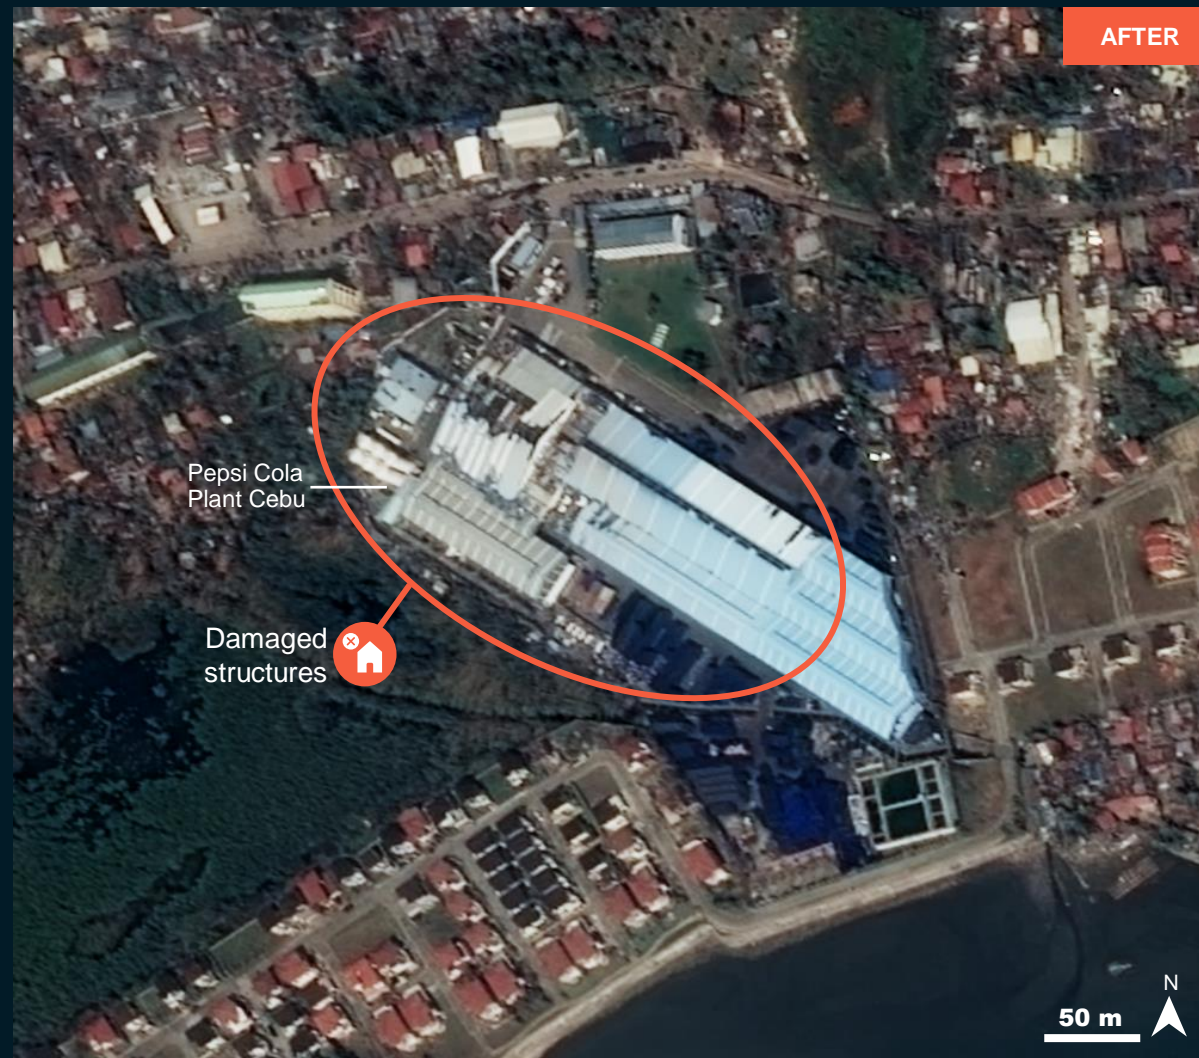
AOI 1-17: PEPSI COLA PLANT CEBU CEBU PROVINCE, REGION VII (CENTRAL VISAYAS)

Damaged roof

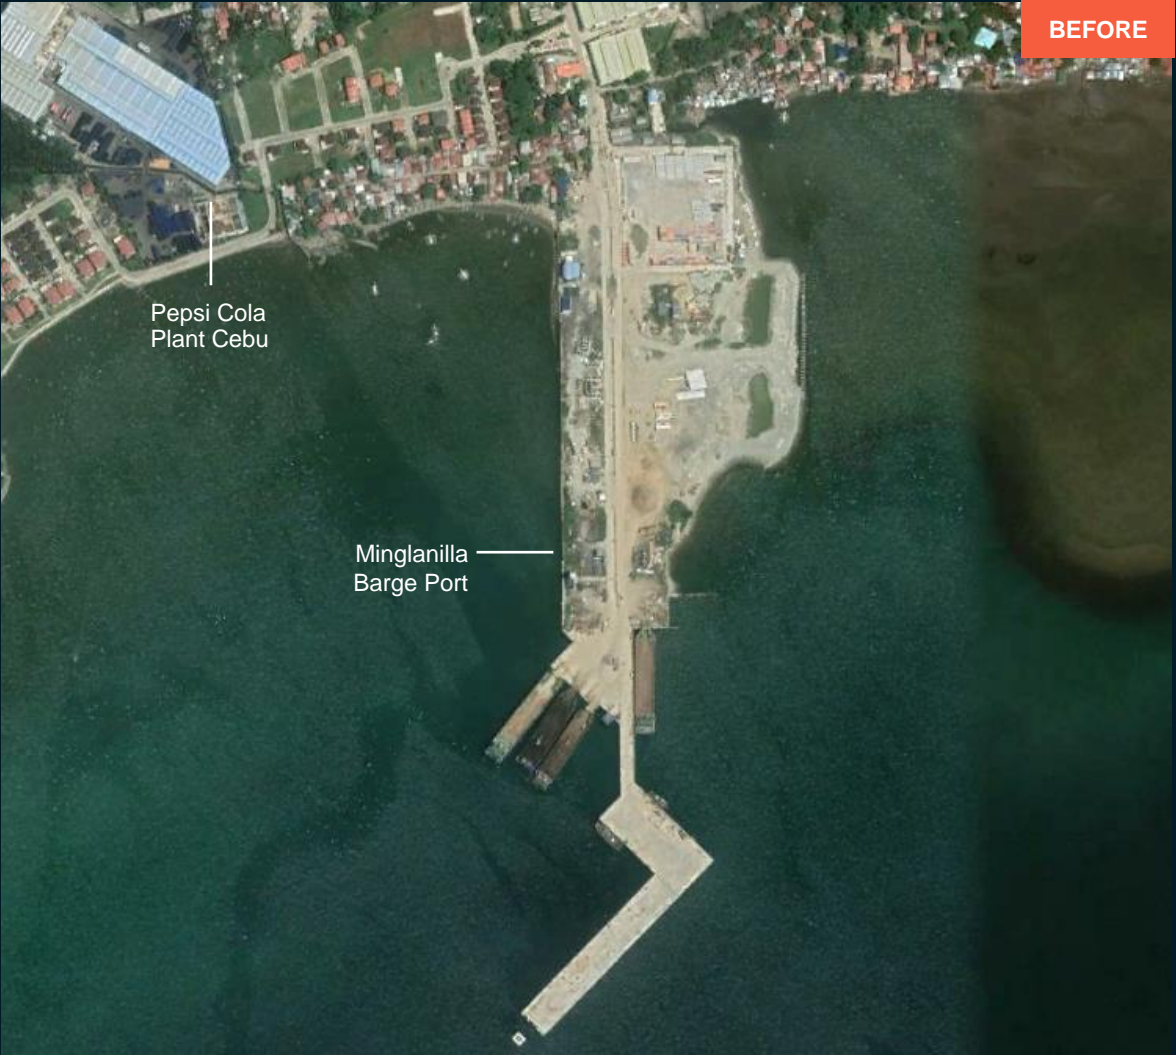
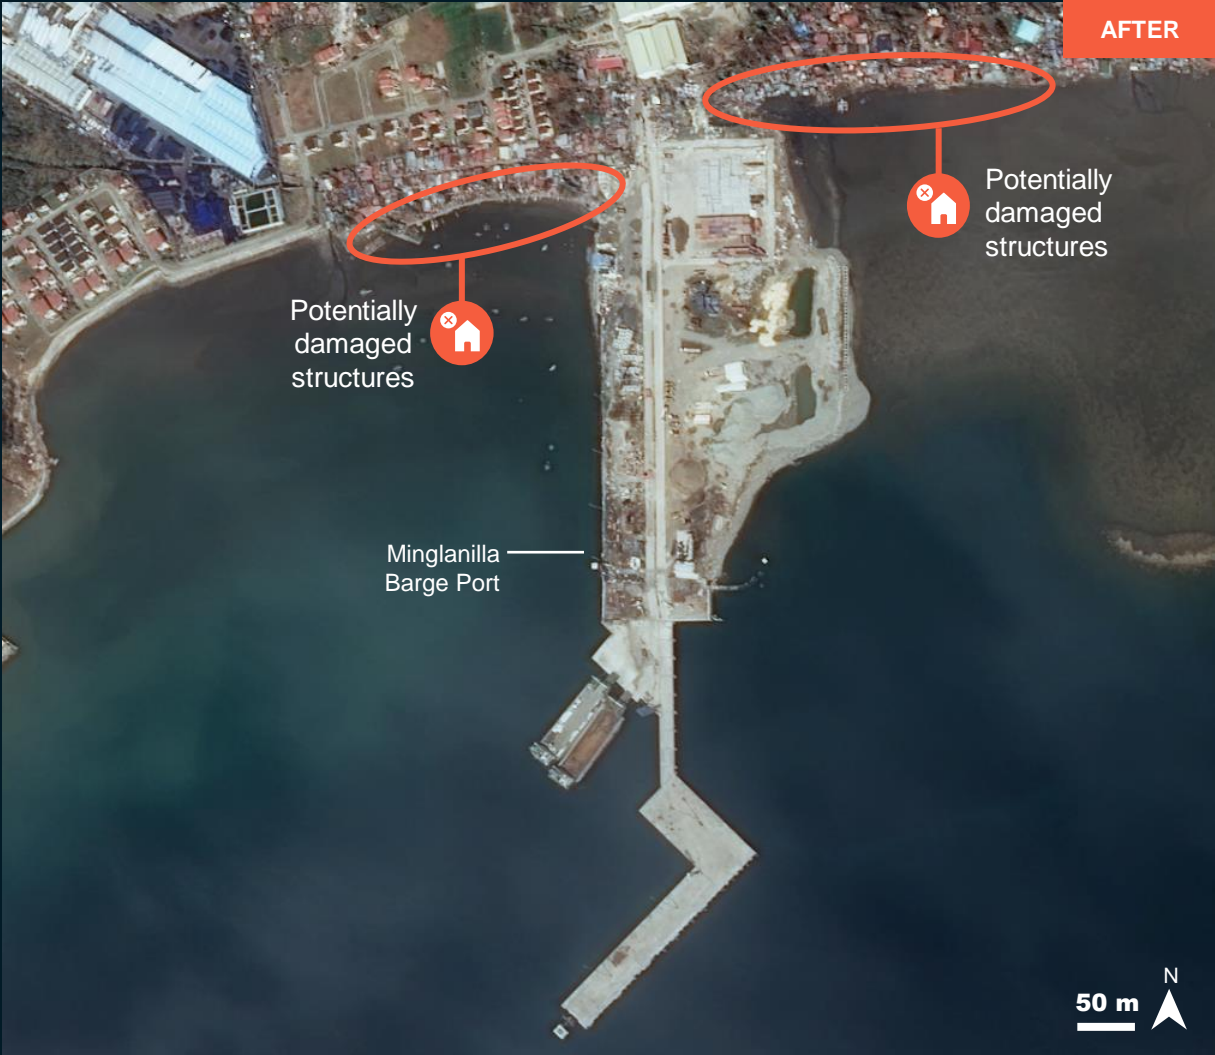
AOI 1-18: MINGLANILLA BARGE PORT CEBU PROVINCE, REGION VII (CENTRAL VISAYAS)

No damage observed in the port zone
