27 December 2021

TROPICAL CYCLONE RAI-21

PRELIMINARY SATELLITE-DERIVED INDUSTRIAL SITES IMPACT ANALYSIS IN CEBU & NAGA

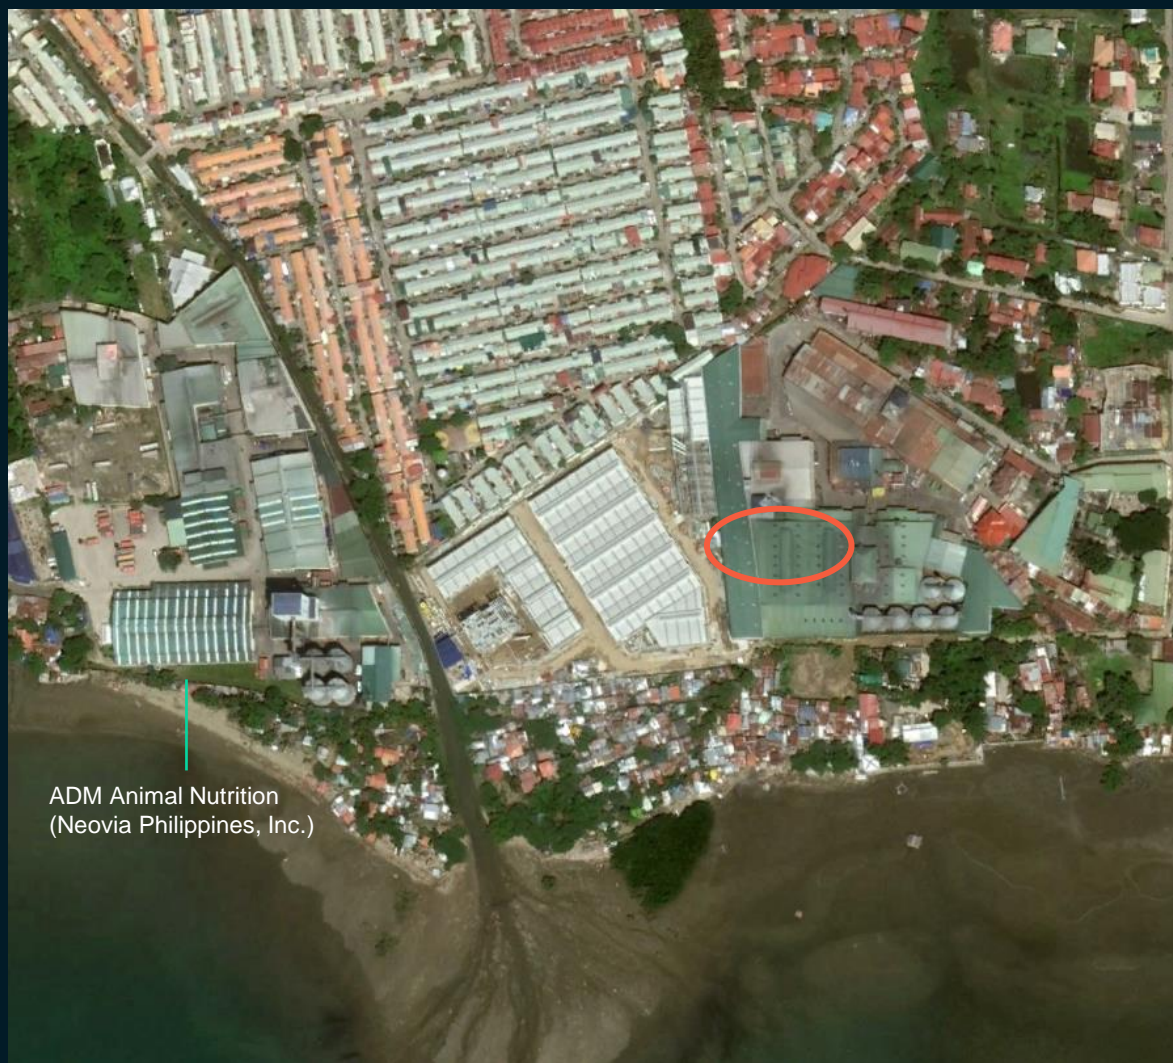
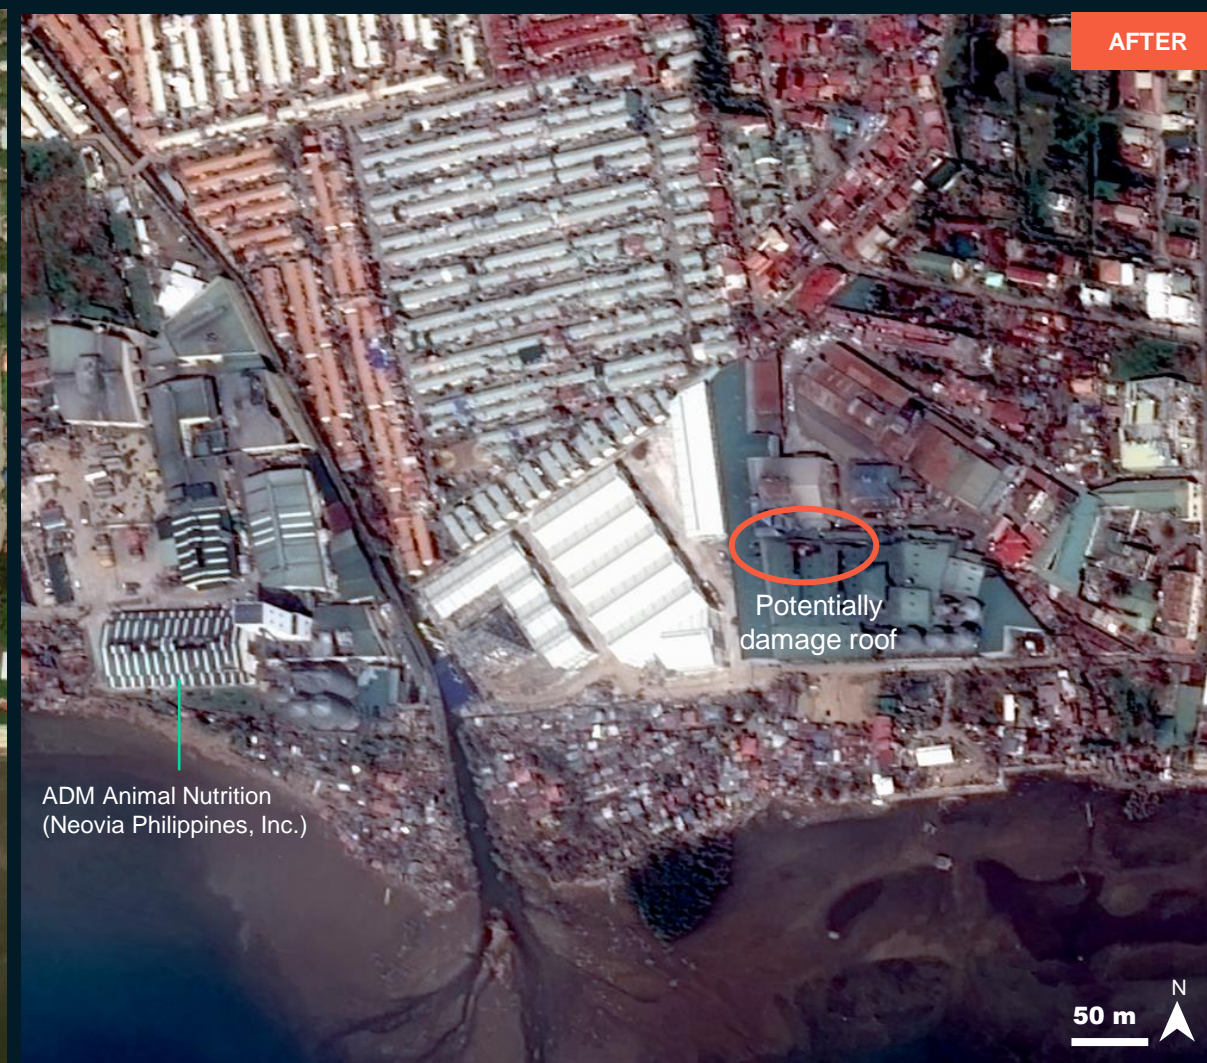
AOI 1-19: ADM ANIMAL NUTRITION (NEOVIA PHILIPPINES, INC.) CEBU PROVINCE, REGION VII (CENTRAL VISAYAS)

Potentially damage roof

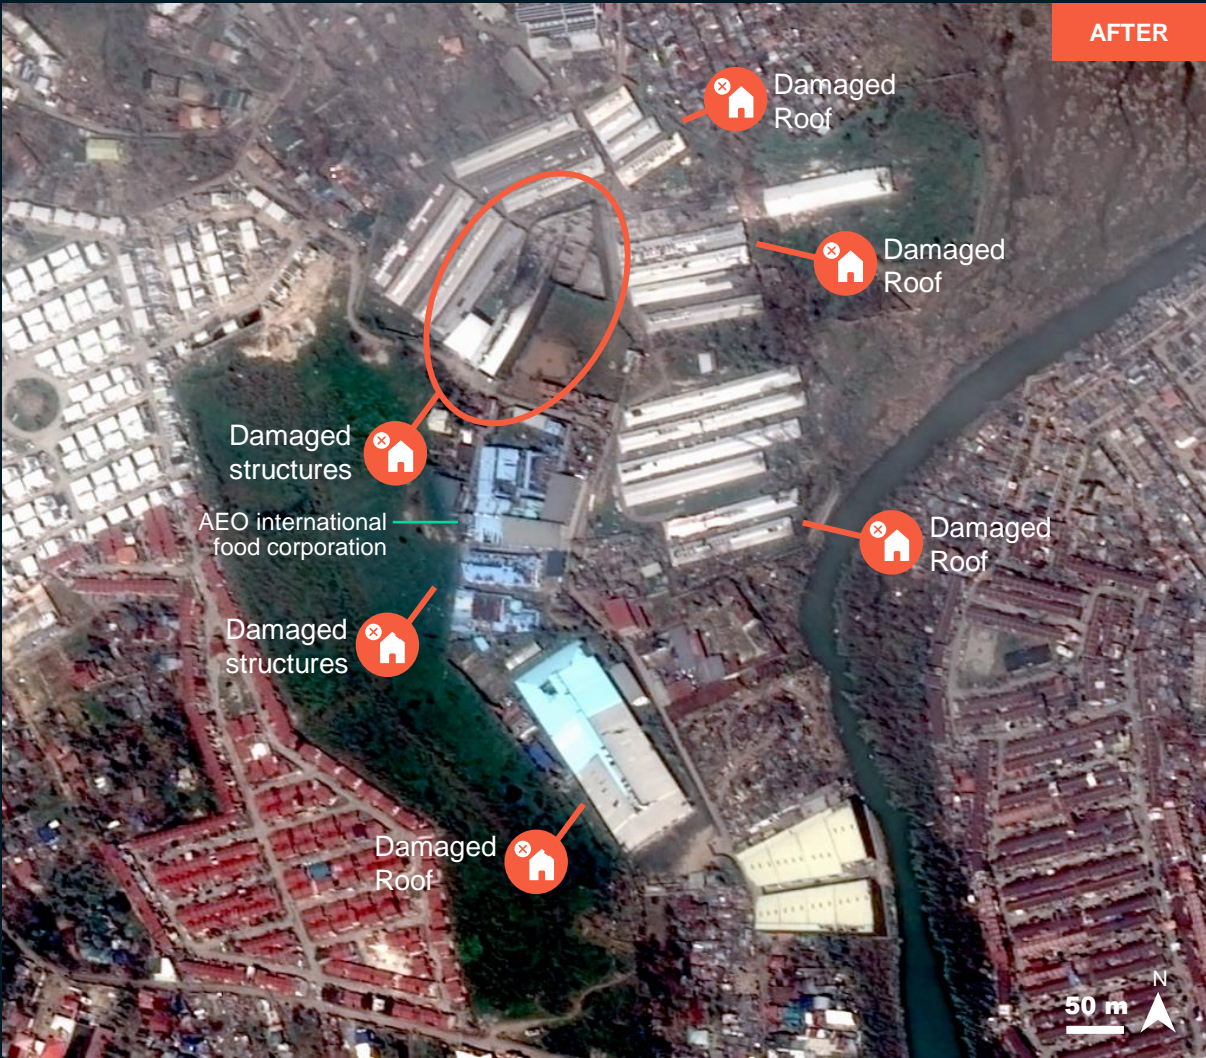
AOI 1-20: AEO INTERNATIONAL FOOD CORPORATION CEBU PROVINCE, REGION VII (CENTRAL VISAYAS)

Damaged roof and structures

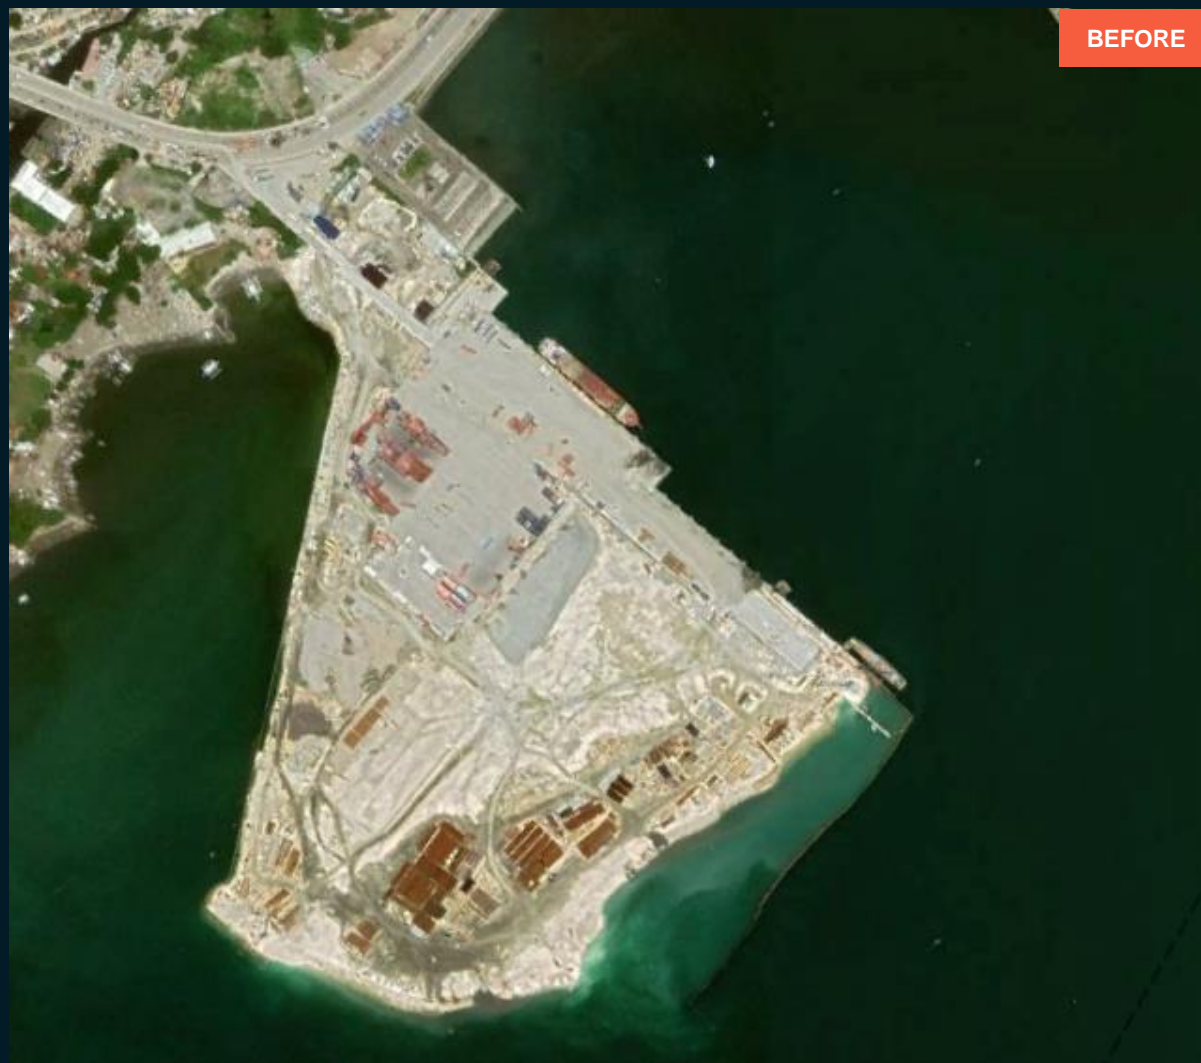
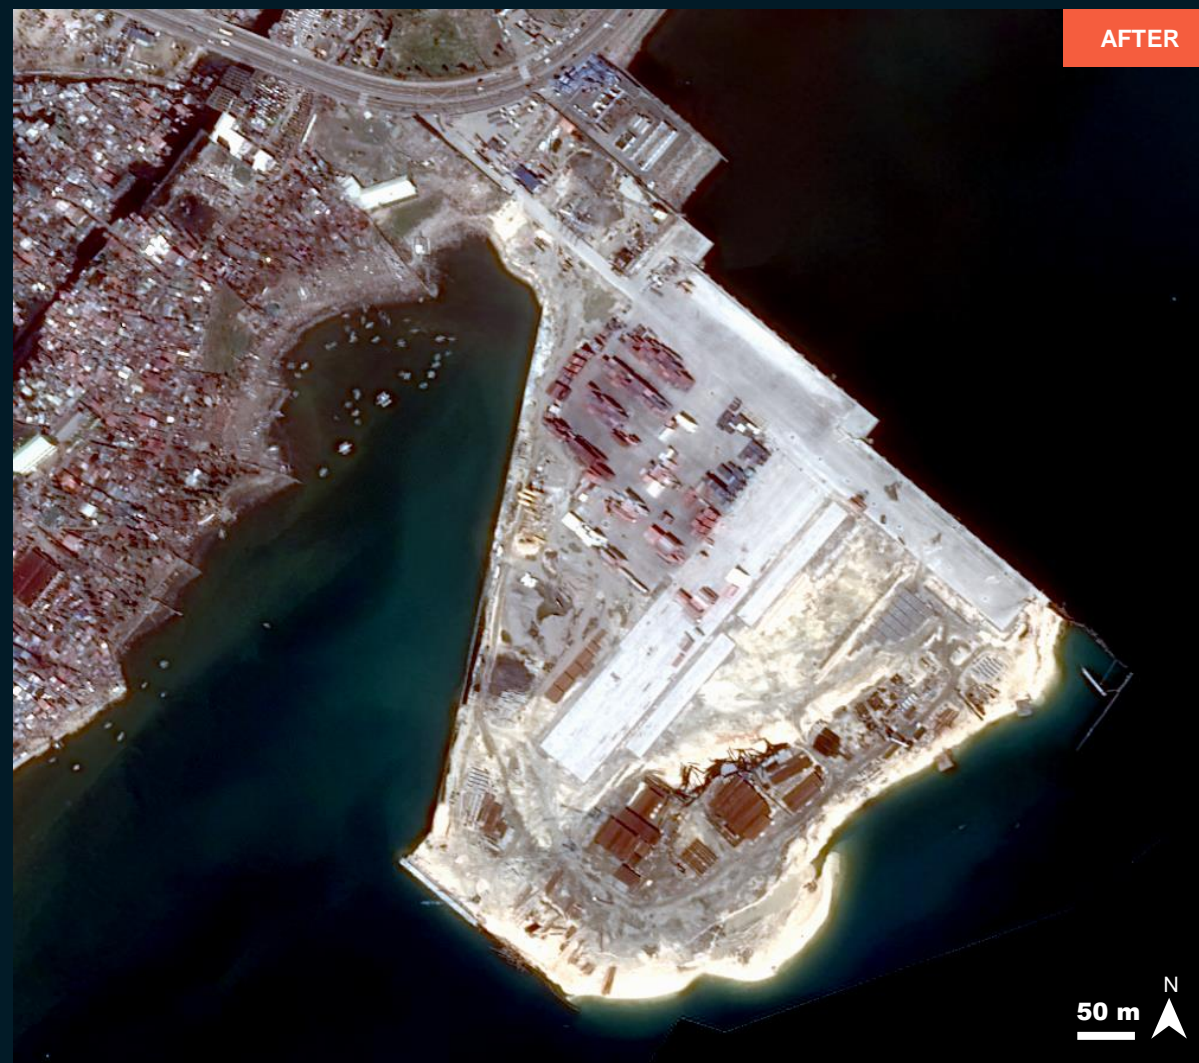
AOI 1-22: CEBU SOUTH HARBOR CONTAINER TERMINAL CORPORATION, CEBU PROVINCE, REGION VII

No damage

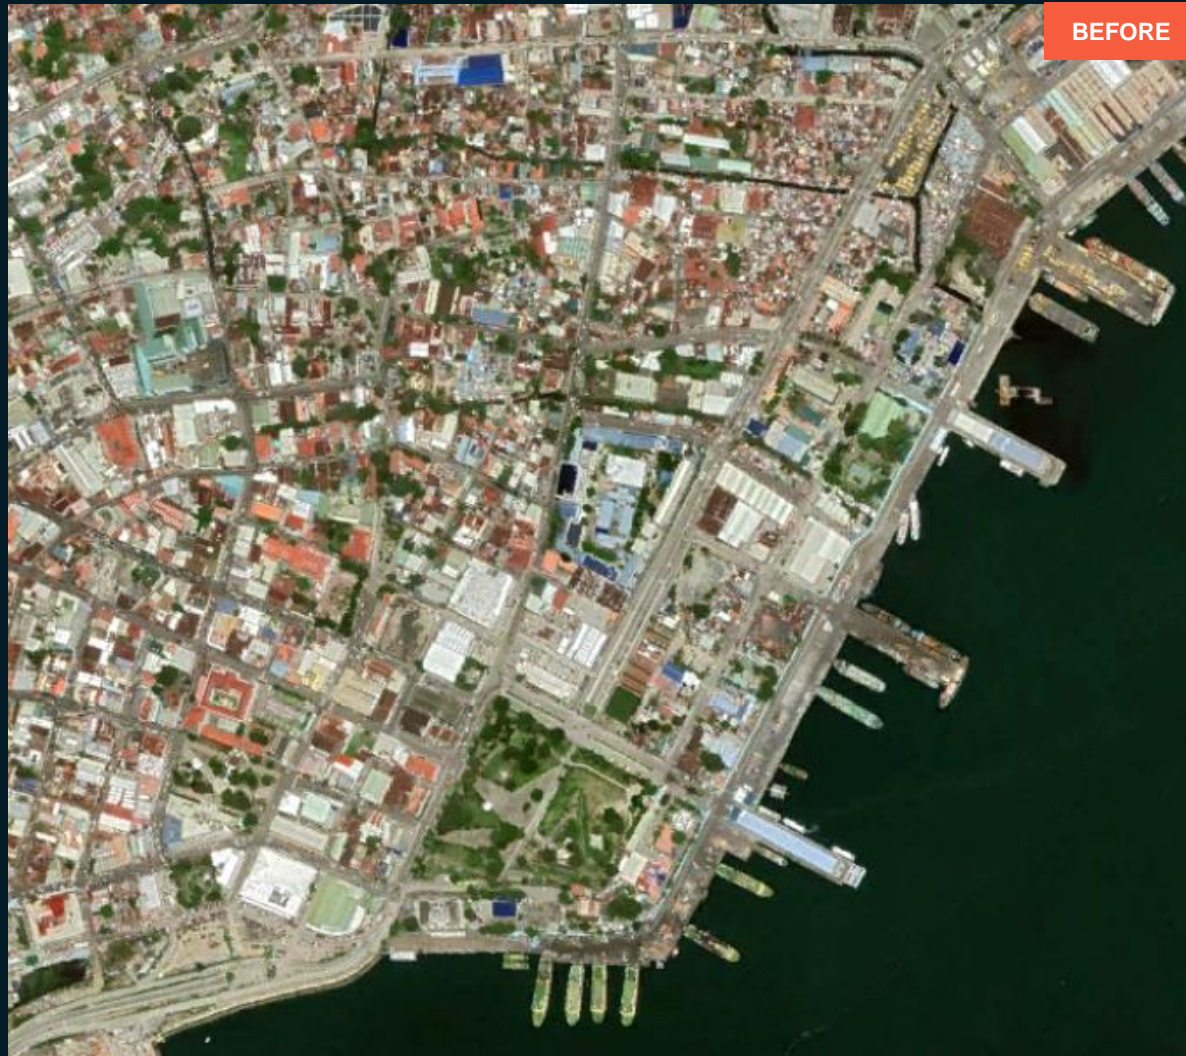
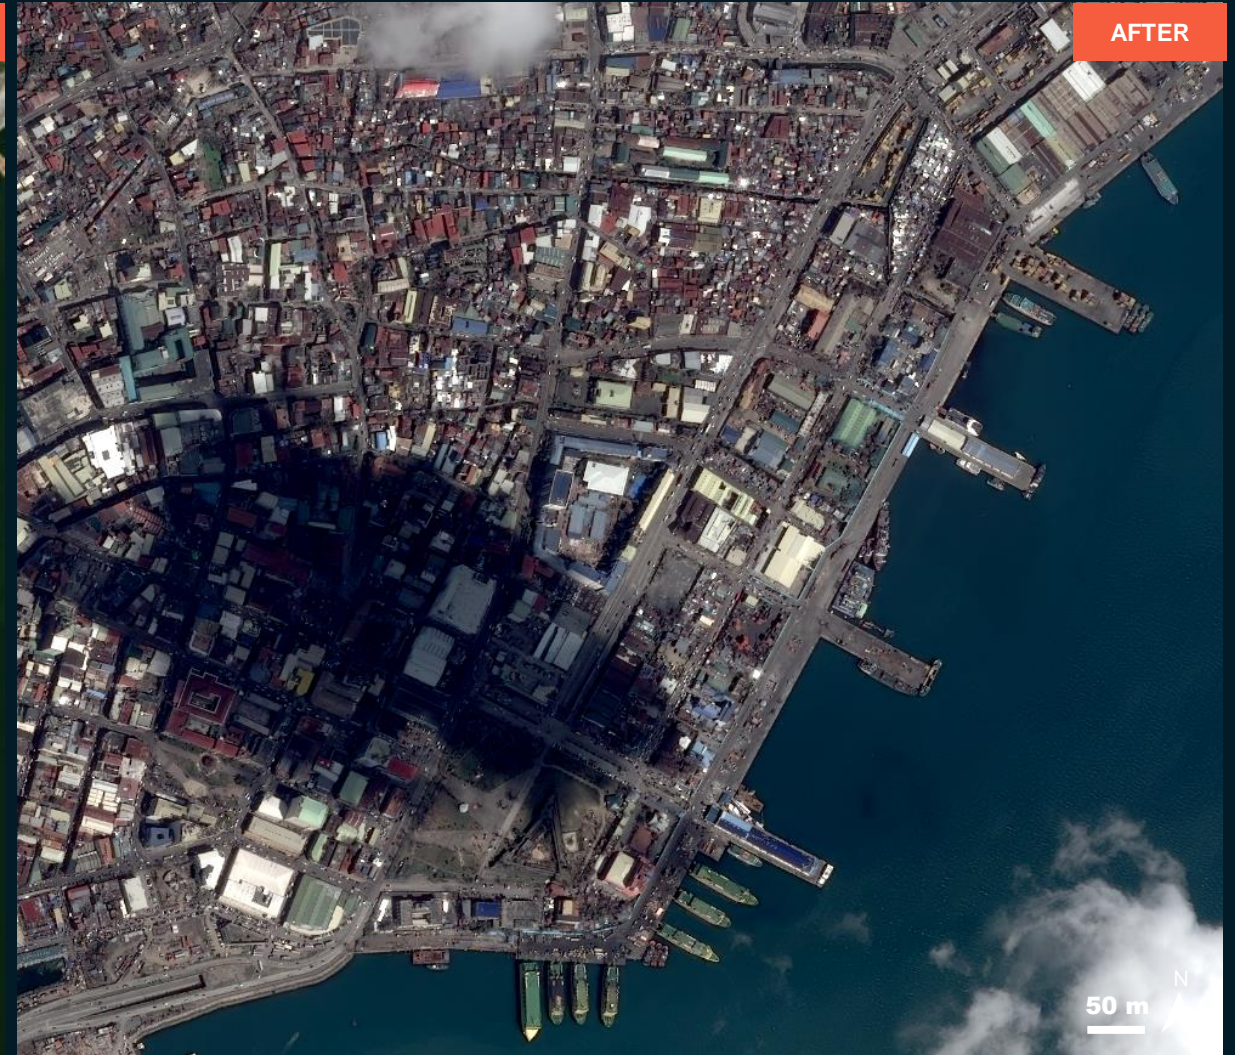
AOI 1-23: CEBU PIER, CEBU CITY, CEBU PROVINCE, REGION VII (CENTRAL VISAYAS)

No damage

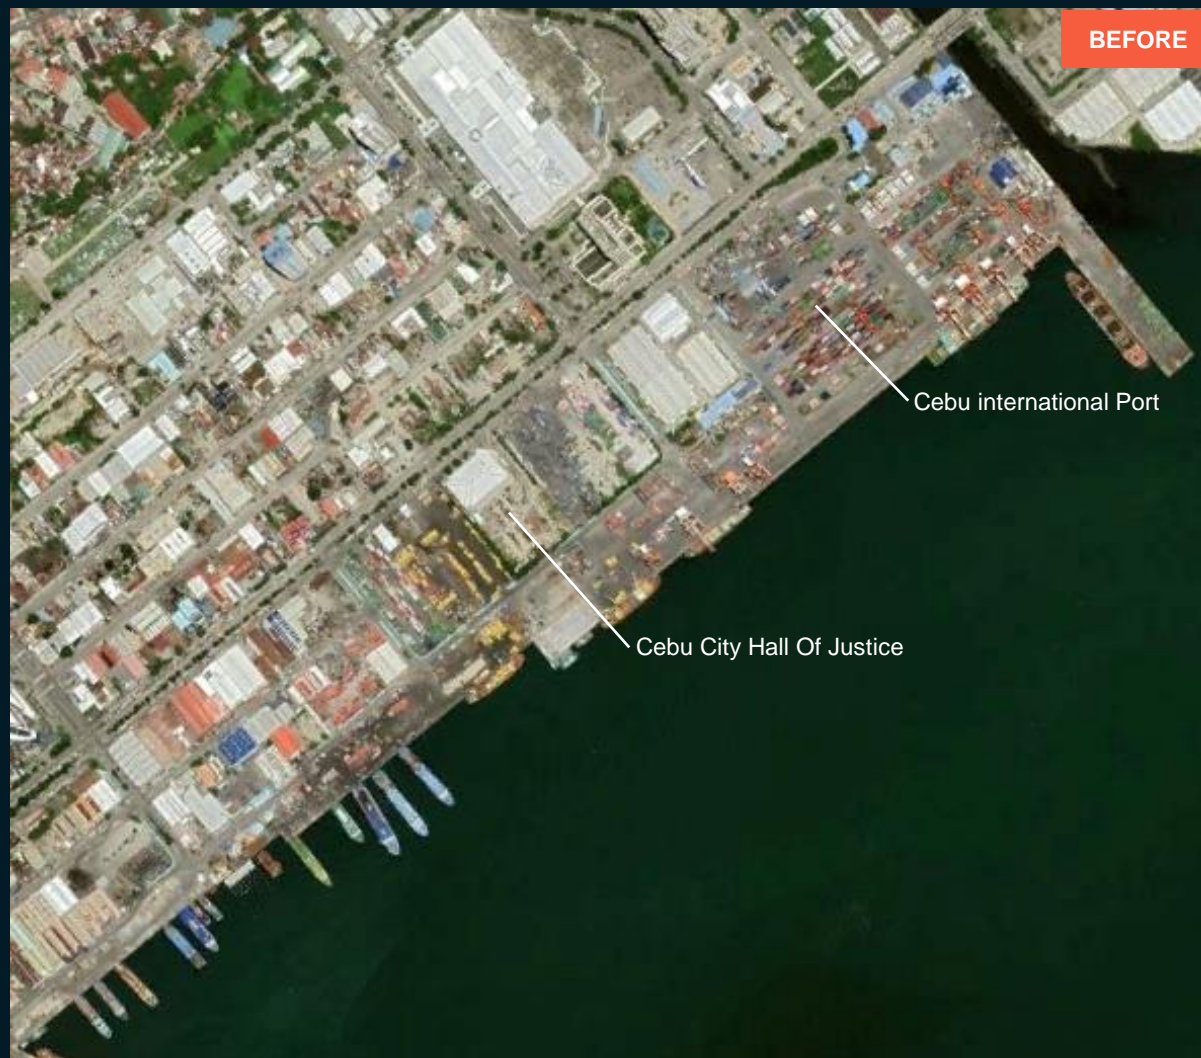
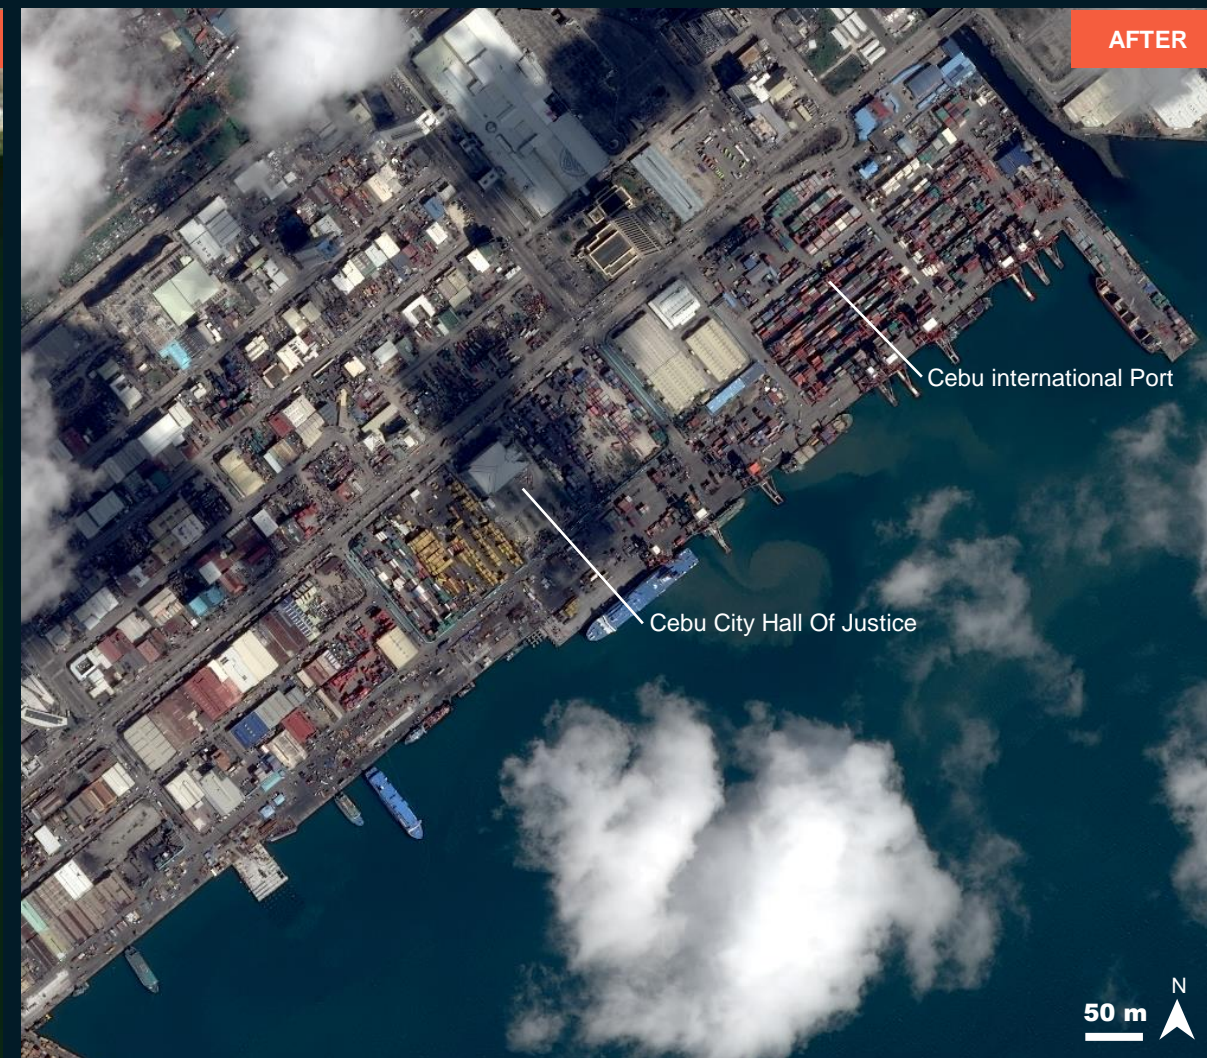
AOI 1-24: CEBU INTERNATIONAL PORT, CEBU CITY, CEBU PROVINCE, REGION VII (CENTRAL VISAYAS)

No damage

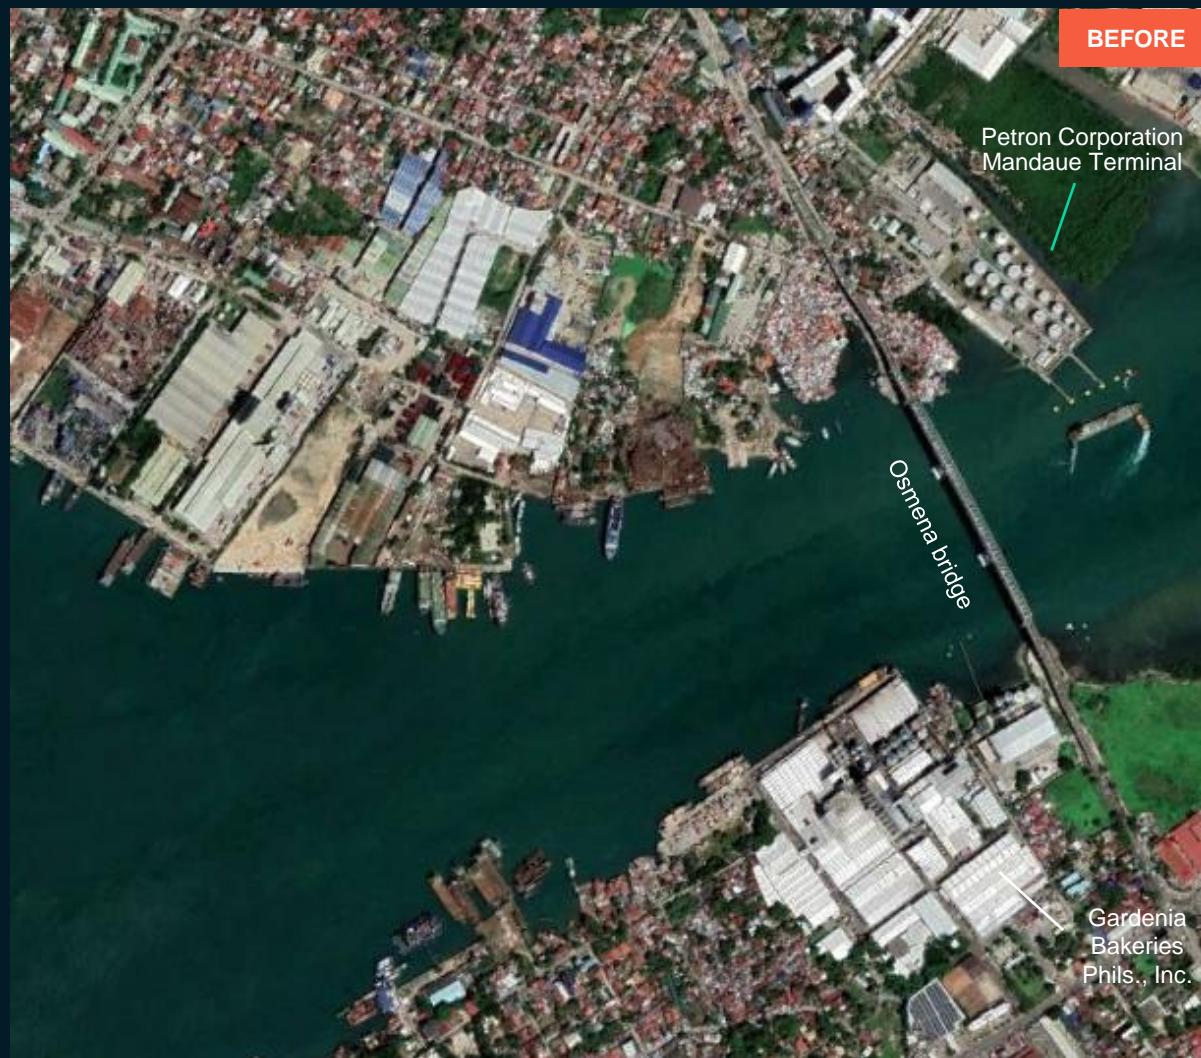
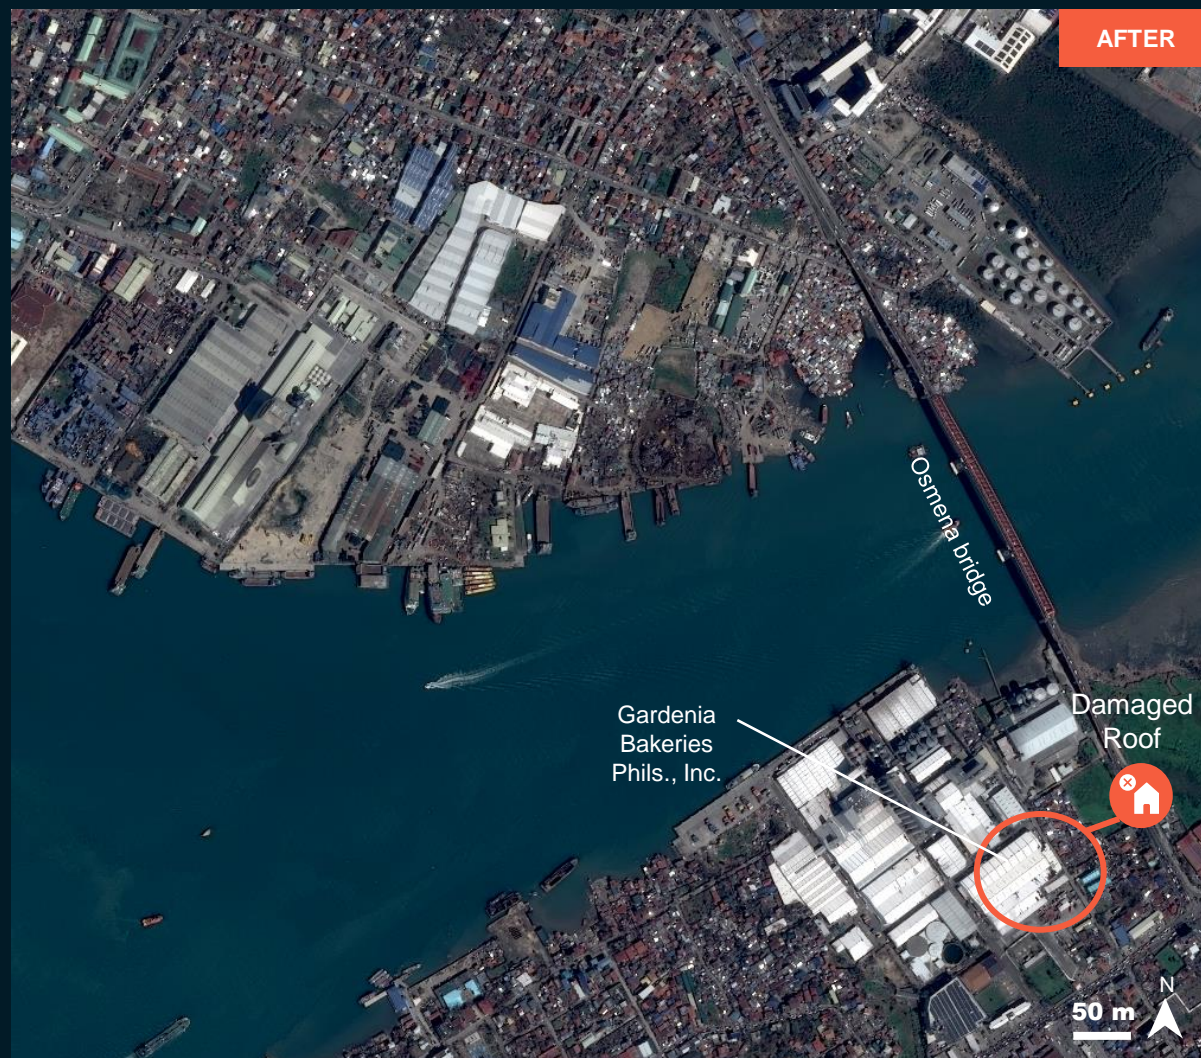
AOI 1-25: OSMENA BRIDGE CEBU PROVINCE, REGION VII (CENTRAL VISAYAS)

Damaged roof

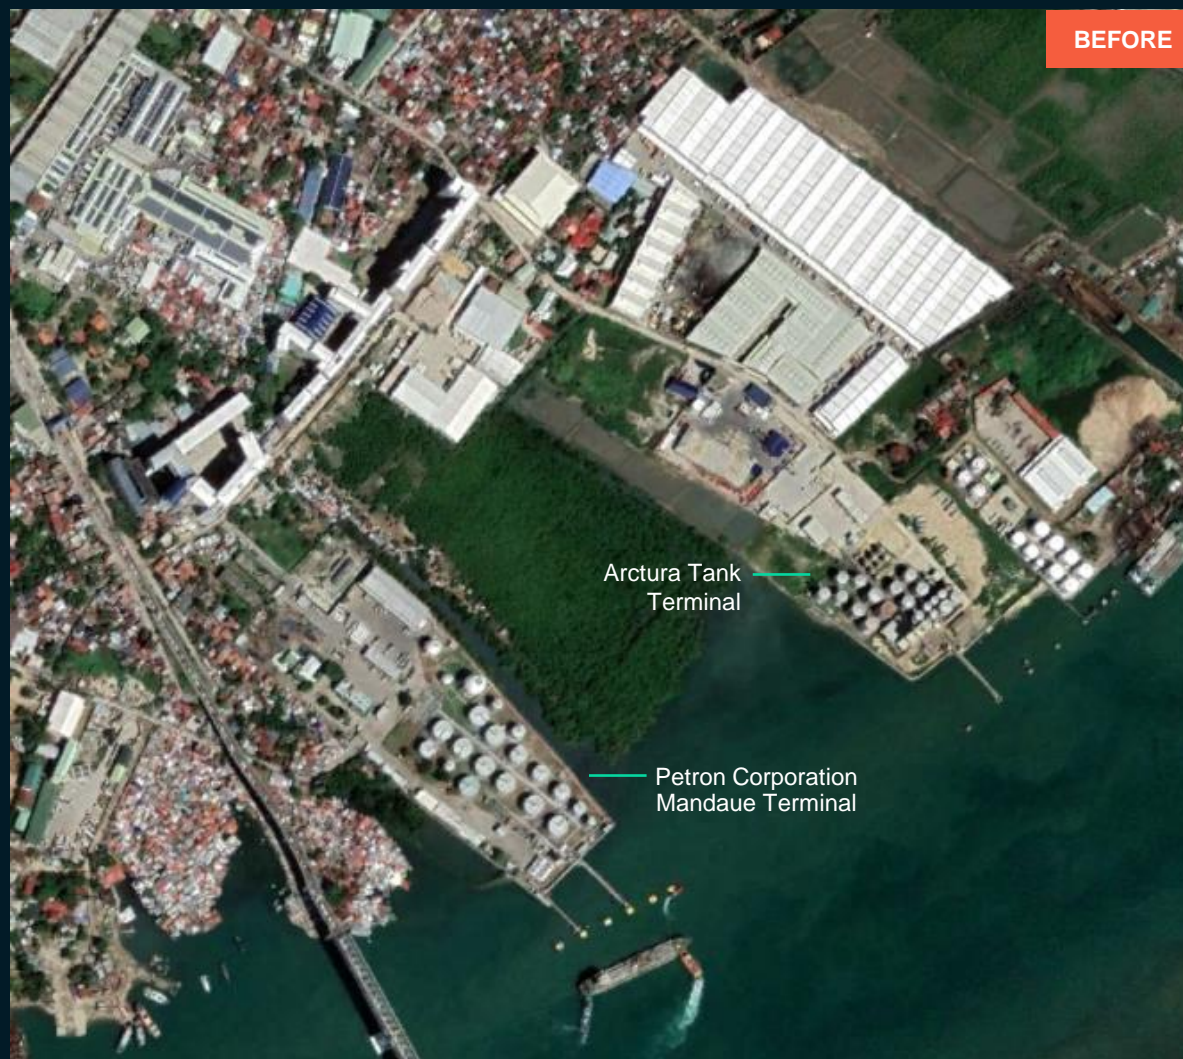
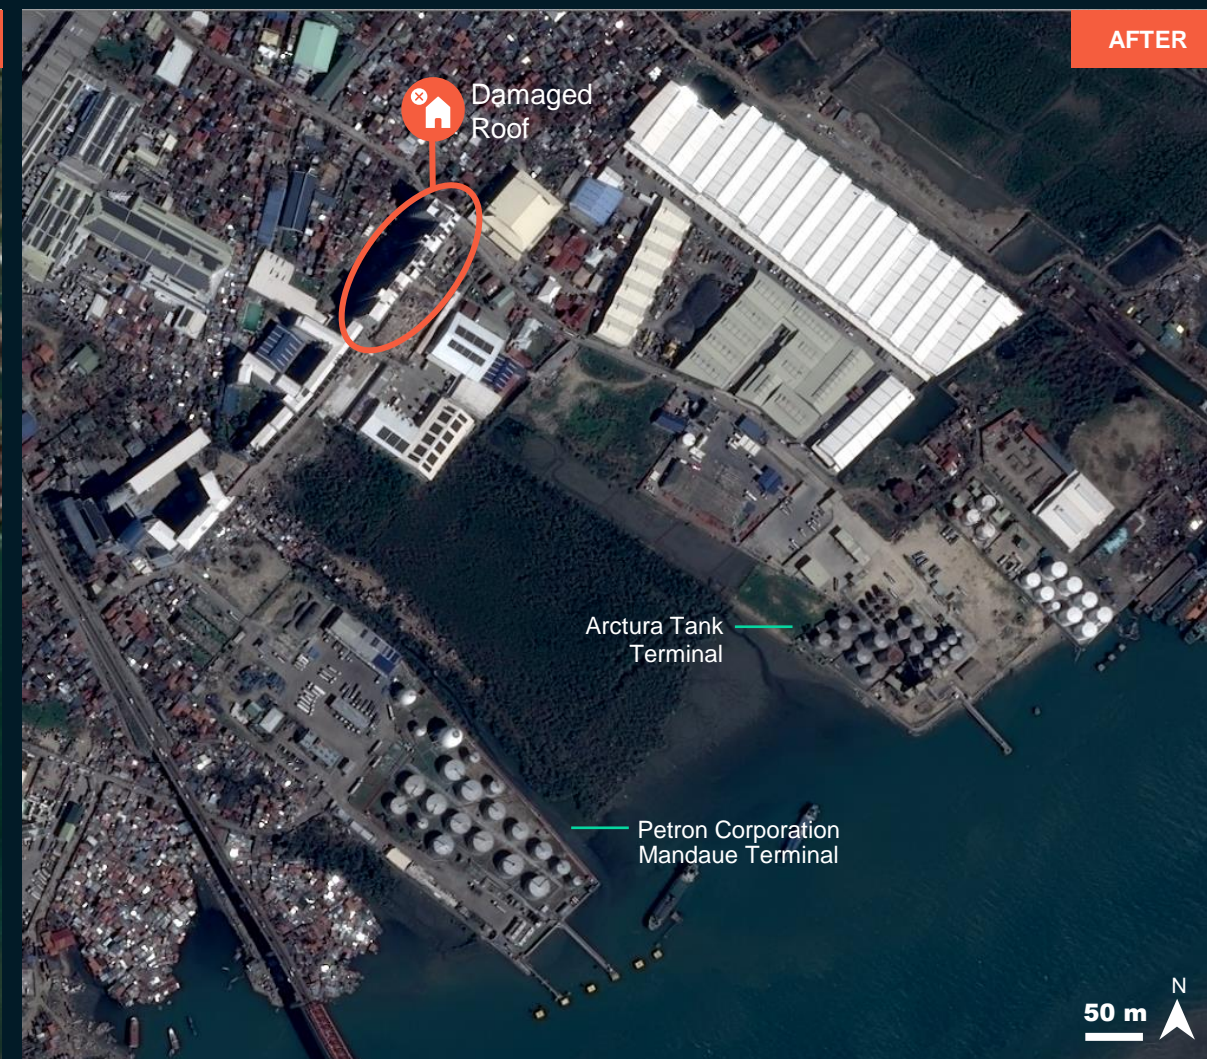
AOI 1-26: ARCTURA TANK TERMINAL CEBU PROVINCE, REGION VII (CENTRAL VISAYAS)

Damaged roof

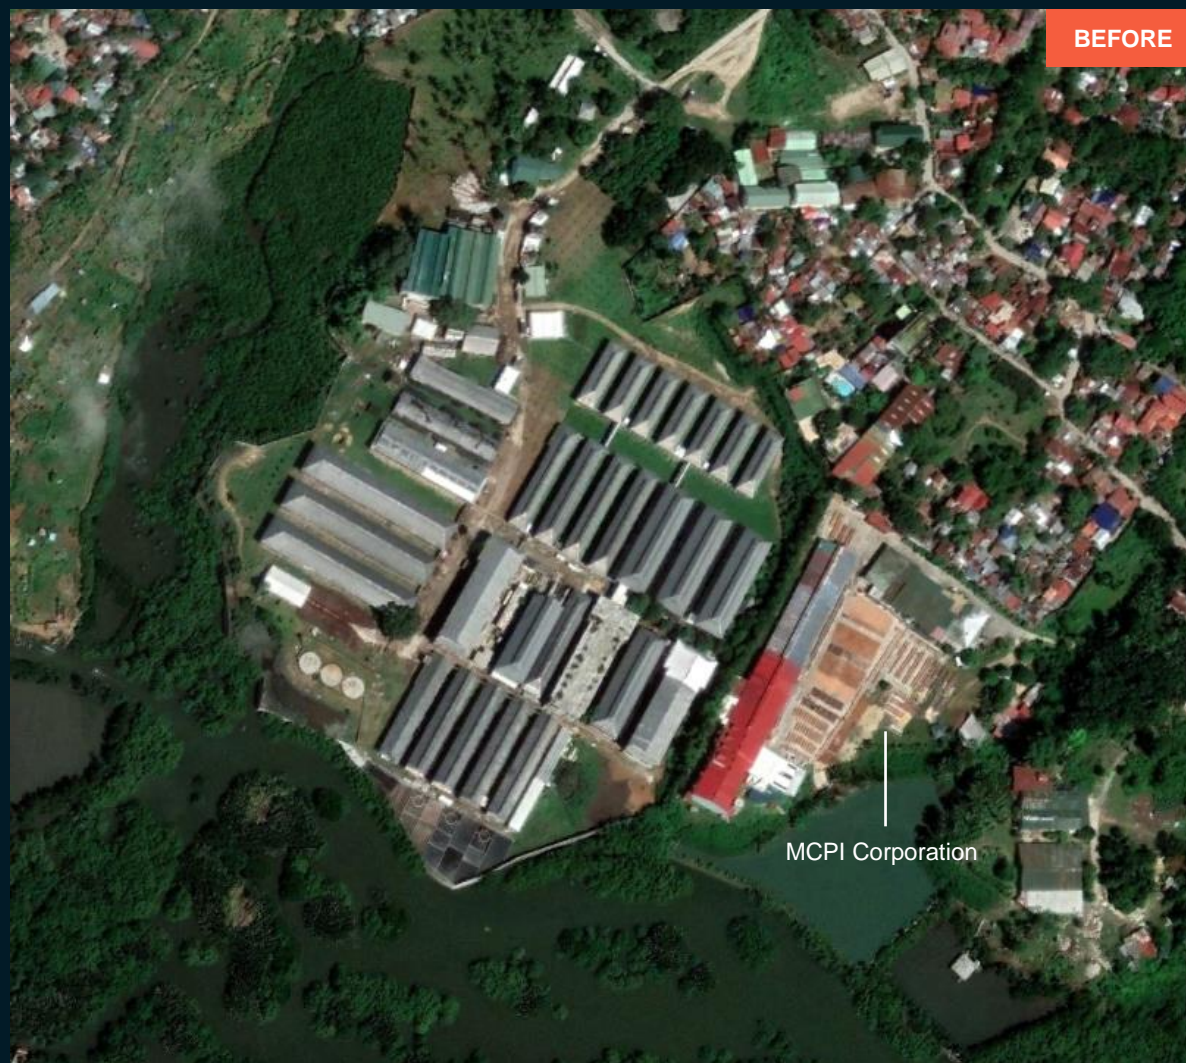
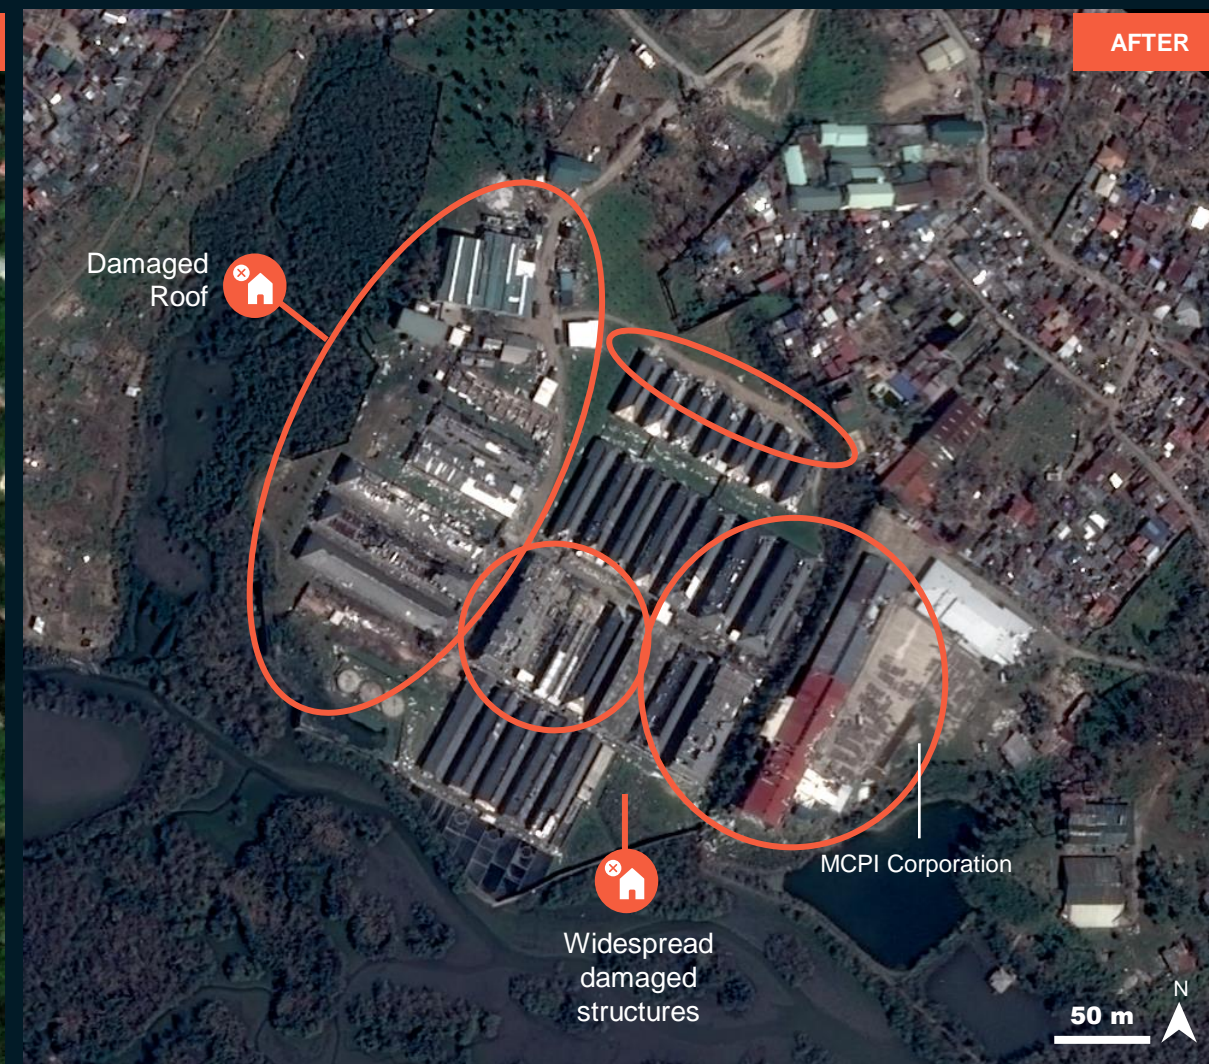
AOI 1-27: MCPI CORPORATION, CEBU PROVINCE, REGION VII (CENTRAL VISAYAS)

Damaged structures

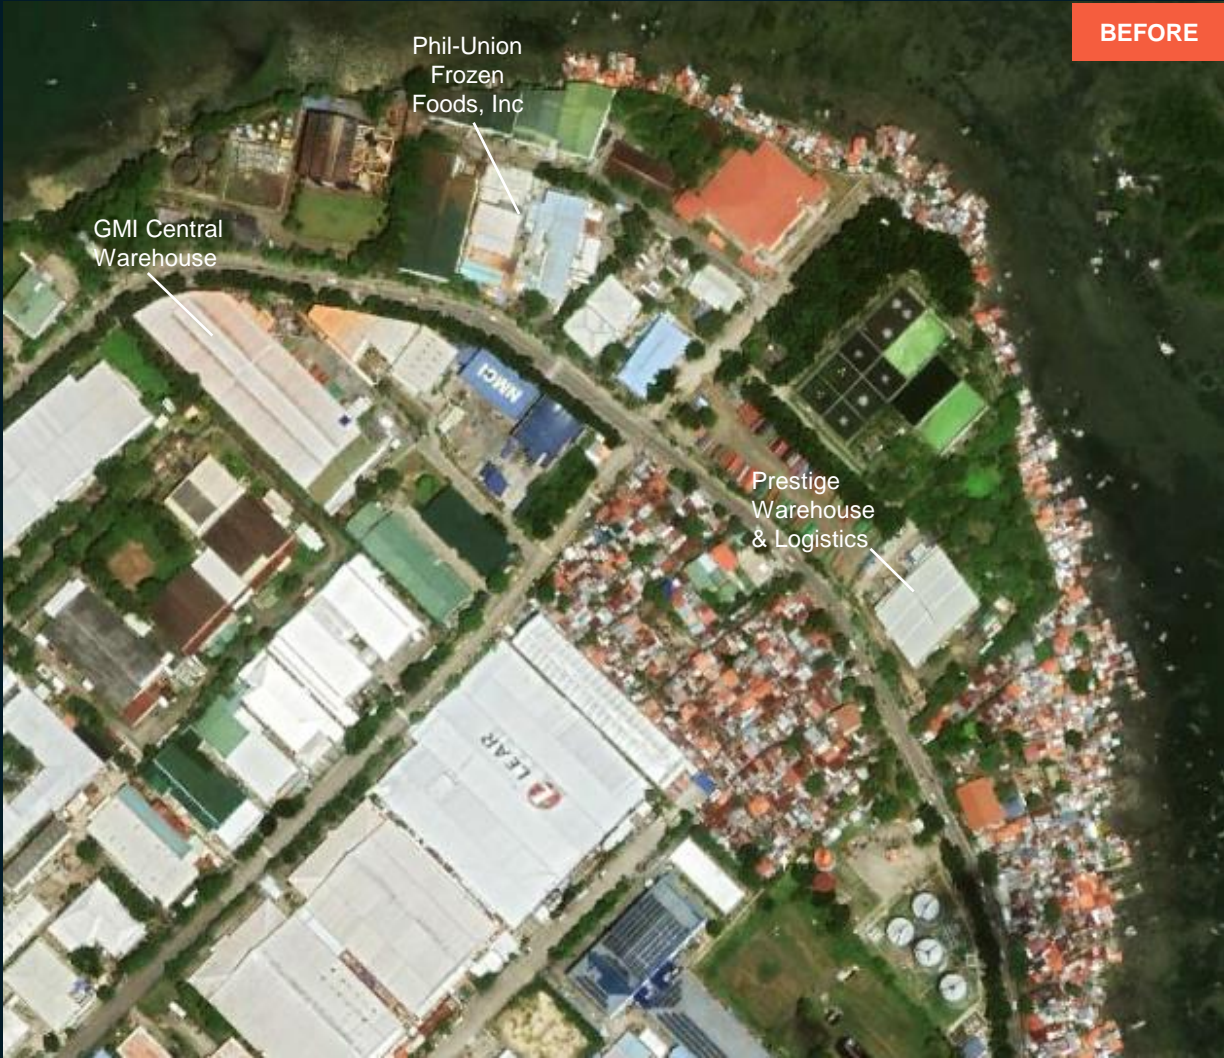
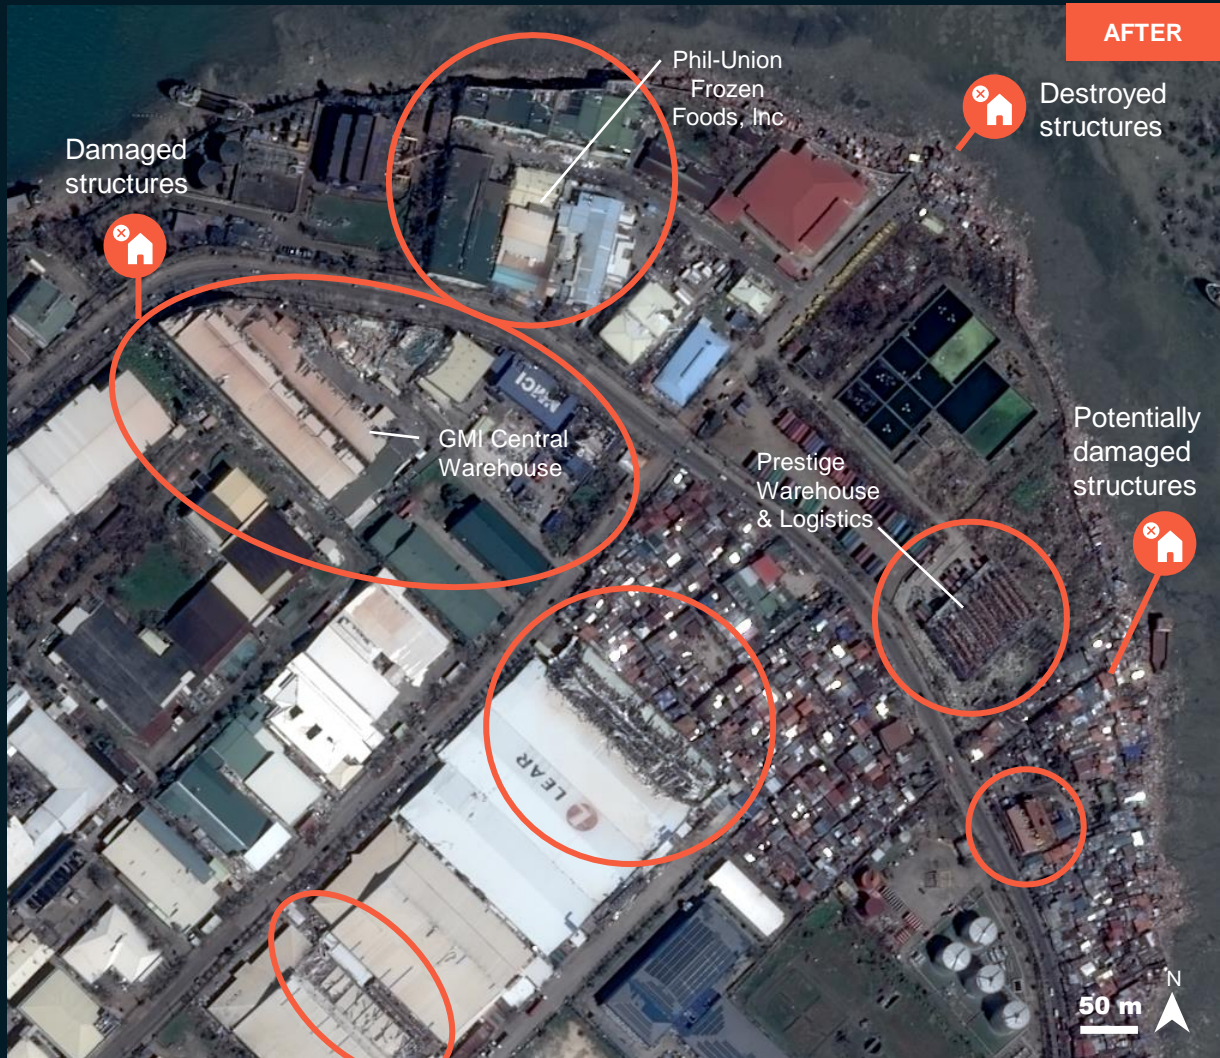
AOI 1-28: IBO INDUSTRIAL ZONE, LAPU-LAPU CITY, CEBU PROVINCE, REGION VII (CENTRAL VISAYAS)

Severely damaged structures in the industrial zone and along the shoreline
