27 December 2021

TROPICAL CYCLONE RAI-21

PRELIMINARY SATELLITE-DERIVED INDUSTRIAL SITES IMPACT ANALYSIS IN CEBU & NAGA

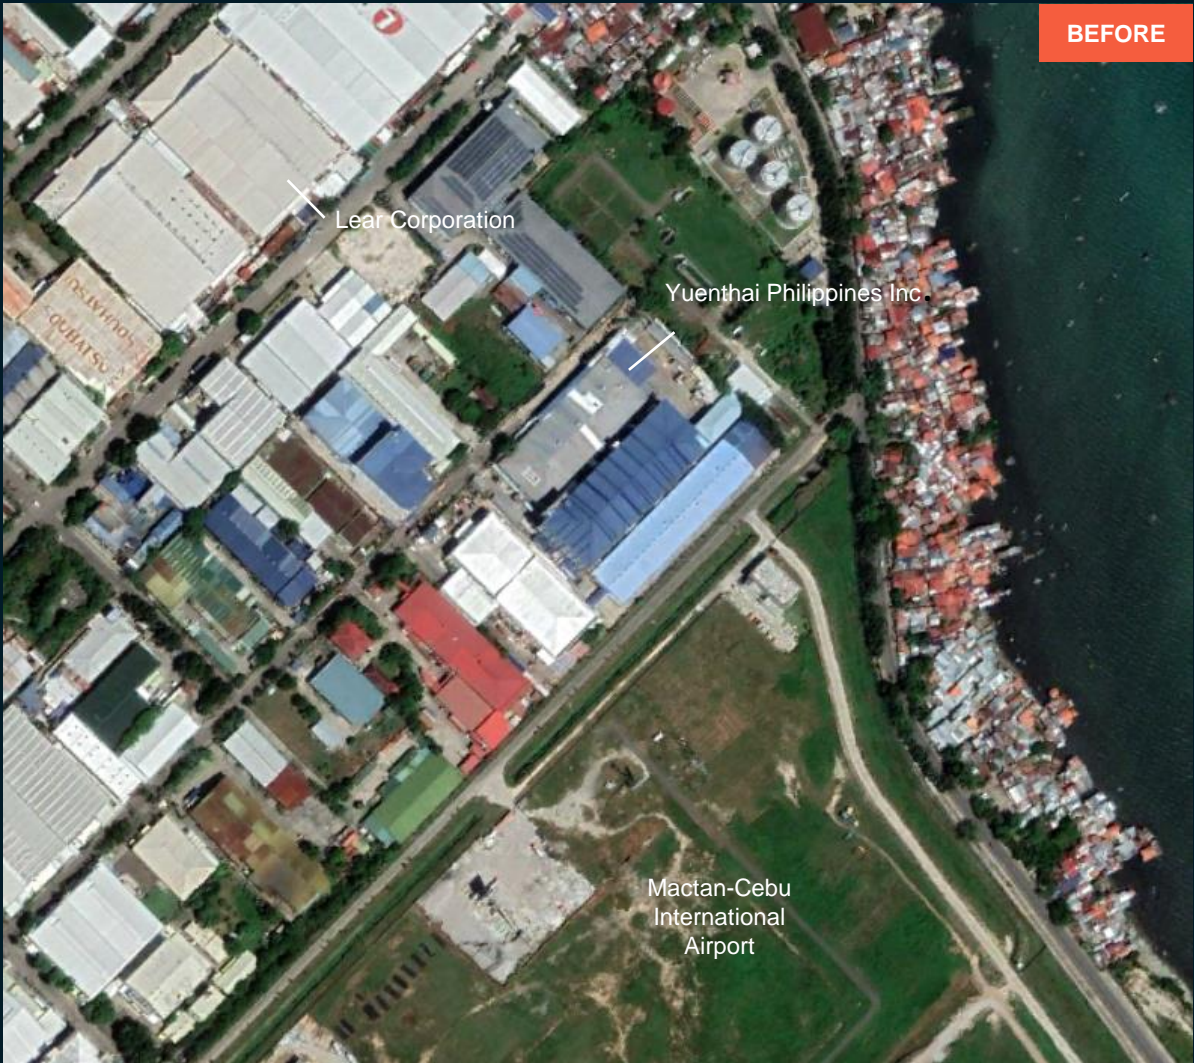
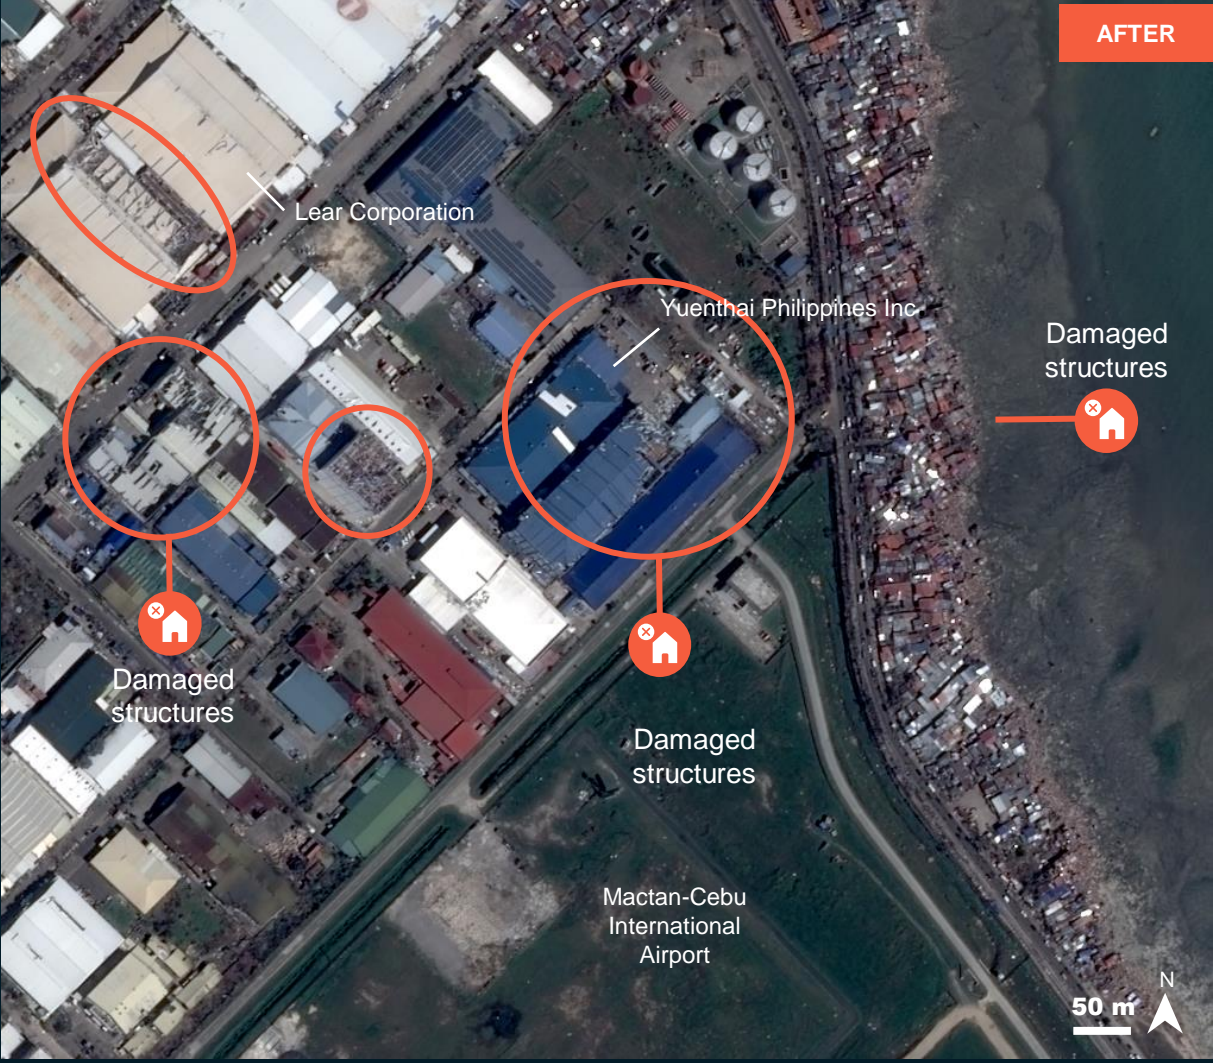
AOI 1-29: IBO INDUSTRIAL ZONE, LAPU-LAPU CITY, CEBU PROVINCE, REGION VII (CENTRAL VISAYAS)

Widespread damaged structures in the industrial zone and along the shoreline

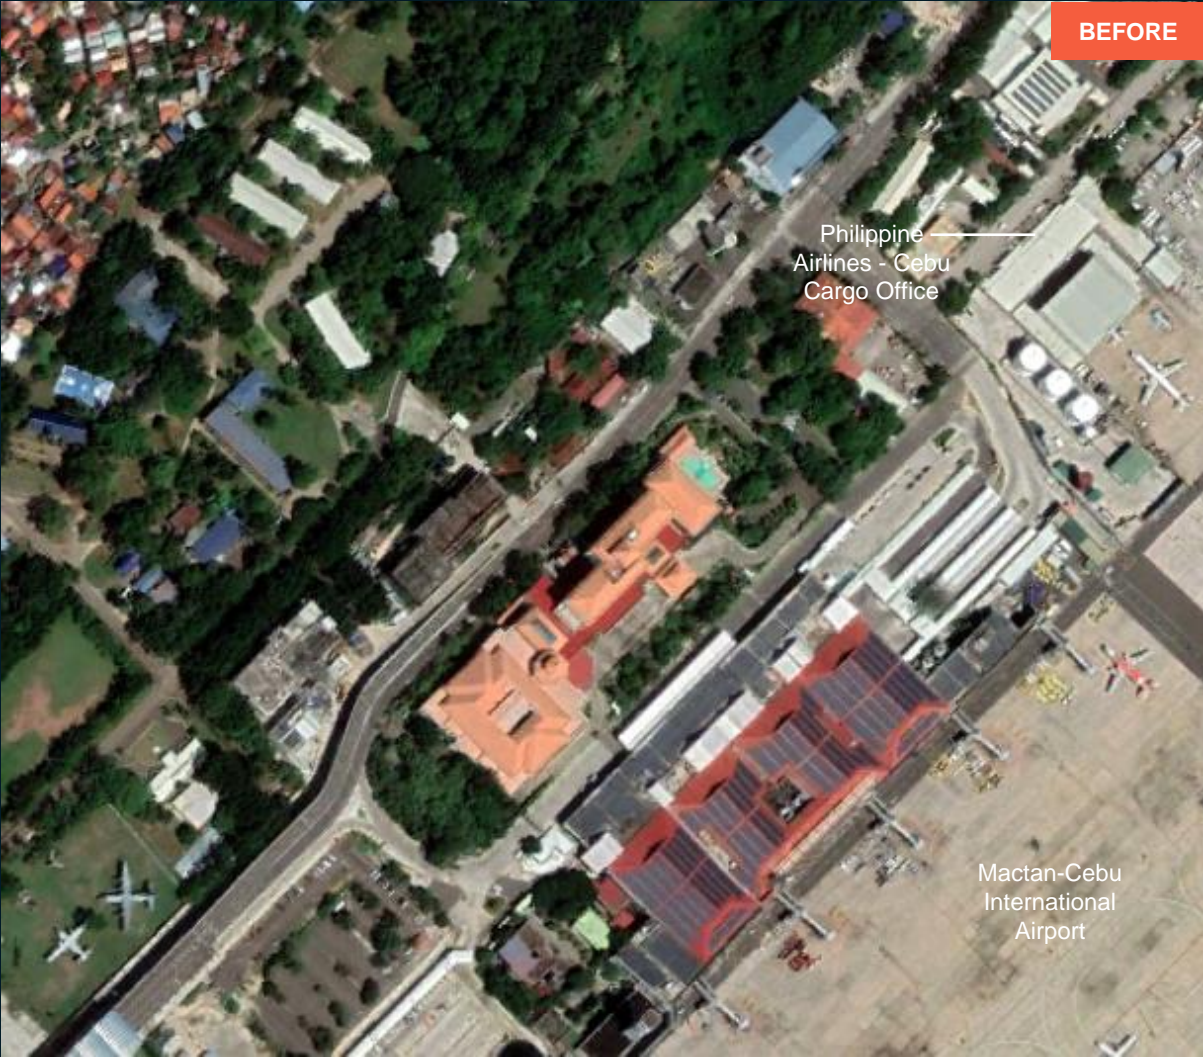
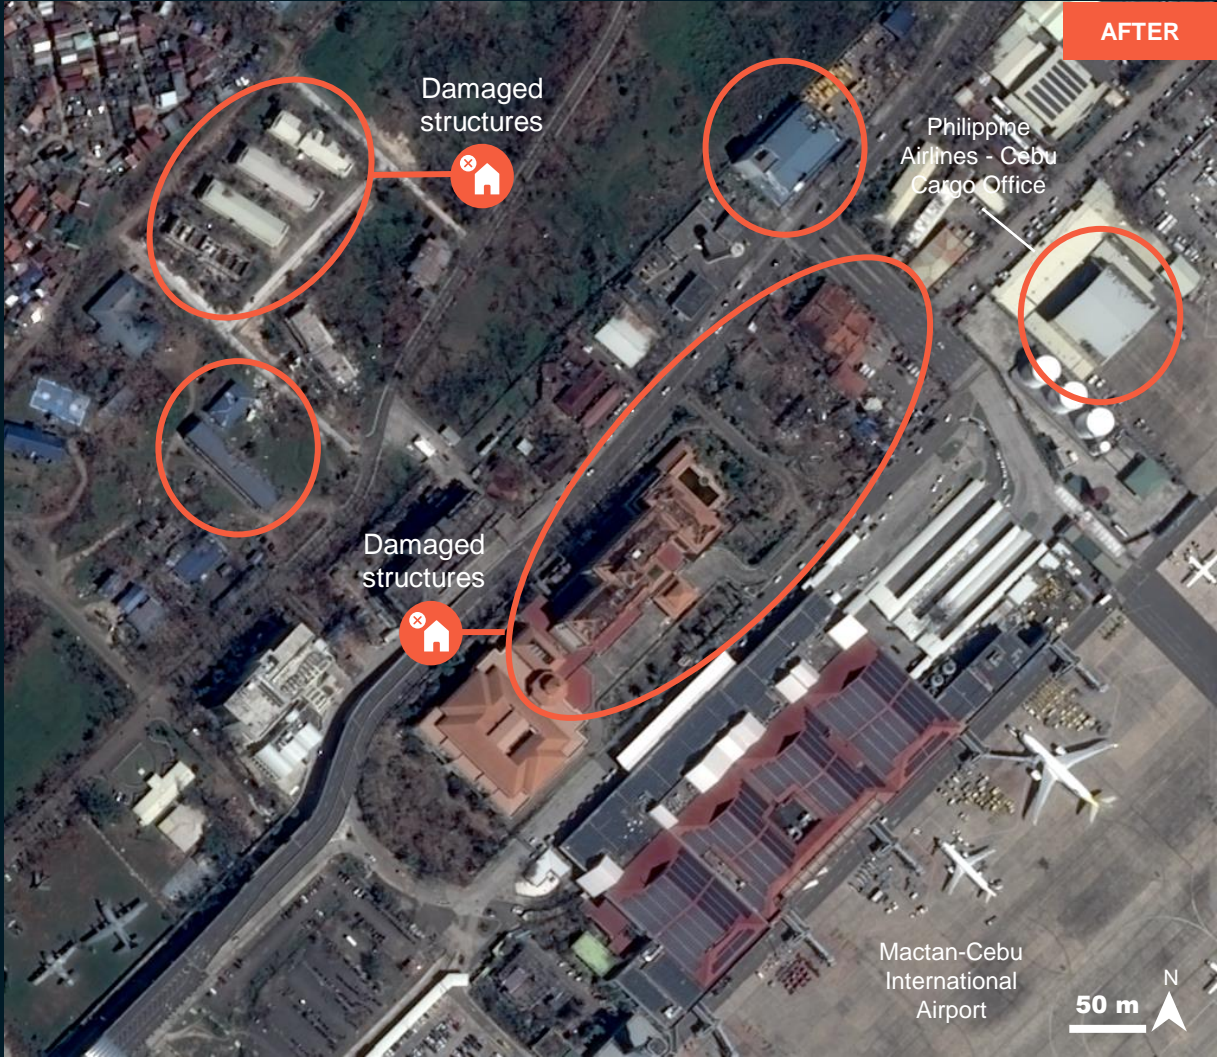
AOI 1-30: MACTAN-CEBU INTERNATIONAL AIRPORT, CEBU PROVINCE, REGION VII (CENTRAL VISAYAS)

Widespread damaged structures and roof

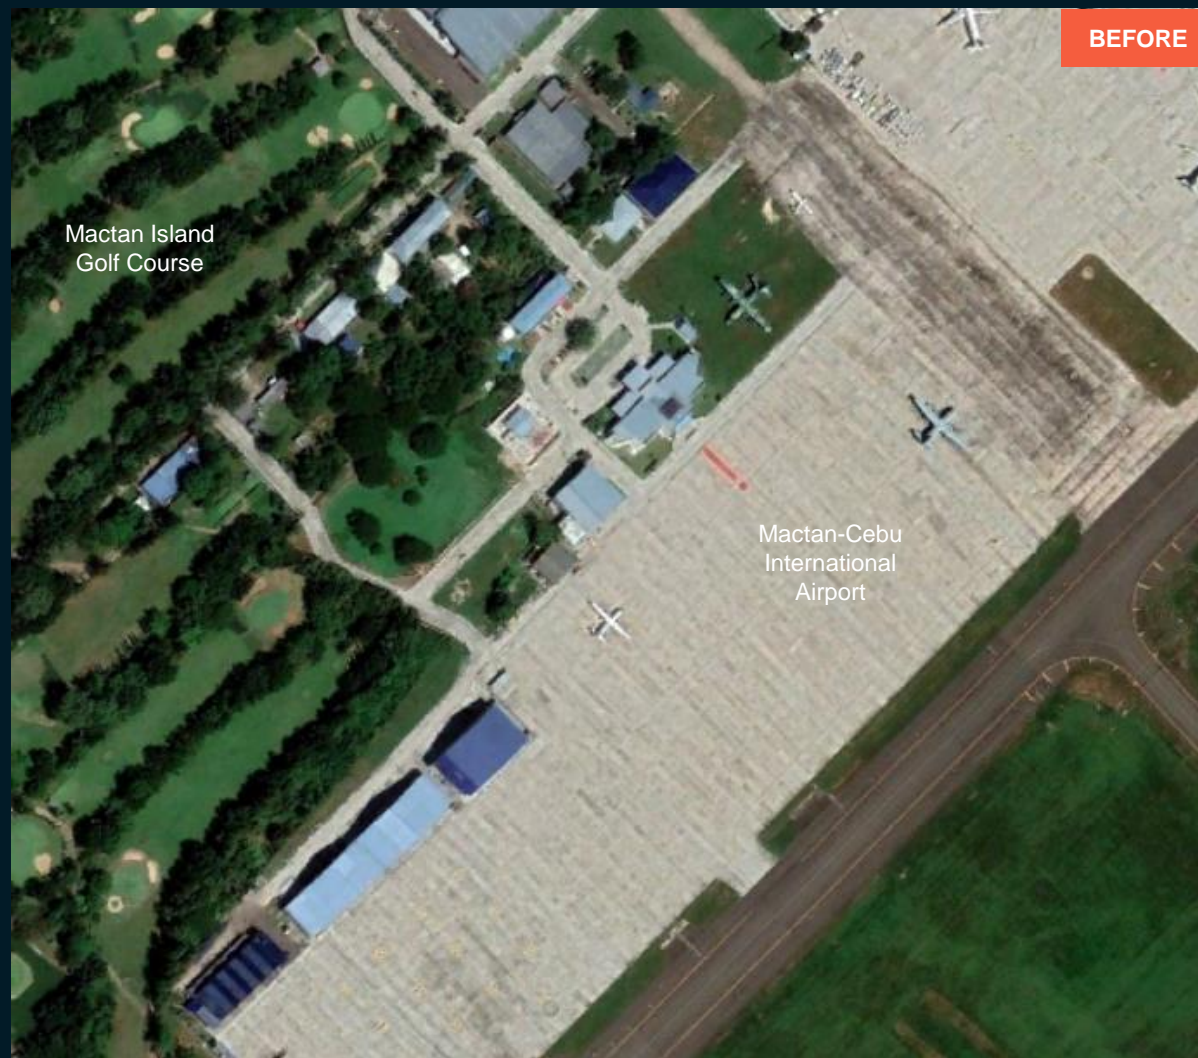
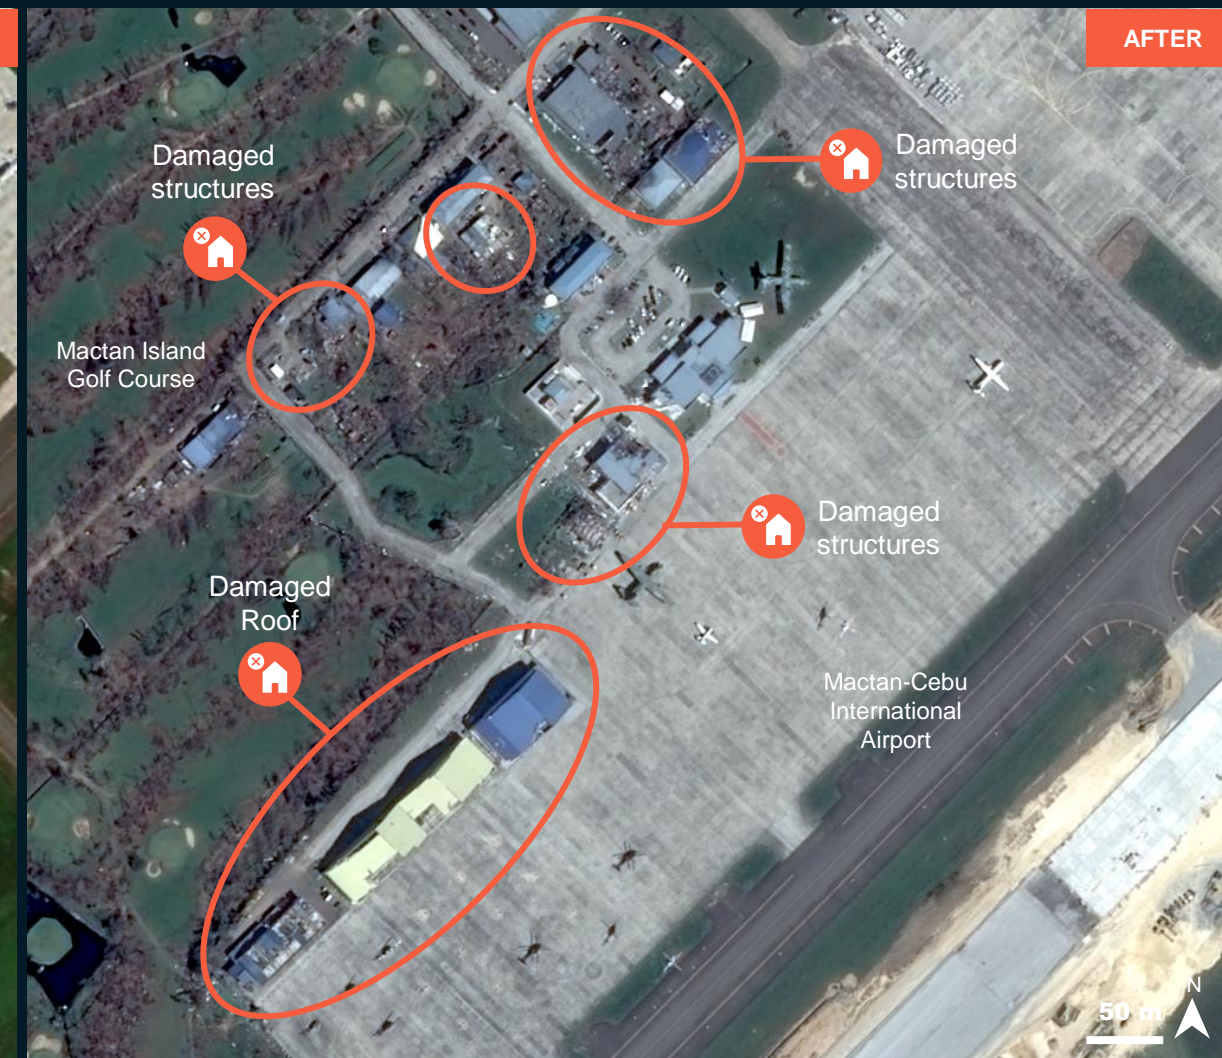
AOI 1-31: MACTAN-CEBU INTERNATIONAL AIRPORT, CEBU PROVINCE, REGION VII (CENTRAL VISAYAS)

Widespread damaged structures and roof

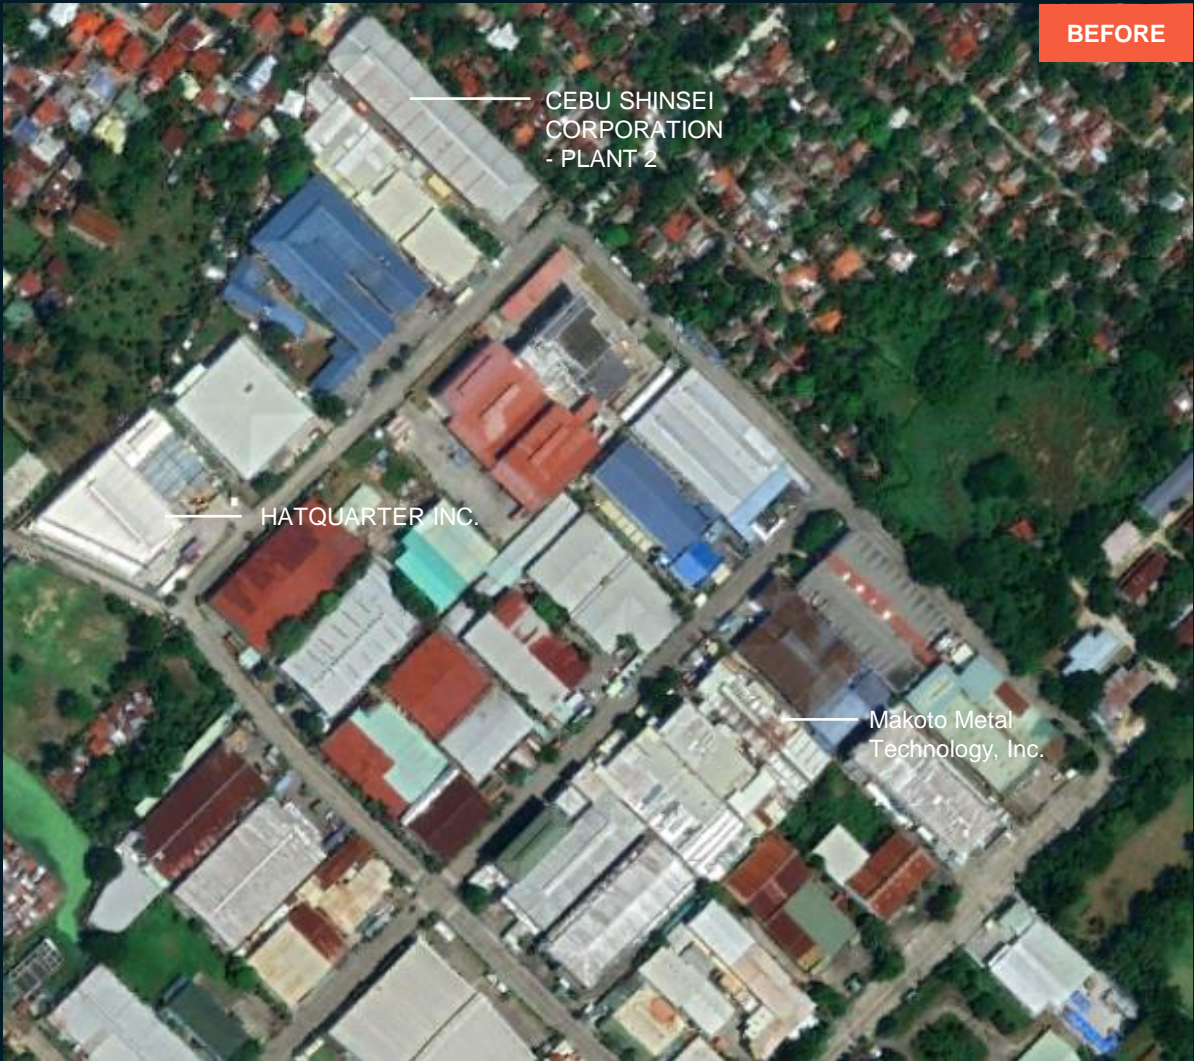
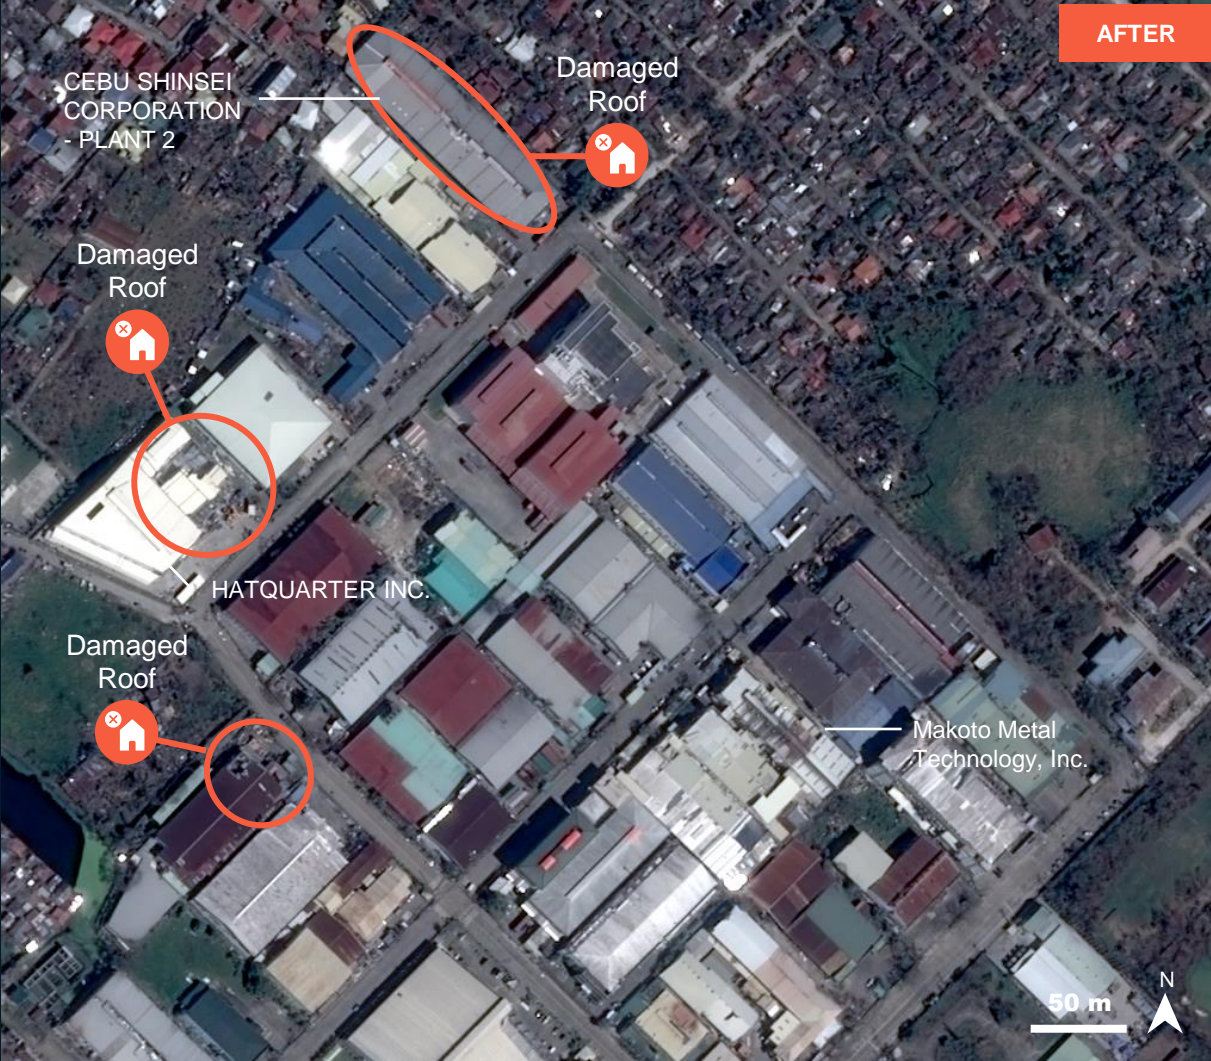
AOI 1-32: MEPZ 2 INDUSTRIAL ZONE, LAPU-LAPU CITY, CEBU PROVINCE, REGION VII (CENTRAL VISAYAS)

Damaged roof

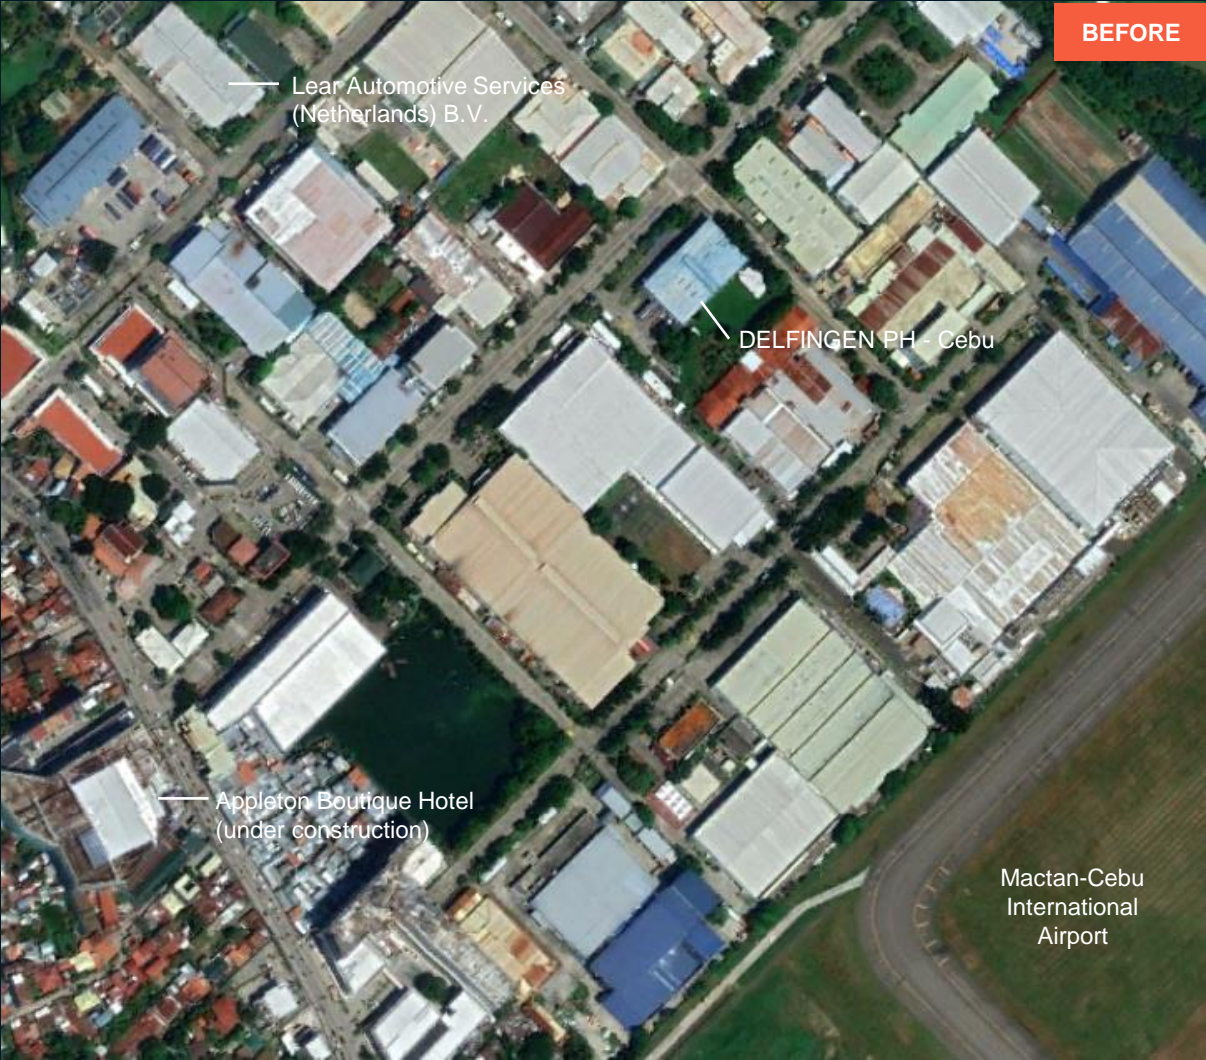
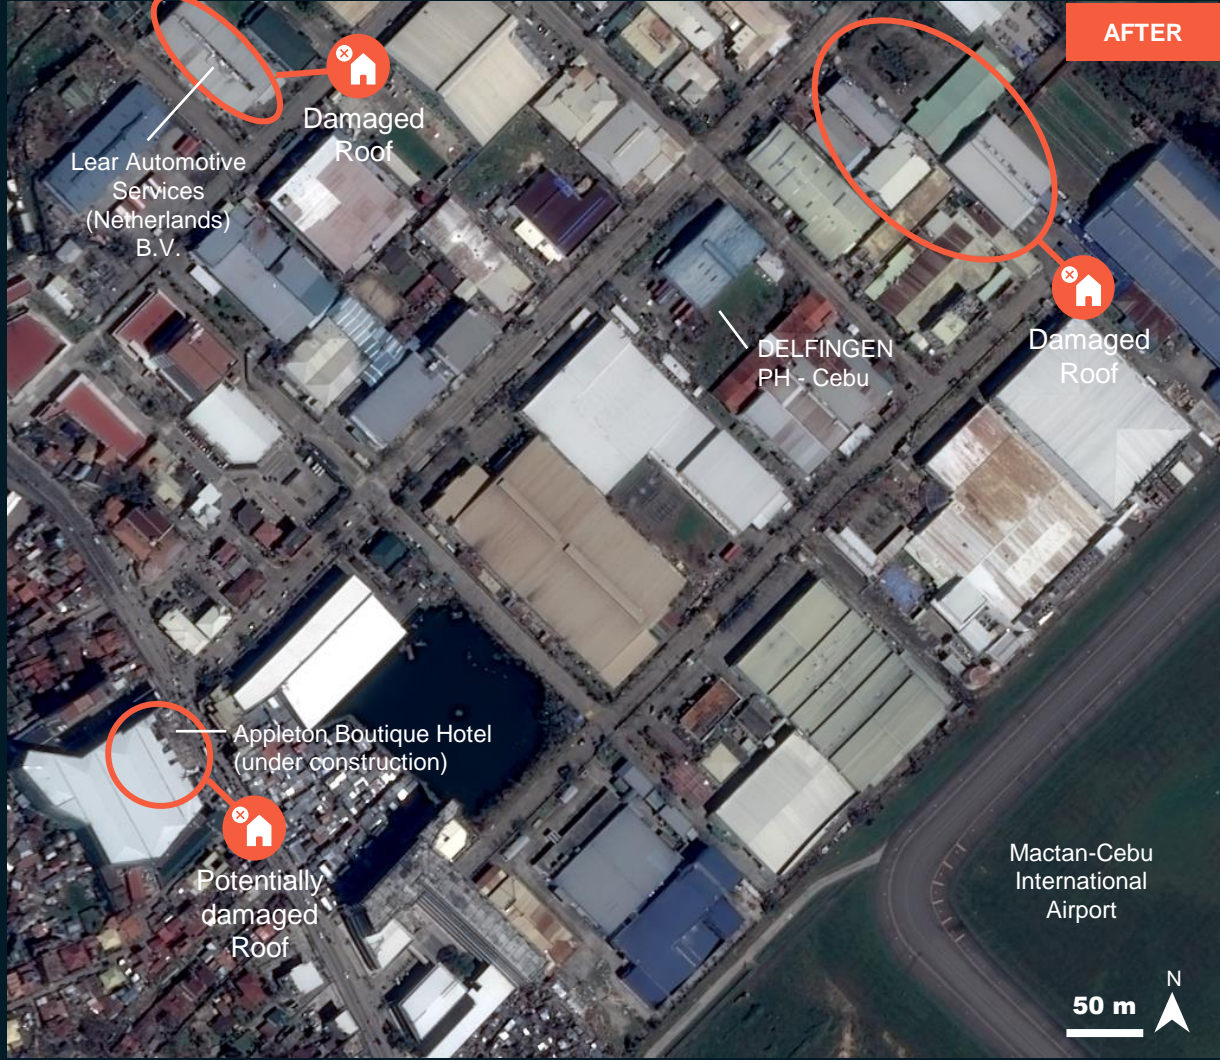
AOI 1-33: MEPZ 2 INDUSTRIAL ZONE, LAPU-LAPU CITY, CEBU PROVINCE, REGION VII (CENTRAL VISAYAS)

Damaged roof

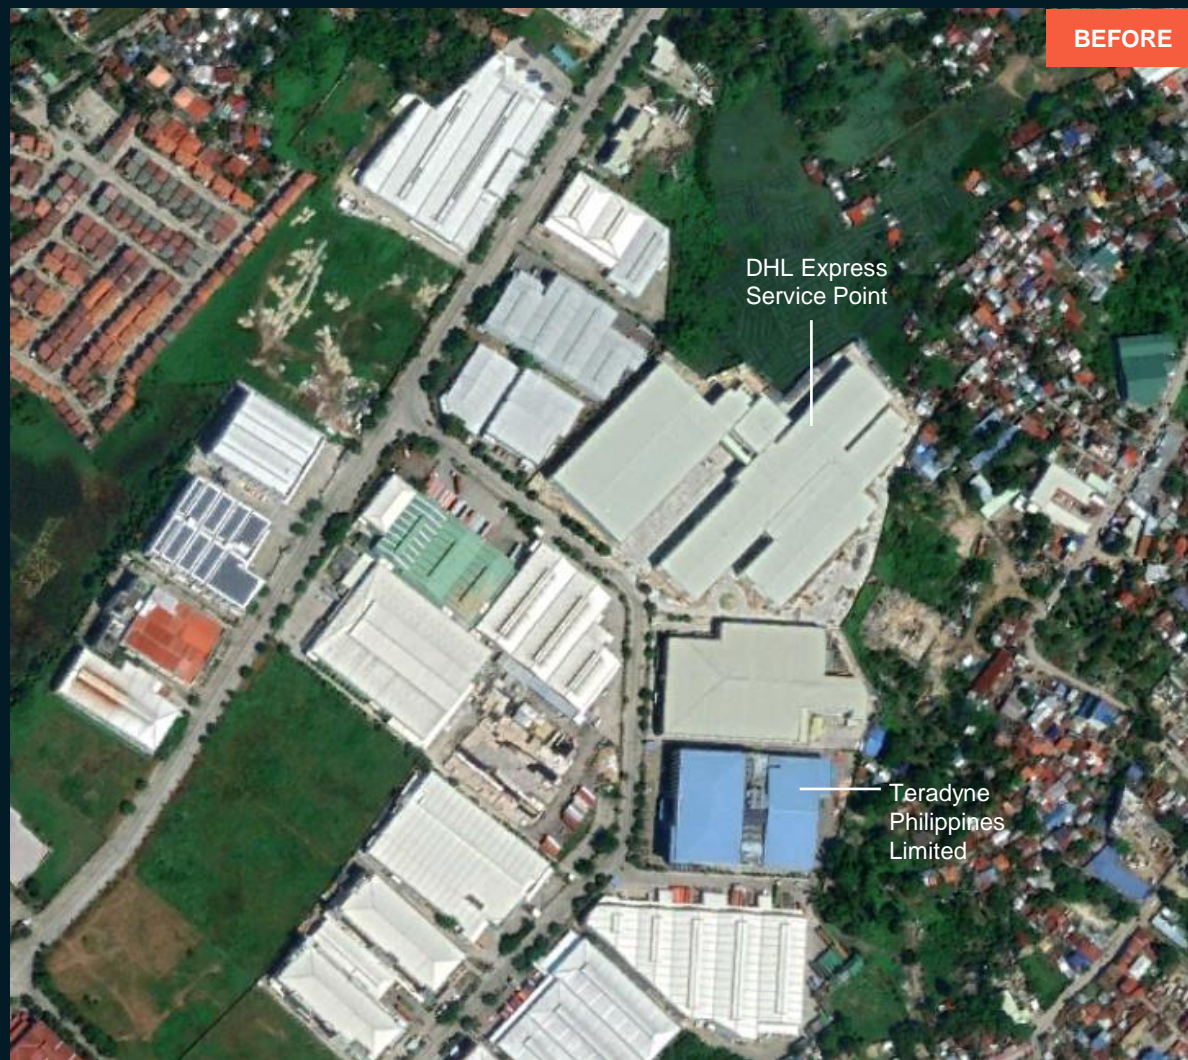
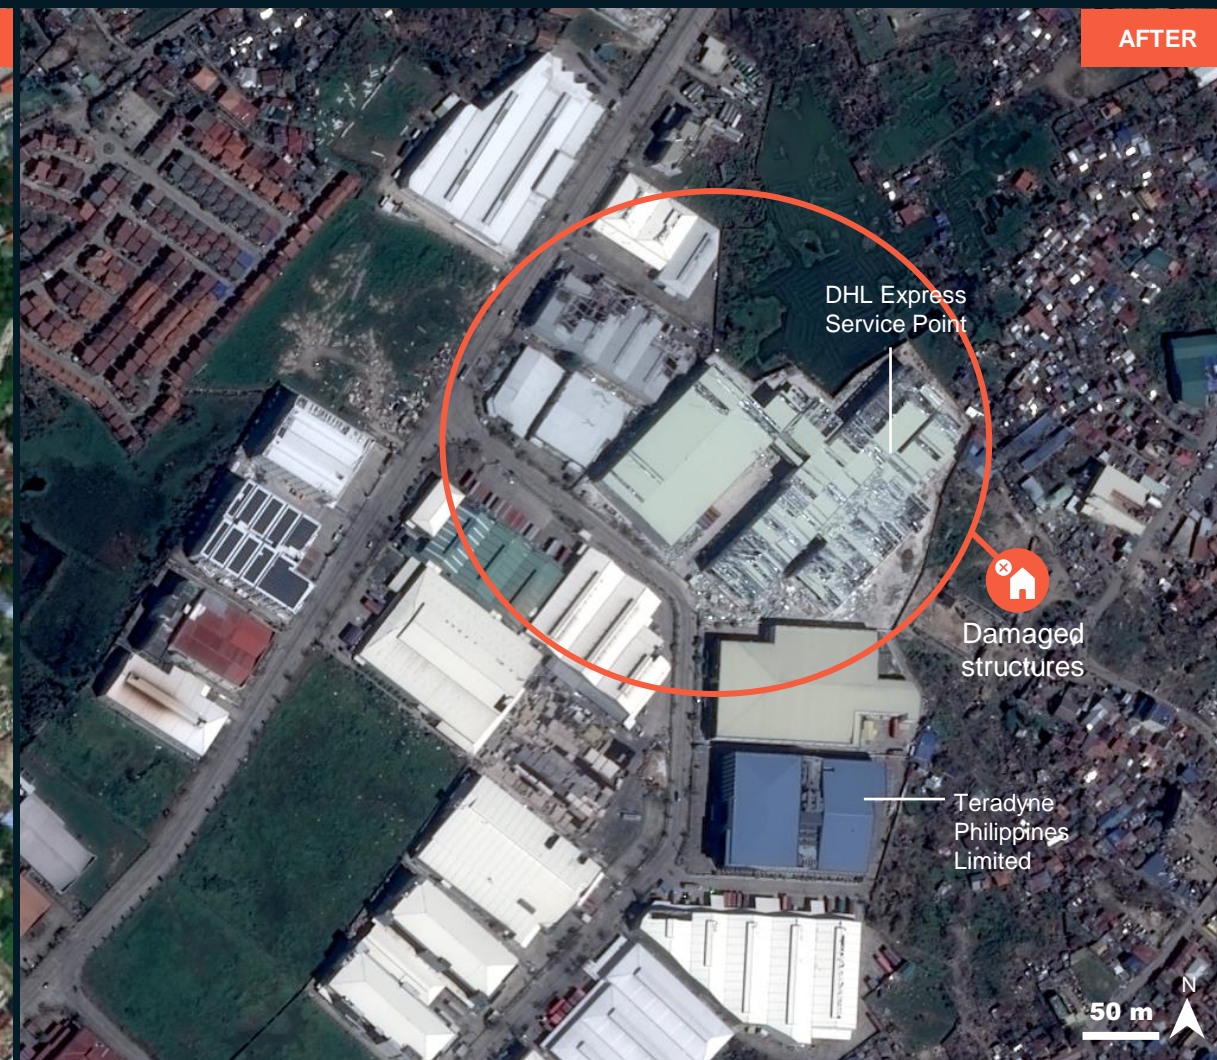
AOI 1-34: BASAK INDUSTRIAL ZONE, LAPU-LAPU CITY, CEBU PROVINCE, REGION VII (CENTRAL VISAYAS)

Damaged roof and structure

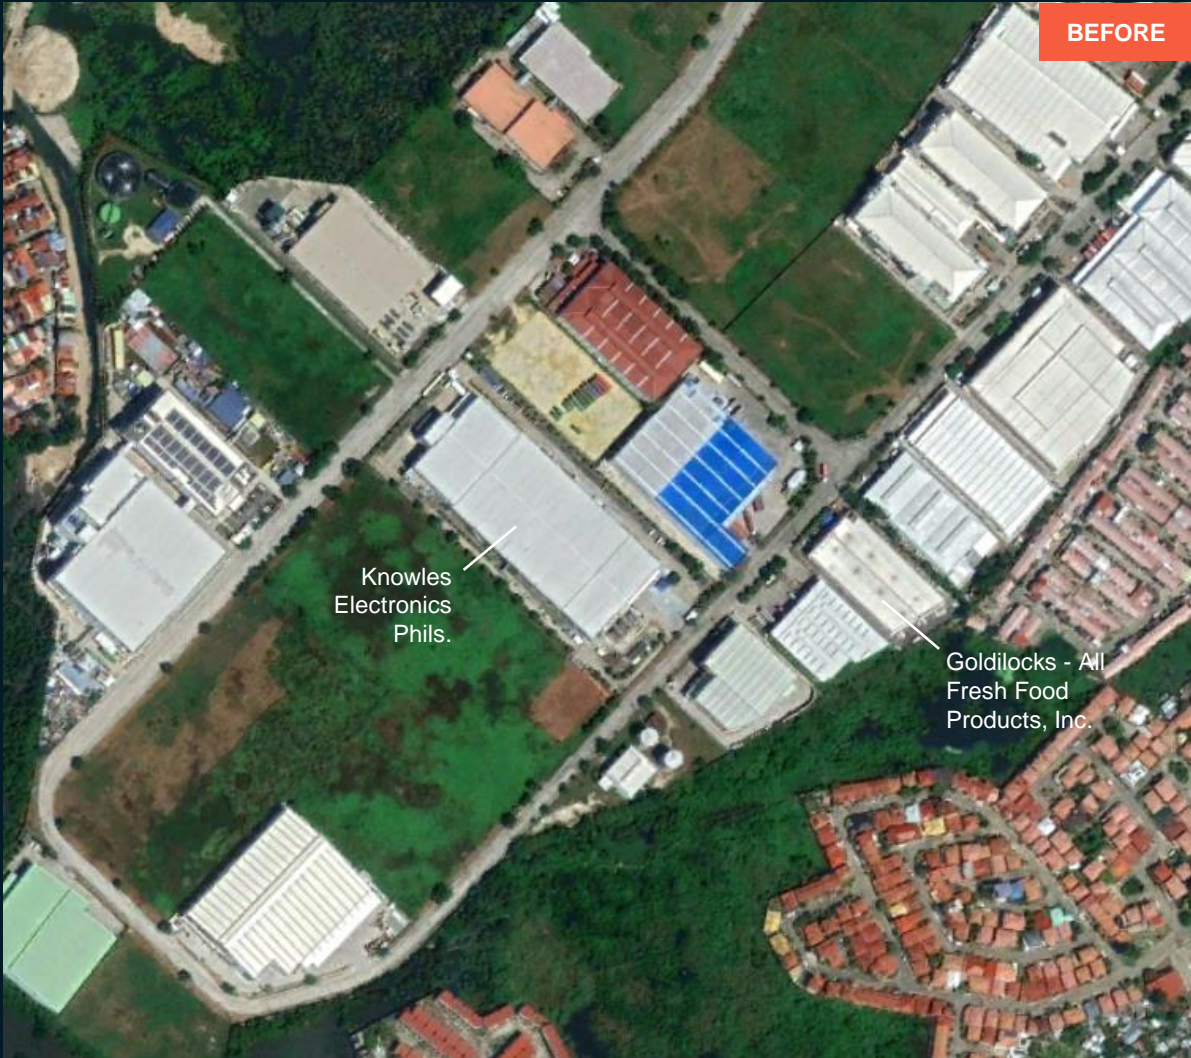
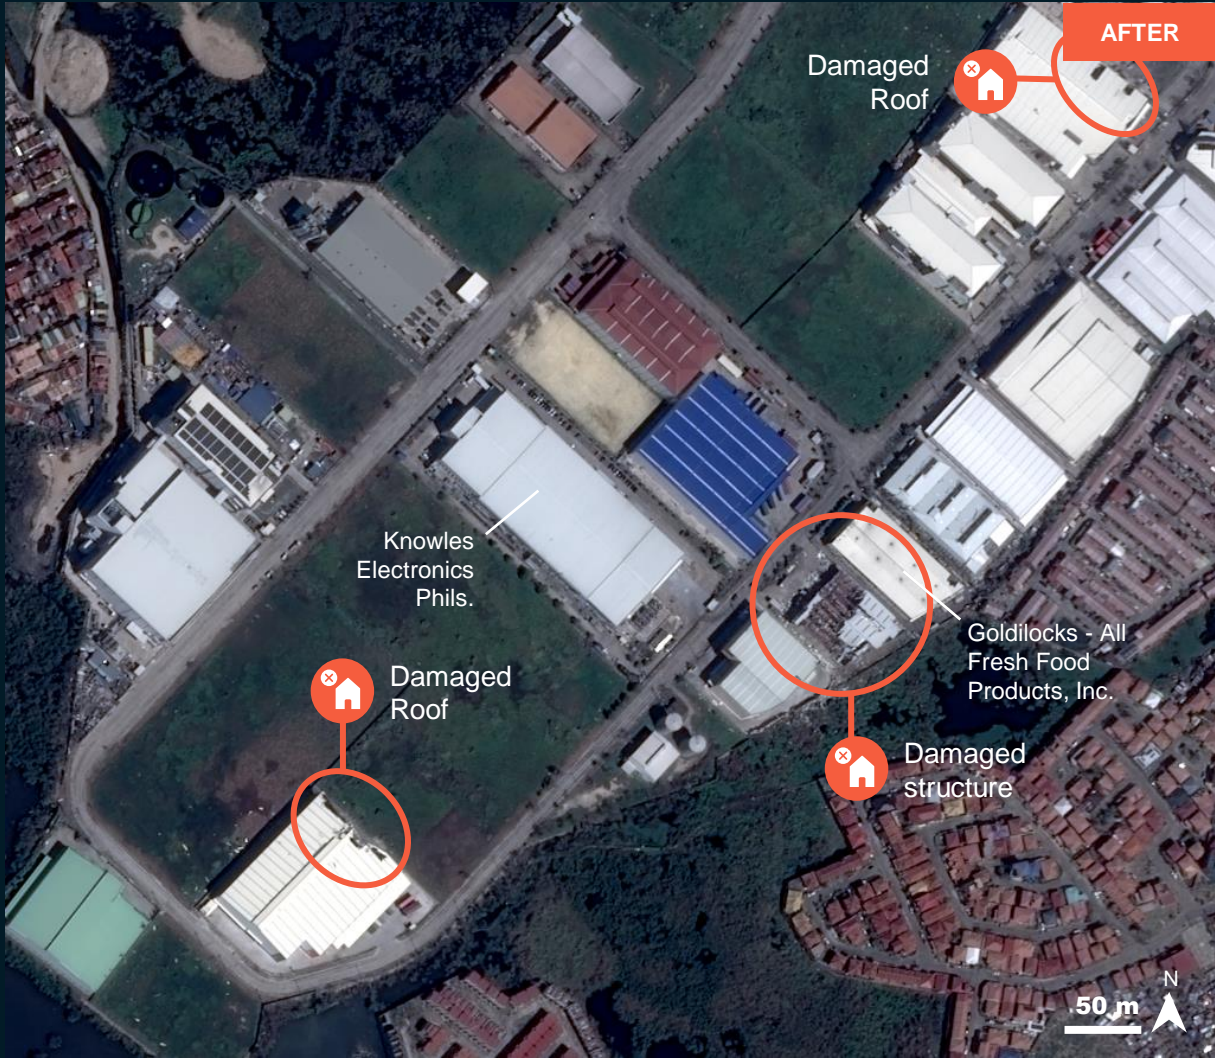
AOI 1-35: BASAK INDUSTRIAL ZONE, LAPU-LAPU CITY, CEBU PROVINCE, REGION VII (CENTRAL VISAYAS)

Damaged roof and structure
