# Pre and Post Satellite Images showing Flash Flood affected areas in parts of Gerkhutar Nuwakot District, Nepal

CHARTER CALL NO :1209

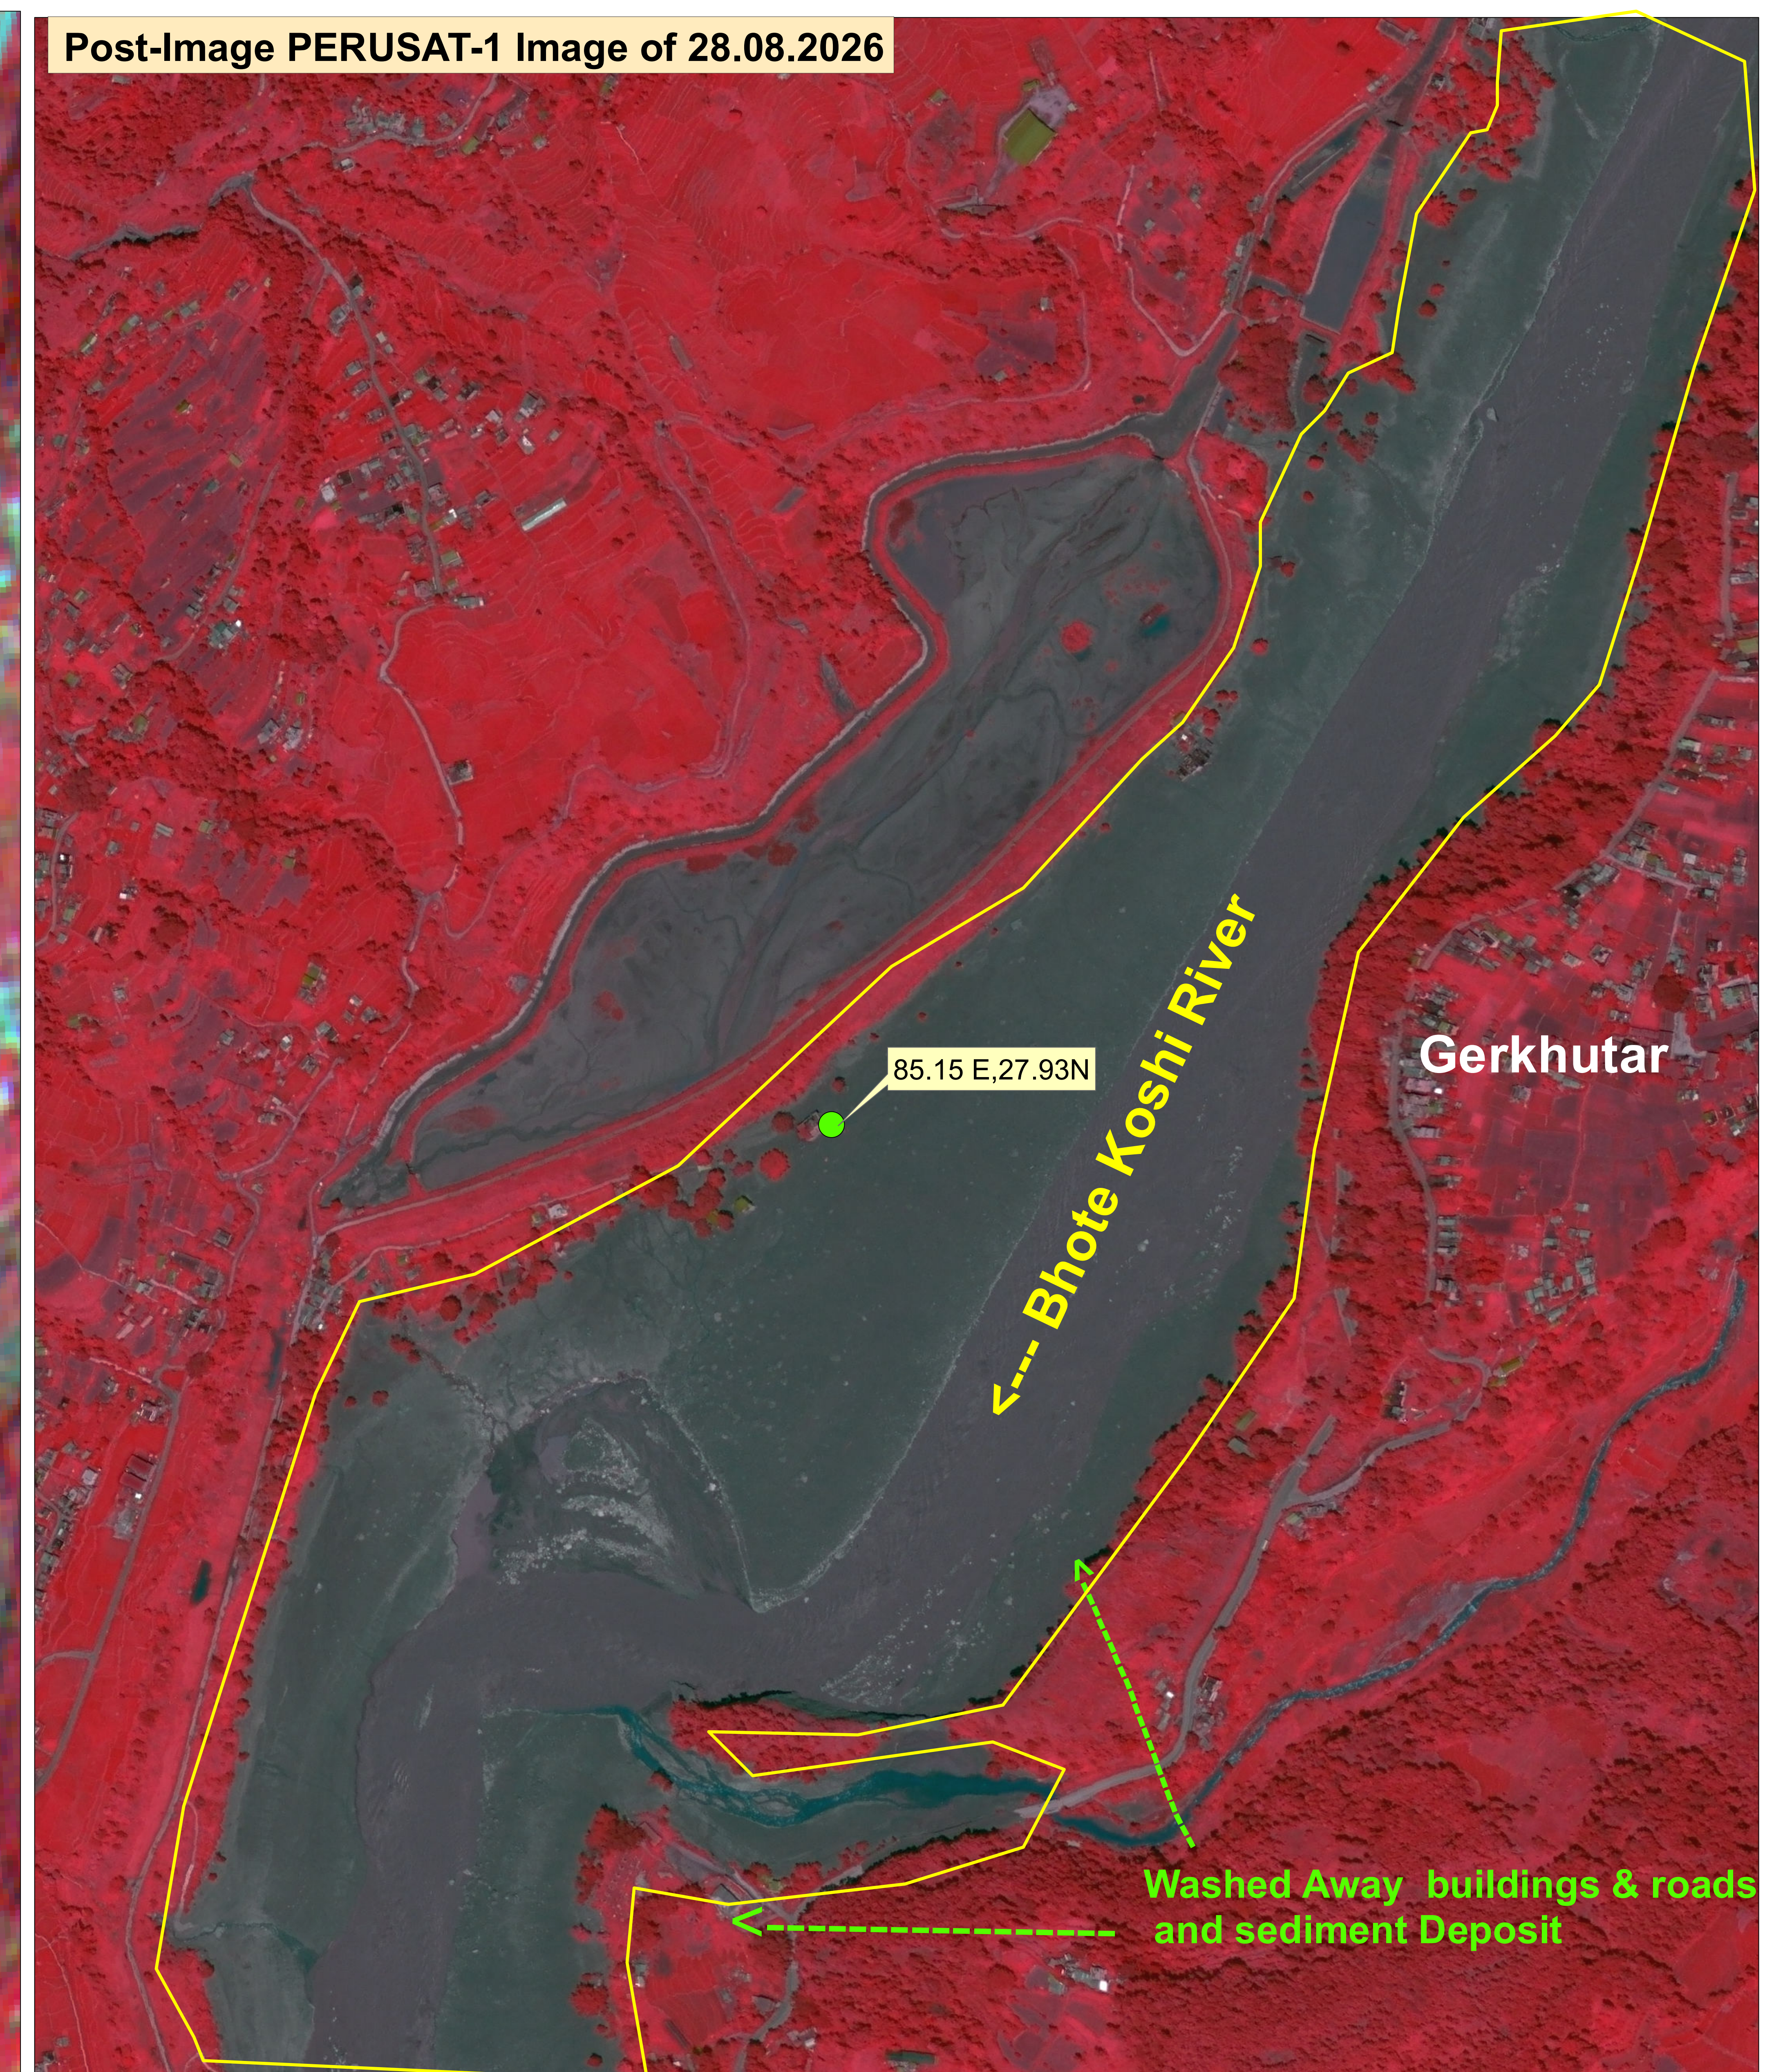
Post-Image PERUSAT-1 Image of 28.08.2026

- \* A Massive flash flood in Lhende Khola (tributary of Bhote Koshi River) around 09:00 AM NPT on 26 August 2026, affecting downstream areas of Rasuwa, Dhading, Nuwakot, Gerkhuta and Chitwan districts,
- \* Flash flood also caused the washing away/ damage of Buildings and infrastructure including severe loss of life in encompassed area of polygon at Gerkhuta in above satellite image
