# Pre and Post Satellite Images showing Flash Flood affected areas in parts of Gerkhutar Nuwakot District, Nepal

CHARTER CALL NO :1209

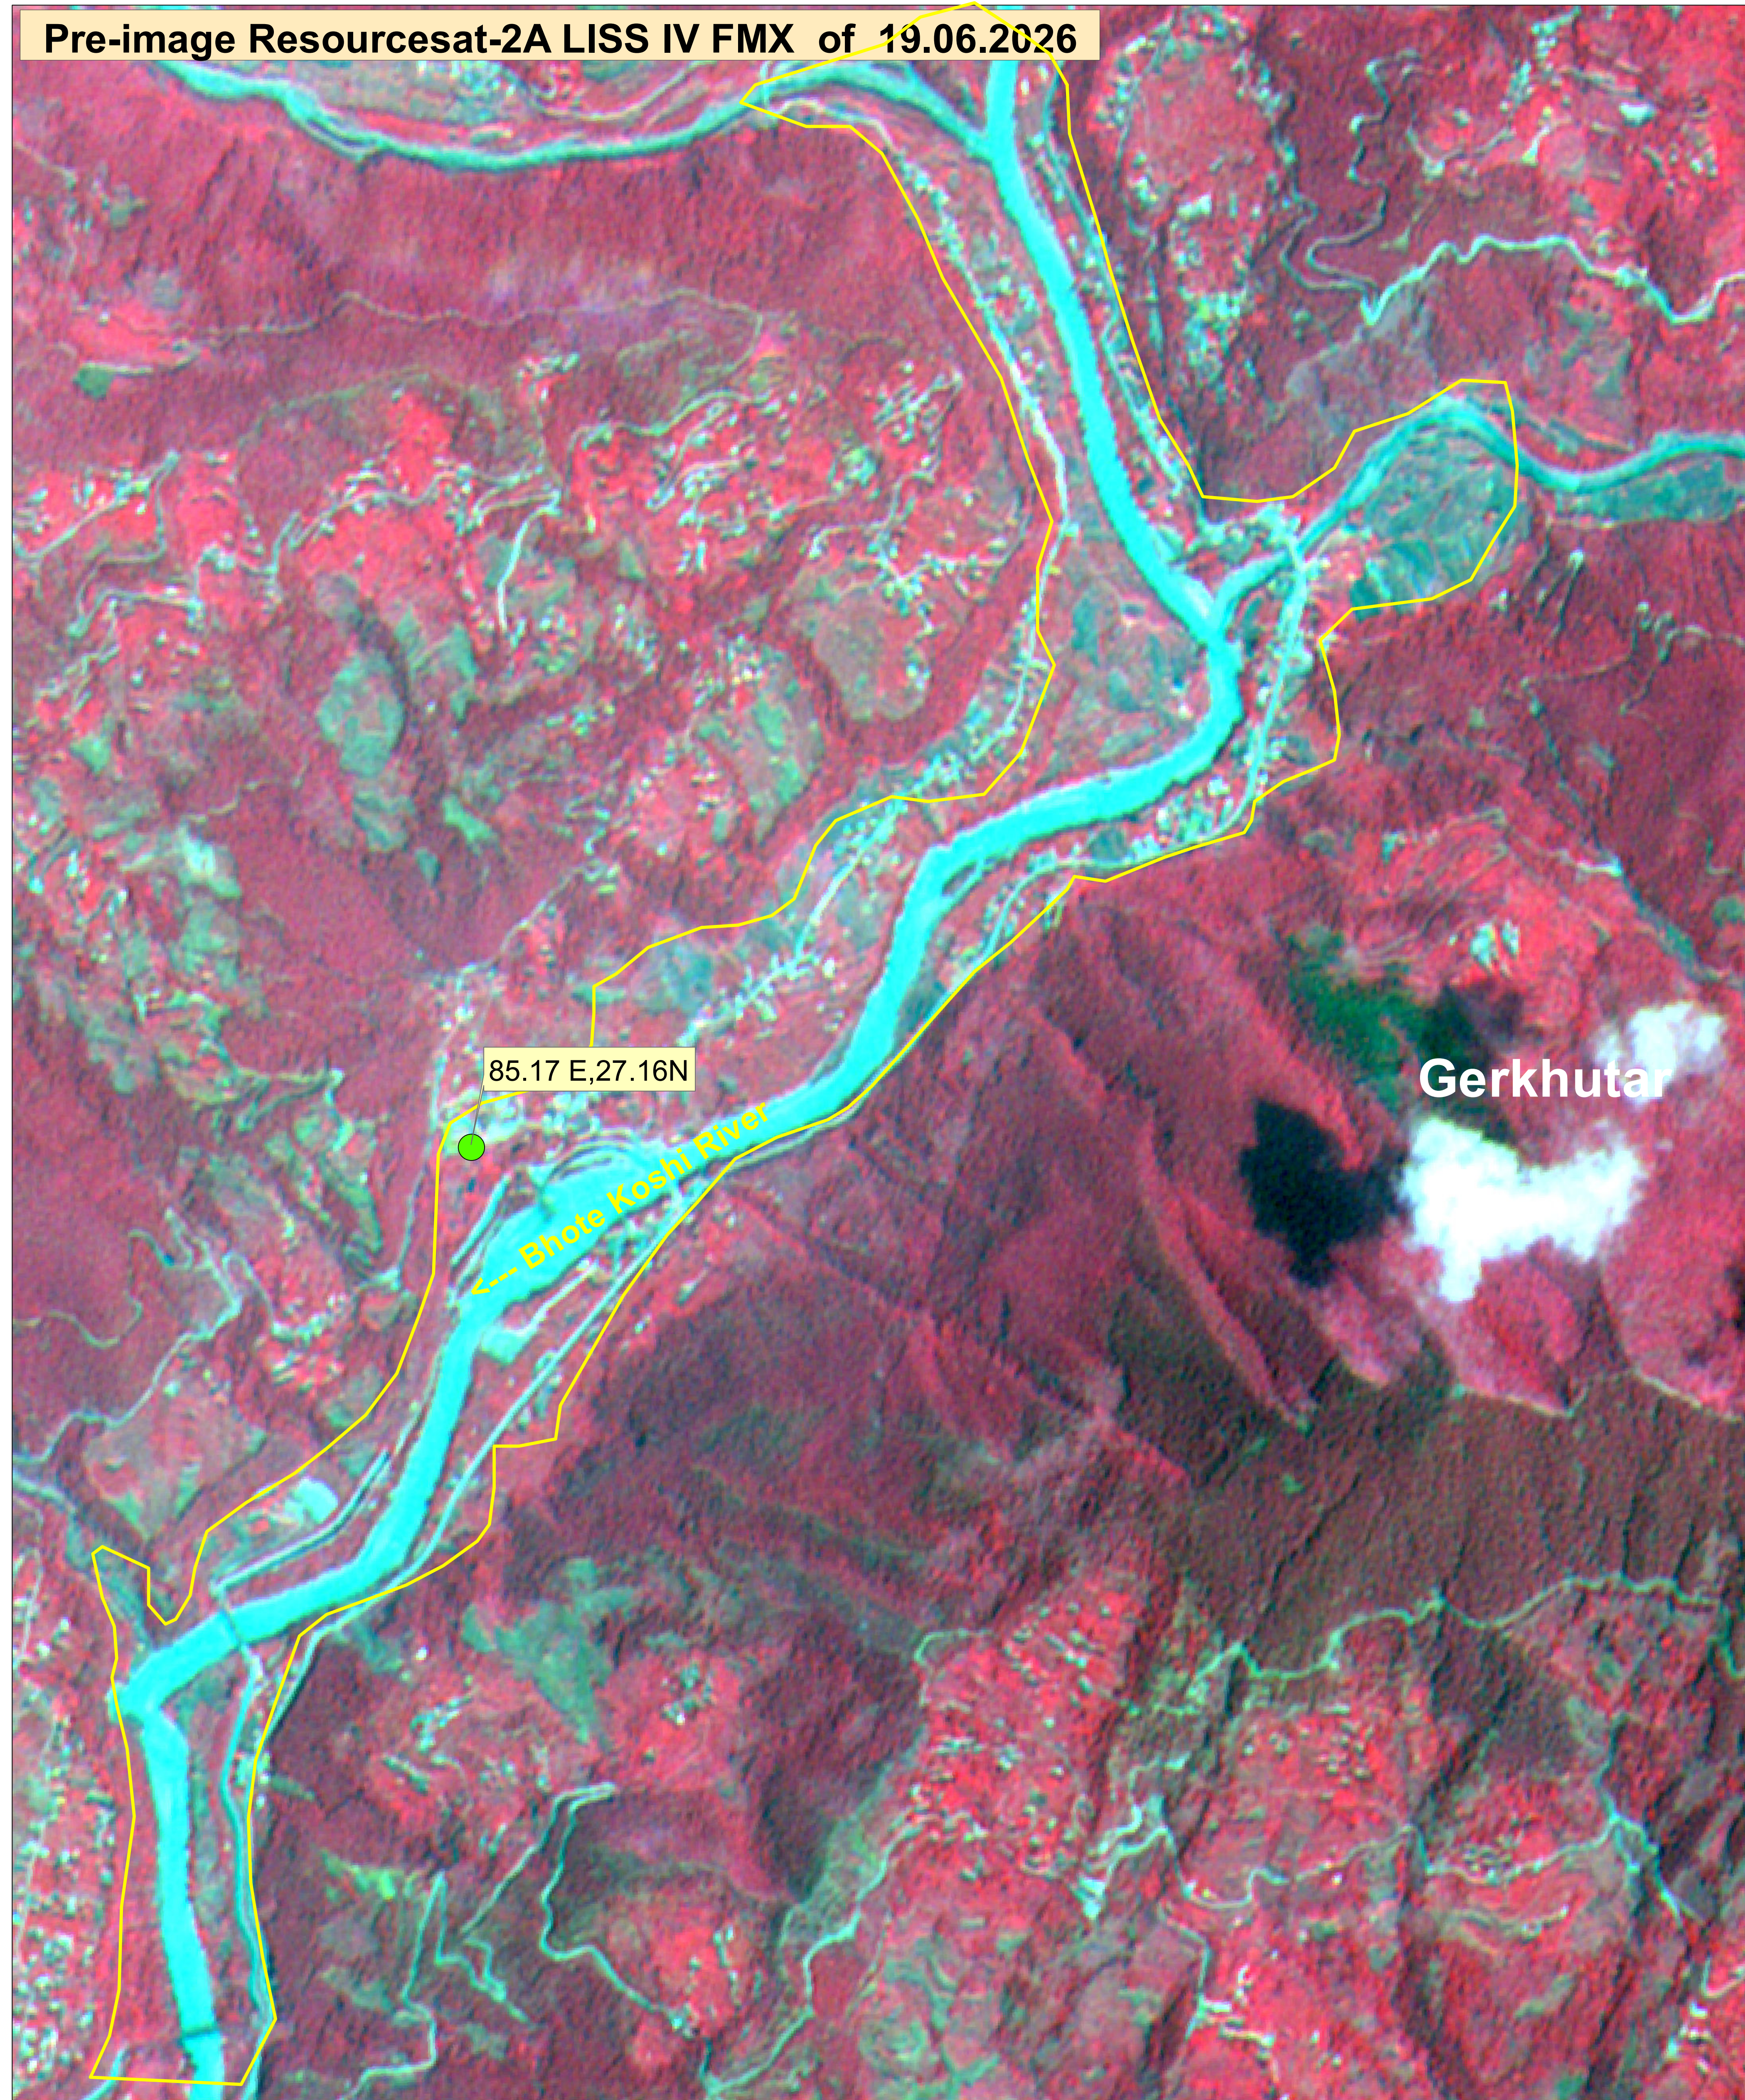
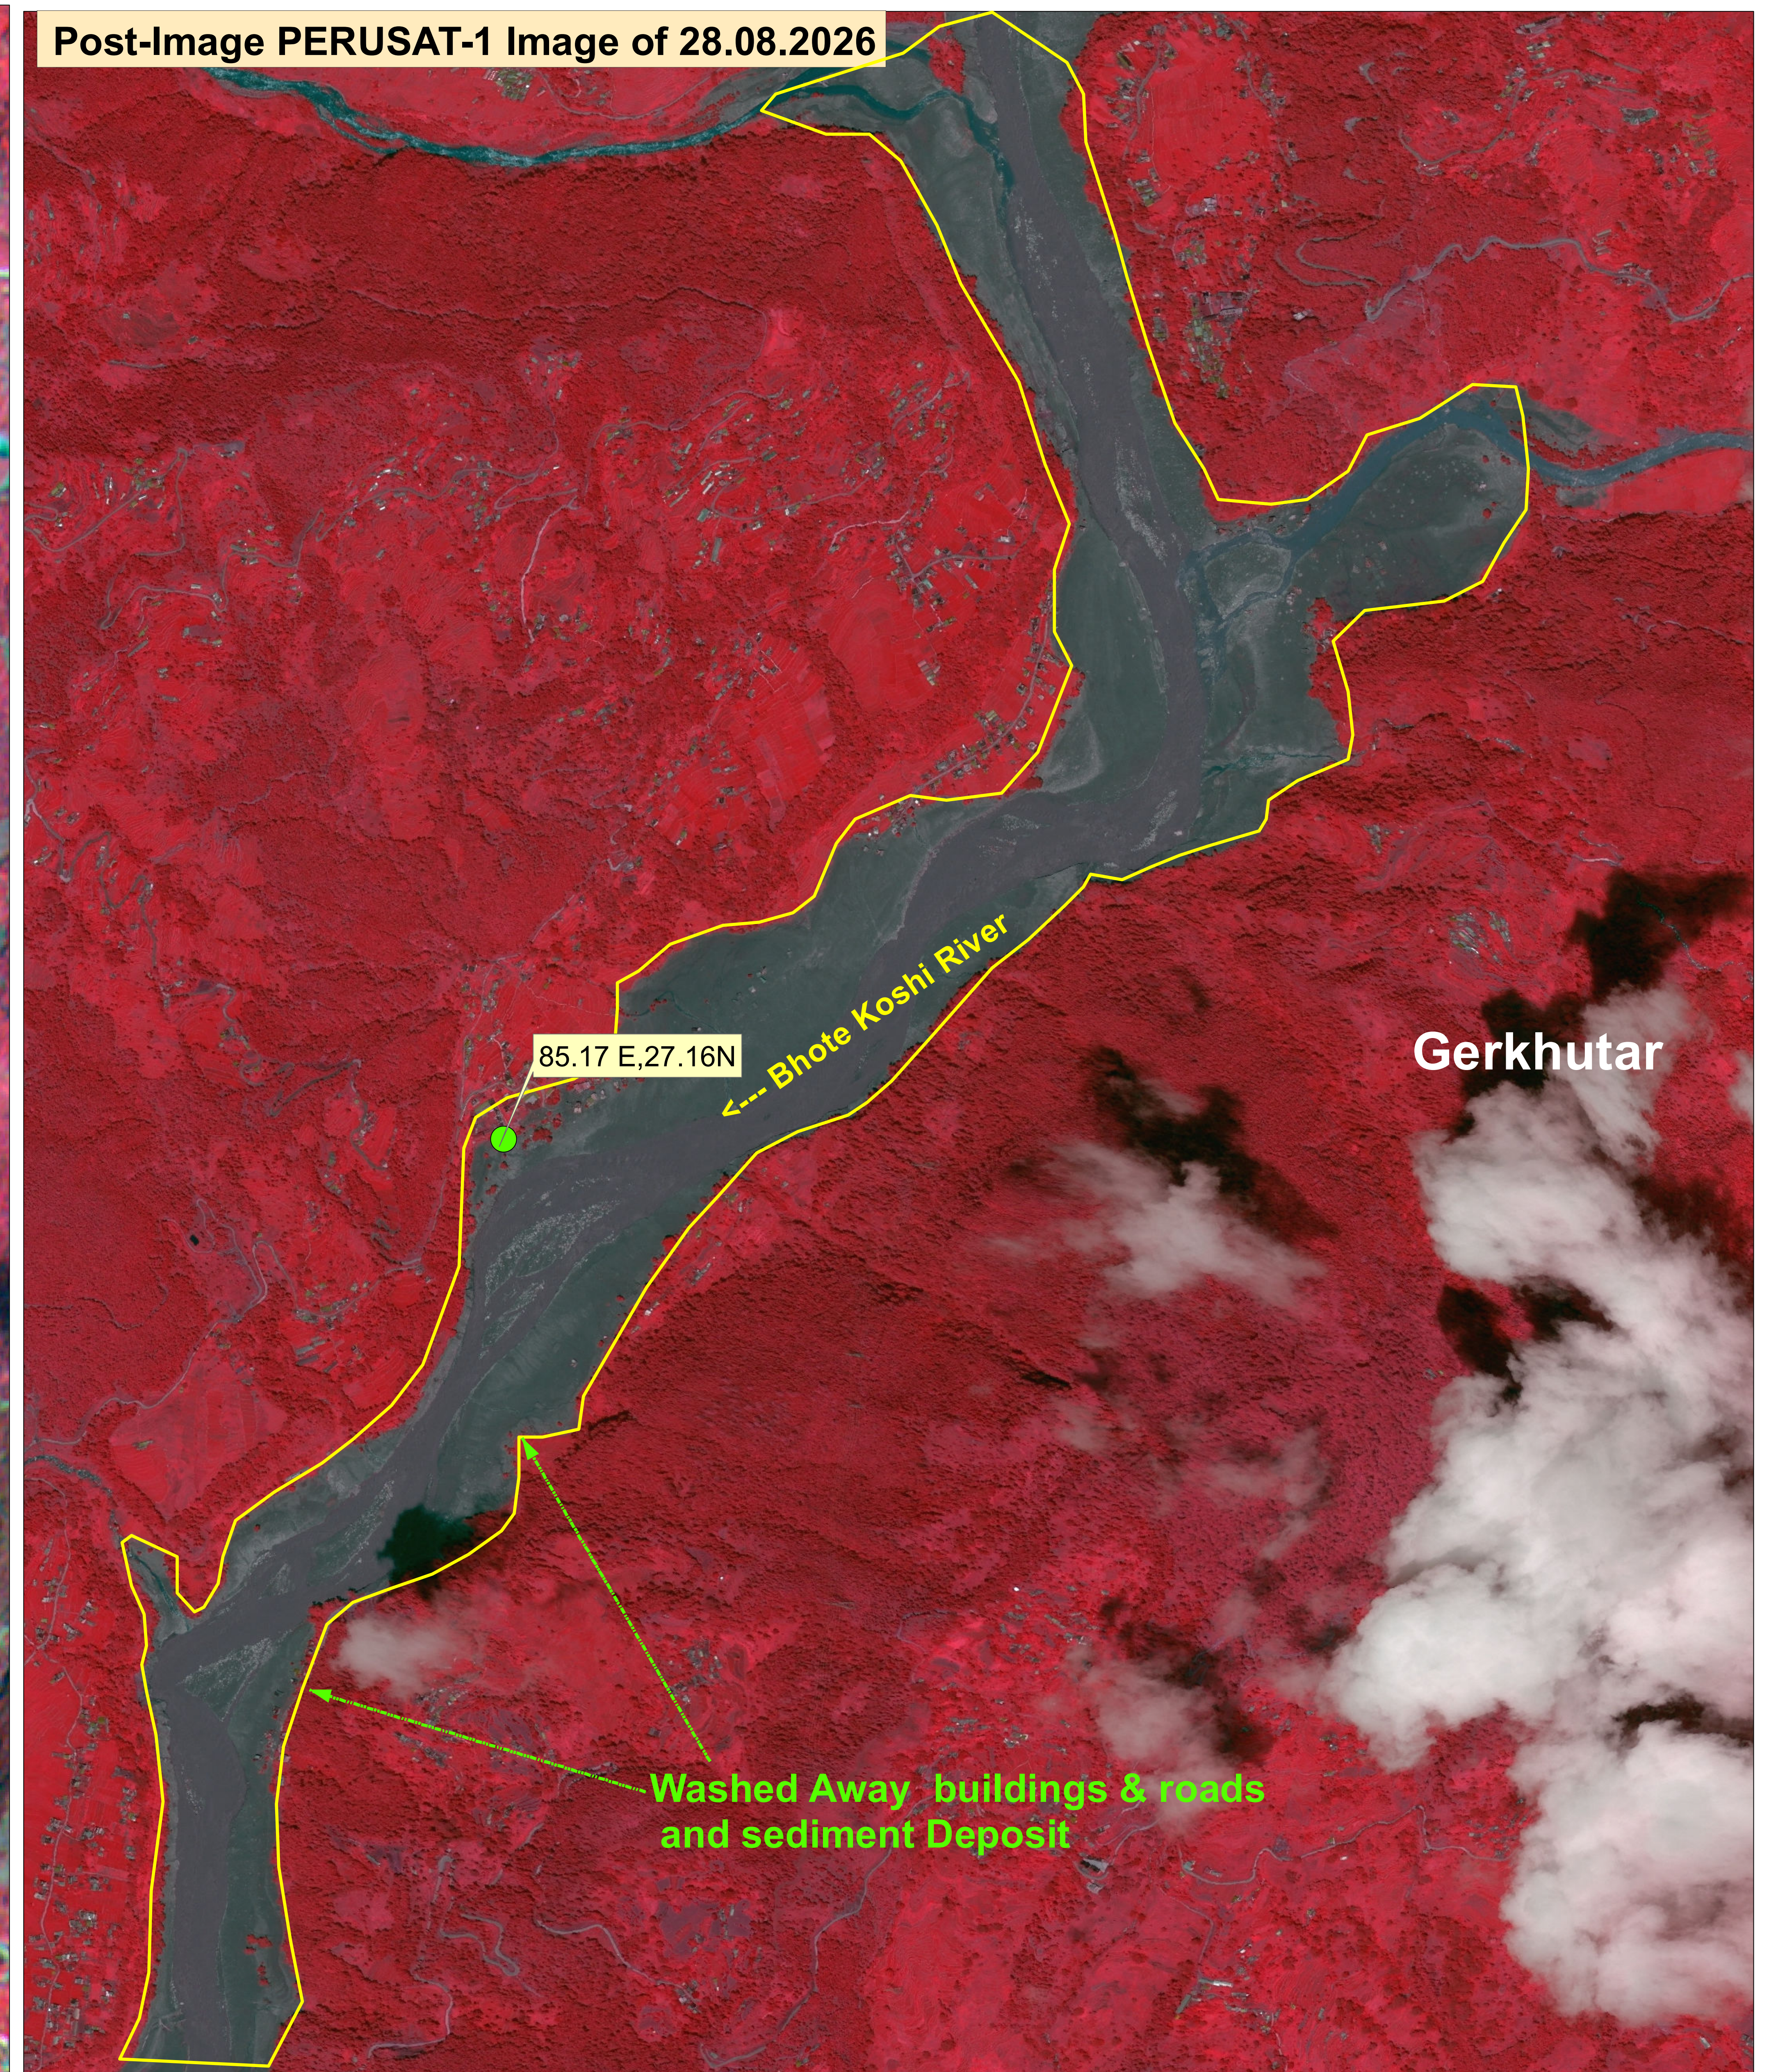
- \* A Massive flash flood in Lhende Khola (tributary of Bhote Koshi River) around 09:00 AM NPT on 26 August 2026, affecting downstream areas of Rasuwa, Dhading, Nuwakot, Gerkhuta and Chitwan districts,
- \* Flash flood also caused the washing away/ damage of Buildings and infrastructure including severe loss of life in encompassed area of polygon at Gerkhuta in above satellite image
