# Pre and Post Satellite Images showing Flash Flood affected areas Rasuwagadhi and Surroundings, Nepal

CHARTER CALL NO :1209 For official use

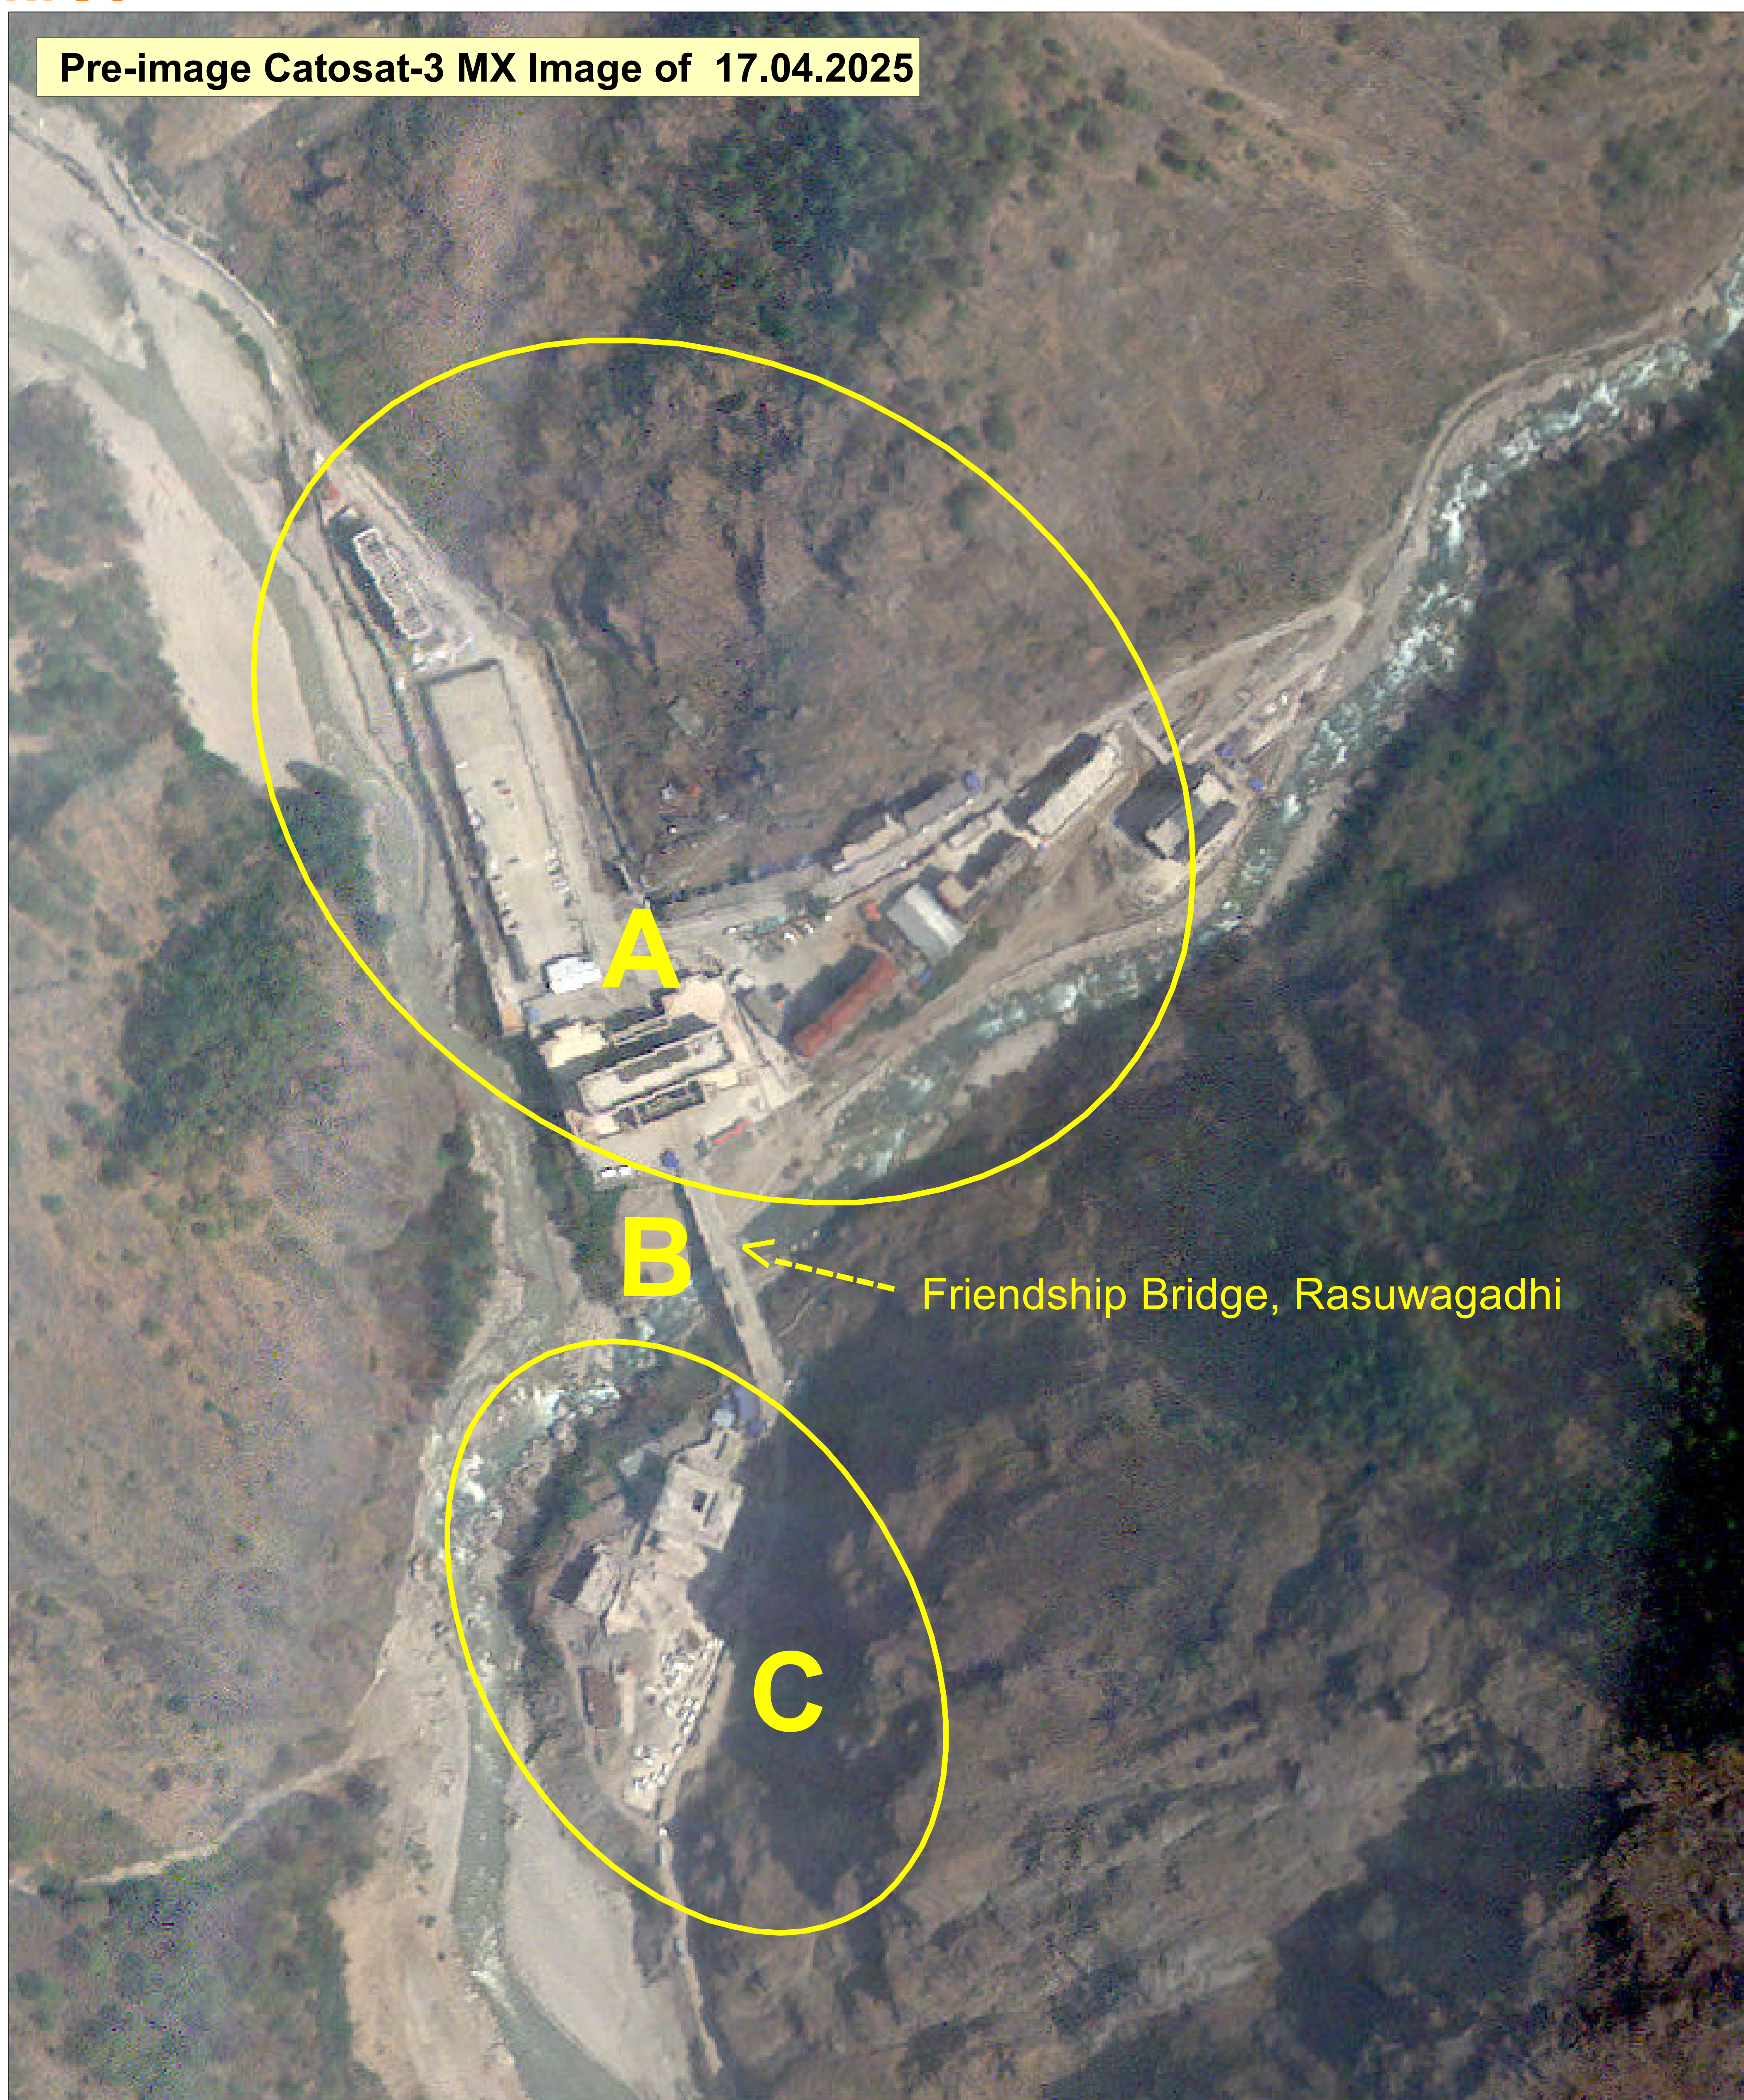
Pre-image Catosat-3 MX Image of 17.04.2025

\* Pre & Post event Satellite images depicts the surroundings of Rasuwagadhi & surroundings where all the buidlings & Roads, bridges and other infrastrcture is washed away. Flash flood also caused the washing away of Friendship bridge. The locations can be observed for its damage at 'A', 'B', 'C' points in the map above.

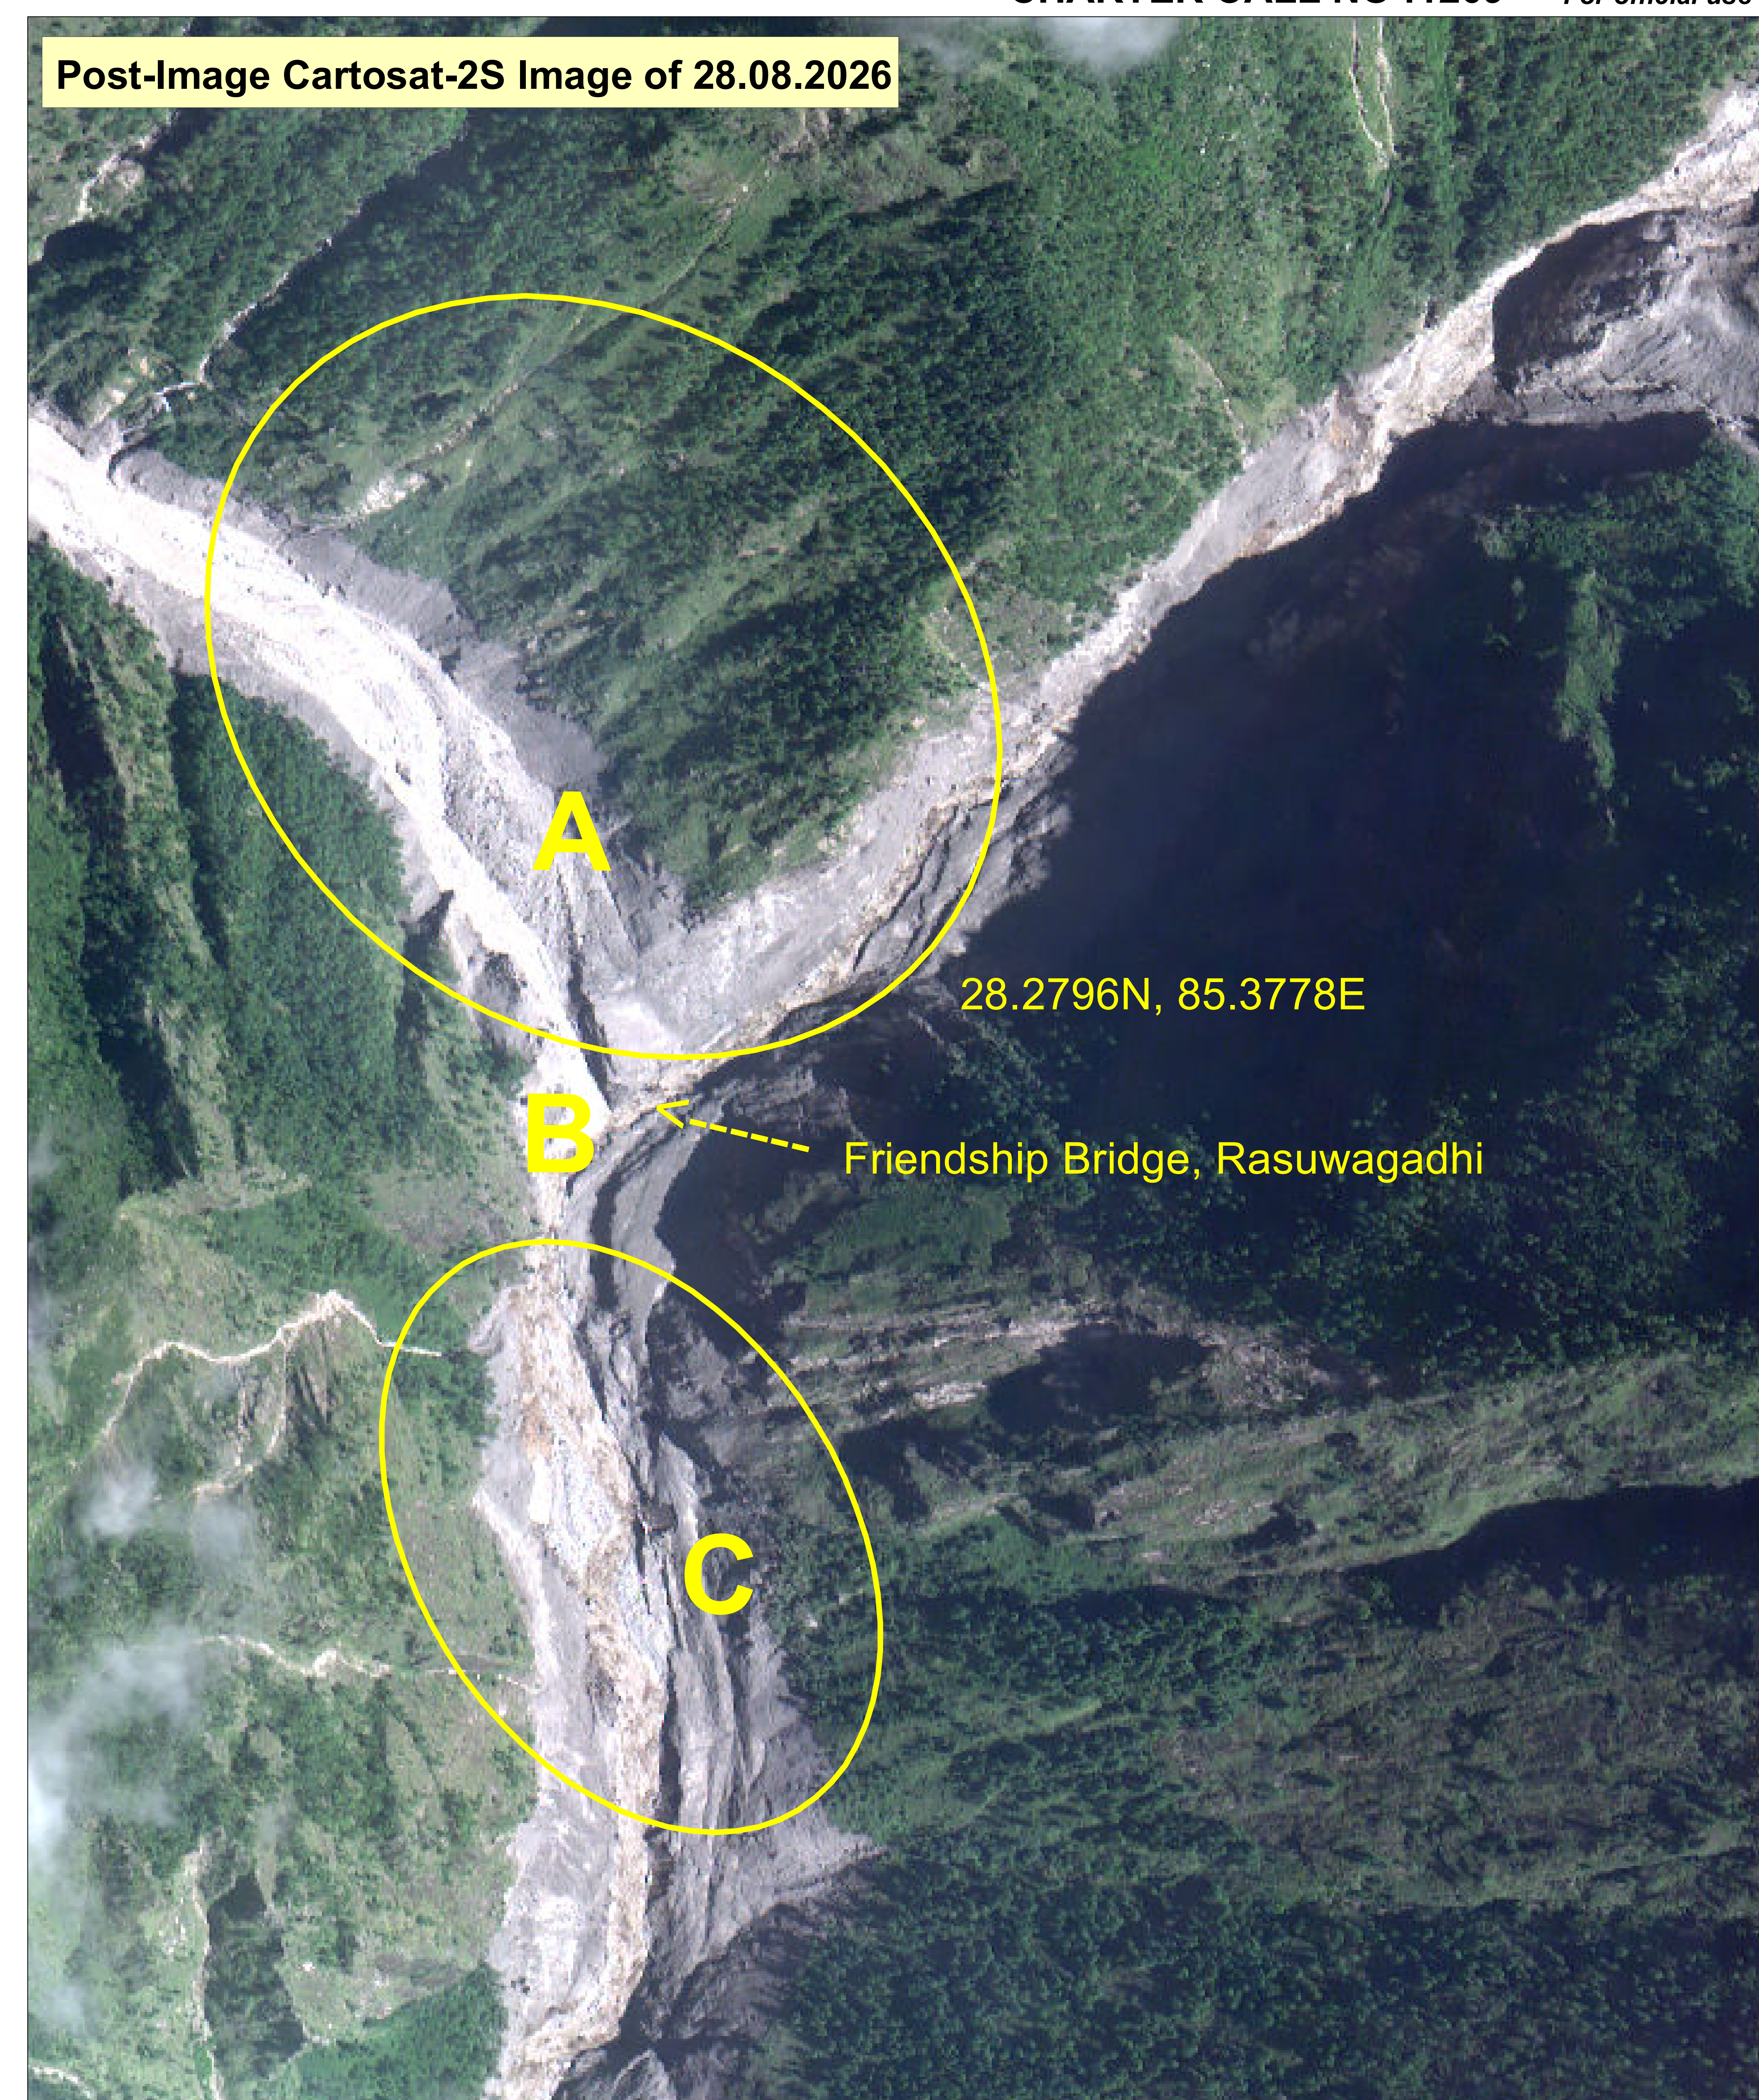
Post-Image Cartosat-2S Image of 28.08.2026

\* A Massive flash flood in Lhende Khola (tributary of Bhote Koshi River) around 09:00 AM NPT on 26 August 2026, affected downstream areas of Trishuli River in Rasuwa, Dhading, Nuwakot, Gorkha and Chitwan districts,
