## Pre and Post Satellite Images showing Flash Flood affected areas in parts of Rasuwa District, Nepal

Note: When publishing this map as part of any report, source may be indicated as ' NRSC (2026) - Pre and Post Satellite Images showing Flood affected areas in parts of Rasuwa District, Nepal (as on 26.08.2026)' , Map no : 2026/FL/NEPAL/5/26082026, NRSC/ISRO, Hyderabad.

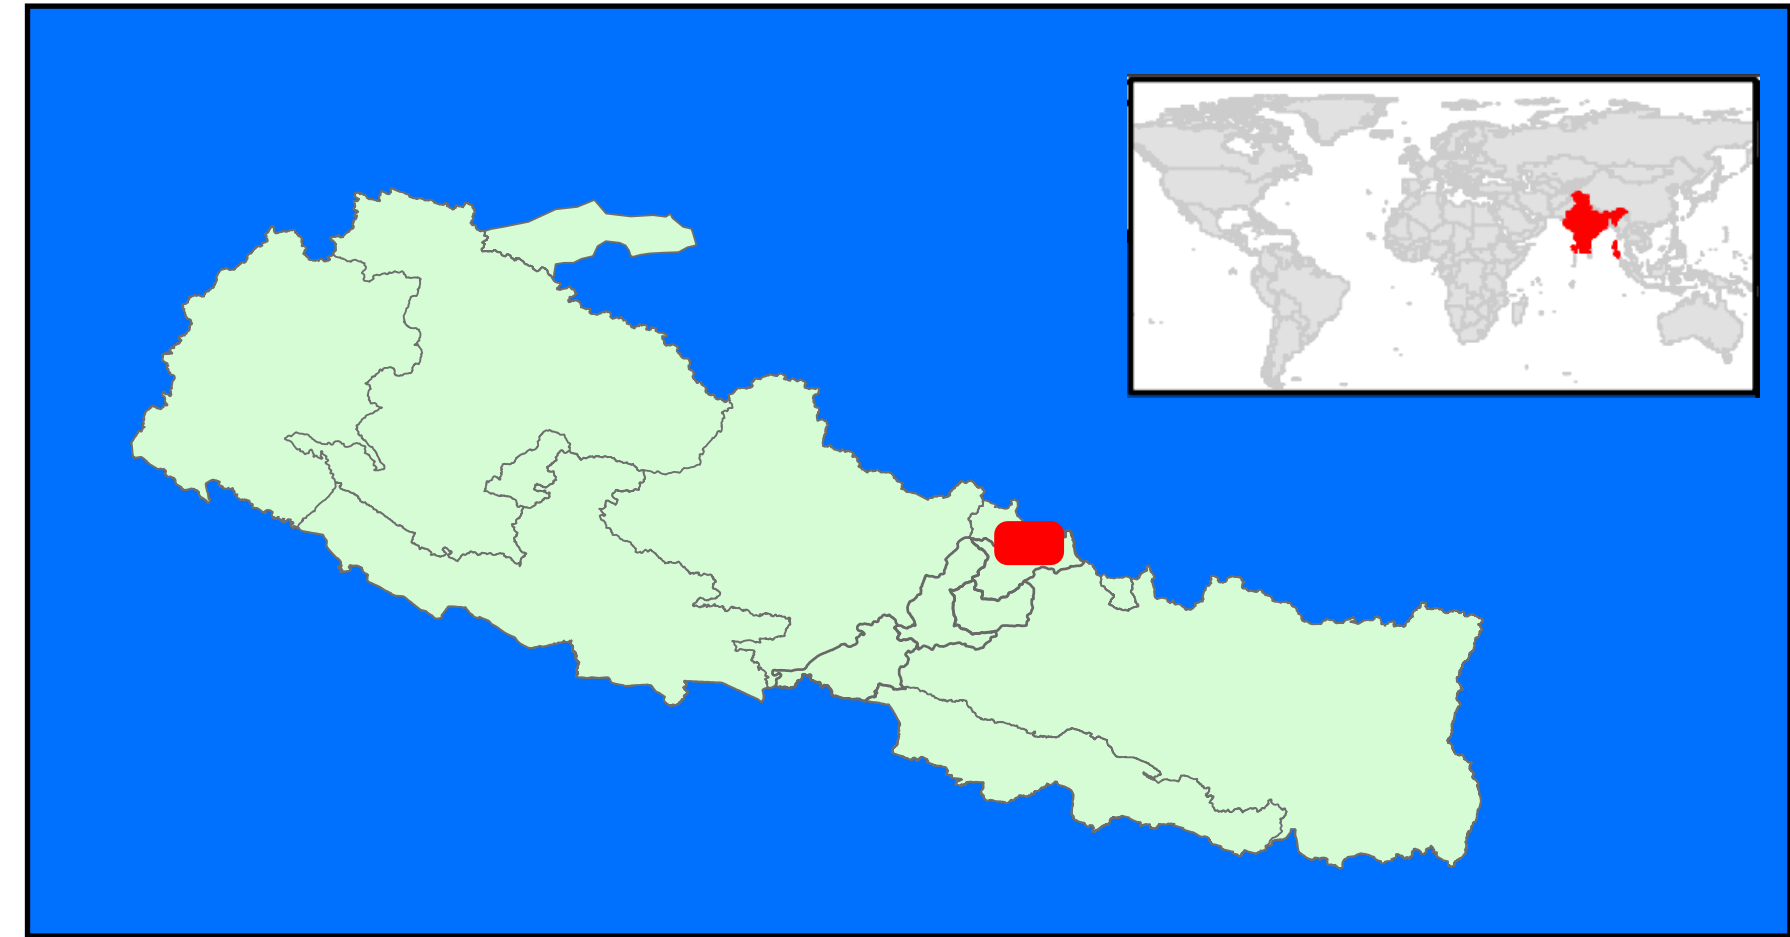
### Location Diagram

A Massive flash flood in Lhende Khola (tributary of Bhote Koshi River) around 09:00 AM NPT on 26 August 2026, affecting downstream areas of Rasuwa, Dhading, Nuwakot, Gorkha and Chitwan districts, Nepal. Flash flood triggered by massive debris has caused severe loss of life and damages to infrastructure. (Source : Newsmedia)

Pre Event Image : Resourcesat-2A AWiFS, 04th April 2026  
Post Event : Resourcesat-2A AWiFS, 26th August 2026
