# Pre and Post Satellite Images showing Flash Flood affected areas in parts of Bidur Nuwakot District, Nepal

CHARTER CALL NO :1209

Date of Issue 28.08.2026

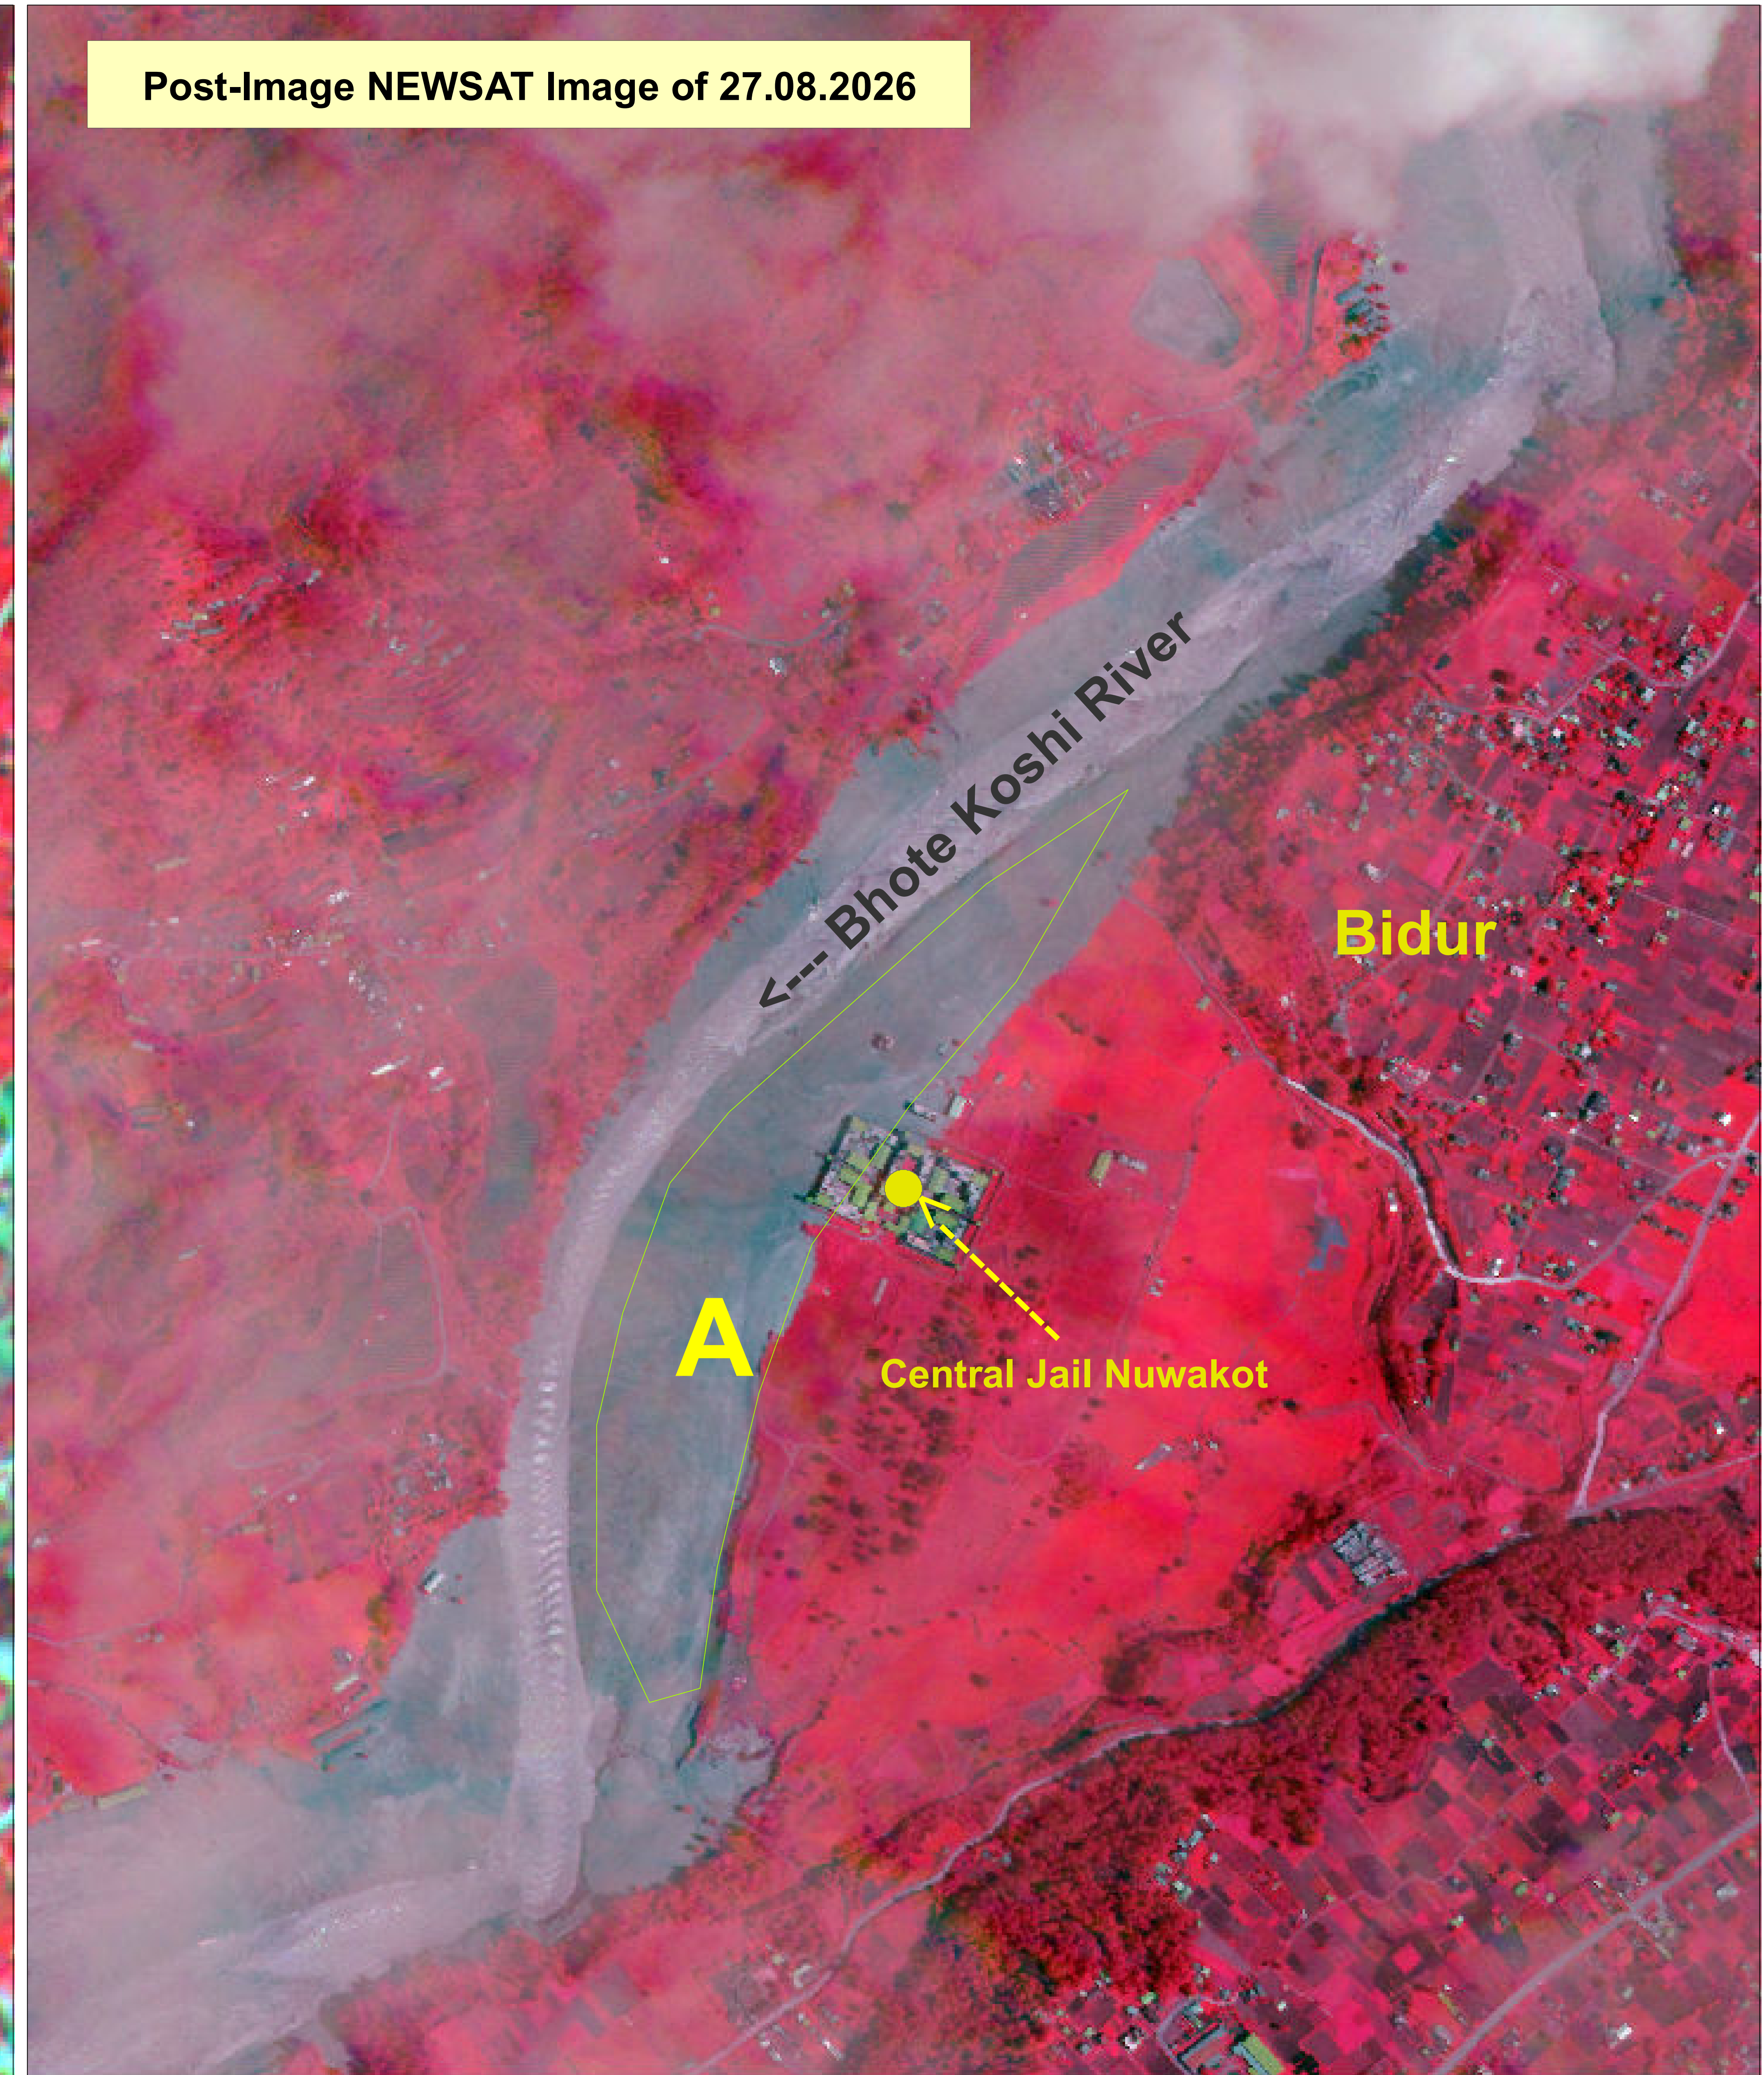
Post-Image NEWSAT Image of 27.08.2026

A Massive flash flood in Lhende Khola (tributary of Bhote Koshi River) around 09:00 AM NPT on 26 August 2026, affecting downstream areas of Rasuwa, Dhading, Nuwakot, Gorkha and Chitwan districts, Nepal. Flash flood triggered by massive debris has caused severe loss of life and damages to infrastructure. (Source : Newsmedia)
