Volcanic Eruption of the 15th of January 2022 and induced tsunami, Hunga Tonga-hunga Ha'apai Volcano

Preliminary Satellite-Derived Damage Assessment

Mango Island, Kingdom of Tonga

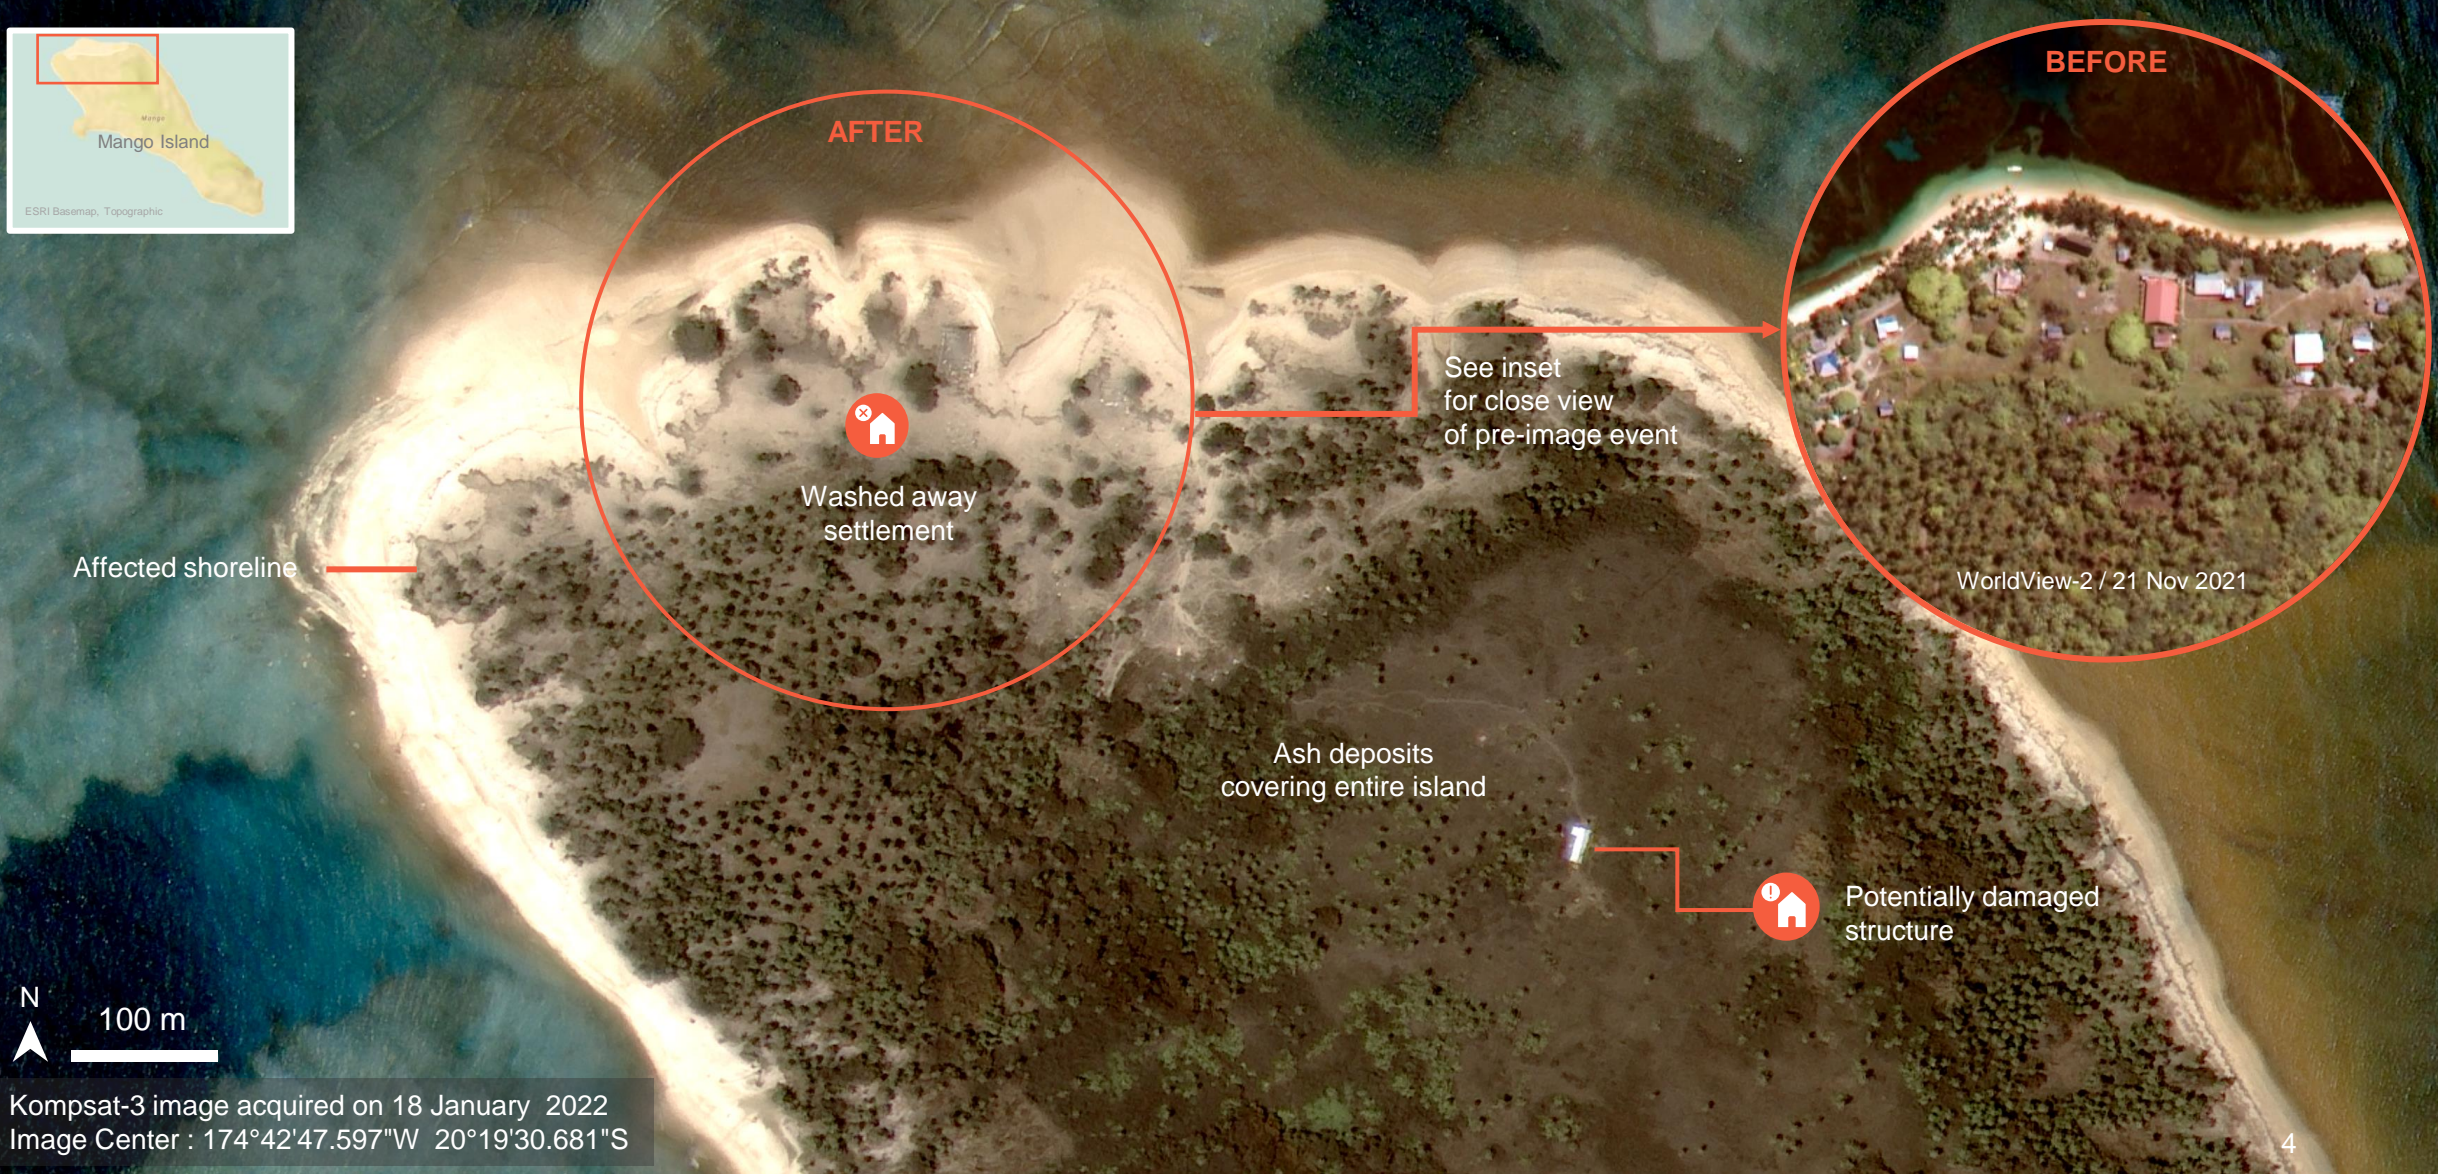
AOI 1 MANGO ISLAND, MU'OMU'A DISTRICT, HA'APAI DIVISION

Extensive damage to structures along the shoreline and ash deposits covering entire the island

Kompsat-3 image acquired on 18 January 2022
Image Center : 174°42'47.597"W 20°19'30.681"S

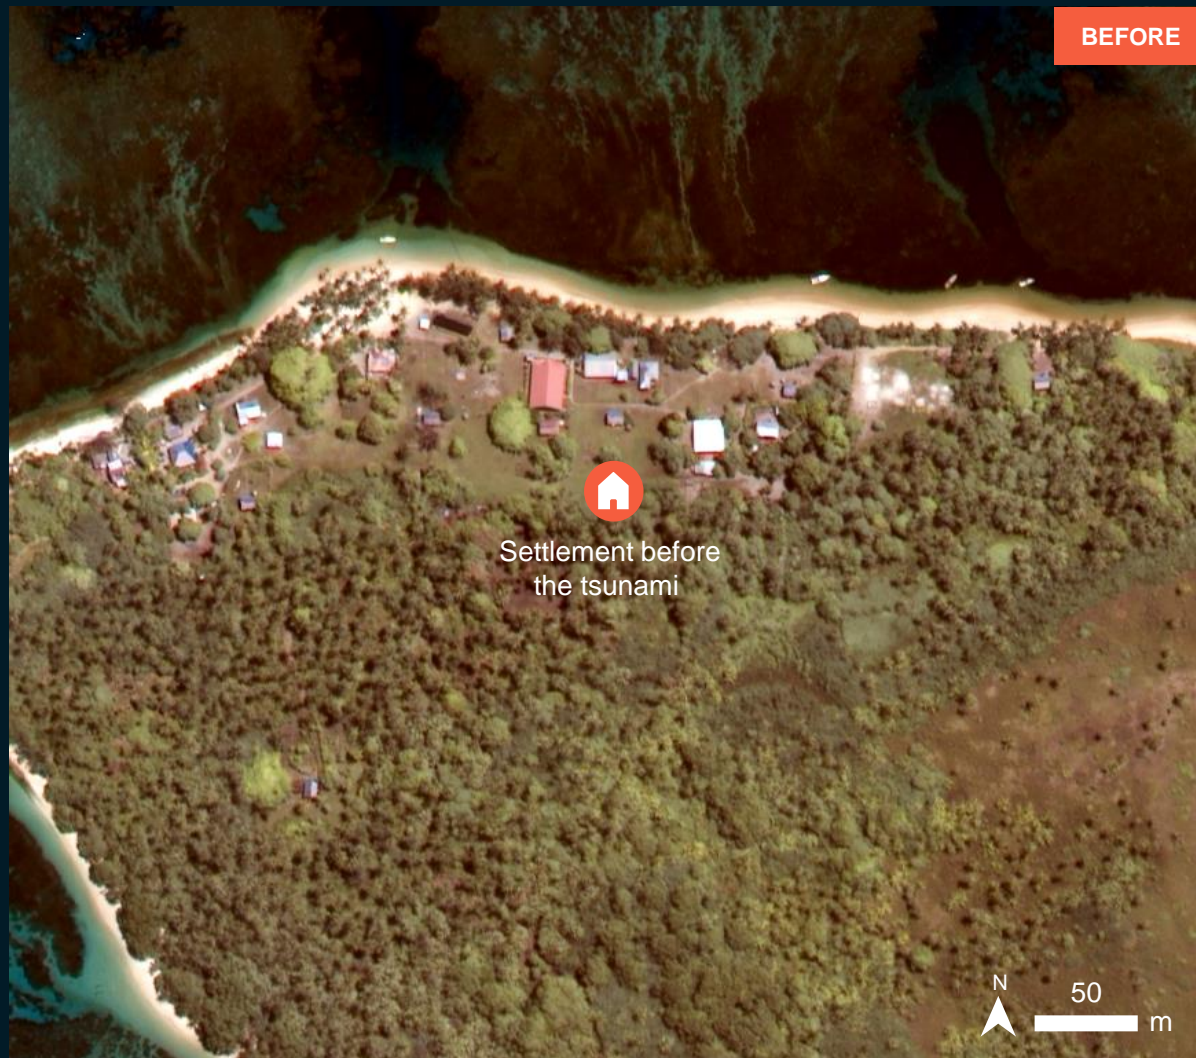
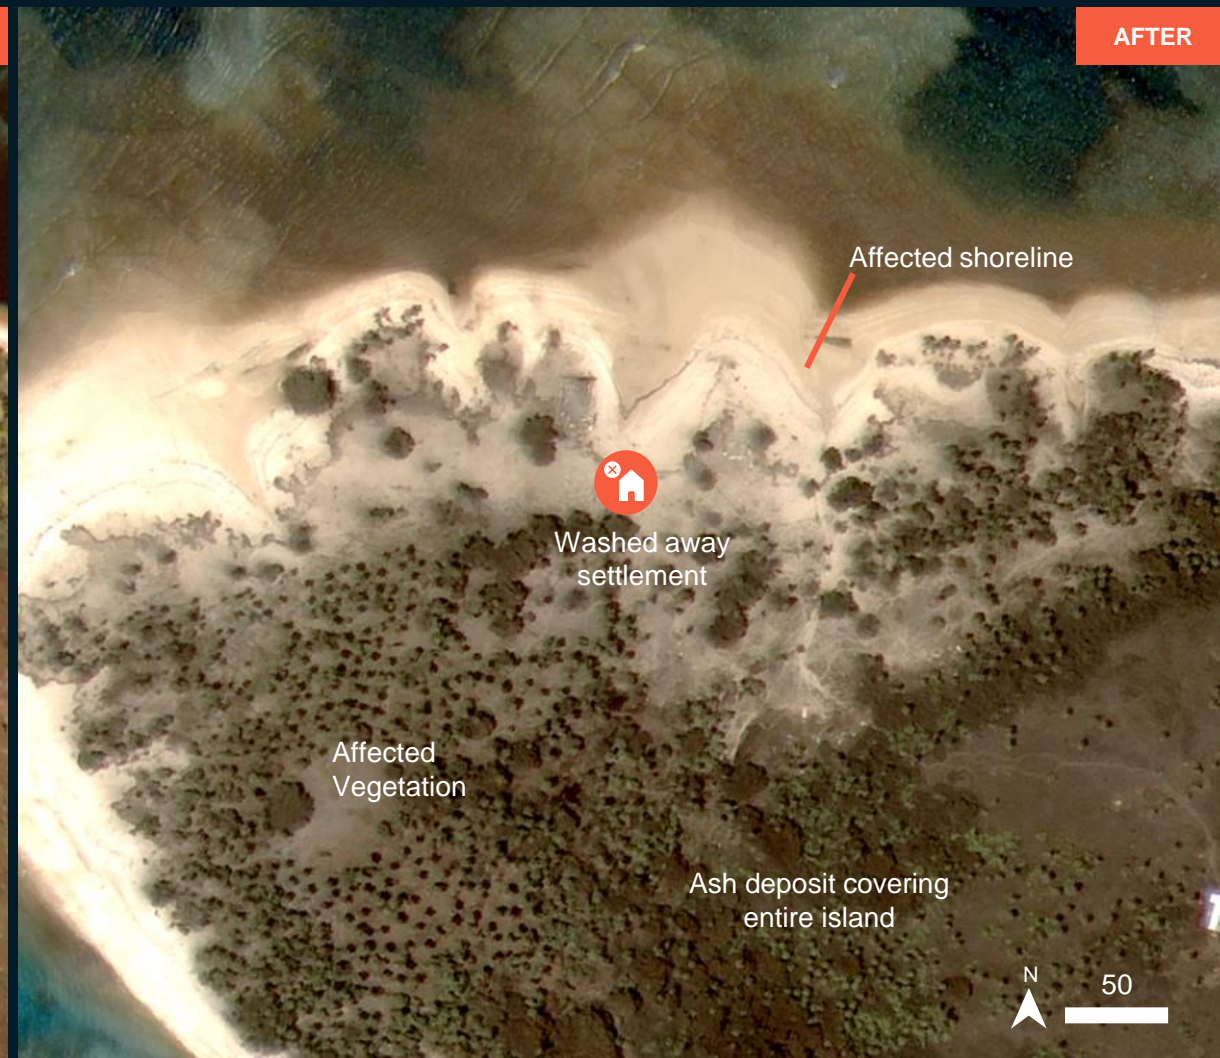
AOI 1 MANGO ISLAND, MU'OMU'A DISTRICT, HA'APAI DIVISION

Damaged structures & affected vegetation in Mango island

WorldView-2 / 21 Nov 2021

Kompsat-3 / 18 Jan 2022

- Extensive damage is observed the Mango island as of 18 January 2022 likely caused by the tsunami waves triggered by the volcanic eruption;
- The main settlement of the island seems to have been washed away by the tsunami waves as of 18 January 2022;
- 27 structures are heavily damaged and/or destroyed;
- Few structures in land seem to have not been destroyed but are likely damaged;
- Vegetation of the island is affected;
- Ash deposits covering entire Mango island as of 17 January 2022.
