# PRELIMINARY SATELLITE-DERIVED FLOOD AND LANDSLIDE ASSESSMENT

Leyte, Southern Leyte, Biliran, Capiz and Iloilo Provinces, Philippines

Status: : Extensive damage to structures and road including agricultural area observed

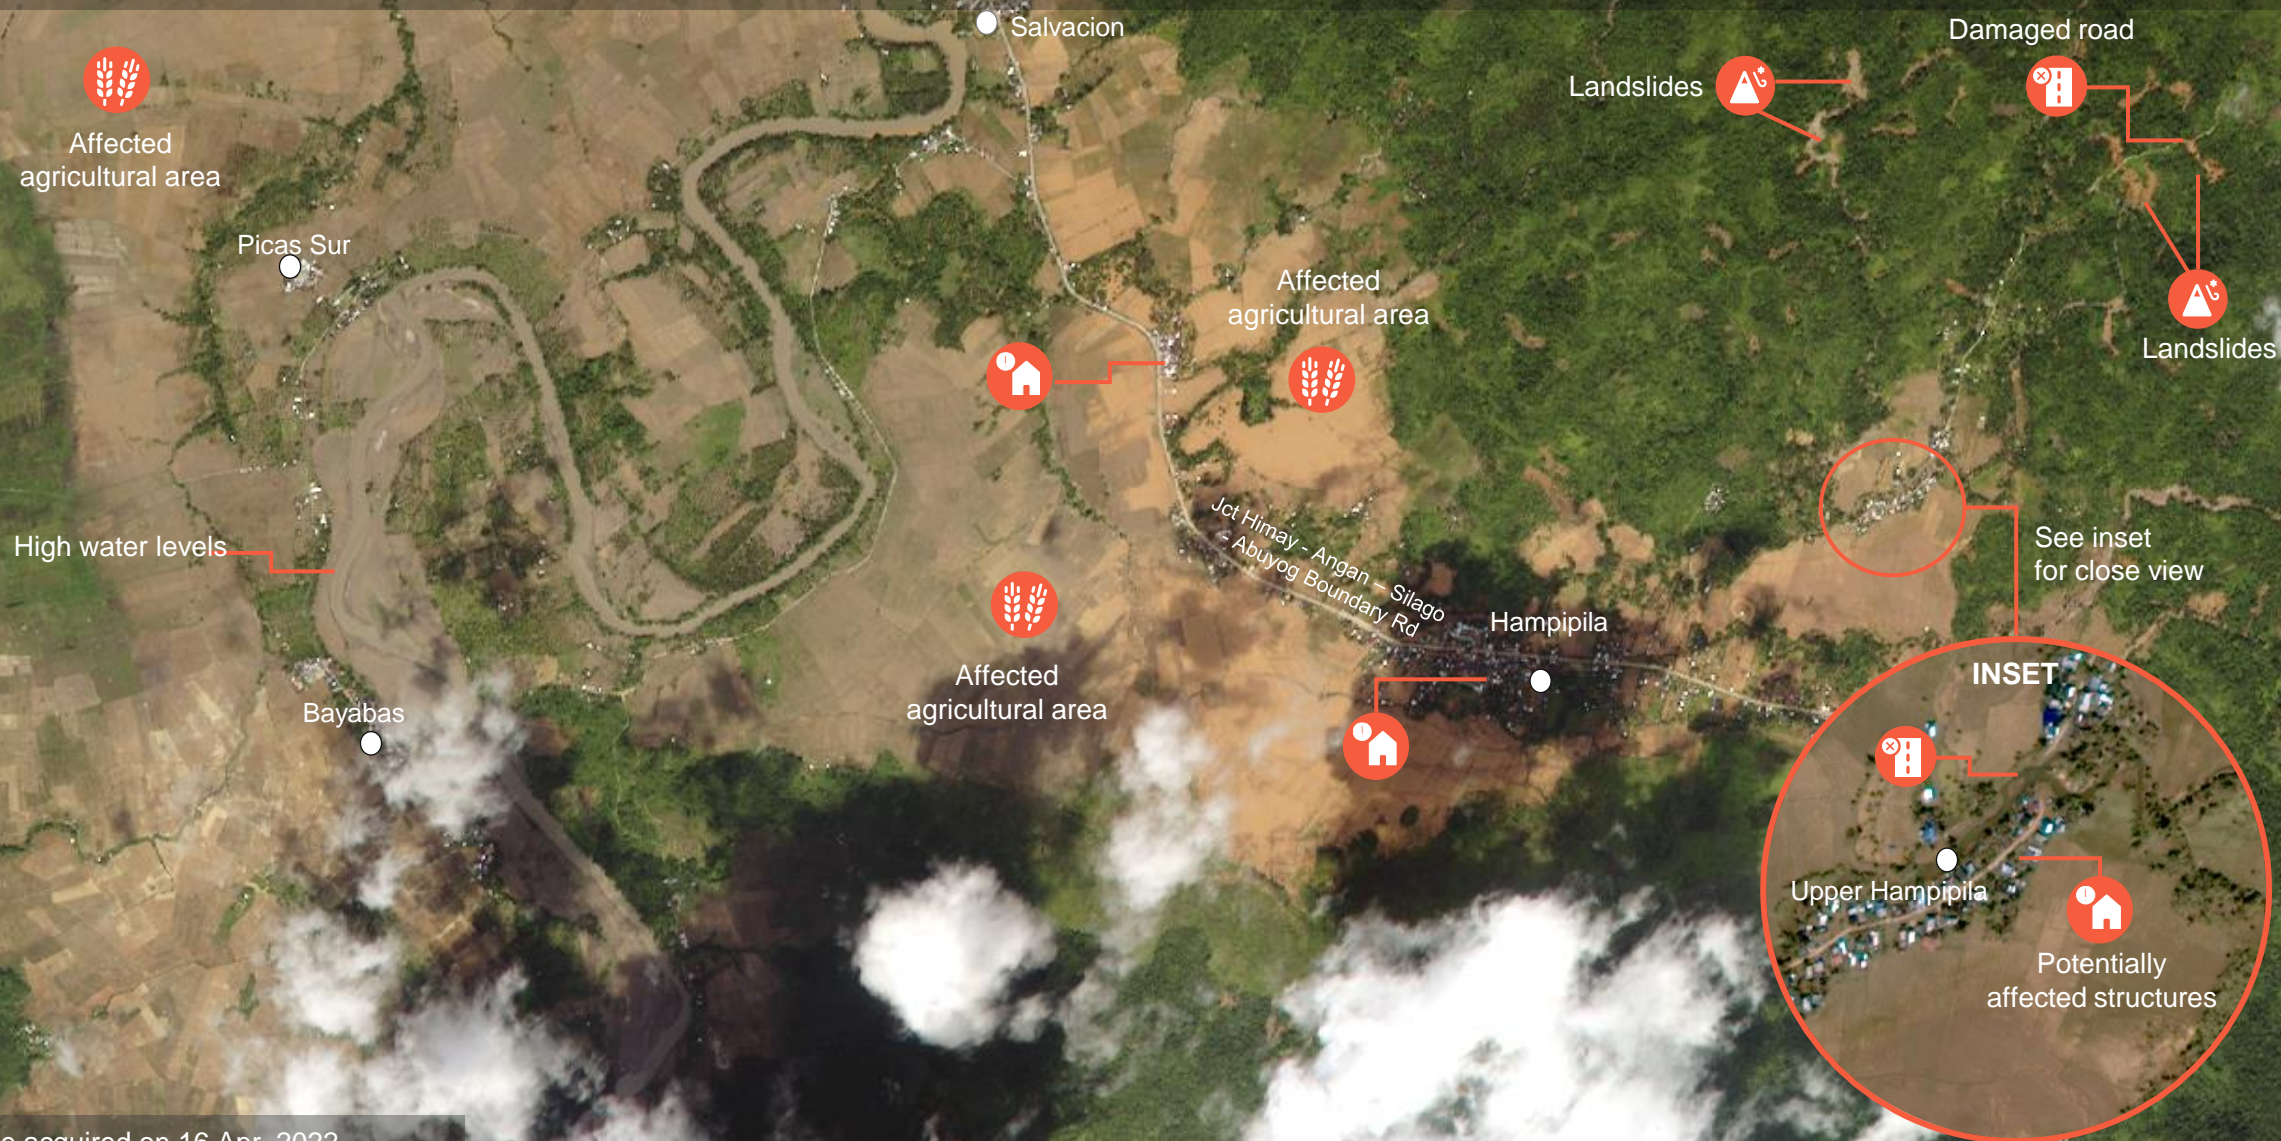
# AOI1-ABUYOG MUNICIPALITY, LEYTE PROVINCE, REGION VIII

Affected agricultural areas and potentially affected structures

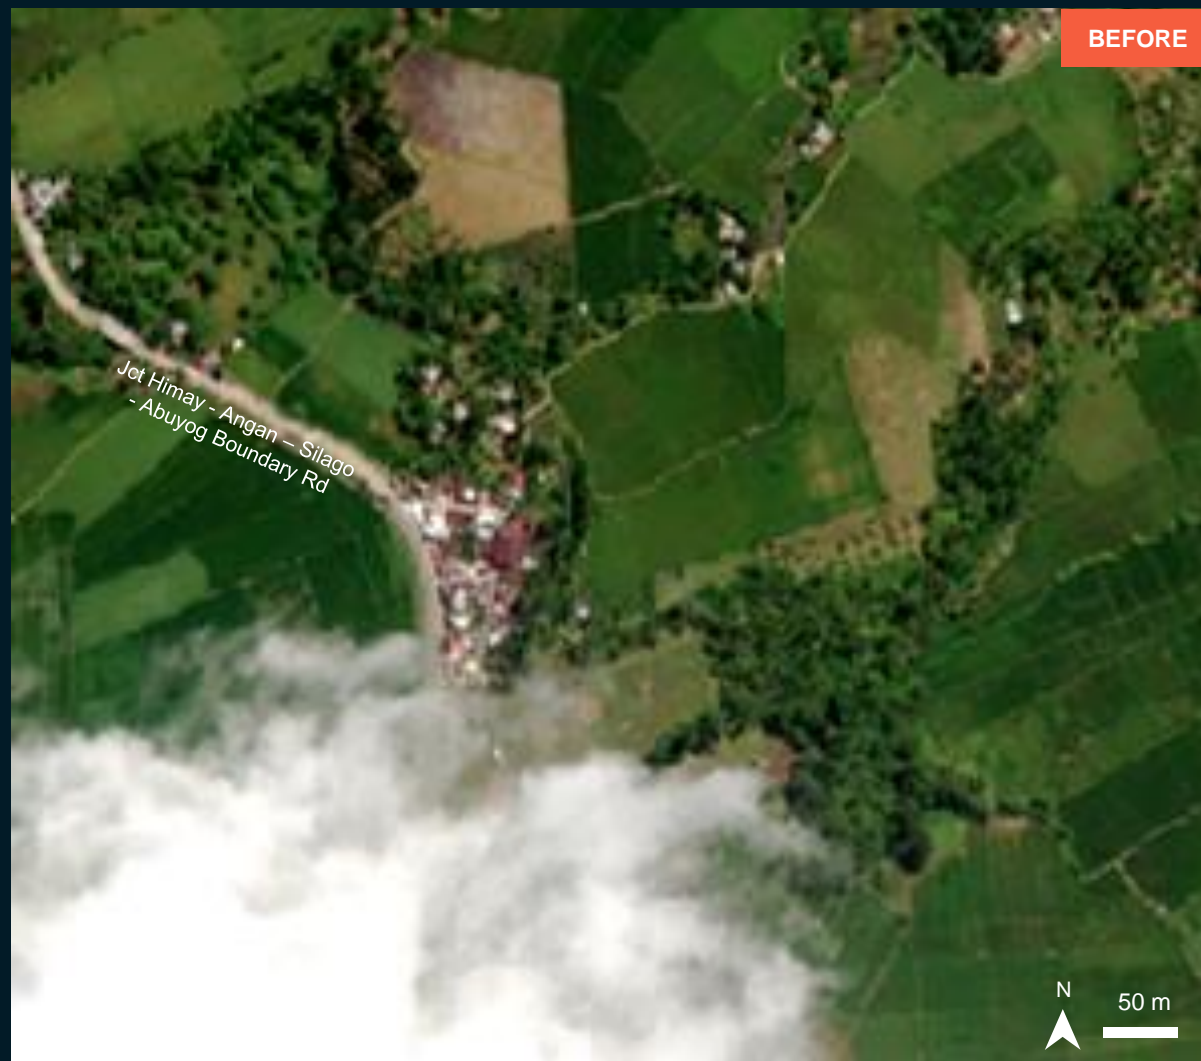
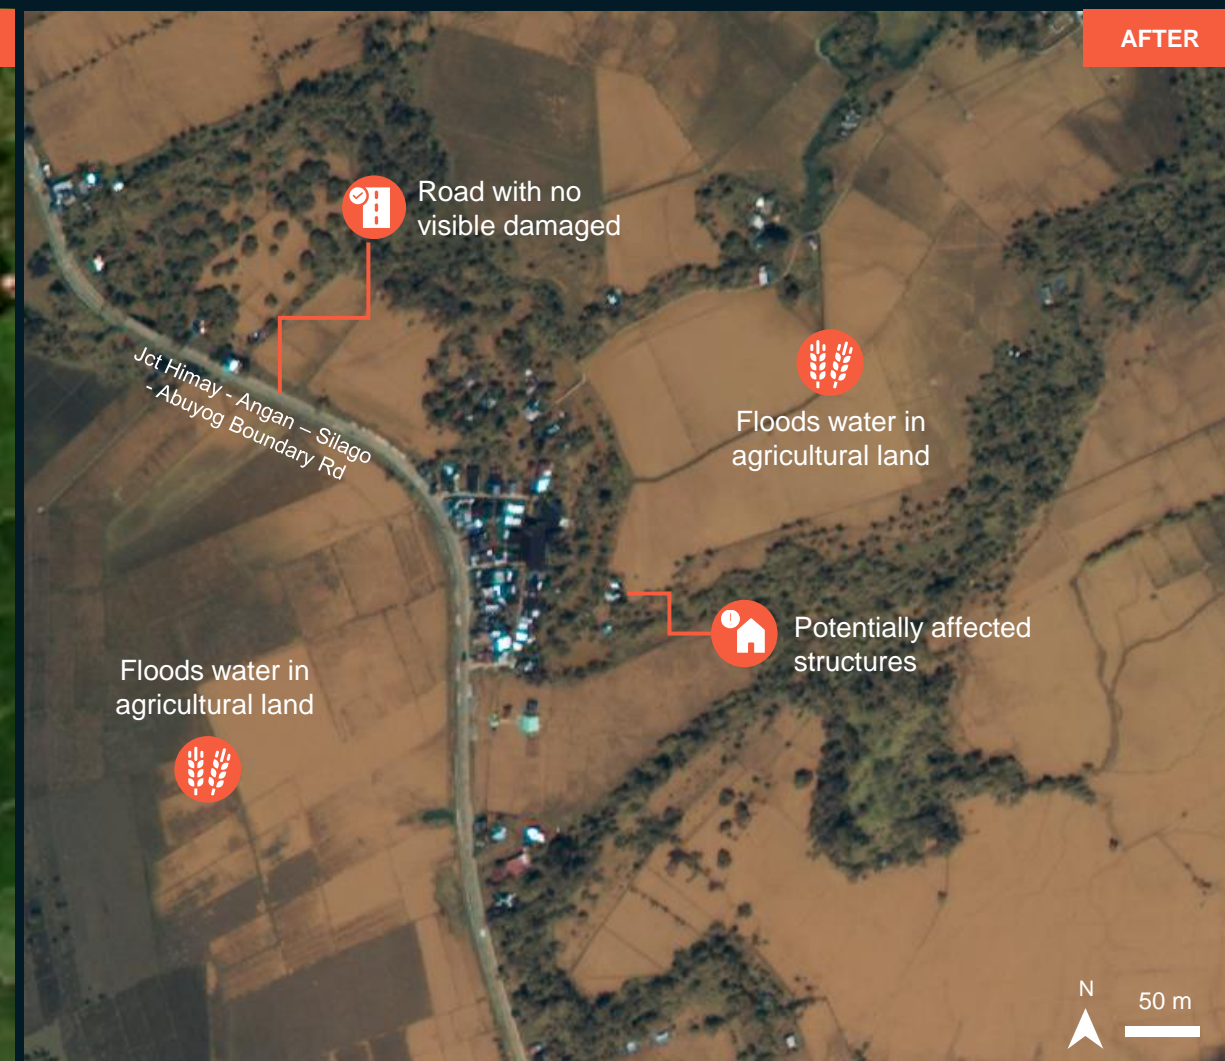
# AOI1-1 ABUYOG MUNICIPALITY, LEYTE PROVINCE, REGION VIII

Affected agricultural areas and potentially affected structures

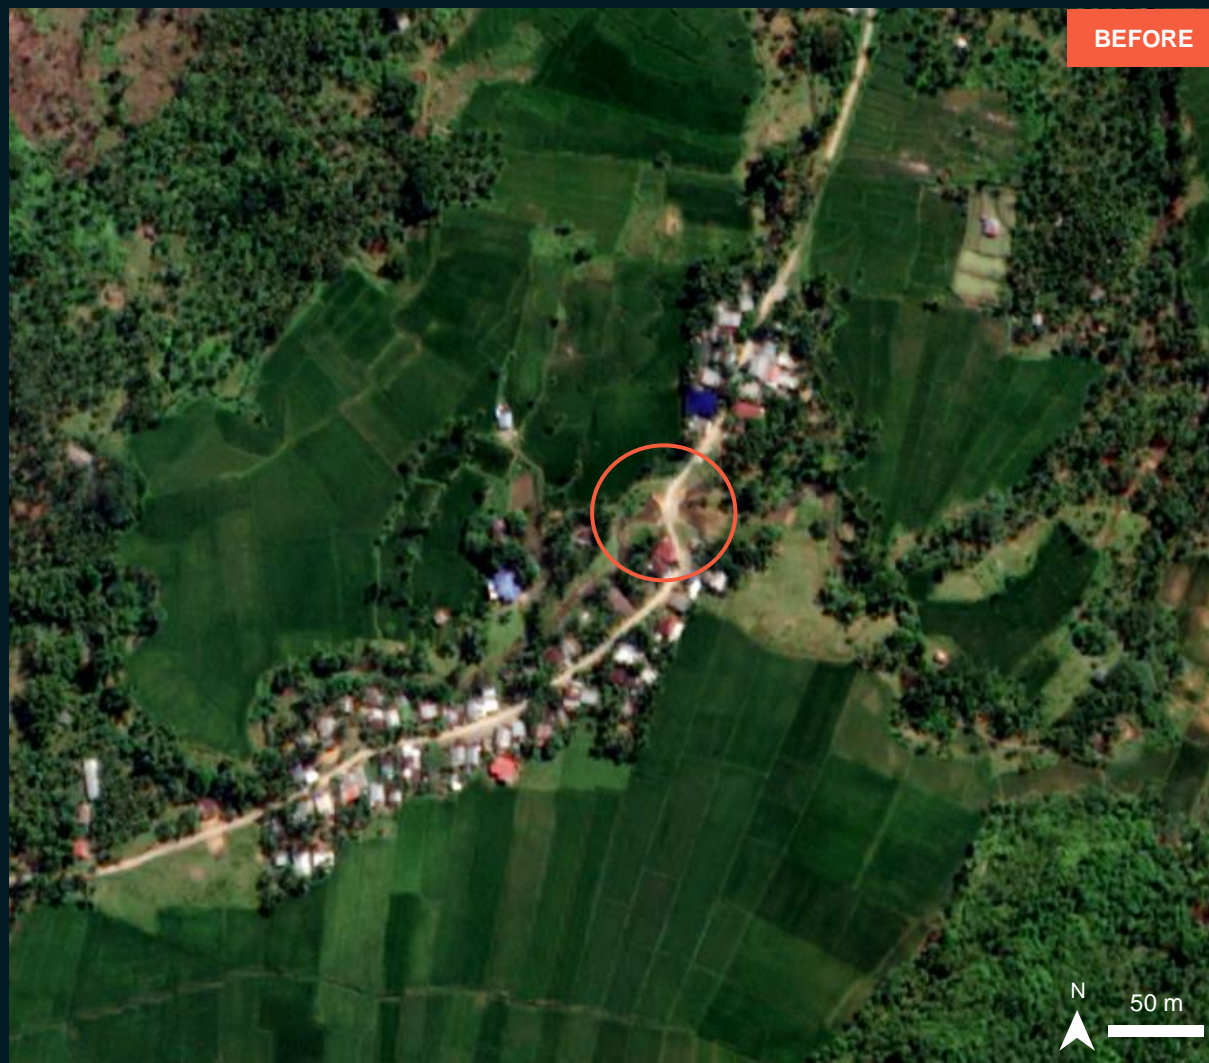
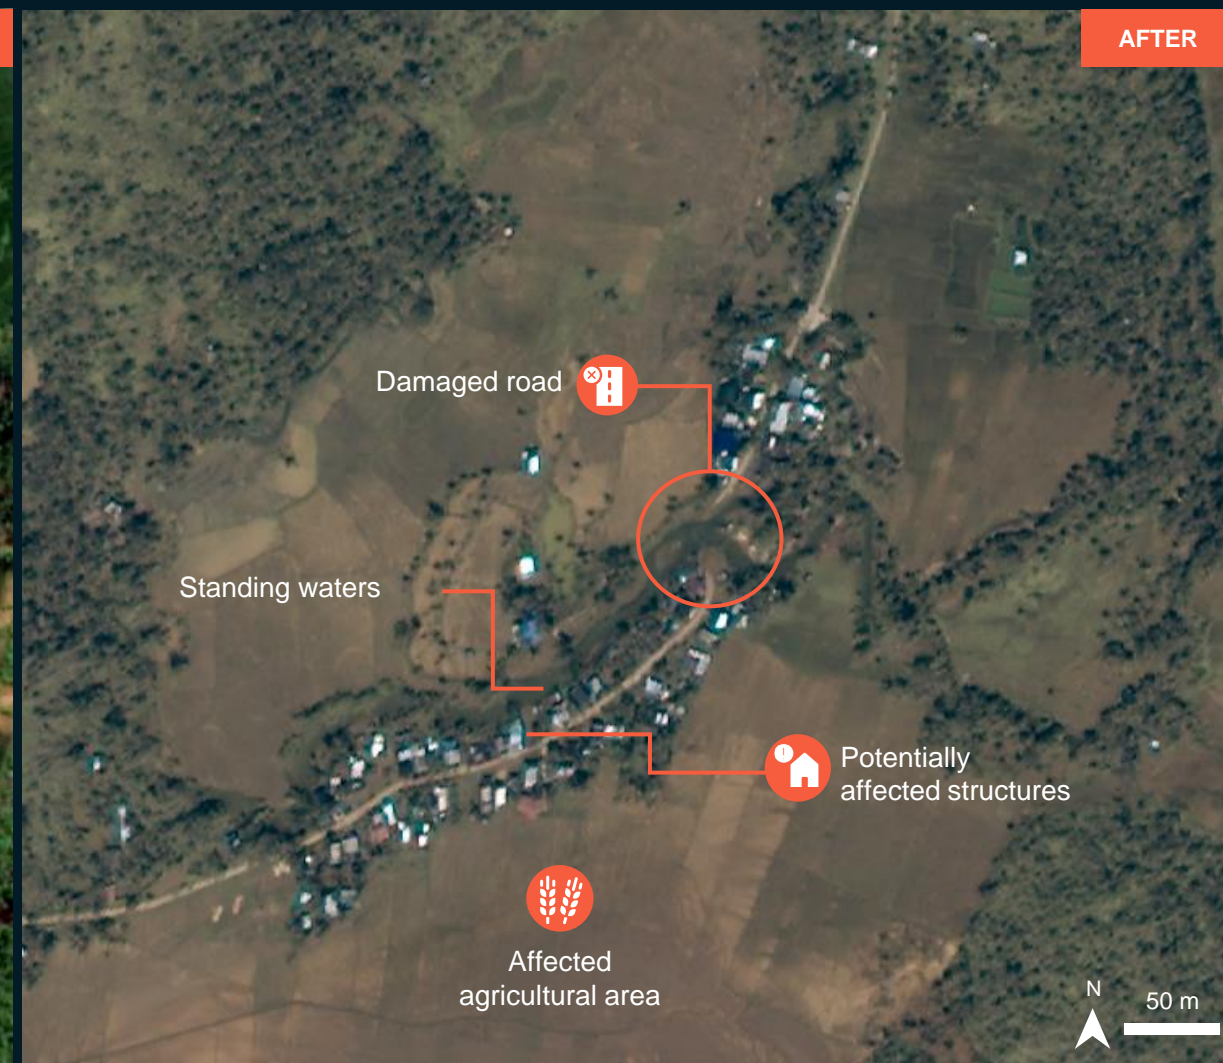
# AOI1-1 ABUYOG MUNICIPALITY, LEYTE PROVINCE, REGION VIII

Affected agricultural area, damaged road and potentially affected structures

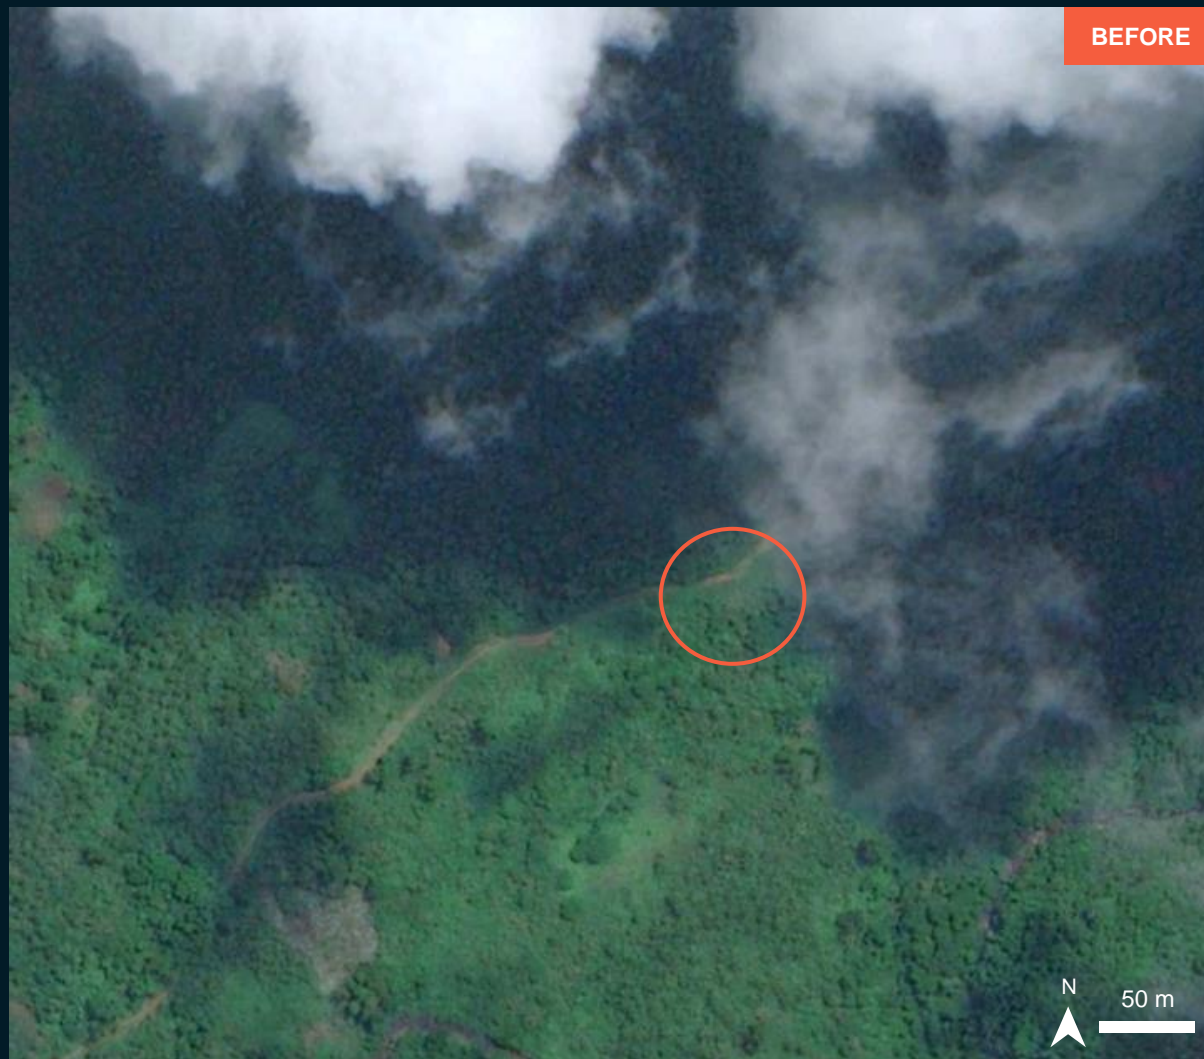
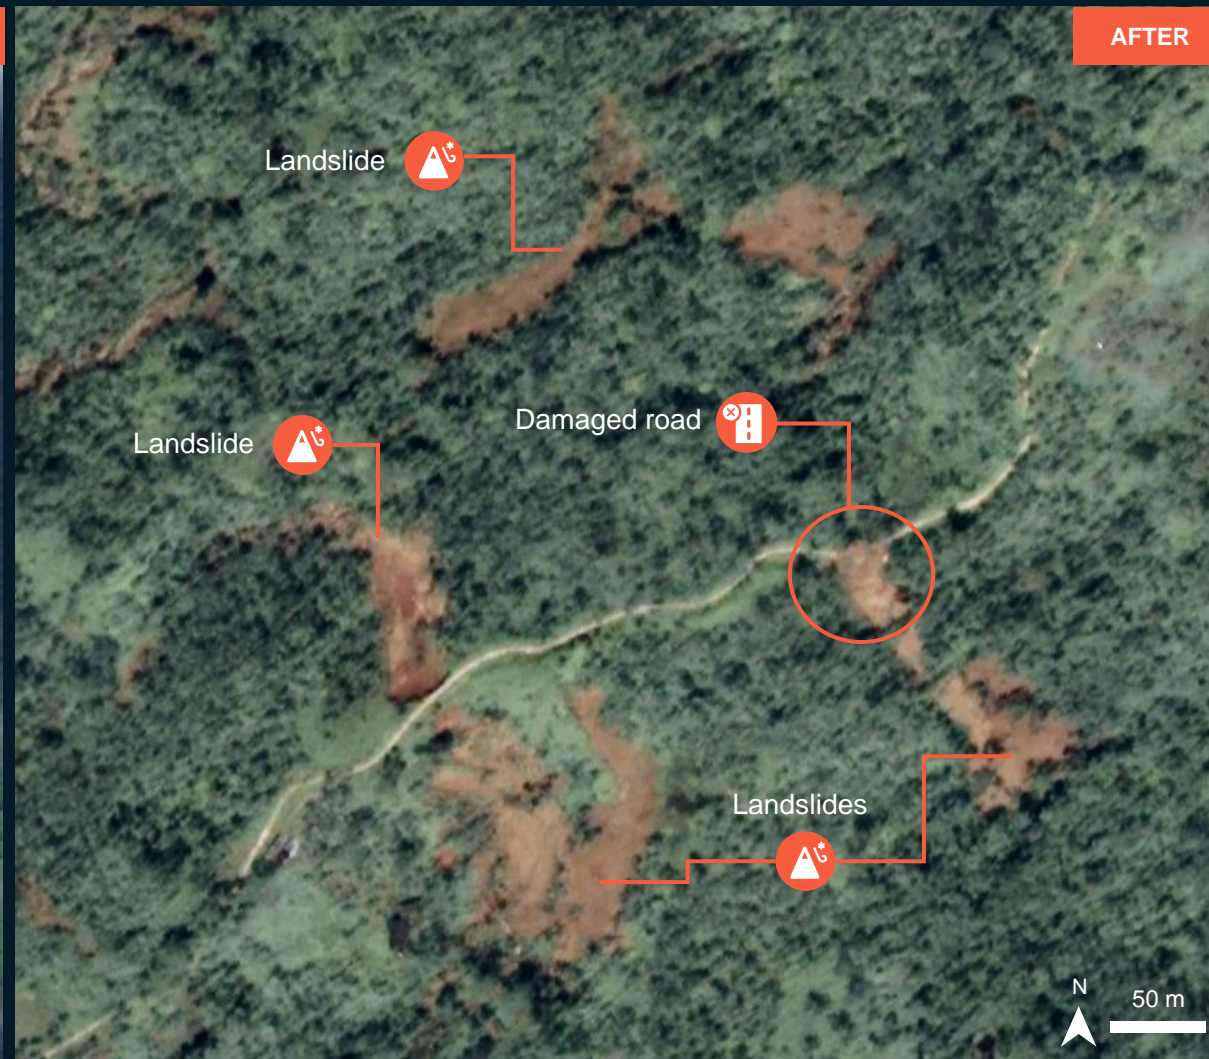
# AOI1-3 ABUYOG MUNICIPALITY, LEYTE PROVINCE, REGION VIII

## Landslides and damaged road

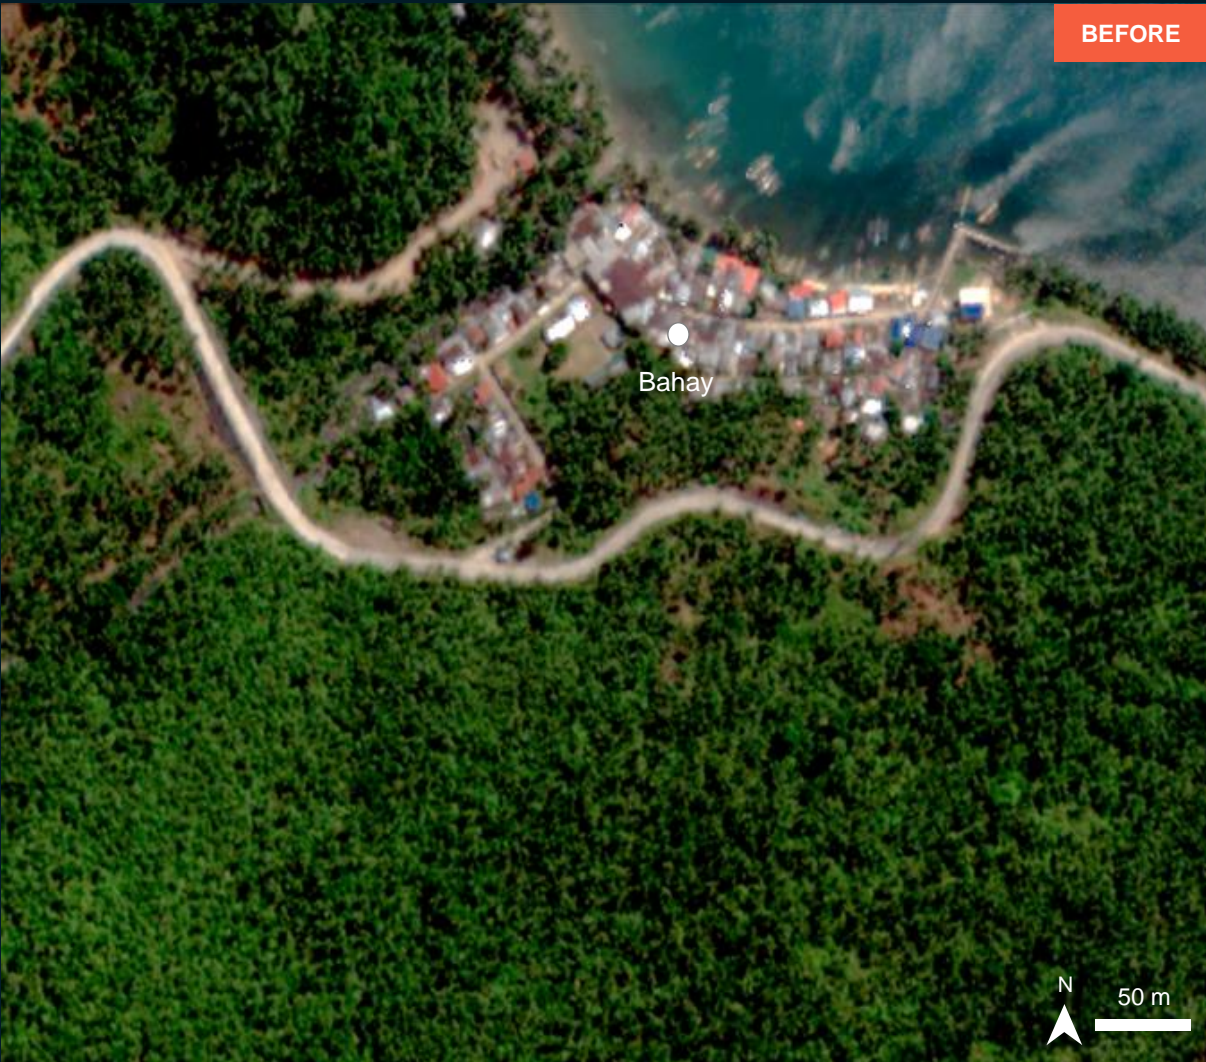
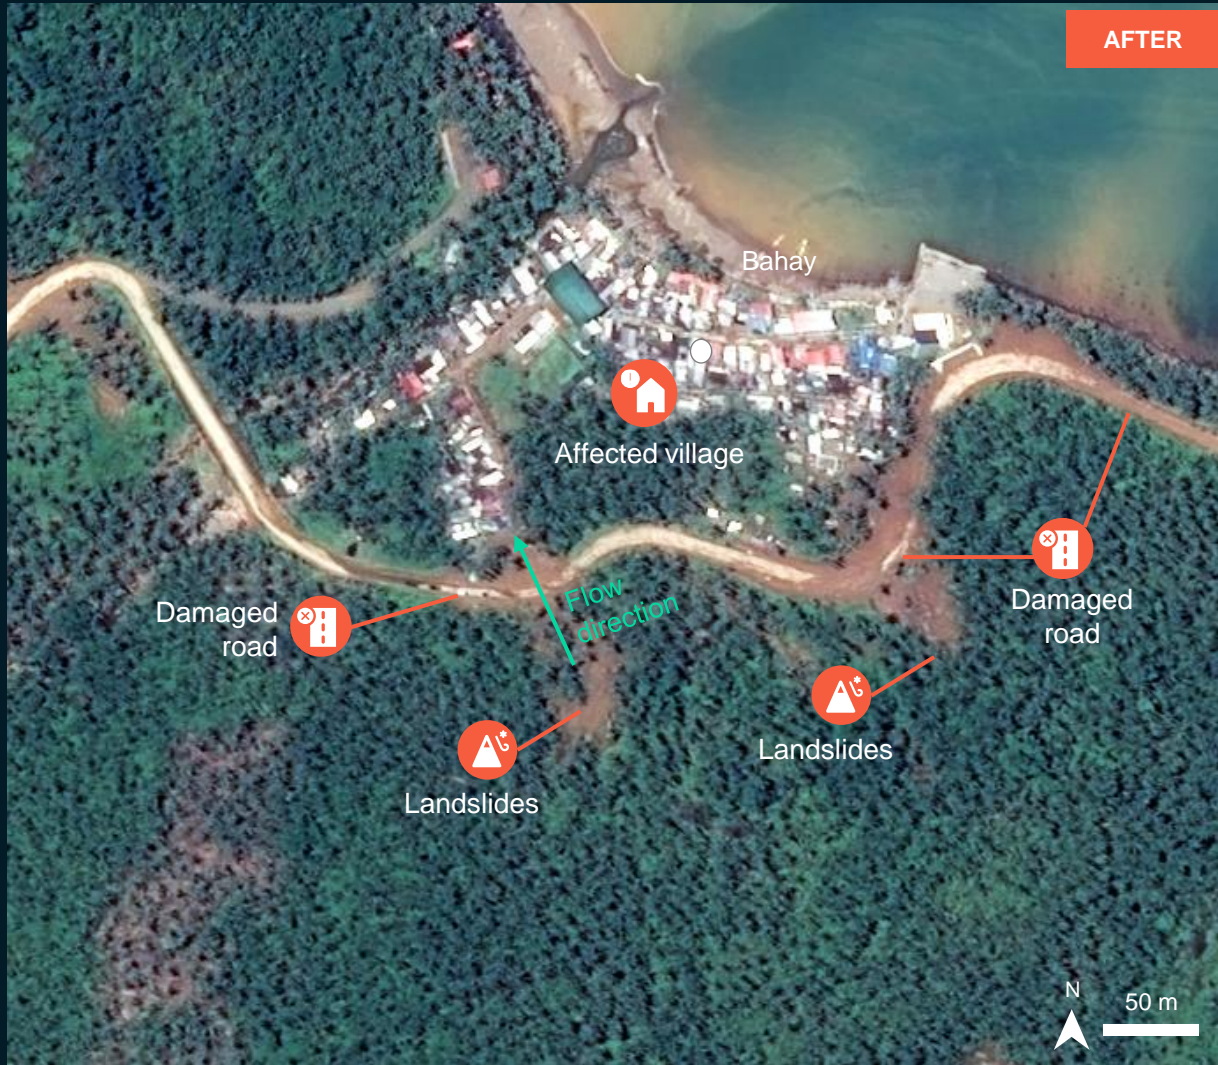
# AOI2-1 BAHAY VILLAGE, ABUYOG MUNICIPALITY, LEYTE PROVINCE, REGION VIII

## Landslides and damaged roads

- Affected structures and damaged road in Bahay village, Abuyog Municipality, City of Baybay, Leyte Province, Region VIII observed as of 16 Apr. 2022;
- Landslides along the road and affected structures in Buaya village, Abuyog Municipality, City of Baybay, Leyte Province, Region VIII observed as of 16 Apr. 2022;

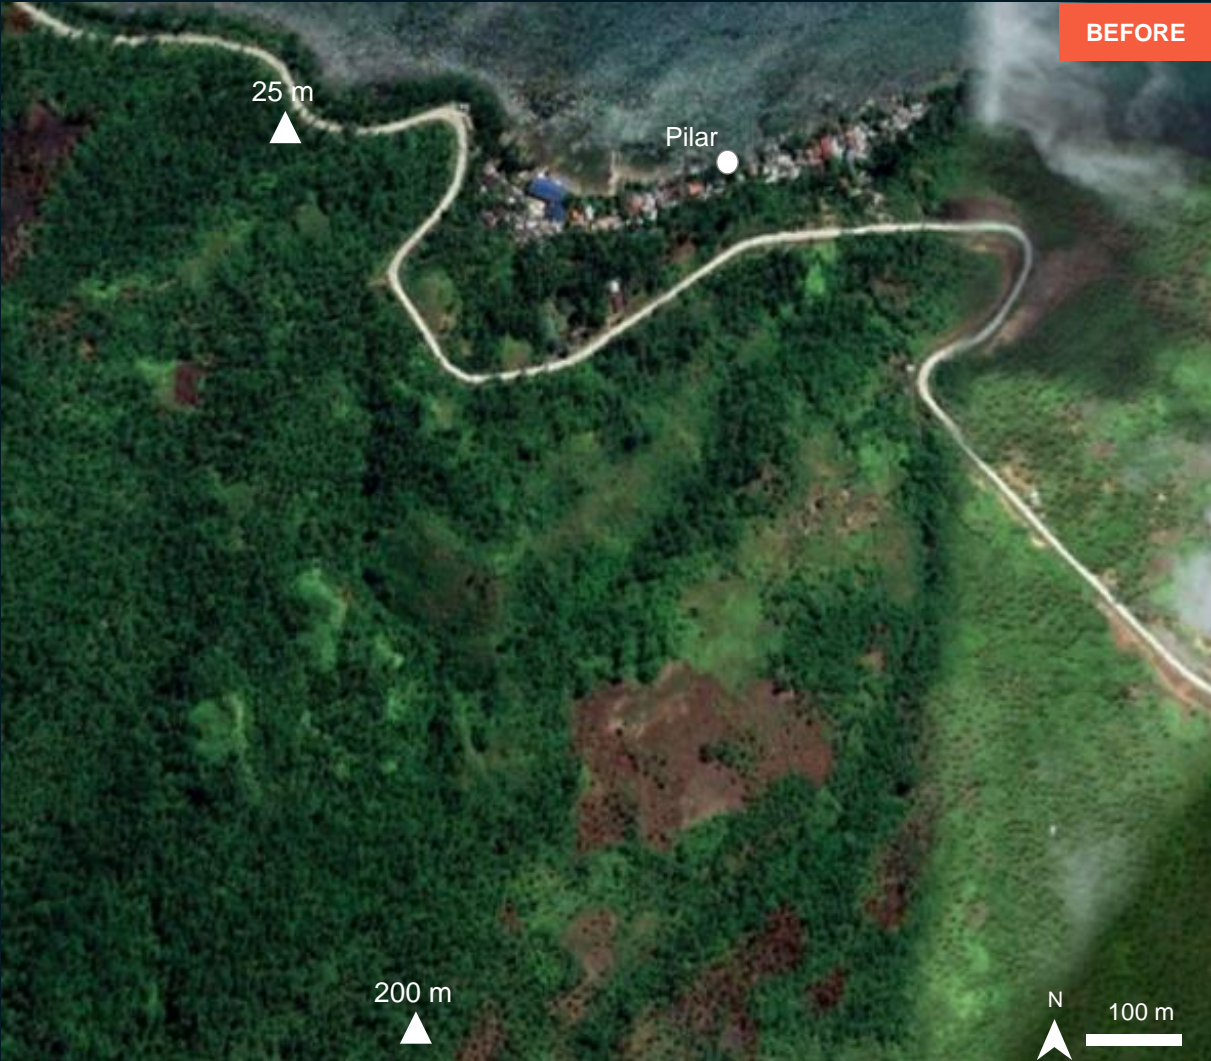
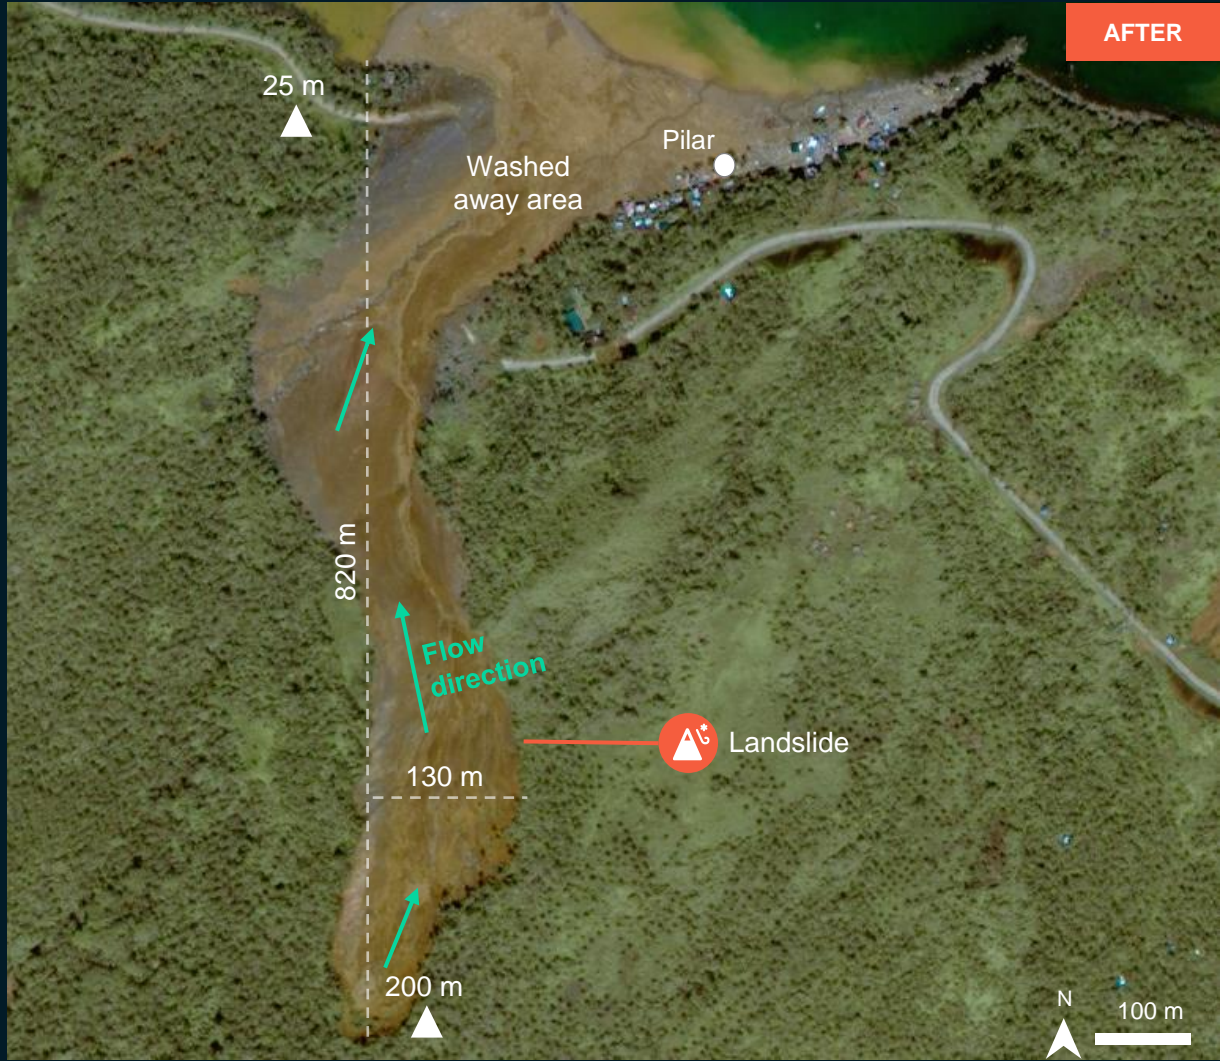
# AOI2-1 PILAR VILLAGE, ABUYOG MUNICIPALITY, LEYTE PROVINCE, REGION VIII

Extensive damage to road and structures in Pilar village

- Damaged roads in Abuyog Municipality, City of Baybay, Leyte Province, Region VIII observed as of 16 Apr. 2022;
- Extensive damage to structures and road in Pilar village, Abuyog Municipality, City of Baybay, Leyte Province, Region VIII observed as of 16 Apr. 2022;

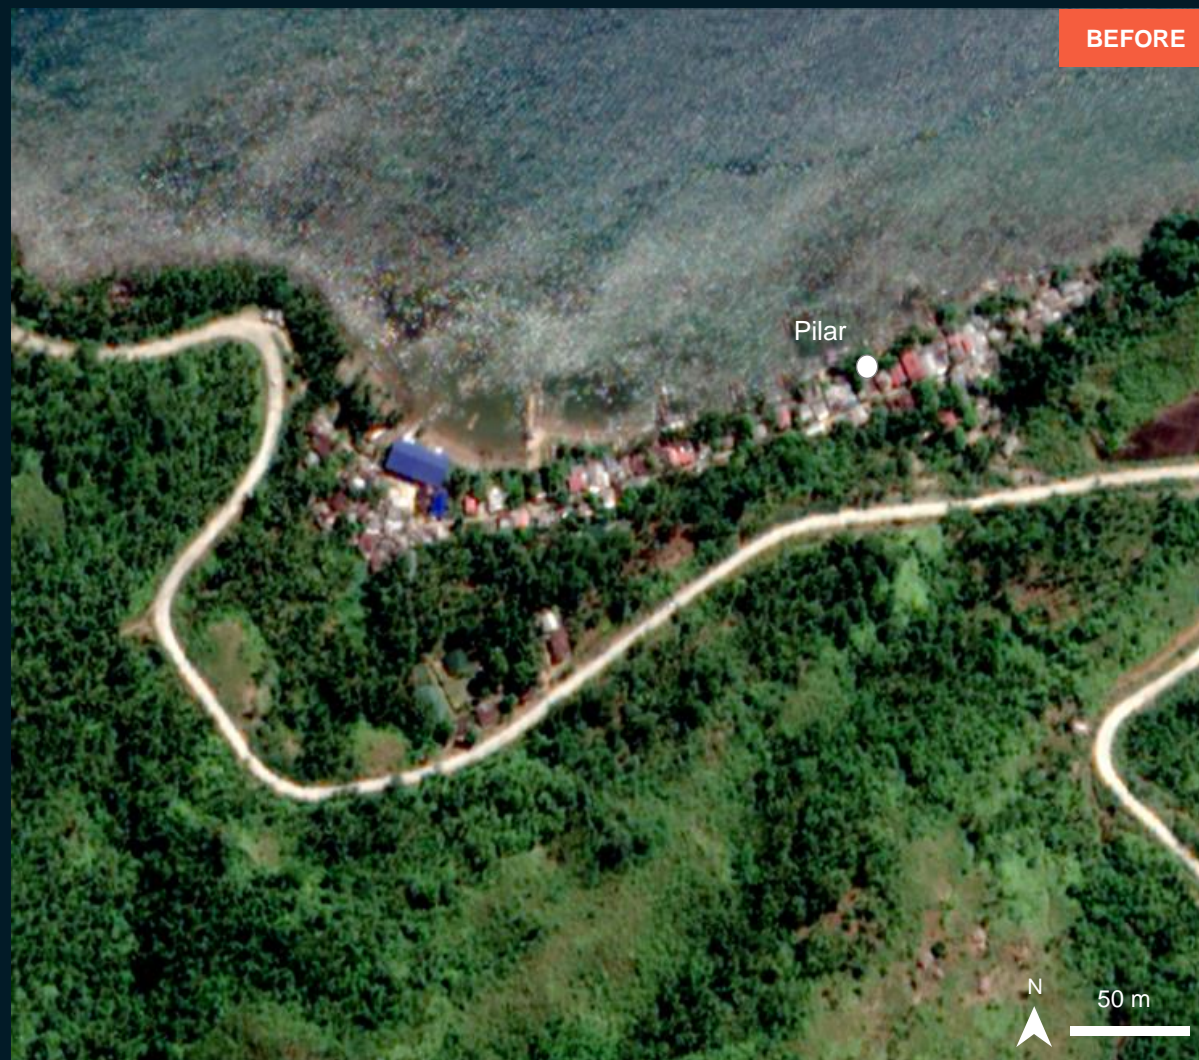
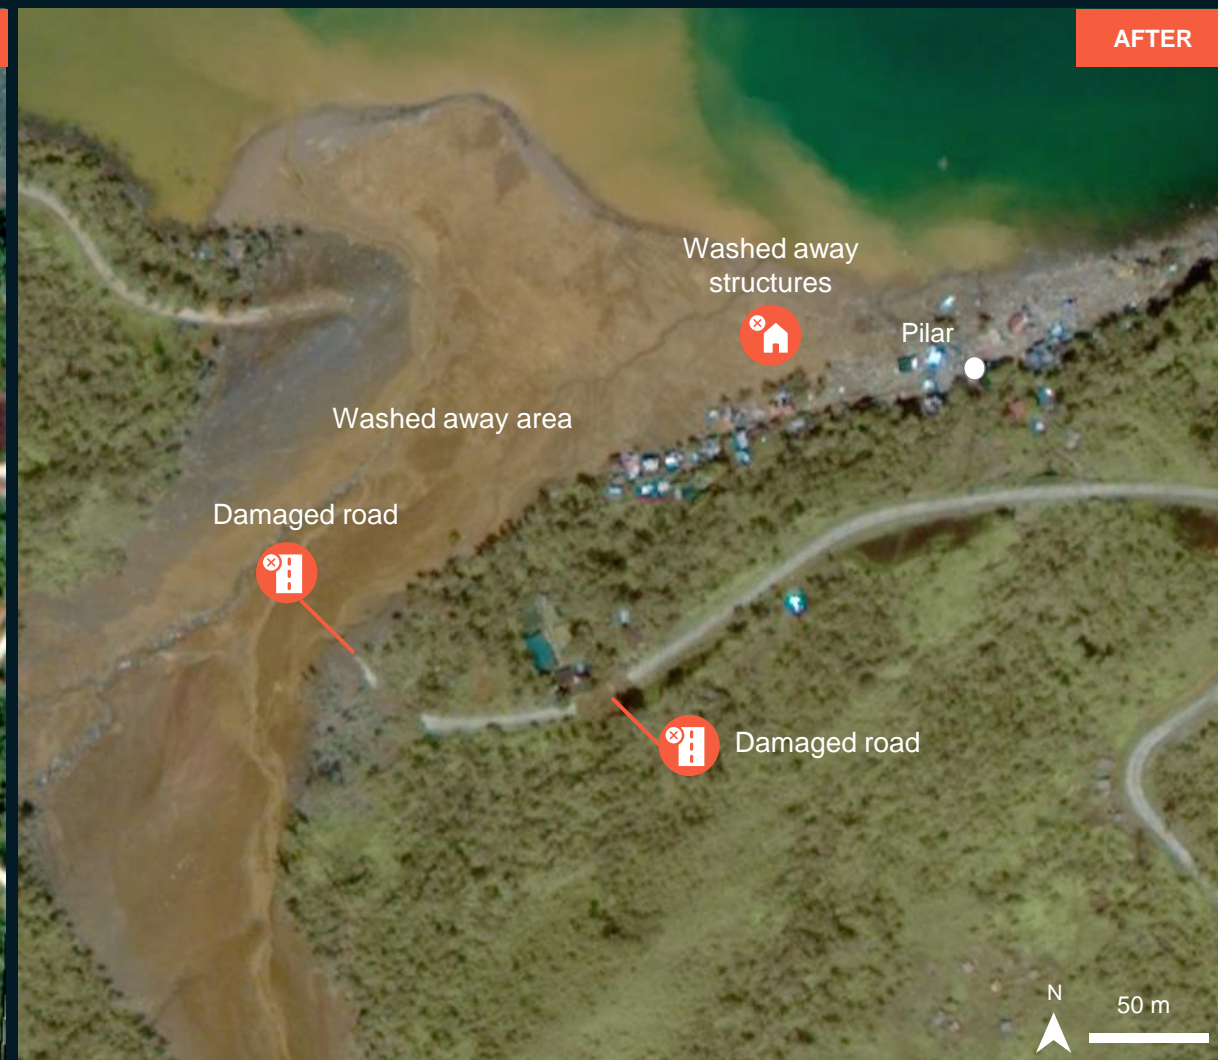
# AOI2-1 PILAR VILLAGE, ABUYOG MUNICIPALITY, LEYTE PROVINCE, REGION VIII

Extensive damage to roads and structures in Pilar village

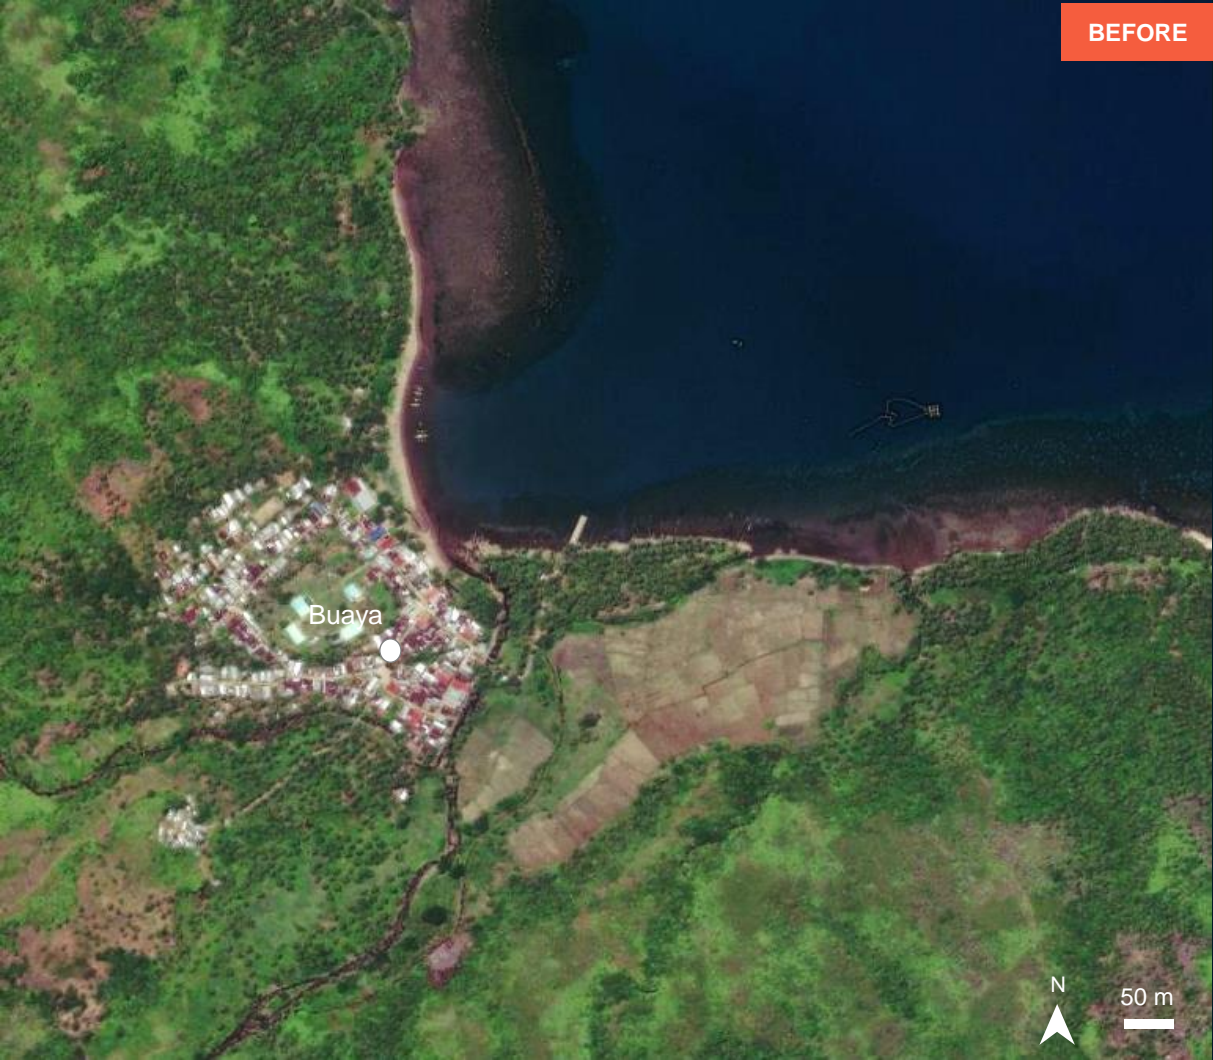
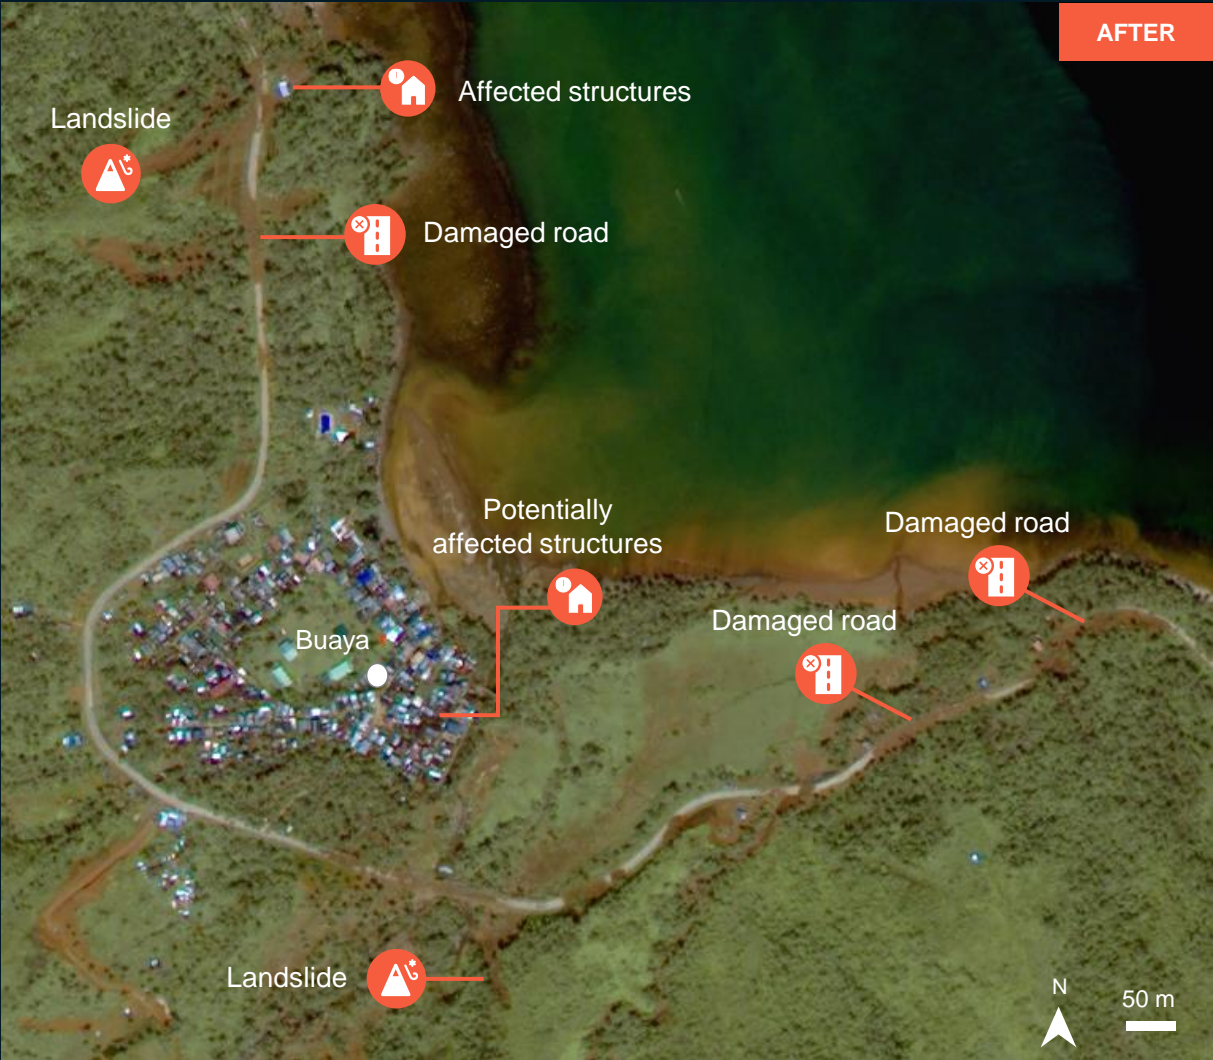
# AOI2-2 BUAYA VILLAGE, ABUYOG MUNICIPALITY, LEYTE PROVINCE, REGION VIII

Landslides along the road and affected structures
