# PRELIMINARY SATELLITE-DERIVED FLOOD AND LANDSLIDE ASSESSMENT

Leyte, Southern Leyte, Biliran, Capiz and Iloilo Provinces, Philippines

Status: : Extensive damage to structures and road including agricultural area observed

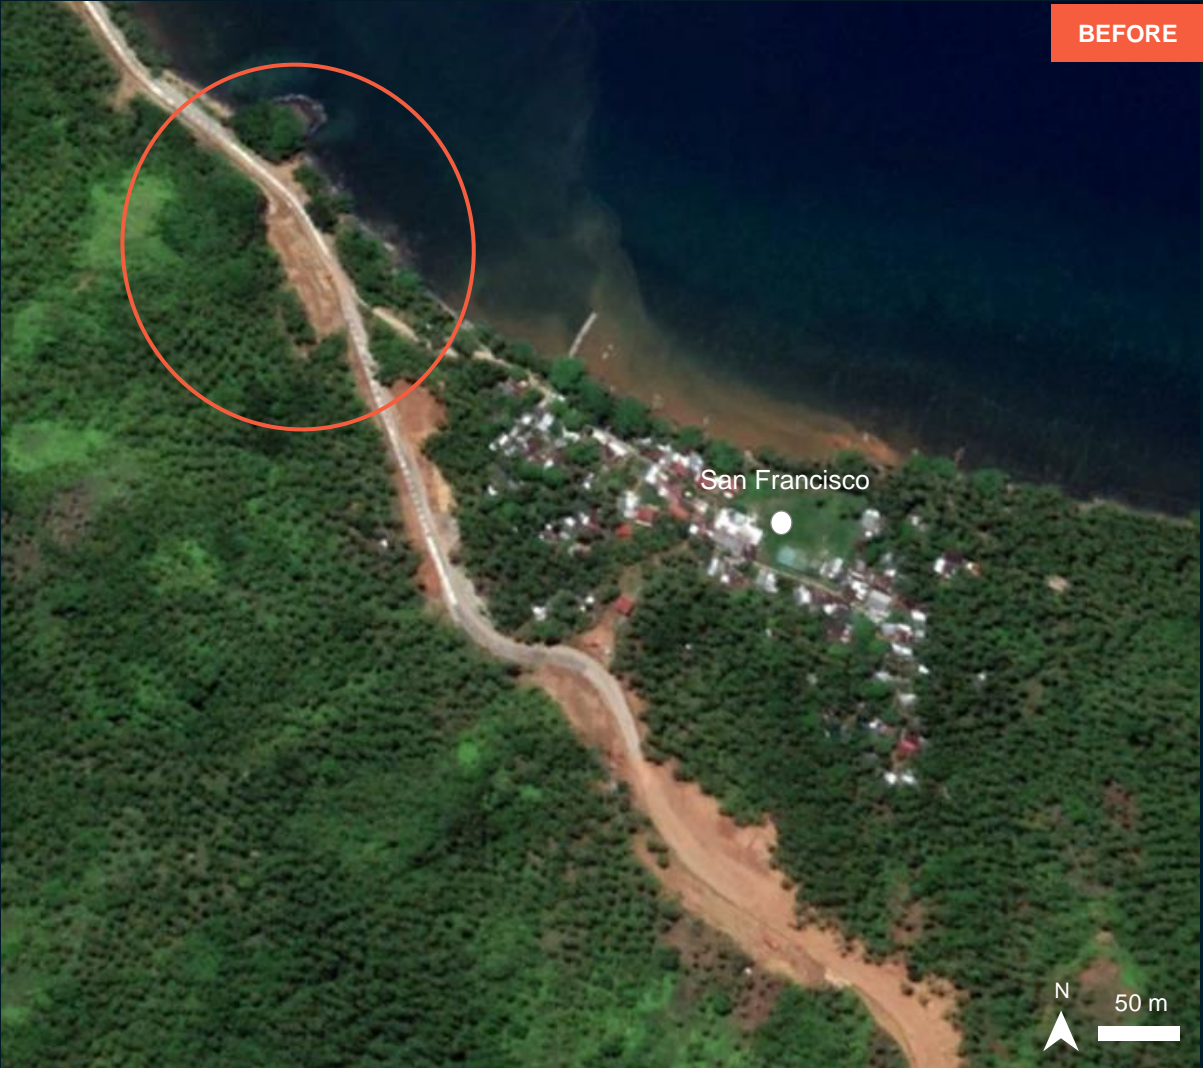
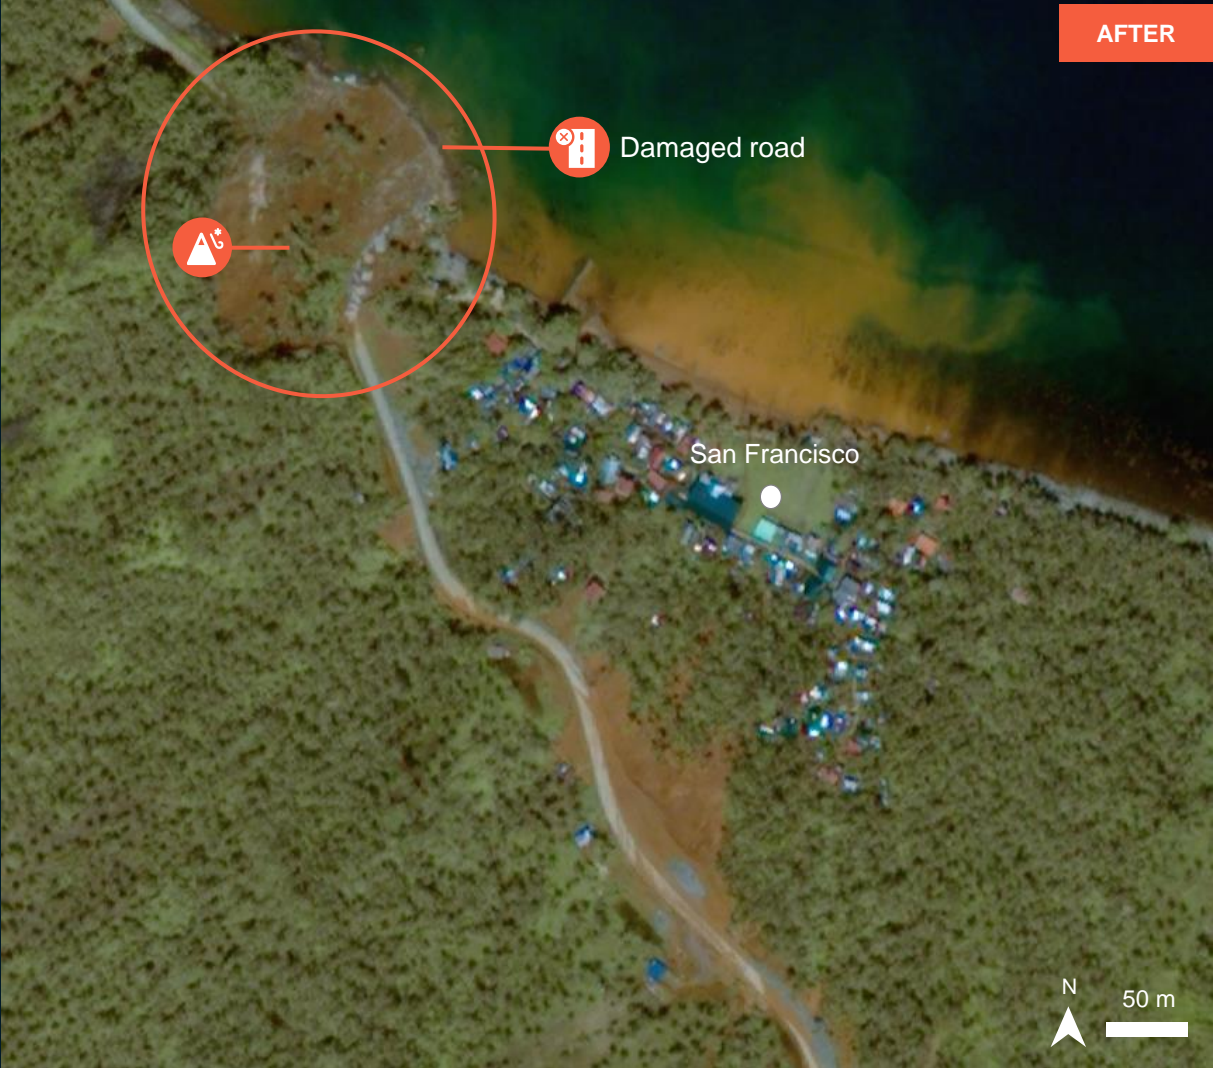
**AOI2-3 SAN FRANCISCO VILLAGE, ABUYOG MUNICIPALITY,  
LEYTE PROVINCE, REGION VIII**

**Landslide and damaged road**

- Damaged road near San Francisco village, Abuyog Municipality, City of Baybay, Leyte Province, Region VIII observed as of 16 Apr. 2022;
- Landslides and affected structures in Tib-O village, Abuyog Municipality, City of Baybay, Leyte Province, Region VIII observed as of 16 Apr. 2022;

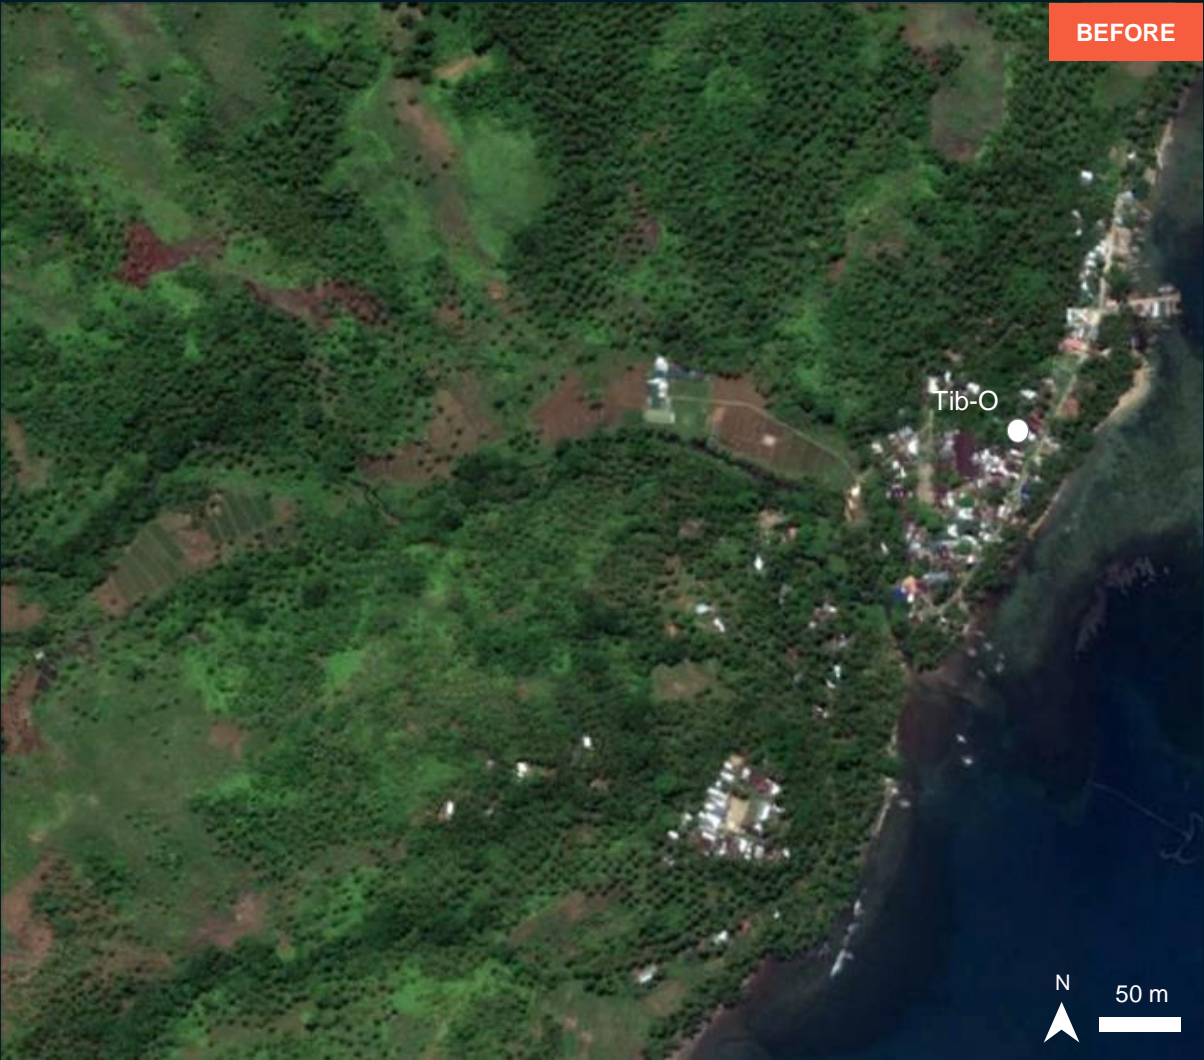
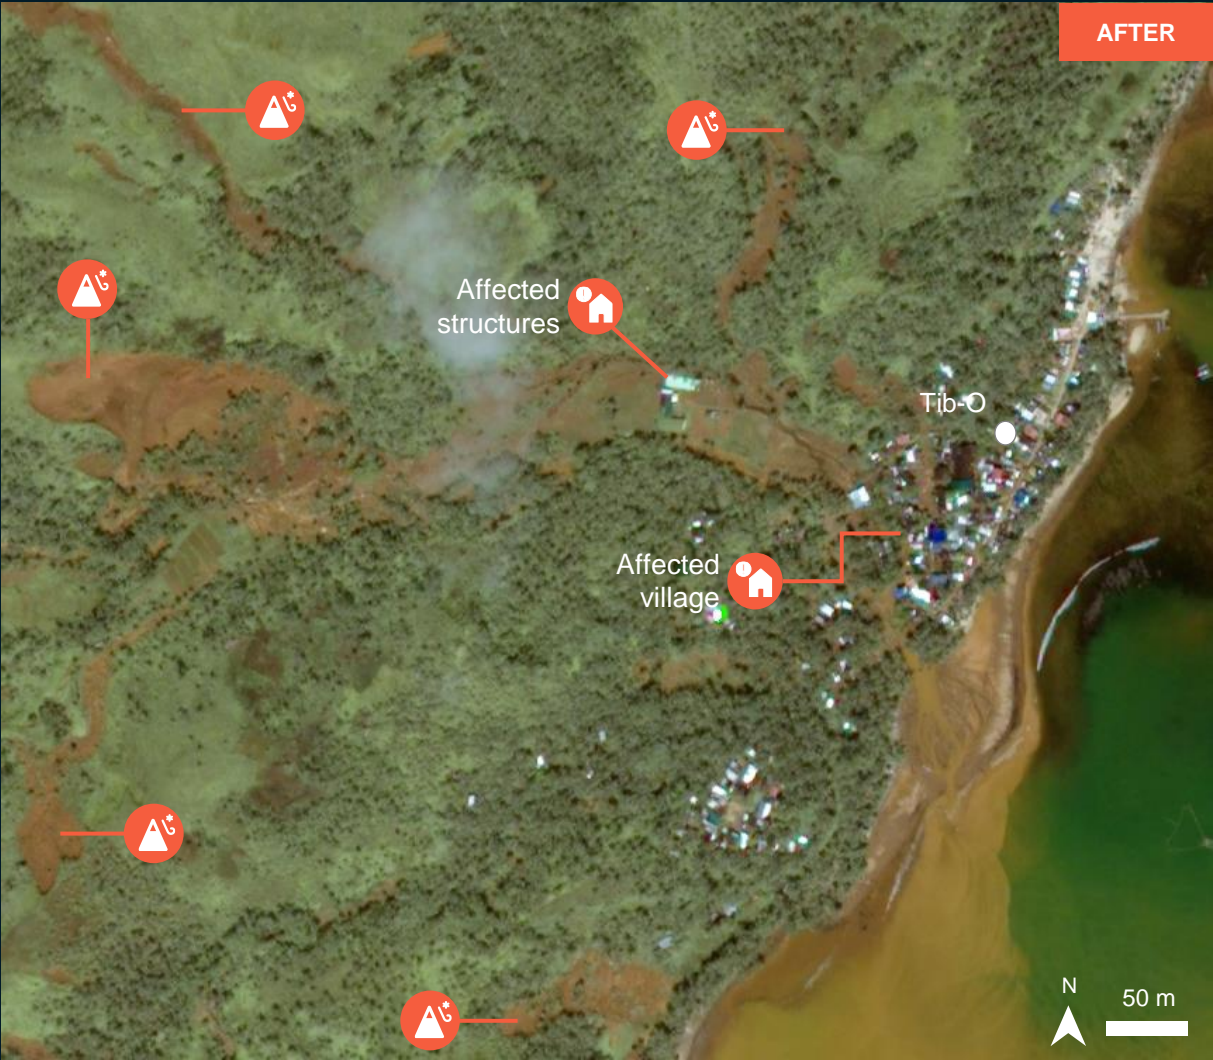
# AOI2-4 TIB-O VILLAGE, ABUYOG MUNICIPALITY, LEYTE PROVINCE, REGION VIII

Landslides and affected village

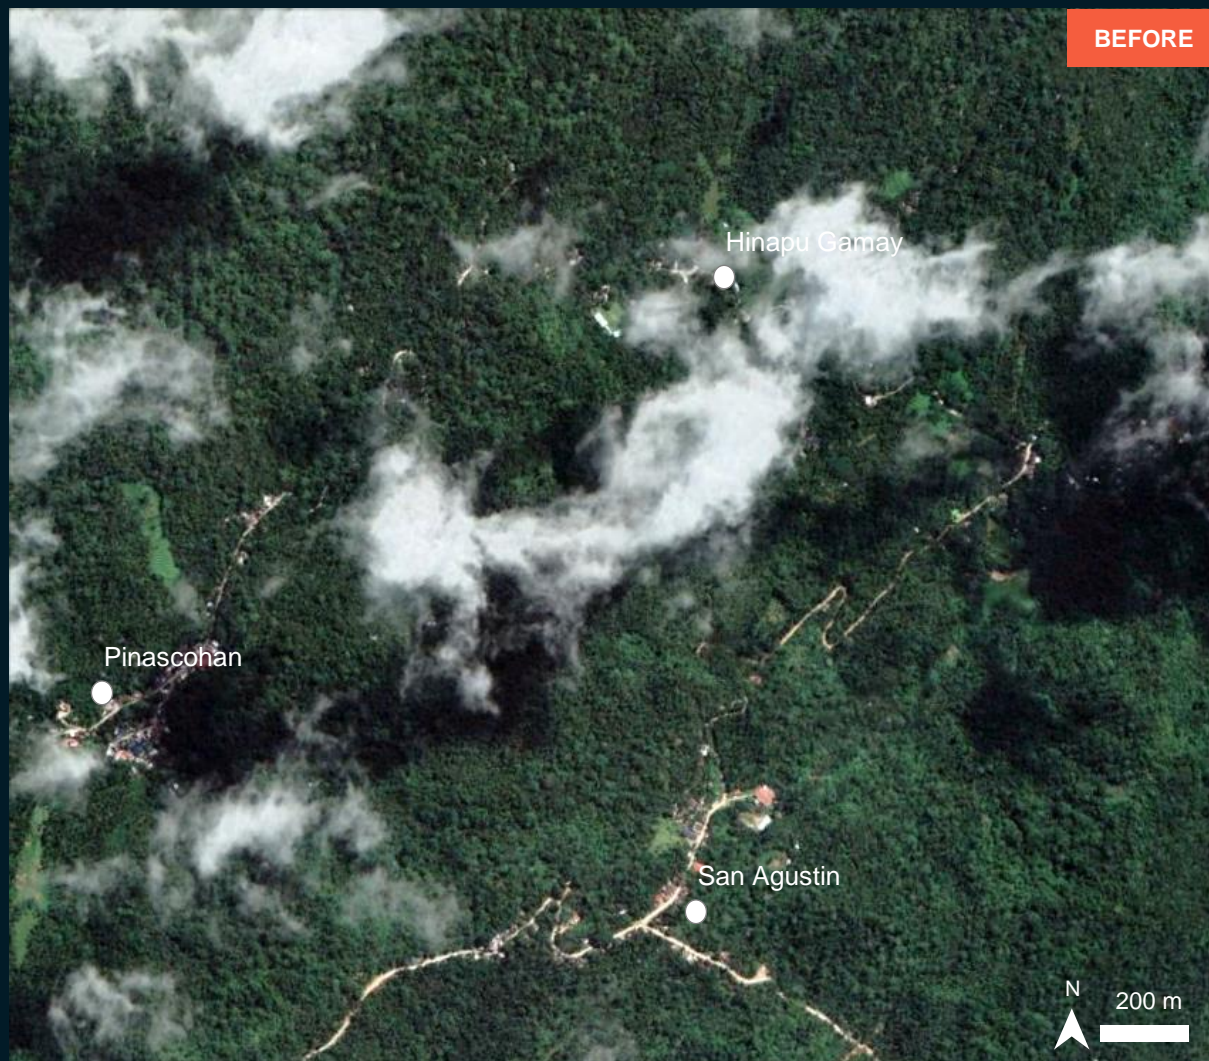
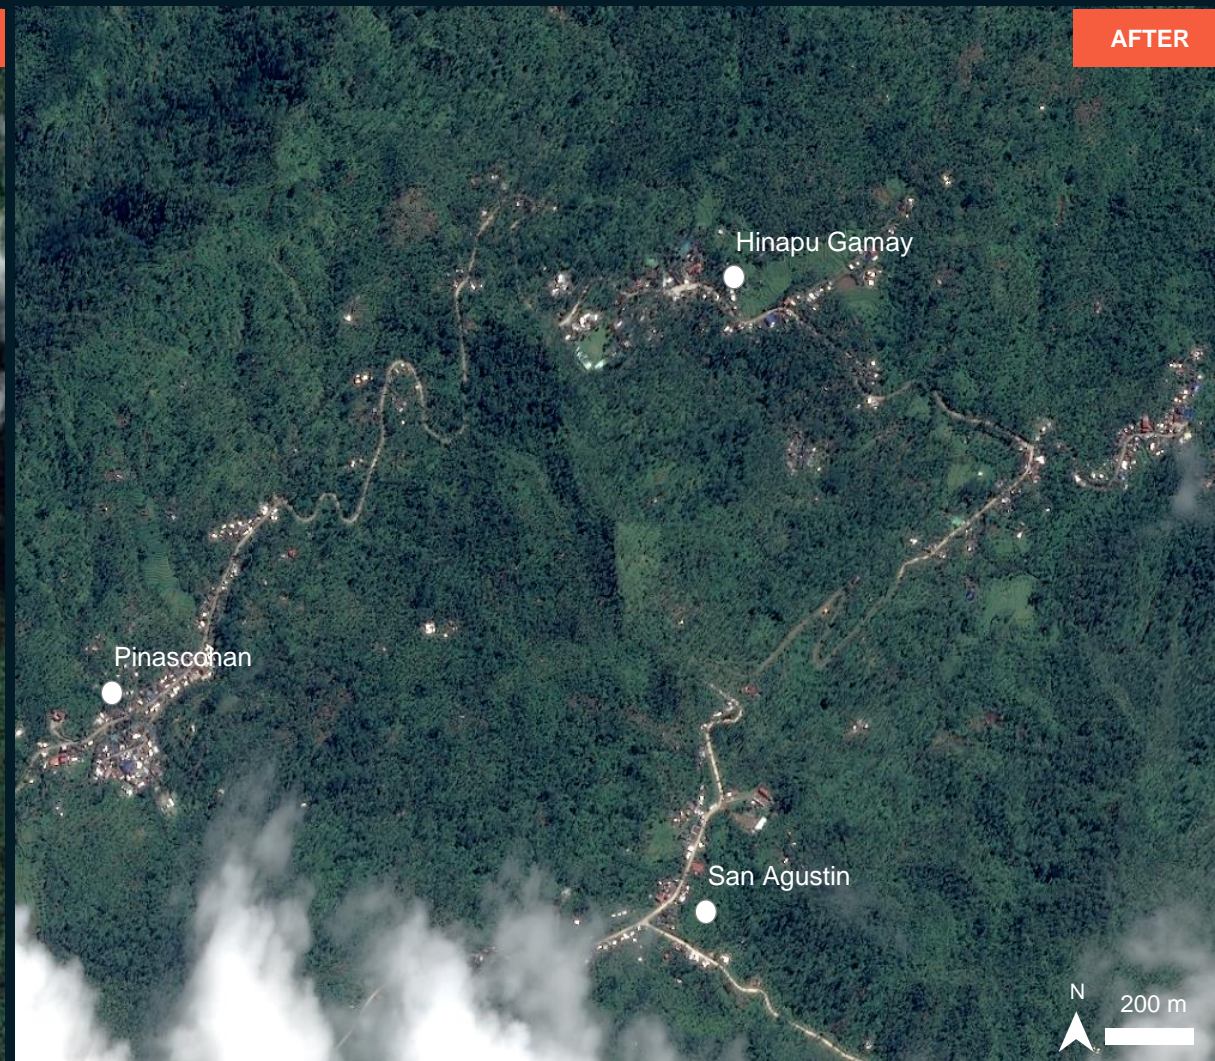
# AOI3-1 HINAPU GAMAY, PINASCOHAN, AND SAN AGUSTIN VILLAGES, CITY OF MAASIN, SOUTHERN LEYTE PROVINCE, REGION VIII

No visible landslide in cloud free zone

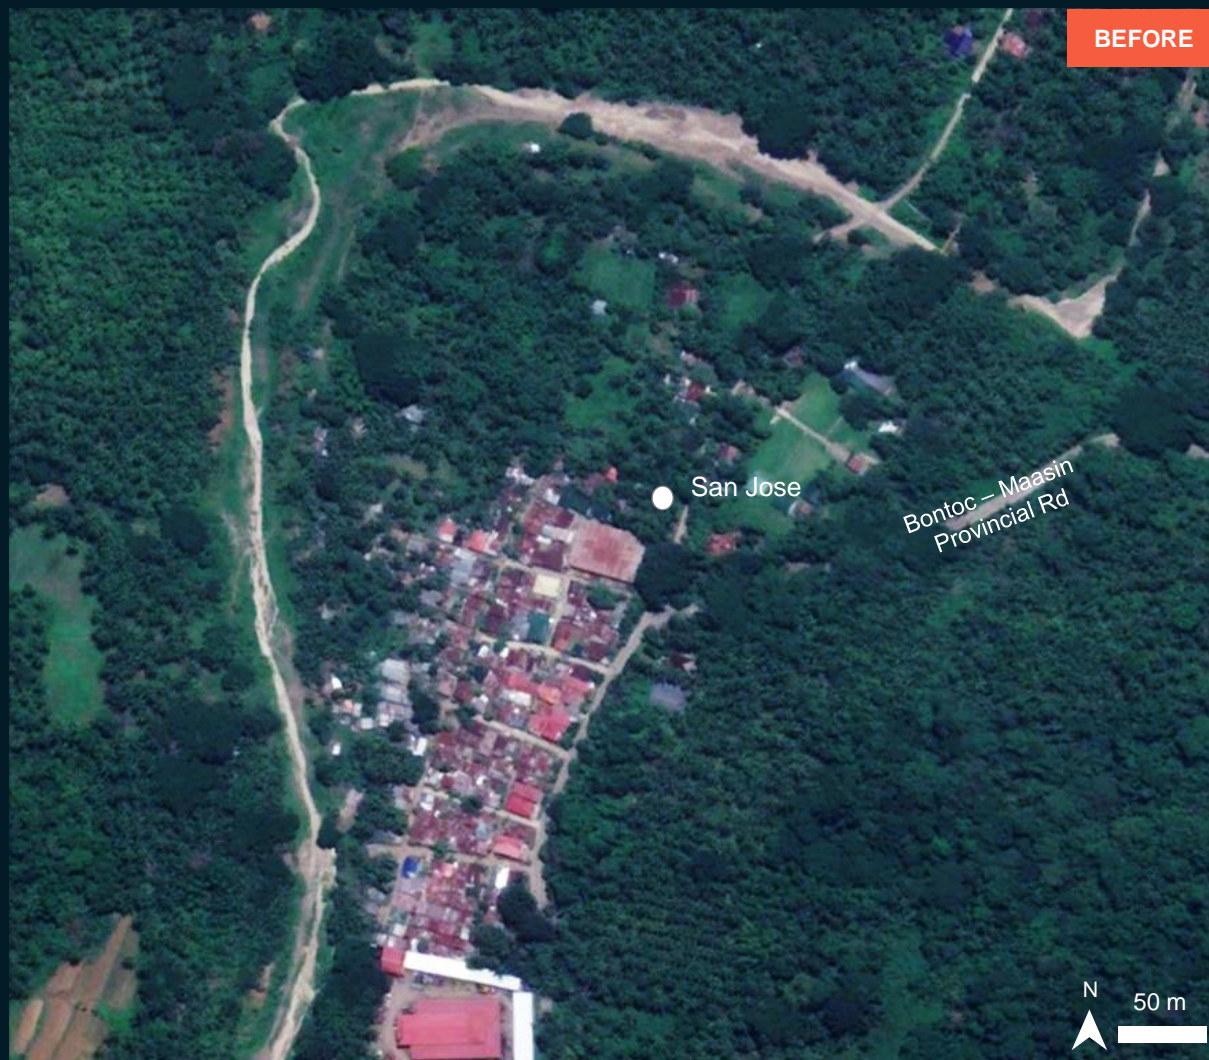
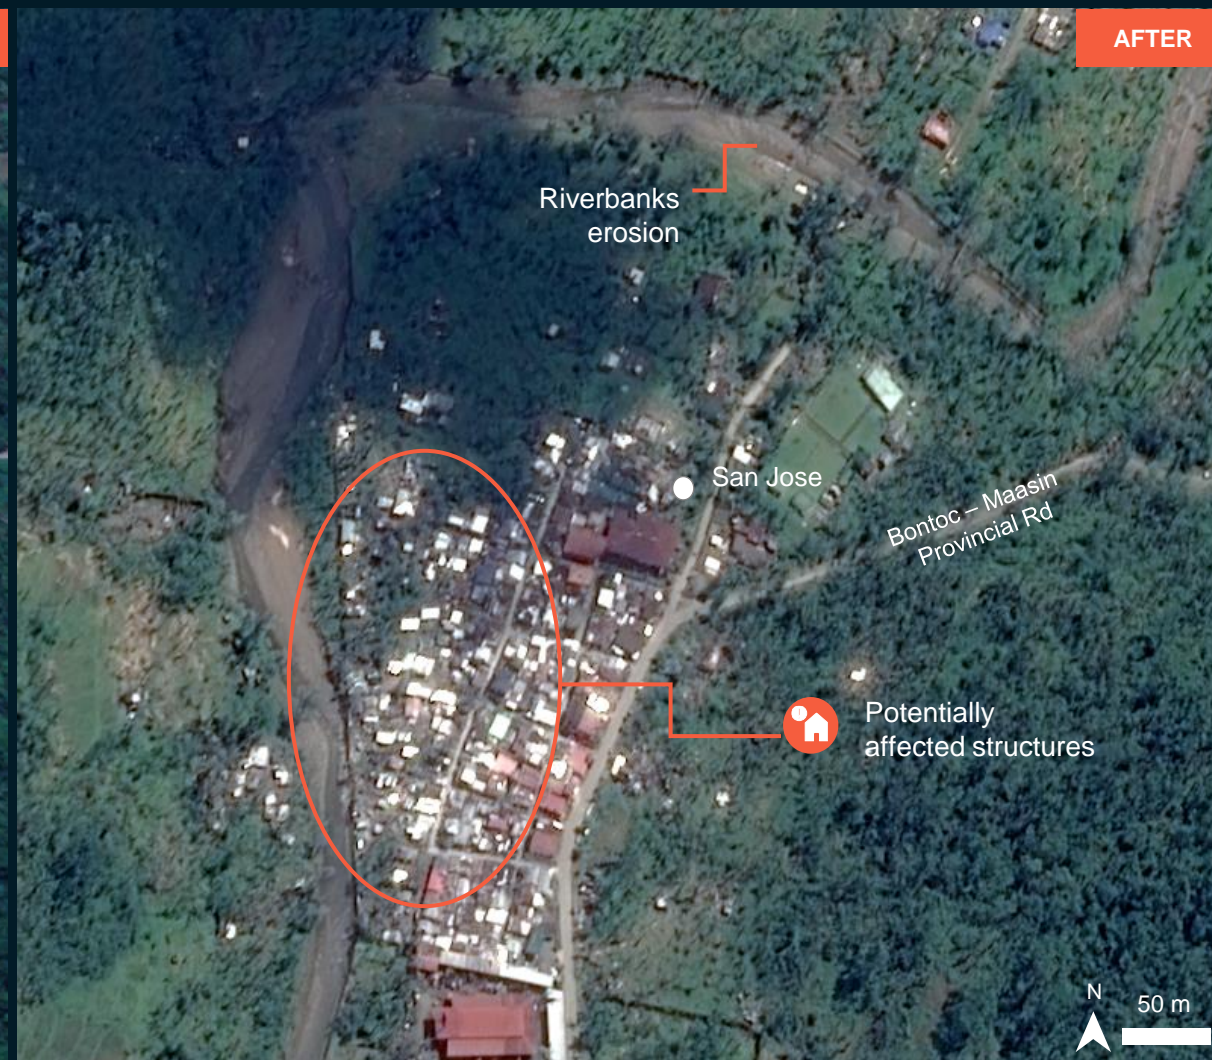
# AOI3-2 SAN JOSE VILLAGE, CITY OF MAASIN, SOUTHERN LEYTE PROVINCE, REGION VIII

## Riverbanks erosion and potentially affected structures

- Riverbanks erosion and potentially affected structures along the river in City of Maasin, Southern Leyte Province Region VIII observed as of 20 Apr. 2022;
- Damaged bridges along the river in City of Maasin, Southern Leyte Province Region VIII observed as of 20 Apr. 2022;

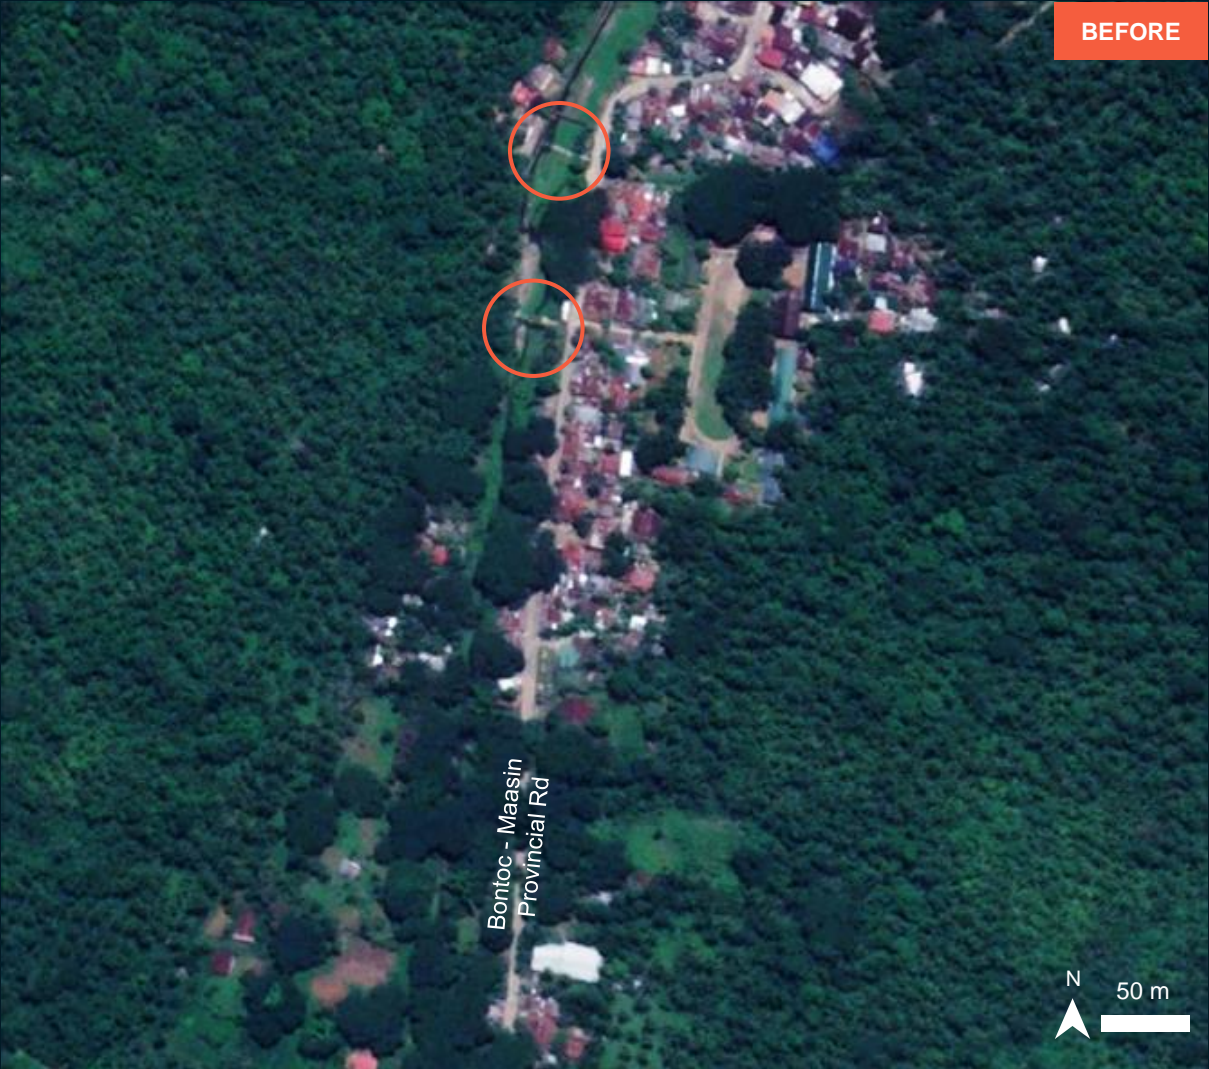
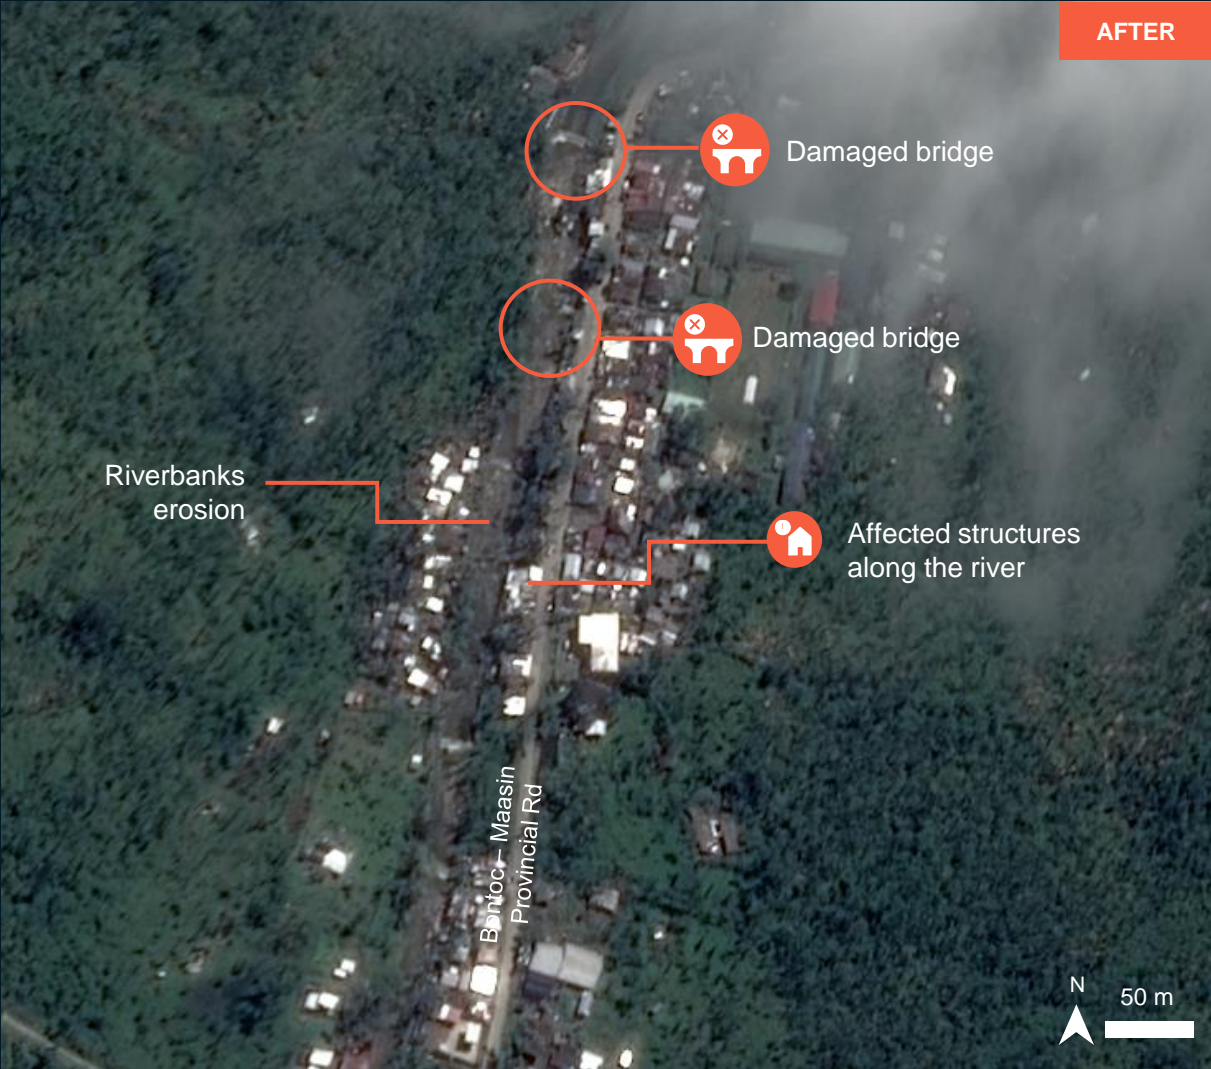
# AOI3-3 SAN RAFAEL VILLAGE, CITY OF MAASIN, SOUTHERN LEYTE PROVINCE, REGION VIII

## Damaged bridges and affected structures along the river

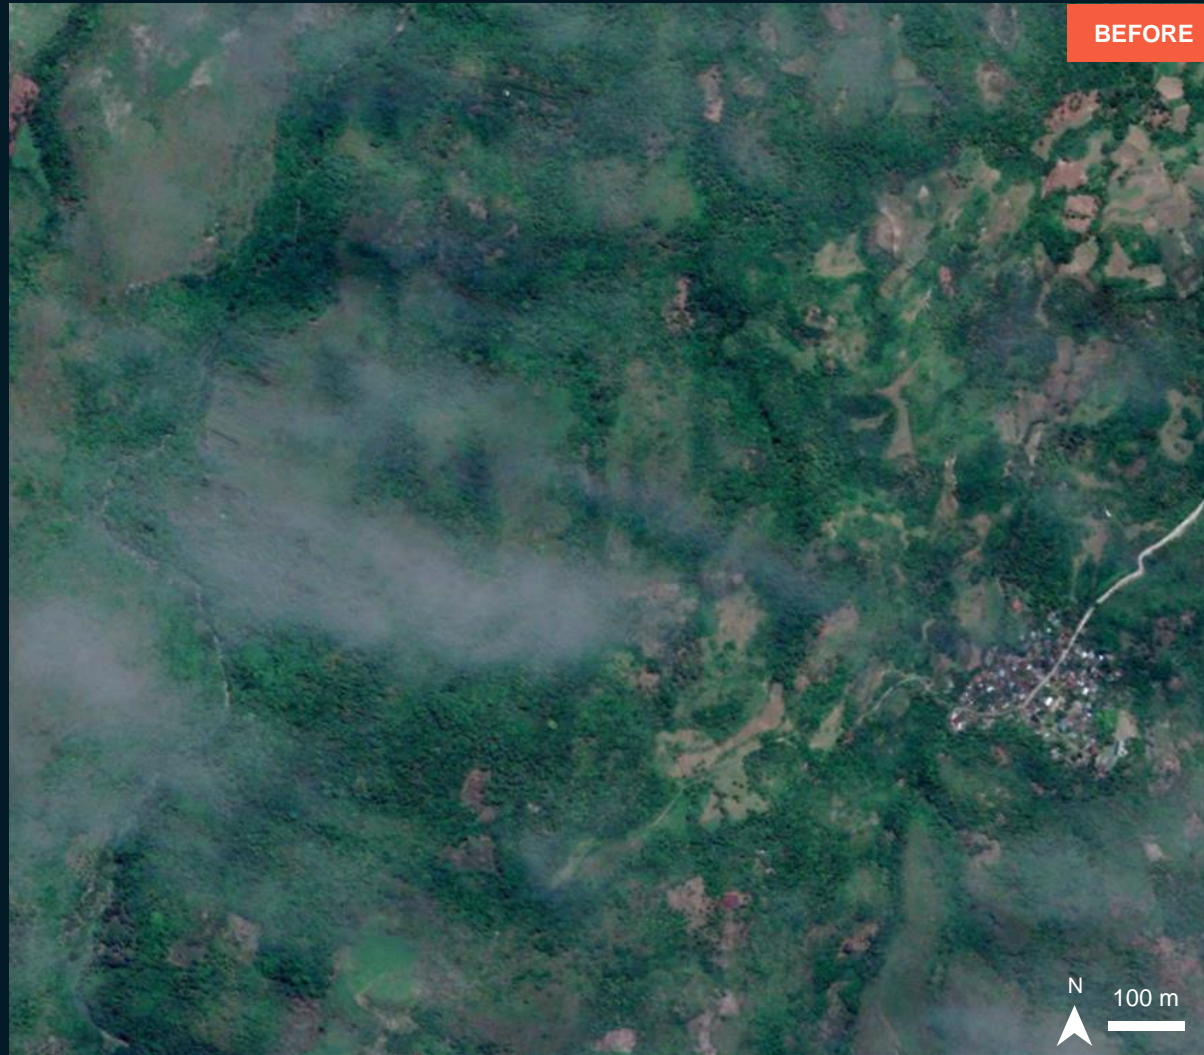
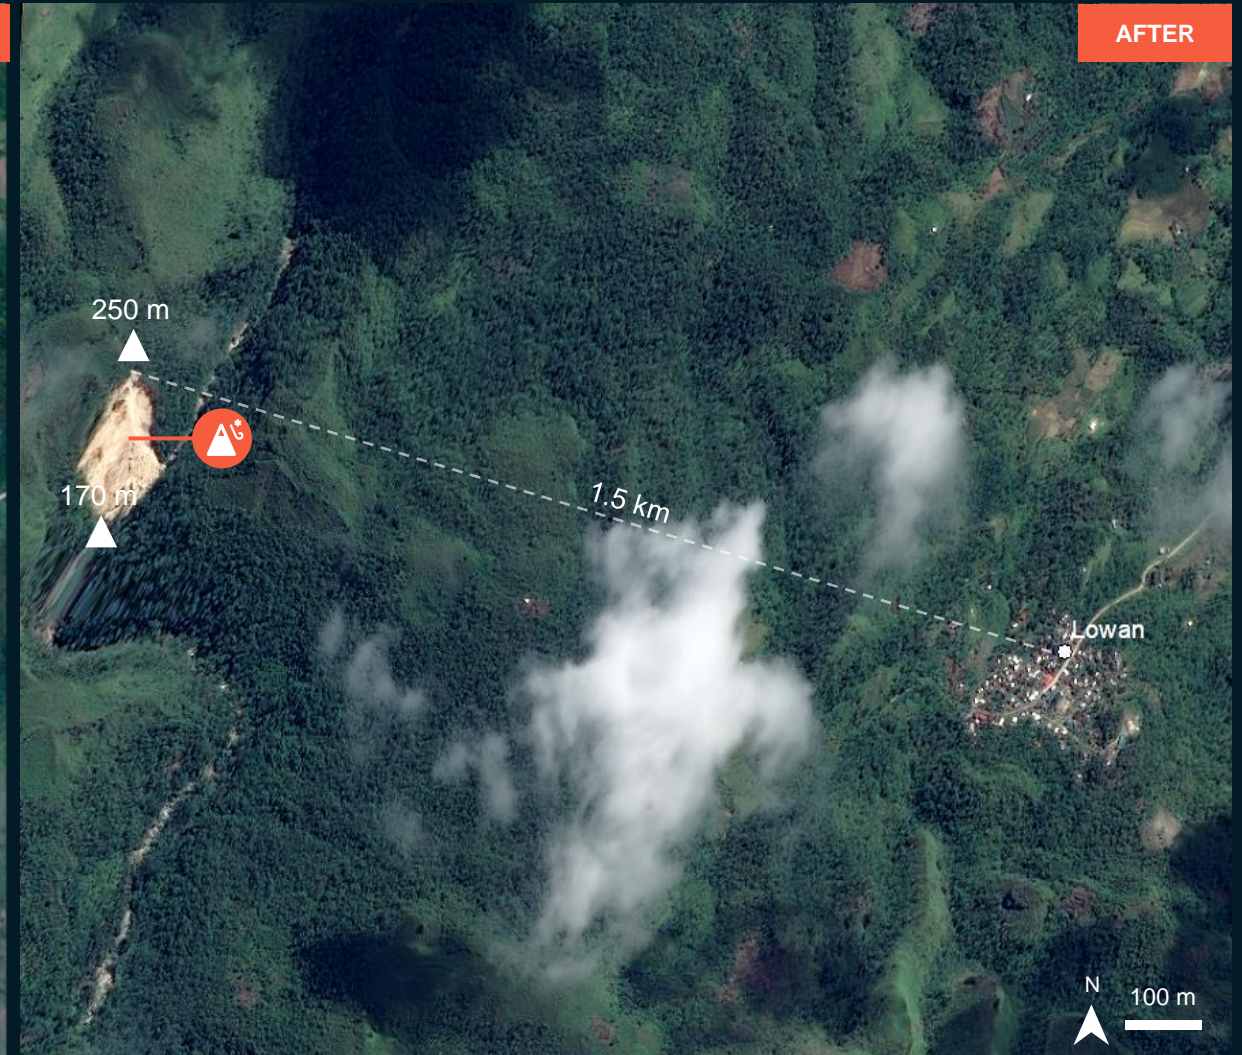
# AOI3-4 MATALOM MUNICIPALITY, SOUTHERN LEYTE PROVINCE, REGION VIII

## Landslide

- Landslide in Matalom Municipality, Leyte Province, Region VIII observed as of 20 Apr. 2022;
- No visible major flood observed in Matalom Municipality, Leyte Province, Region VIII observed as of 20 Apr. 2022;

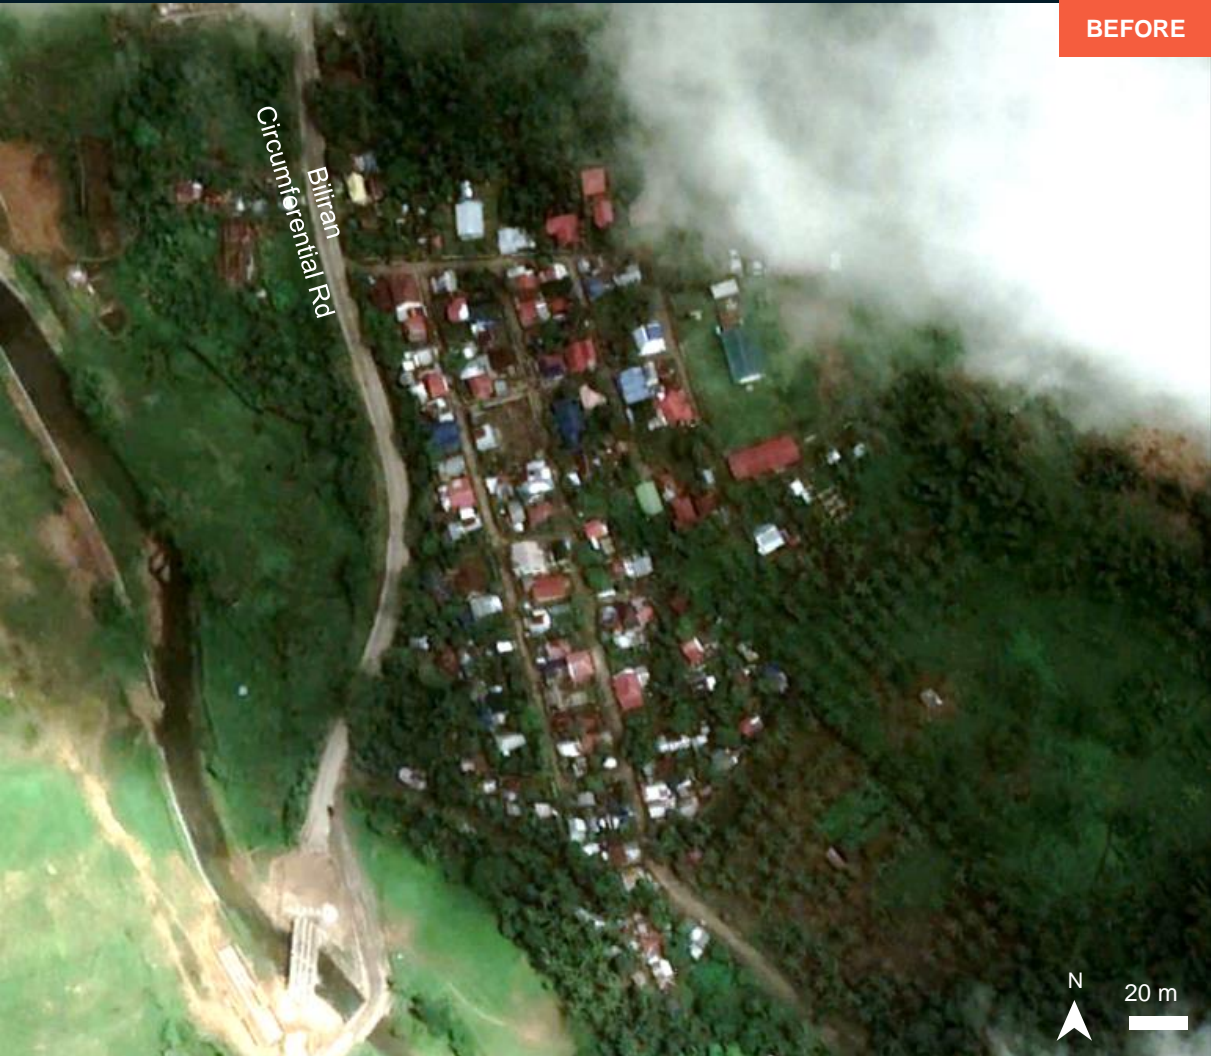
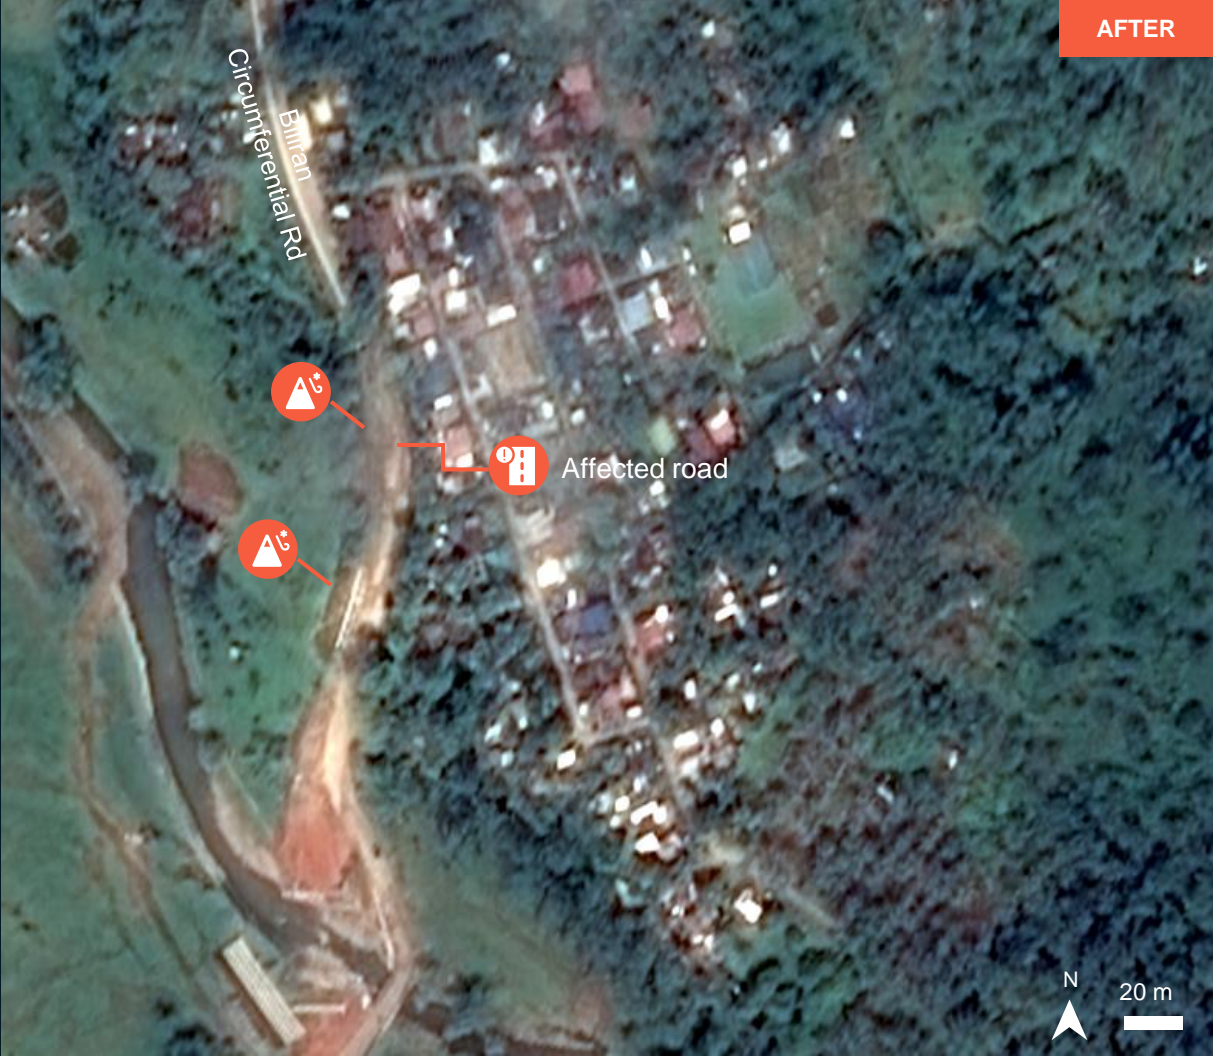
# AOI4-1 NAVAL MUNICIPALITY, BILIRAN PROVINCE, REGION VIII

## Landslide and affected road

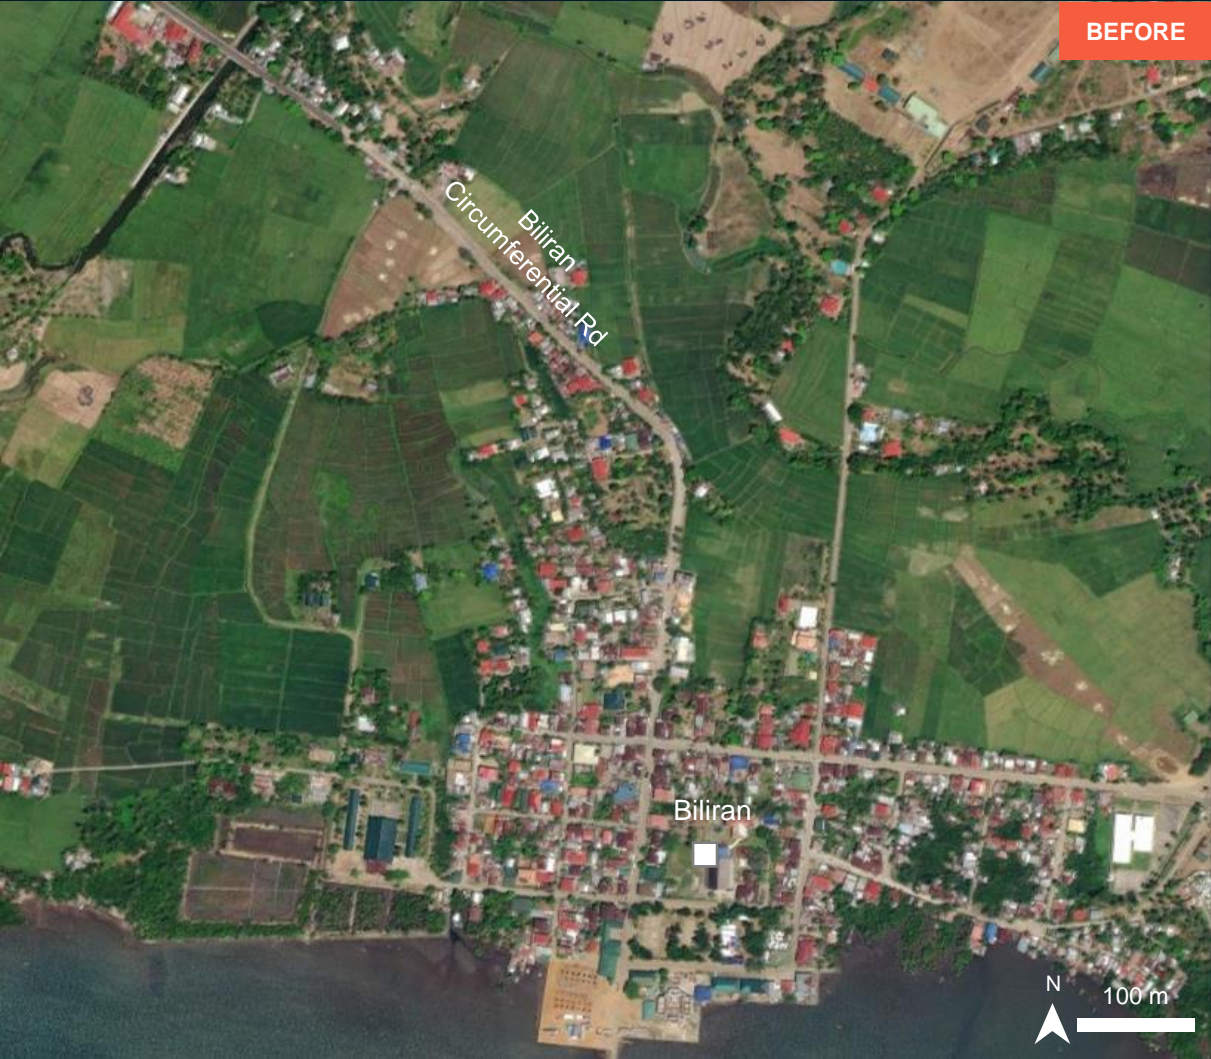
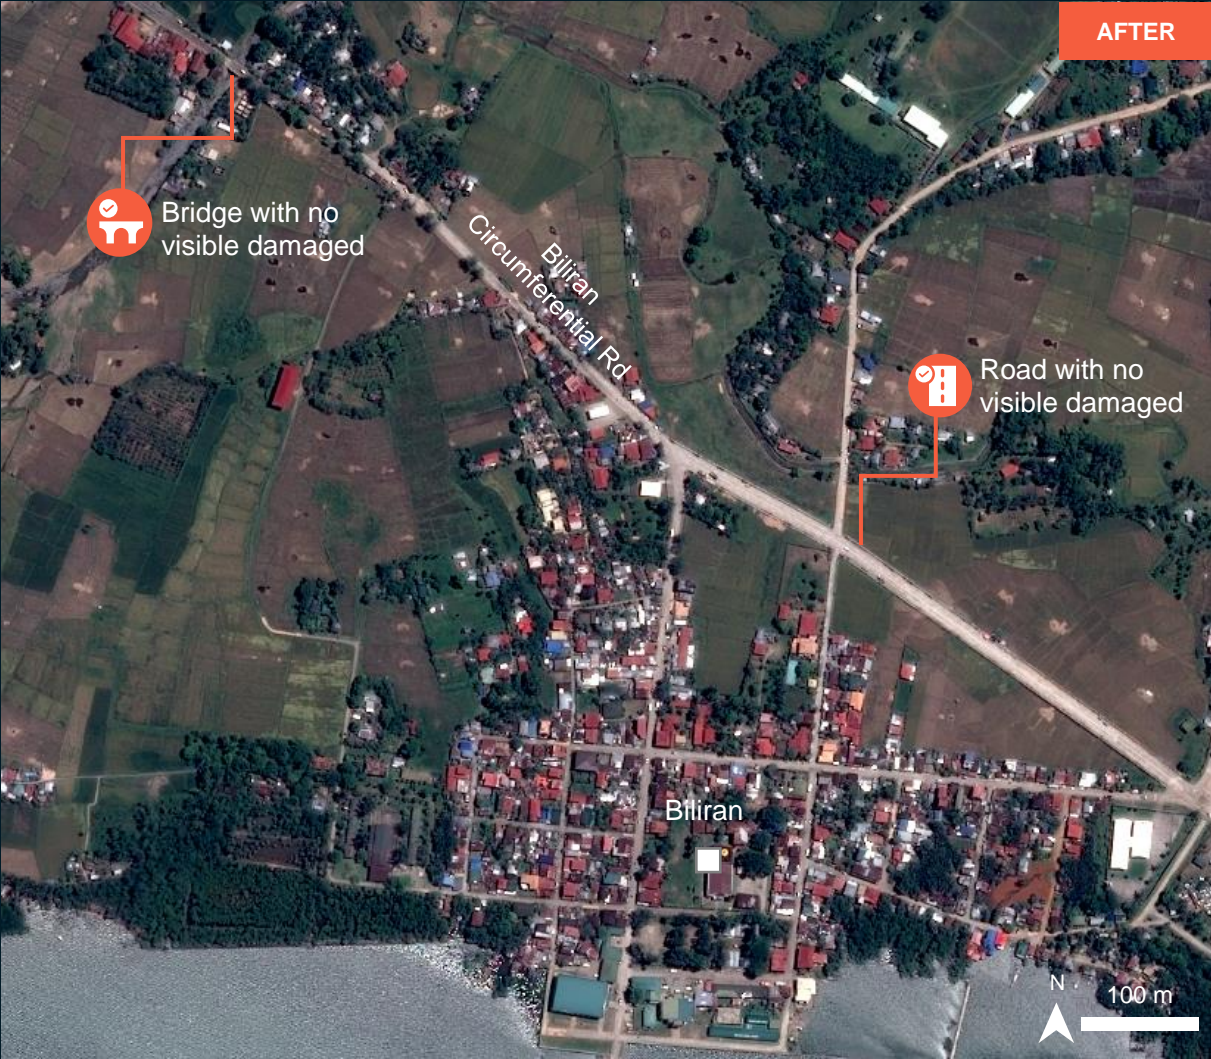
# AOI4-2 BILIRAN TOWN, BILIRAN MUNICIPALITY, BILIRAN PROVINCE, REGION VIII

No visible landslide and flood

Bridge with no  
visible damaged

Road with no  
visible damaged
