# PRELIMINARY SATELLITE-DERIVED FLOOD AND LANDSLIDE ASSESSMENT

Leyte, Southern Leyte, Biliran, Capiz and Iloilo Provinces, Philippines

Status: : Extensive damage to structures and road including agricultural area observed

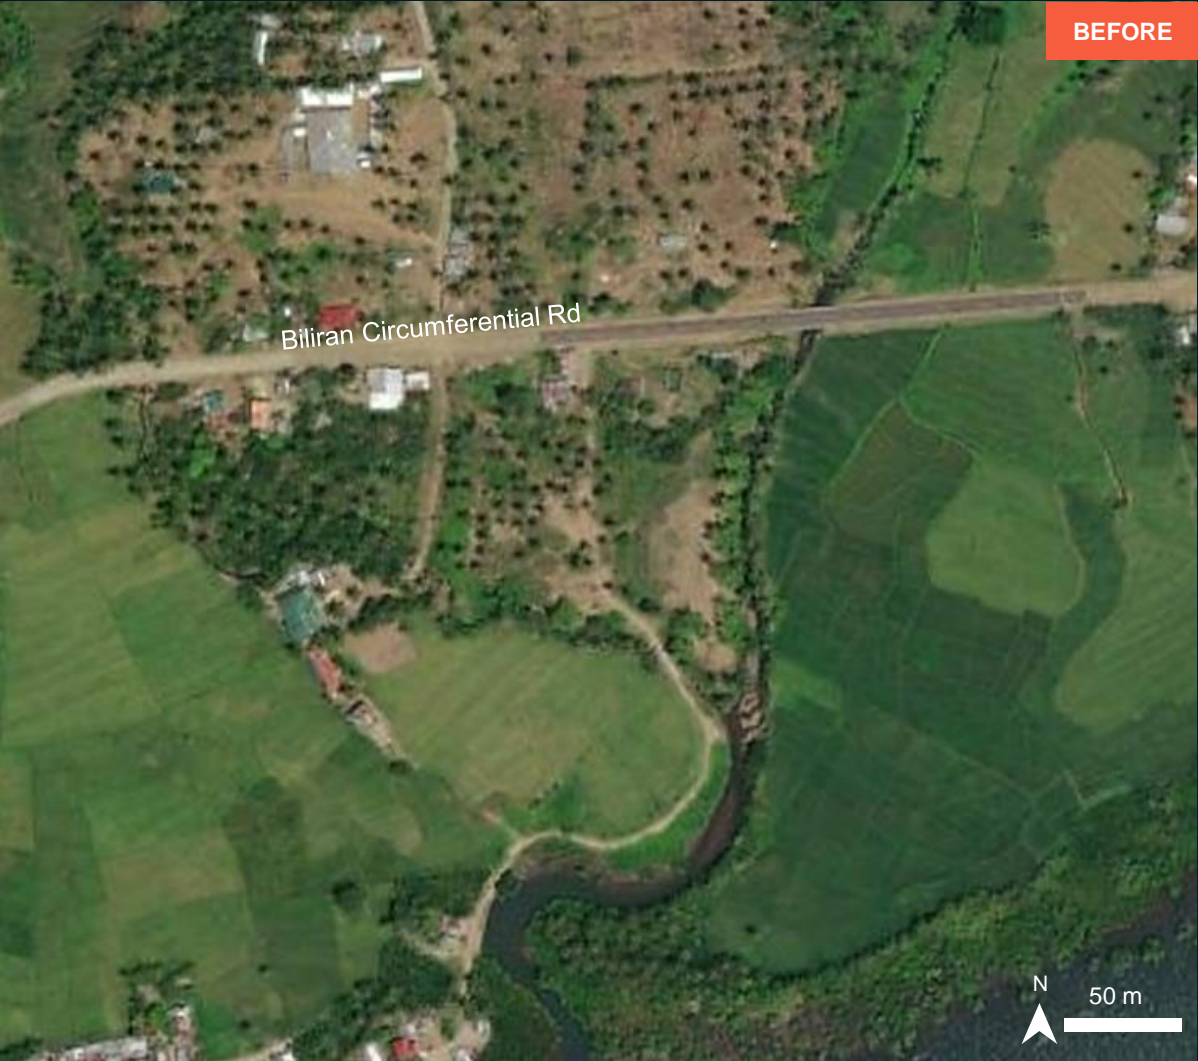
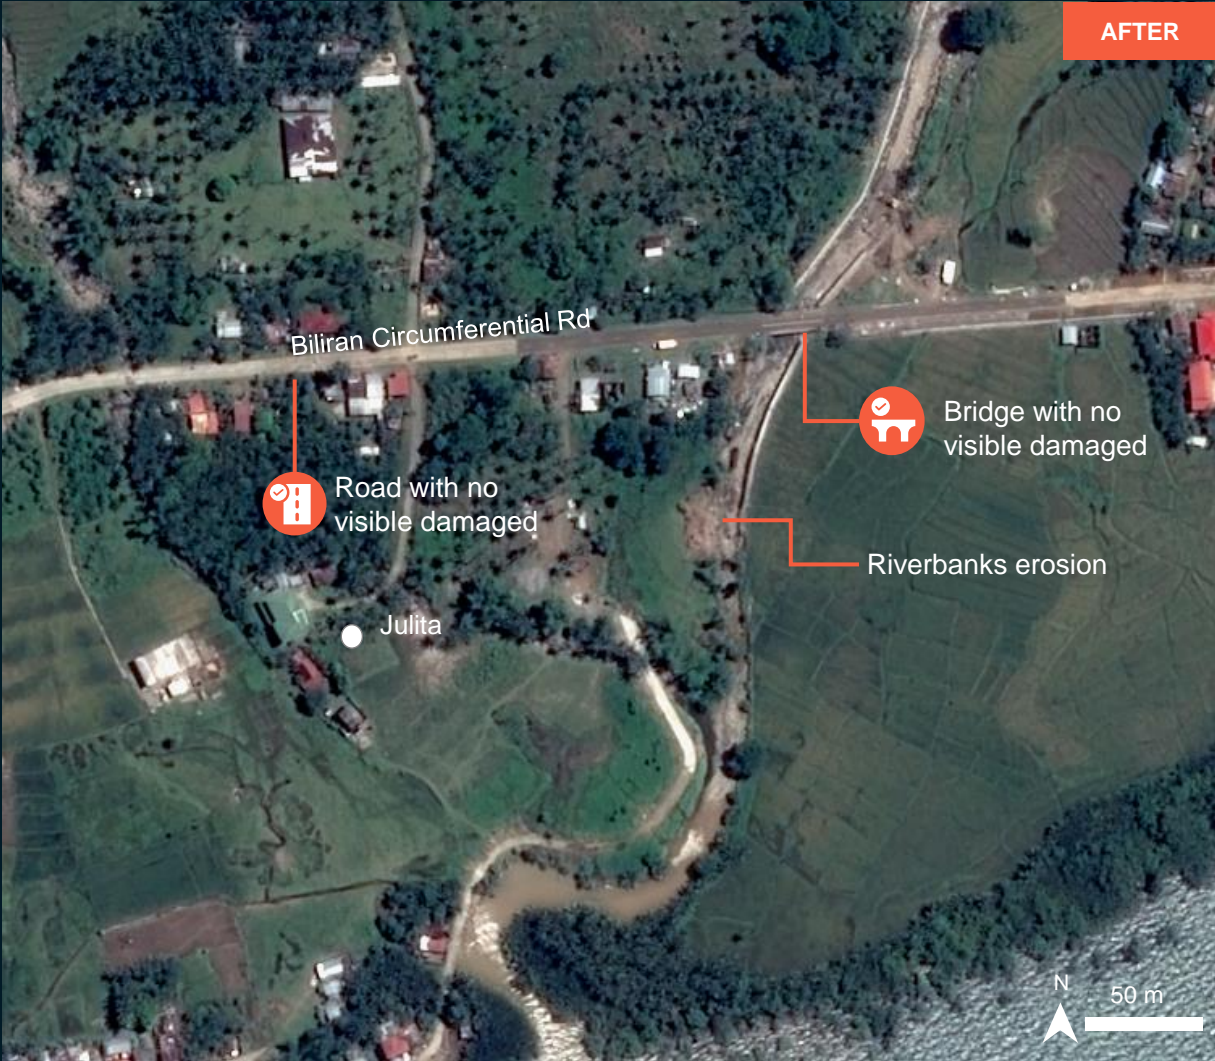
# AOI4-3 BILIRAN MUNICIPALITY, BILIRAN PROVINCE, REGION VIII

Riverbanks erosion, no visible landslide and flood

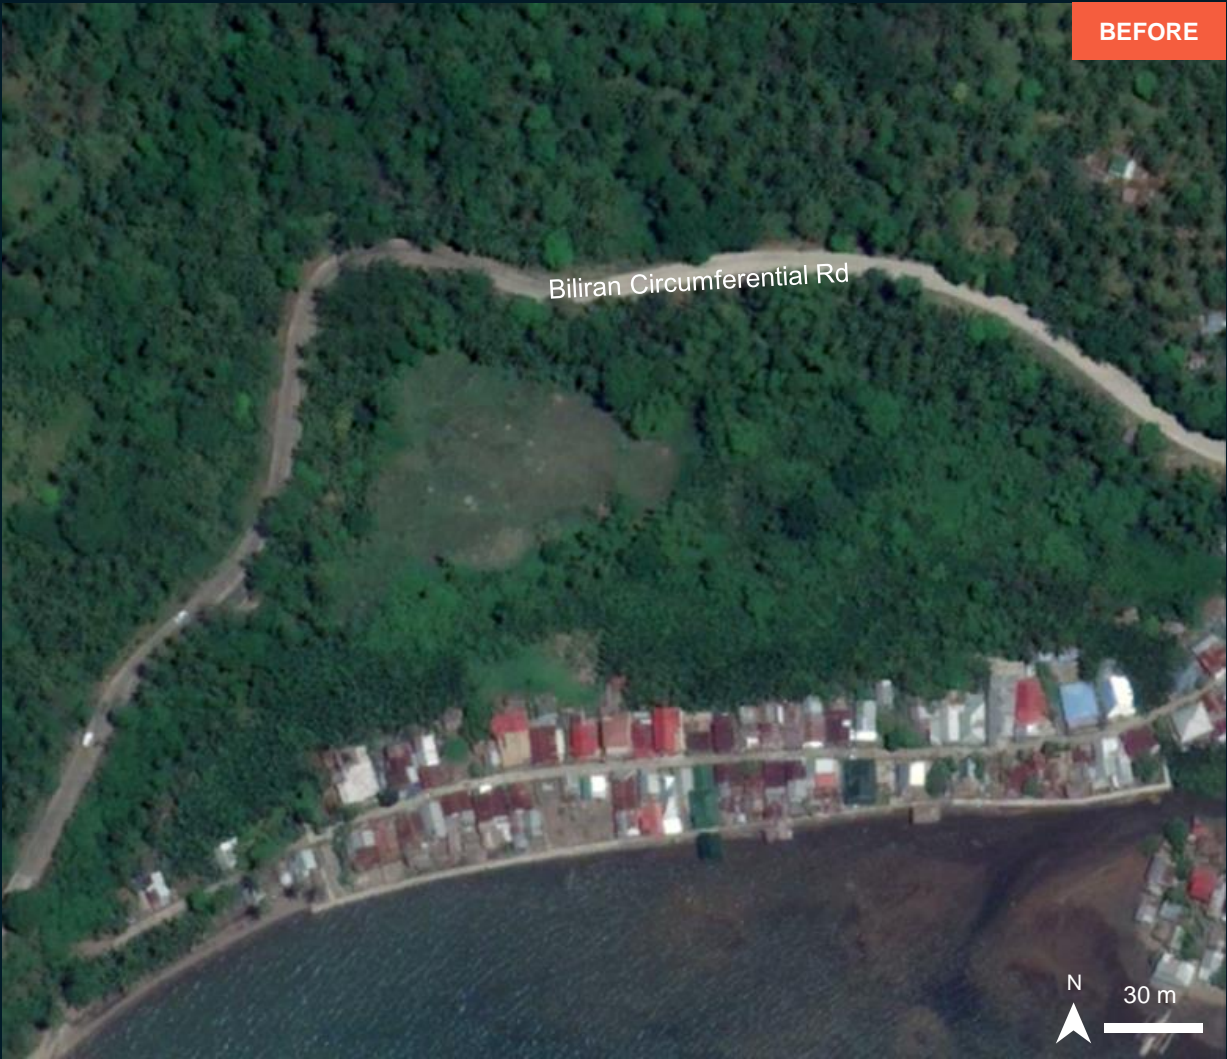
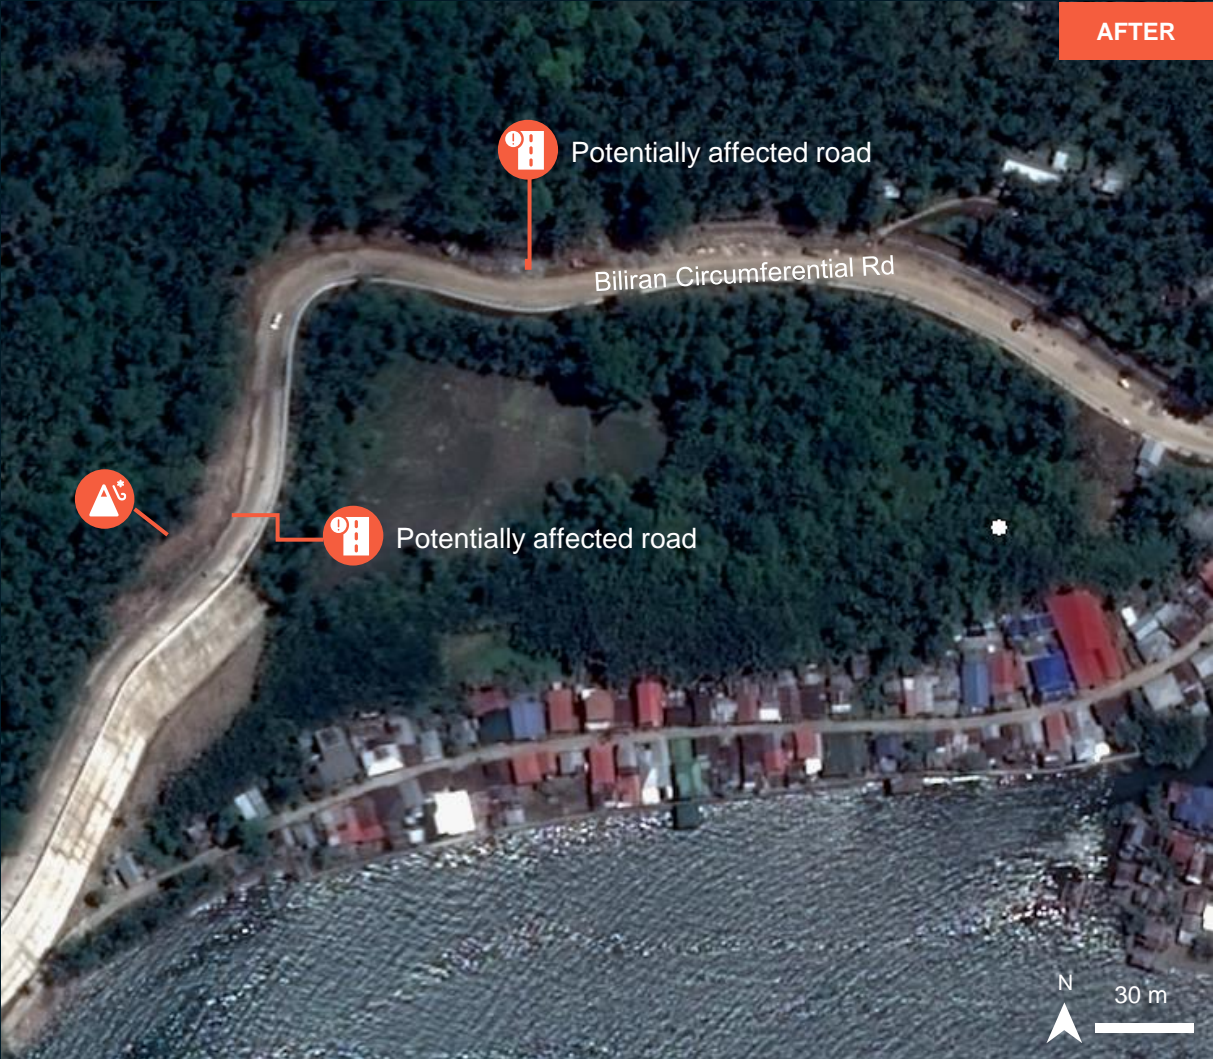
# AOI4-4 CABUCGAYAN MUNICIPALITY, BILIRAN PROVINCE, REGION VIII

Landslide and potentially affected road

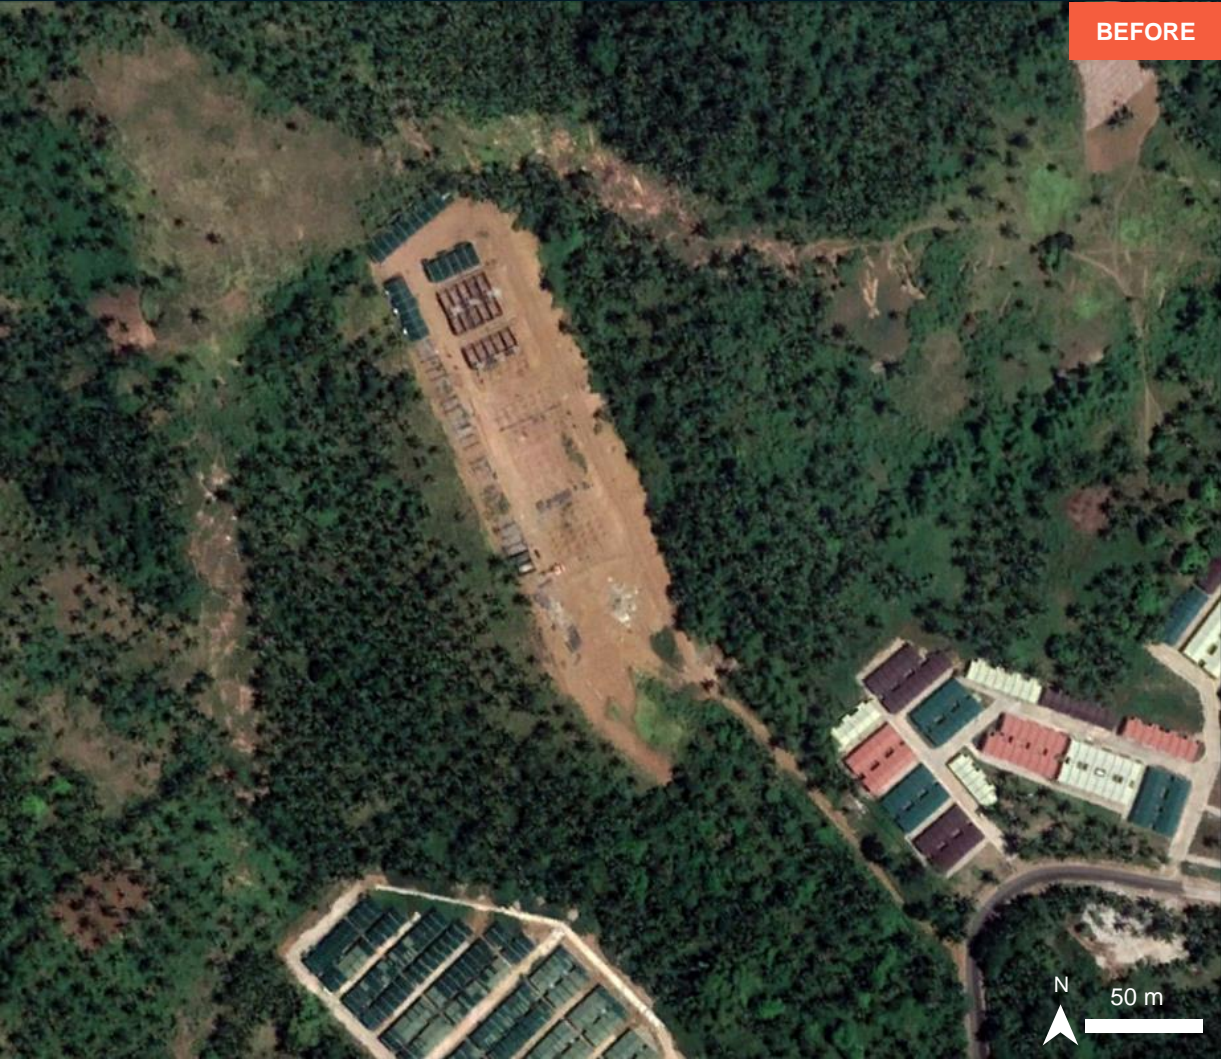
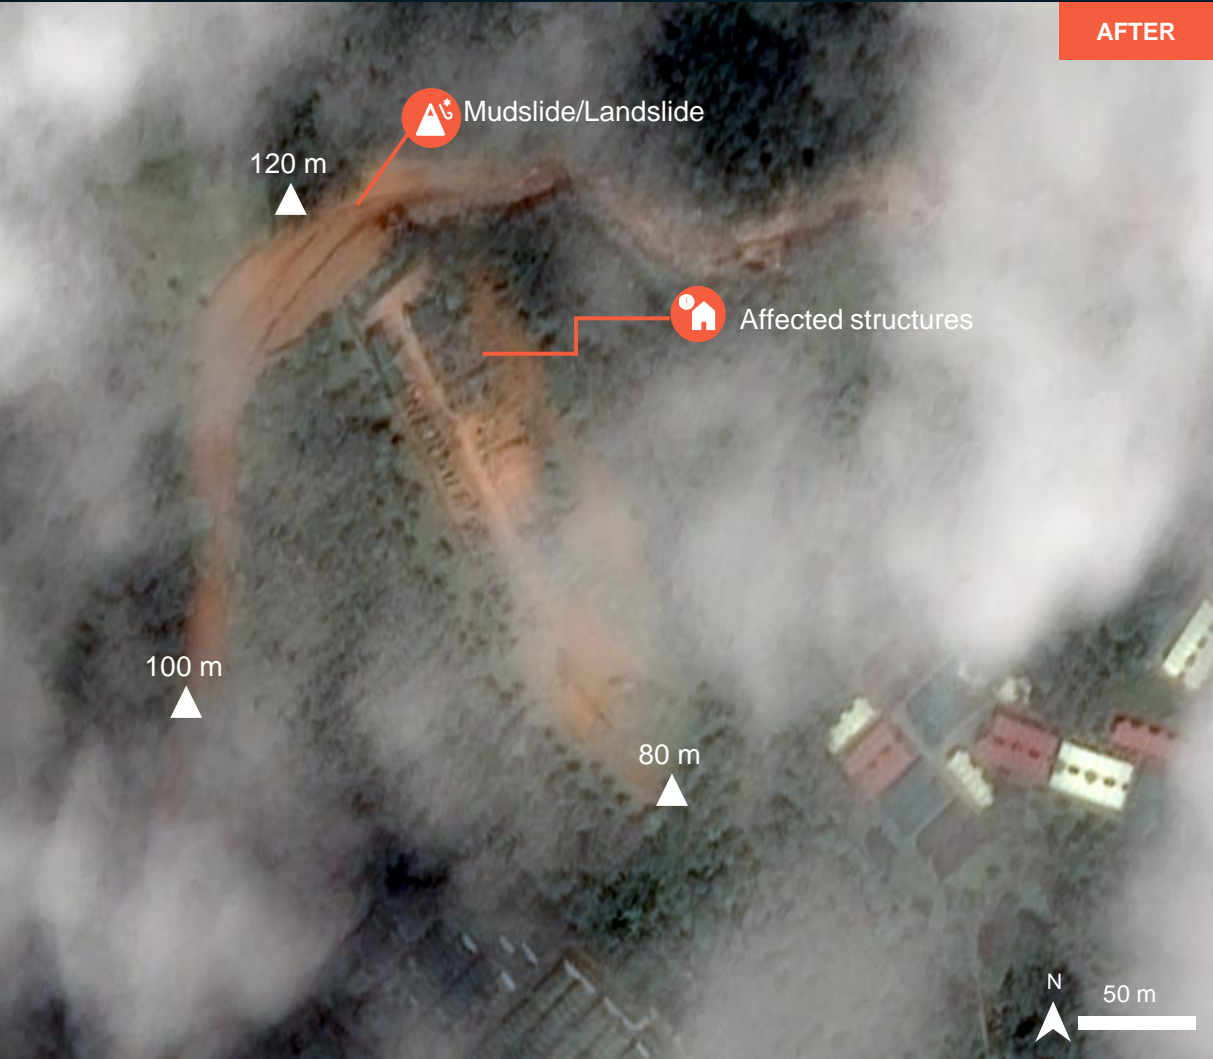
# AOI4-5 CABUCGAYAN MUNICIPALITY, BILIRAN PROVINCE, REGION VIII

Mudslide/Landslide

Affected structures

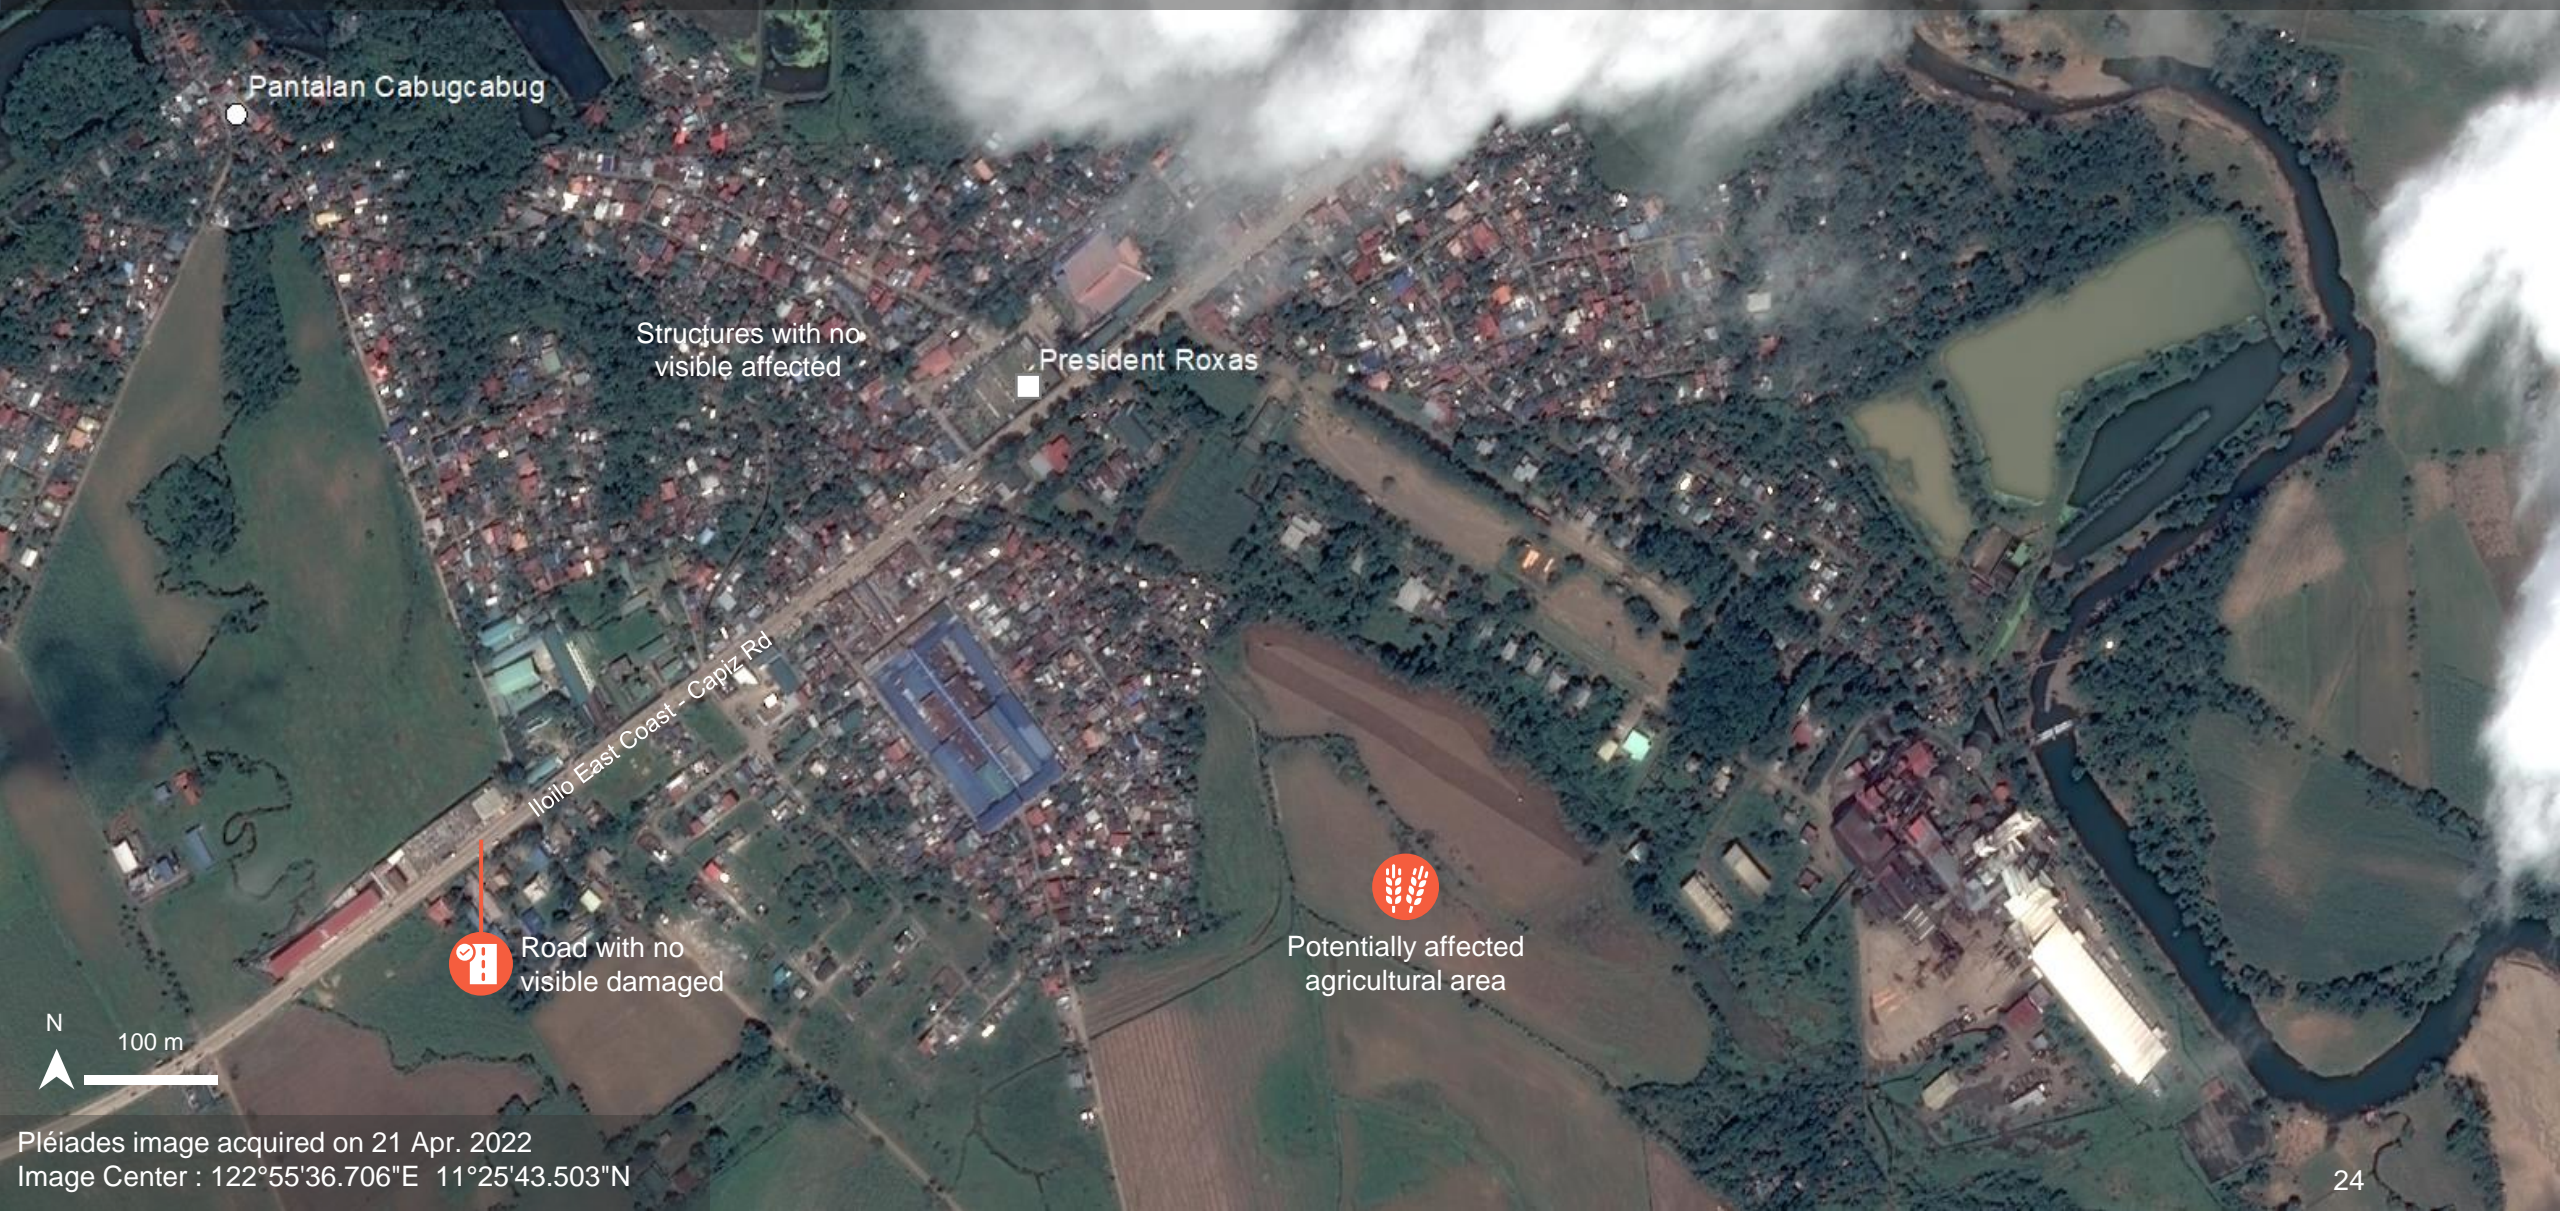
# AOI5-1-PRESIDENT ROXAS TOWN, PRESIDENT ROXAS MUNICIPALITY, CAPIZ PROVINCE, REGION VI

No visible affected structures, Potentially affected agricultural lands

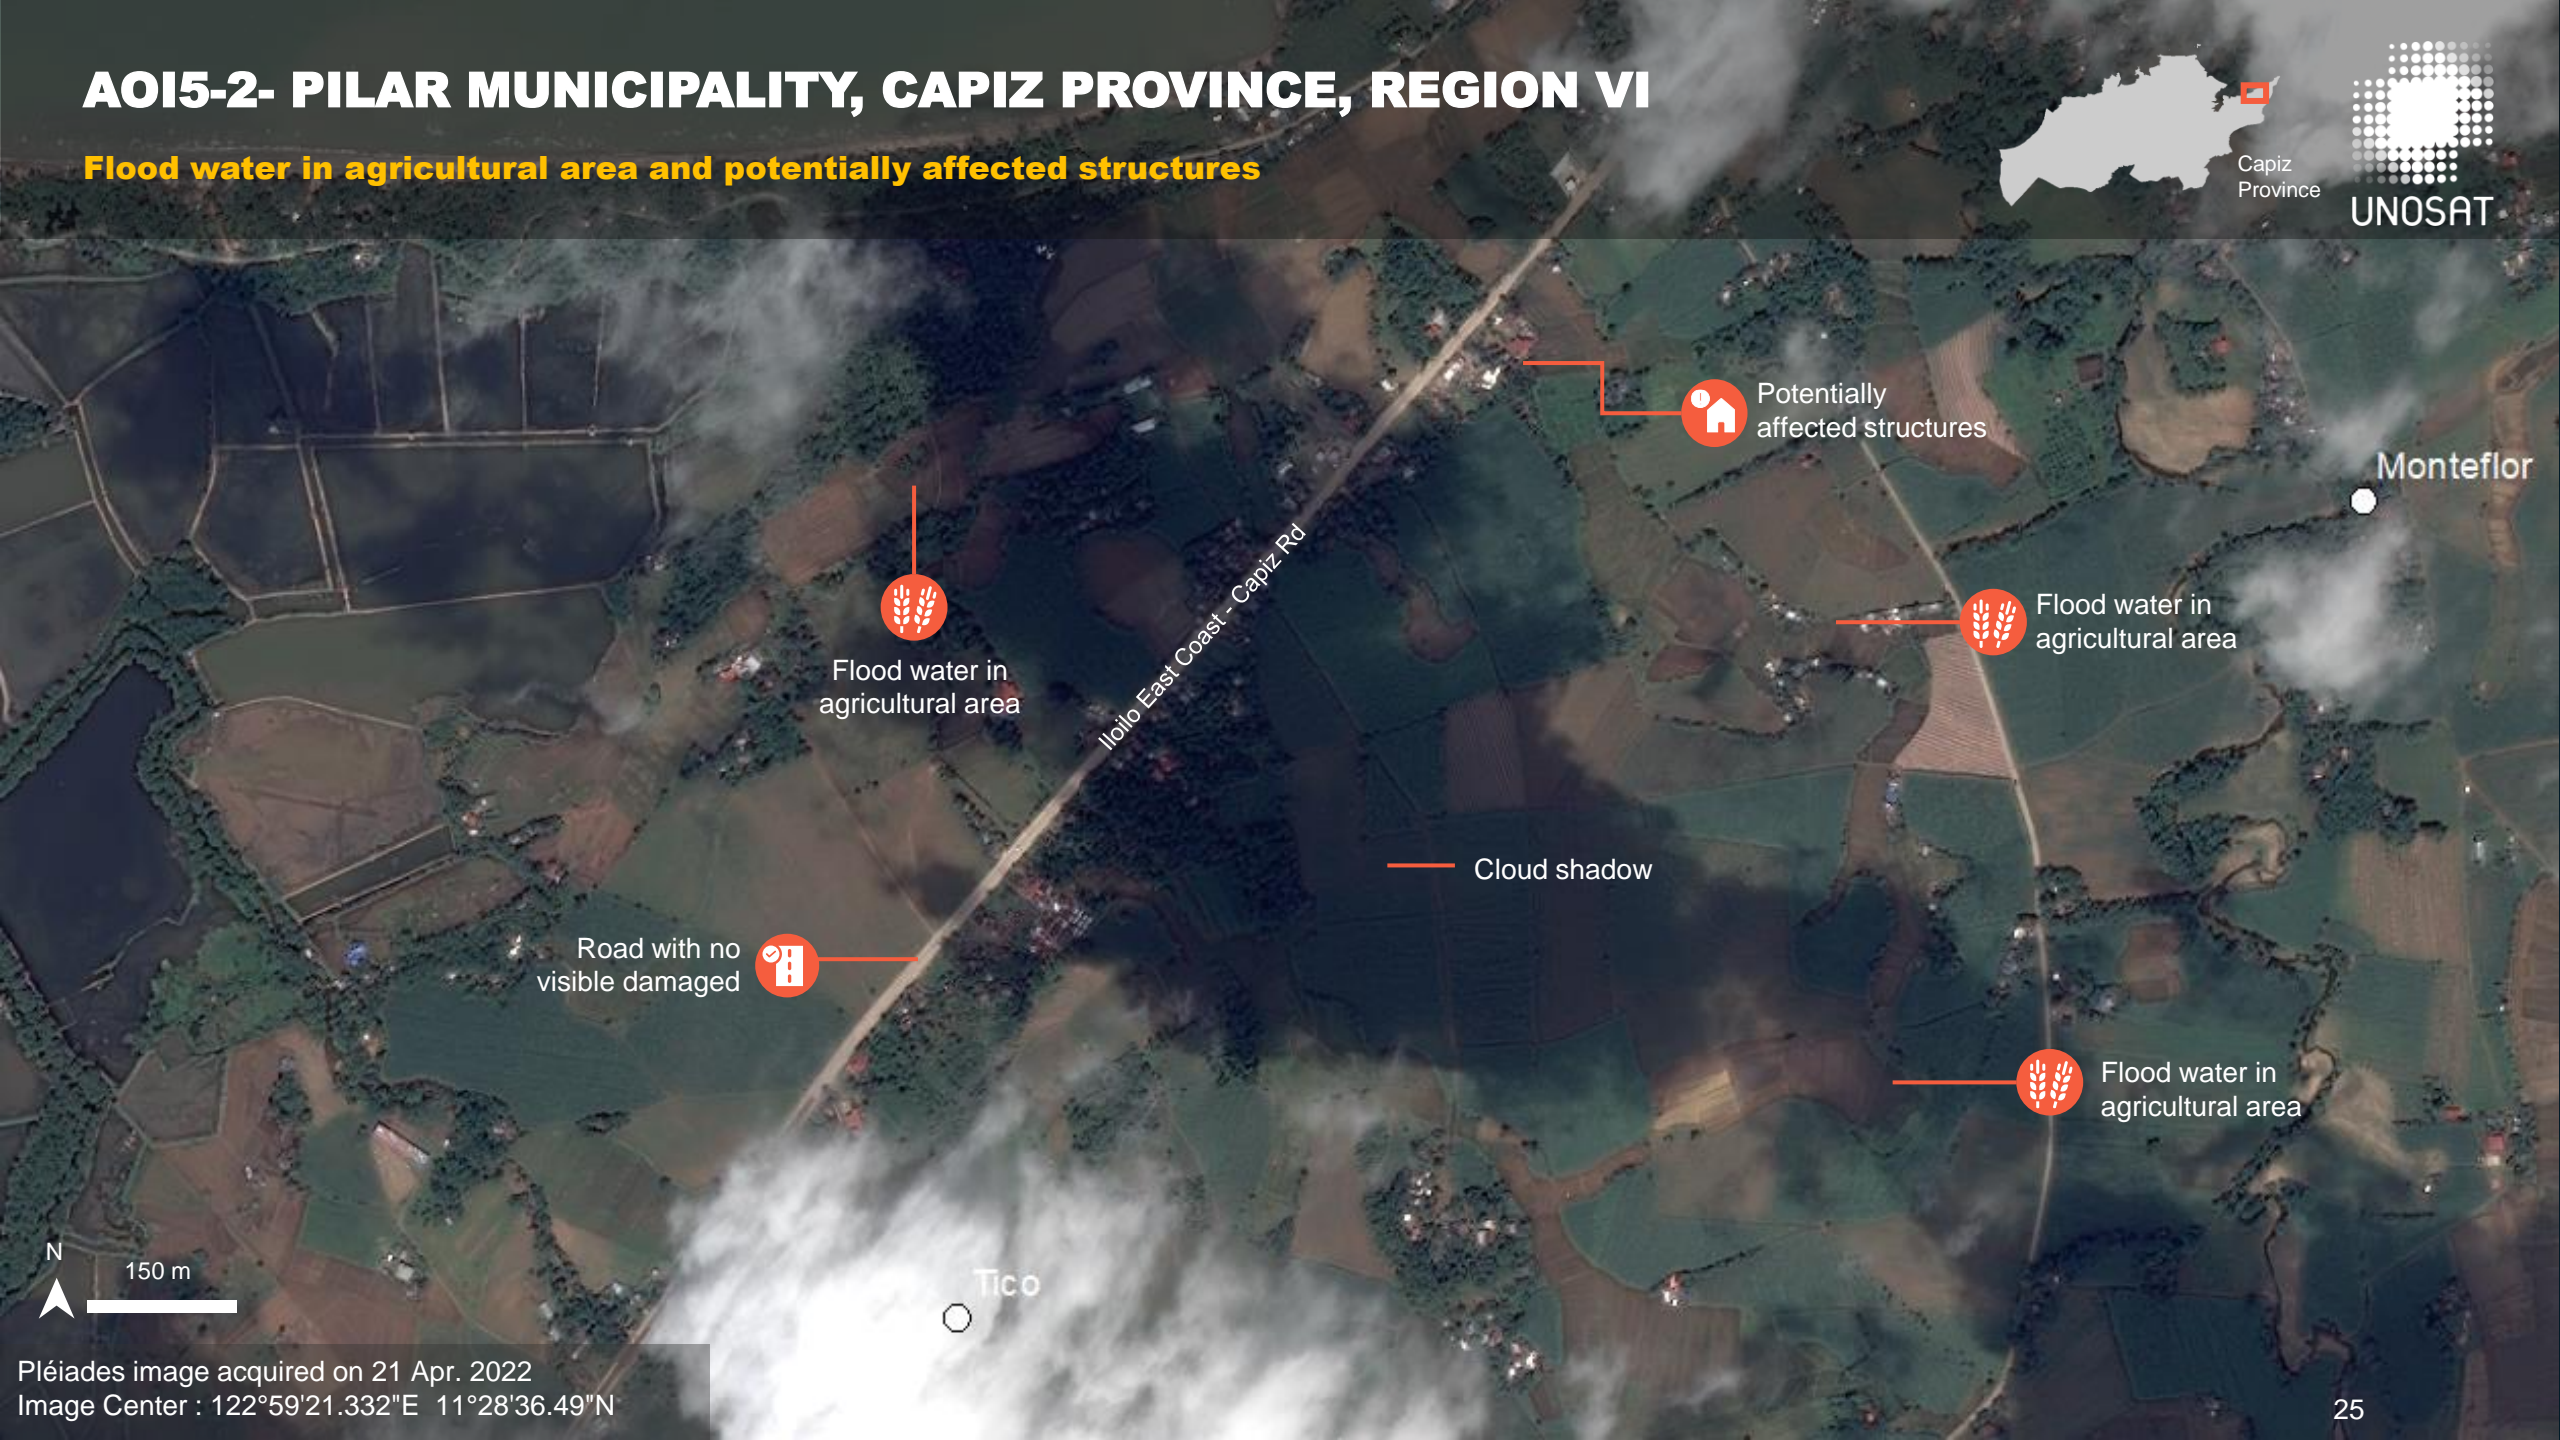
# AOI5-2- PILAR MUNICIPALITY, CAPIZ PROVINCE, REGION VI

Flood water in agricultural area and potentially affected structures

Flood water in agricultural area

Potentially affected structures

Road with no visible damaged

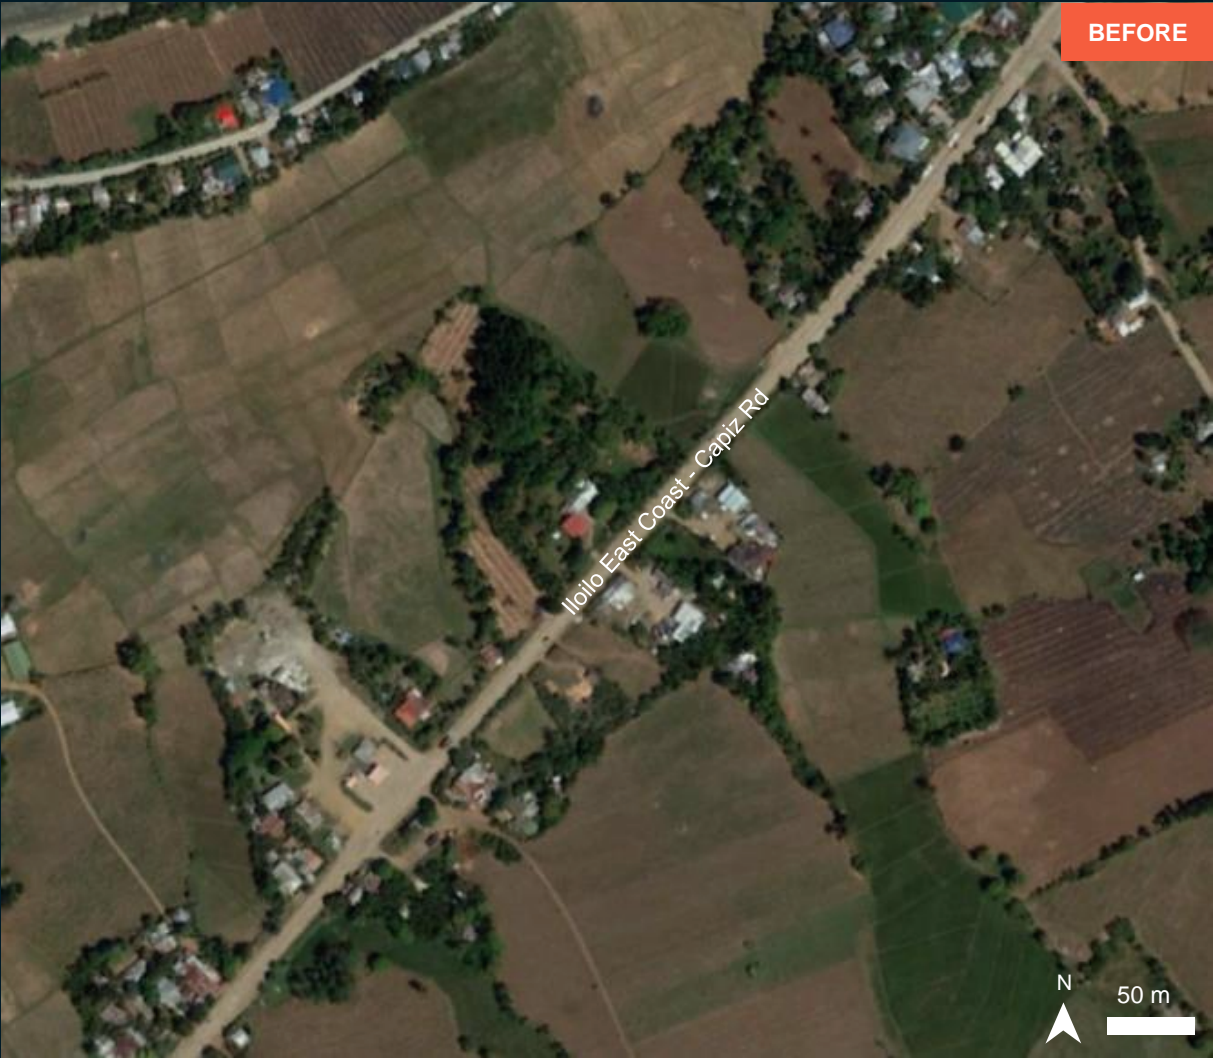
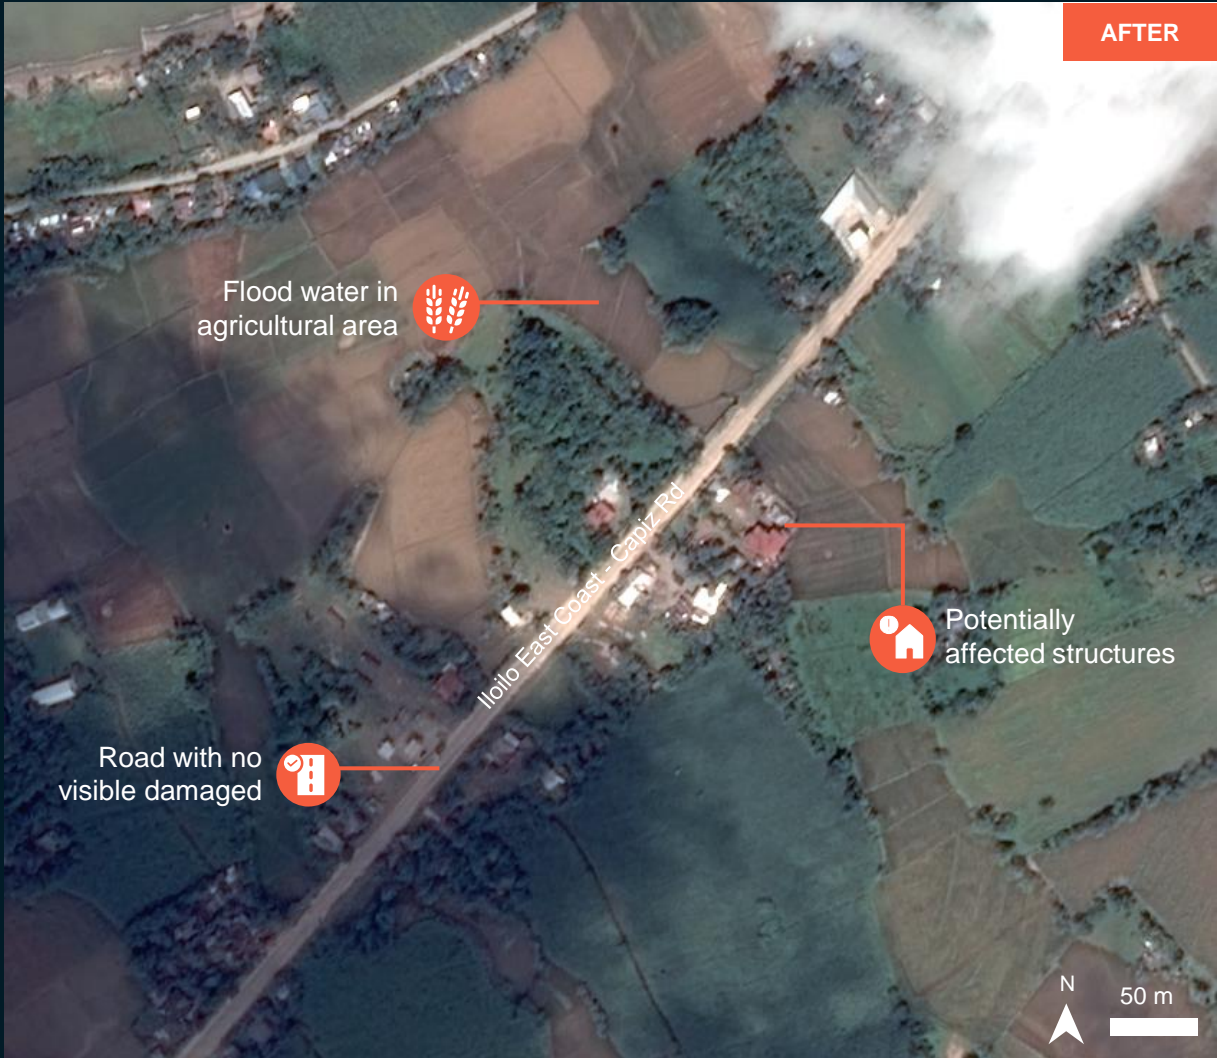
**AOI5-2 PILAR MUNICIPALITY,  
CAPIZ PROVINCE, REGION VI**

**Flood water in agricultural area and potentially affected structures**

- Flood waters in agricultural area and potentially affected structures in Pilar Municipality, Capiz Province, Region VI observed as of 21 Apr 2022;

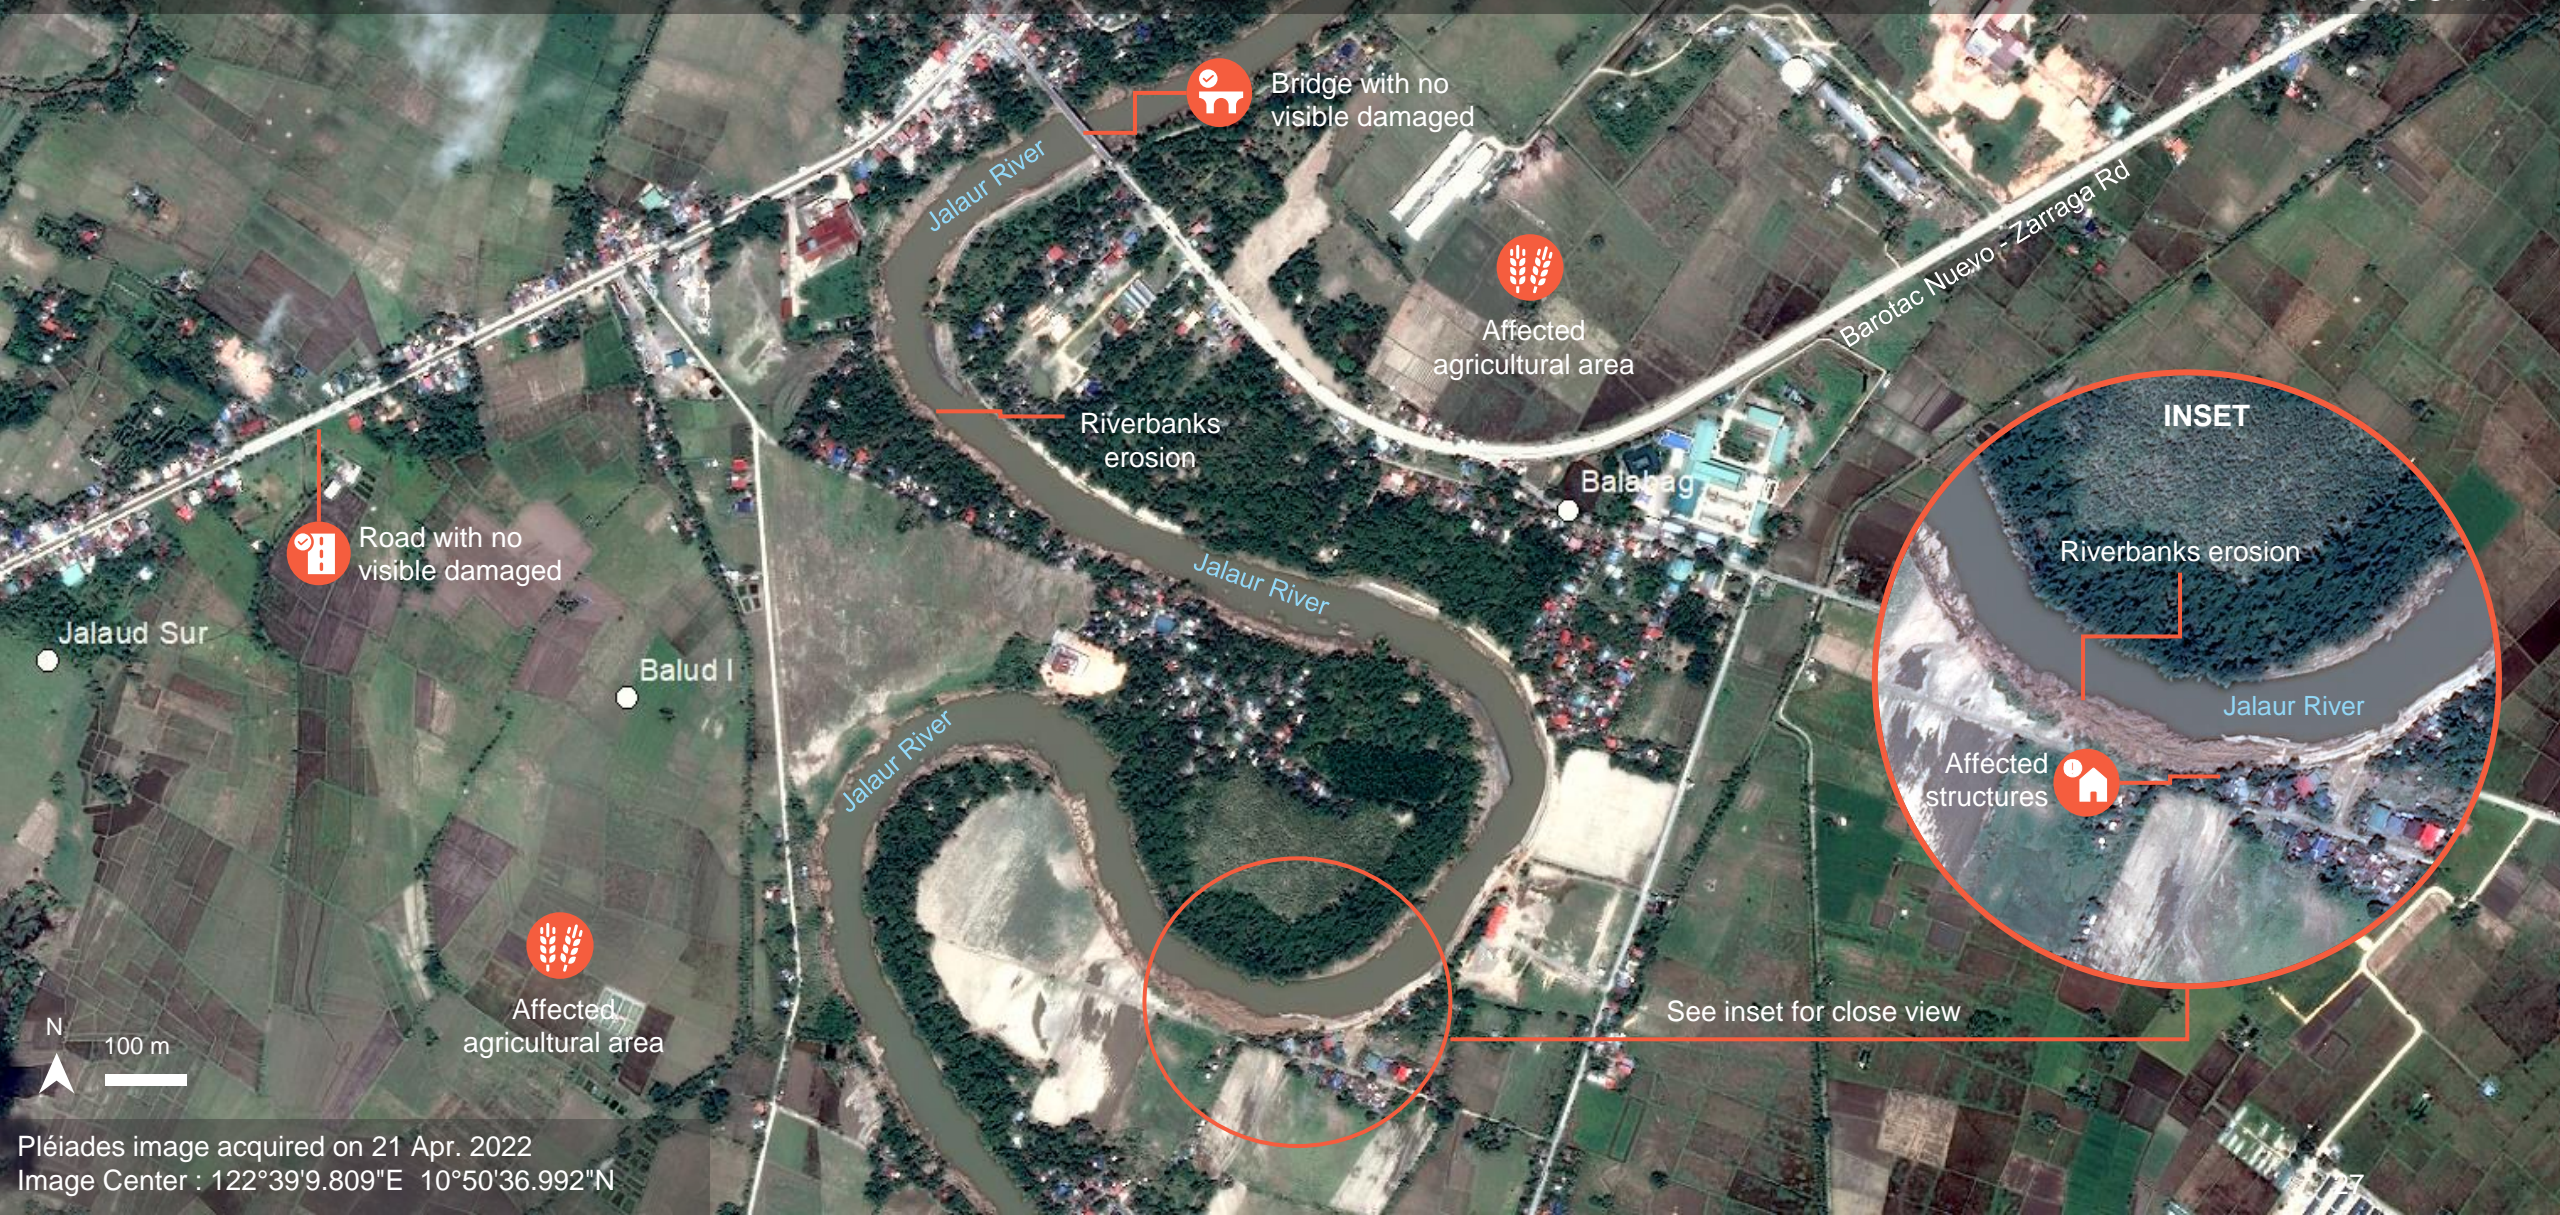
# AOI6-1-ZARRAGA AND DUMANGAS MUNICIPALITIES, ILOILO PROVINCE, REGION VI

Riverbanks erosion and affected structures along Jalaur River

Bridge with no visible damaged

Affected agricultural area

Riverbanks erosion

Road with no visible damaged

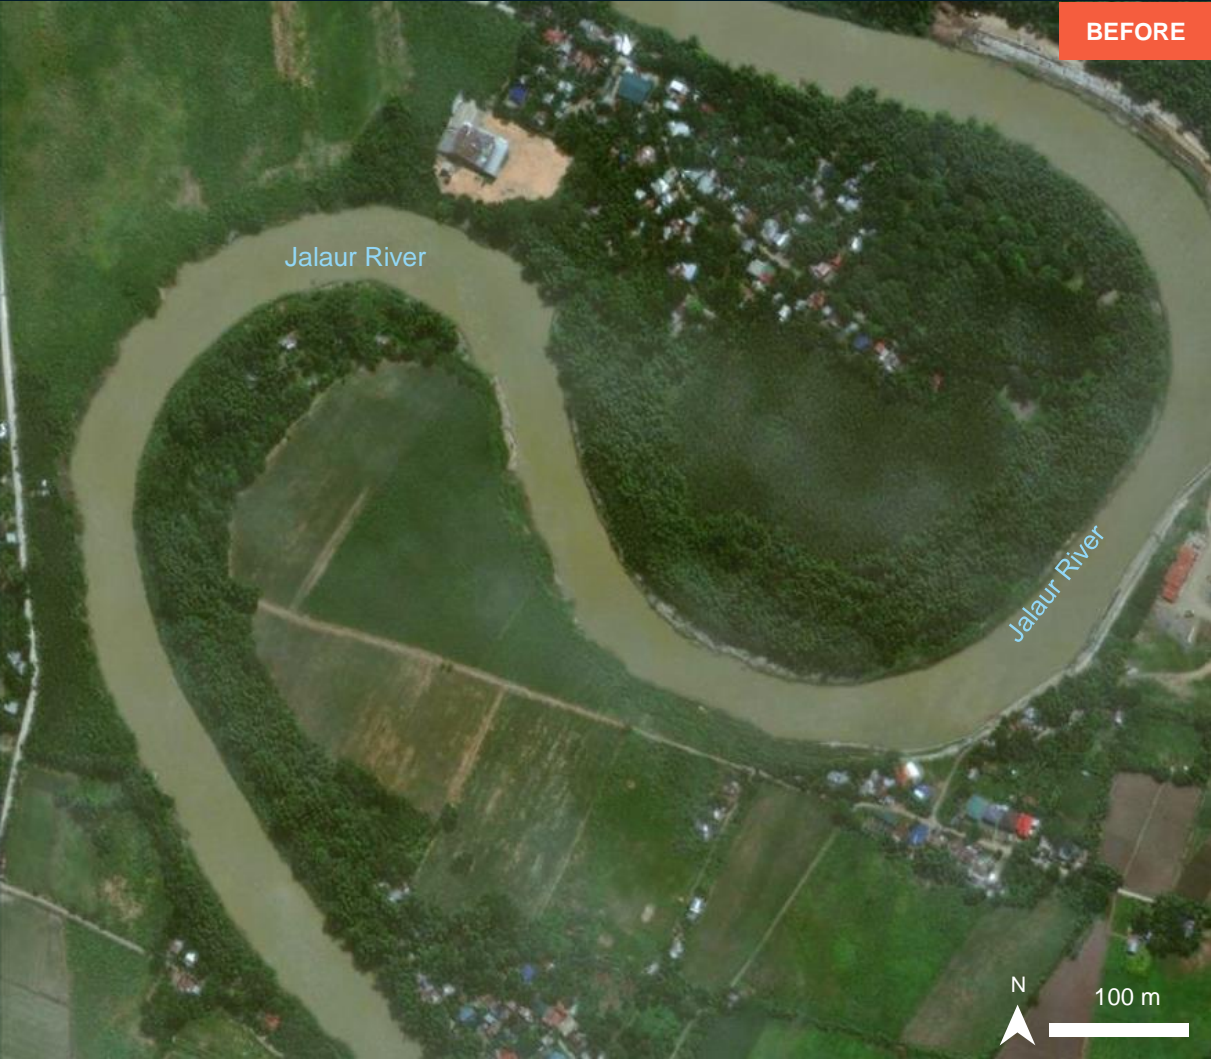
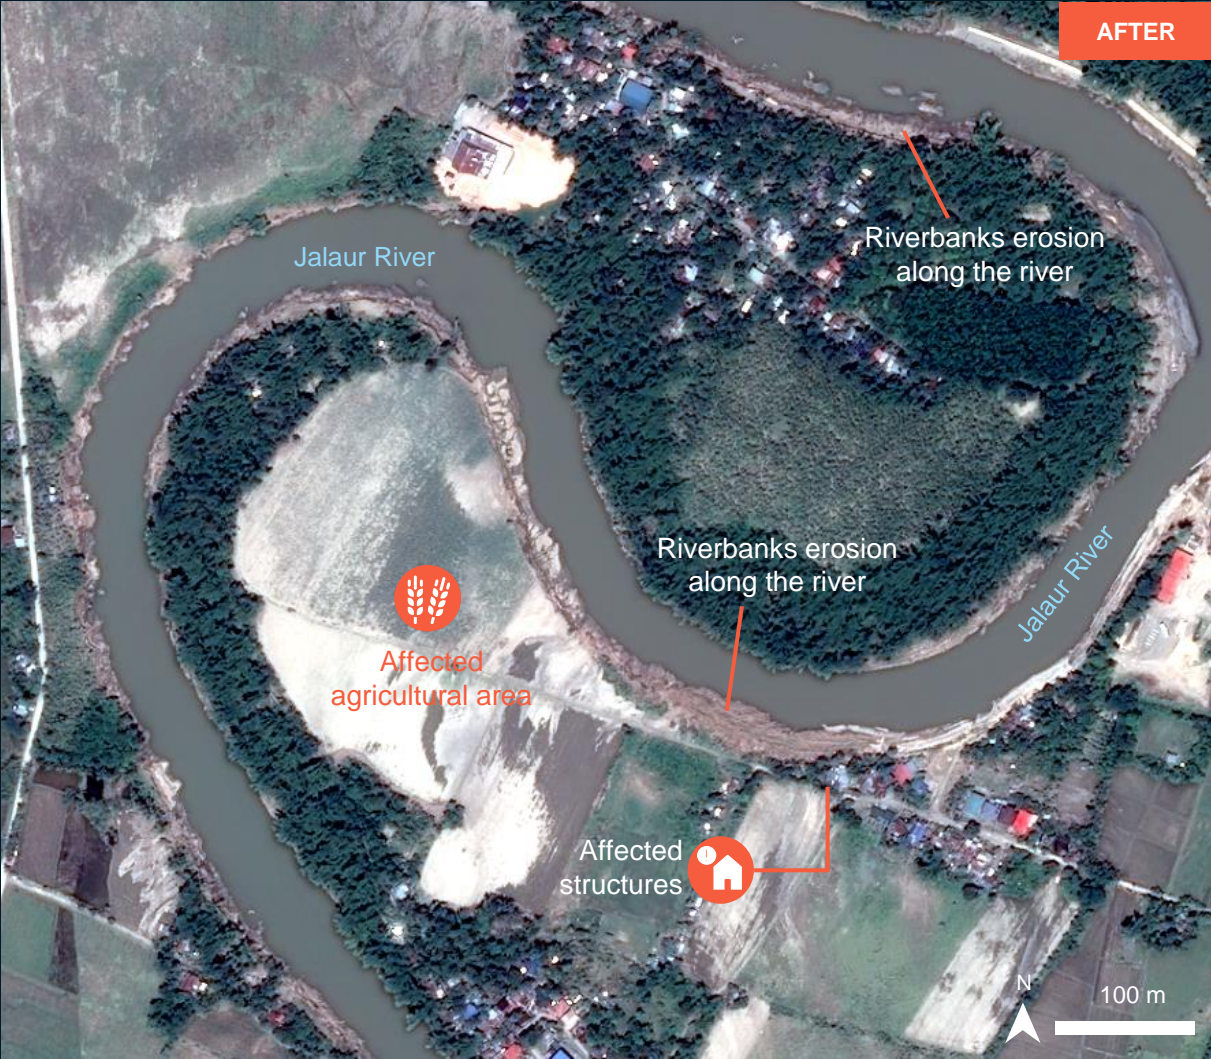
# AOI6-1 ZARRAGA AND DUMANGAS MUNICIPALITIES, ILOILO PROVINCE, REGION VI

## Riverbanks erosion and affected structures along Jalaur River

- Riverbanks erosion and affected structures along Jalaur River, Iloilo Province, Region VI observed as of 21 Apr 2022;
- Affected agricultural area in Iloilo Province, Region VI observed as of 21 Apr 2022;
