# PRELIMINARY SATELLITE-DERIVED FLOOD AND LANDSLIDE ASSESSMENT

Northern eThekweni Municipality, Kwazulu-Natal Province, South Africa

Status: : Increased water level and landslides/mudslides observed

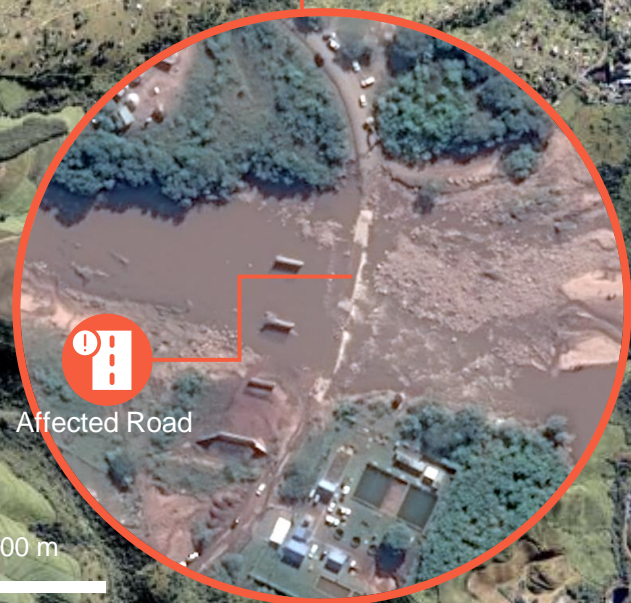
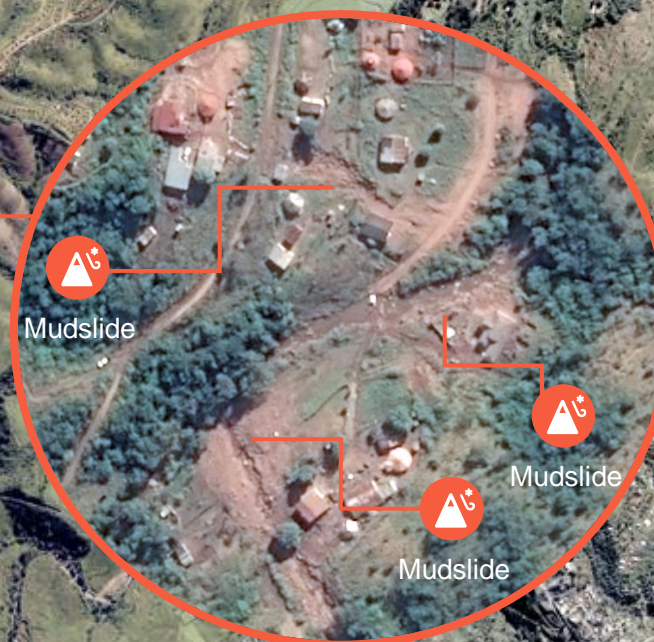
# AOI 1 NORTHERN ETHEKWINI MUNICIPALITY, KWAZULU-NATAL PROVINCE

**Mudslides, increased water level and affected infrastructure along the Mdloti River**

Affected Road

Mudslide

Eroded riverbanks and  
increased water level

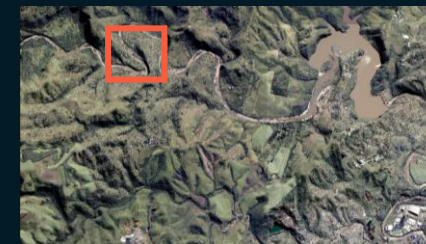
# AOI 1-1 NORTHERN ETHEKWINI MUNICIPALITY, KWAZULU-NATAL PROVINCE

## Increased water level & Inundated Road

Esri Basemap / 15 Jan. 2020

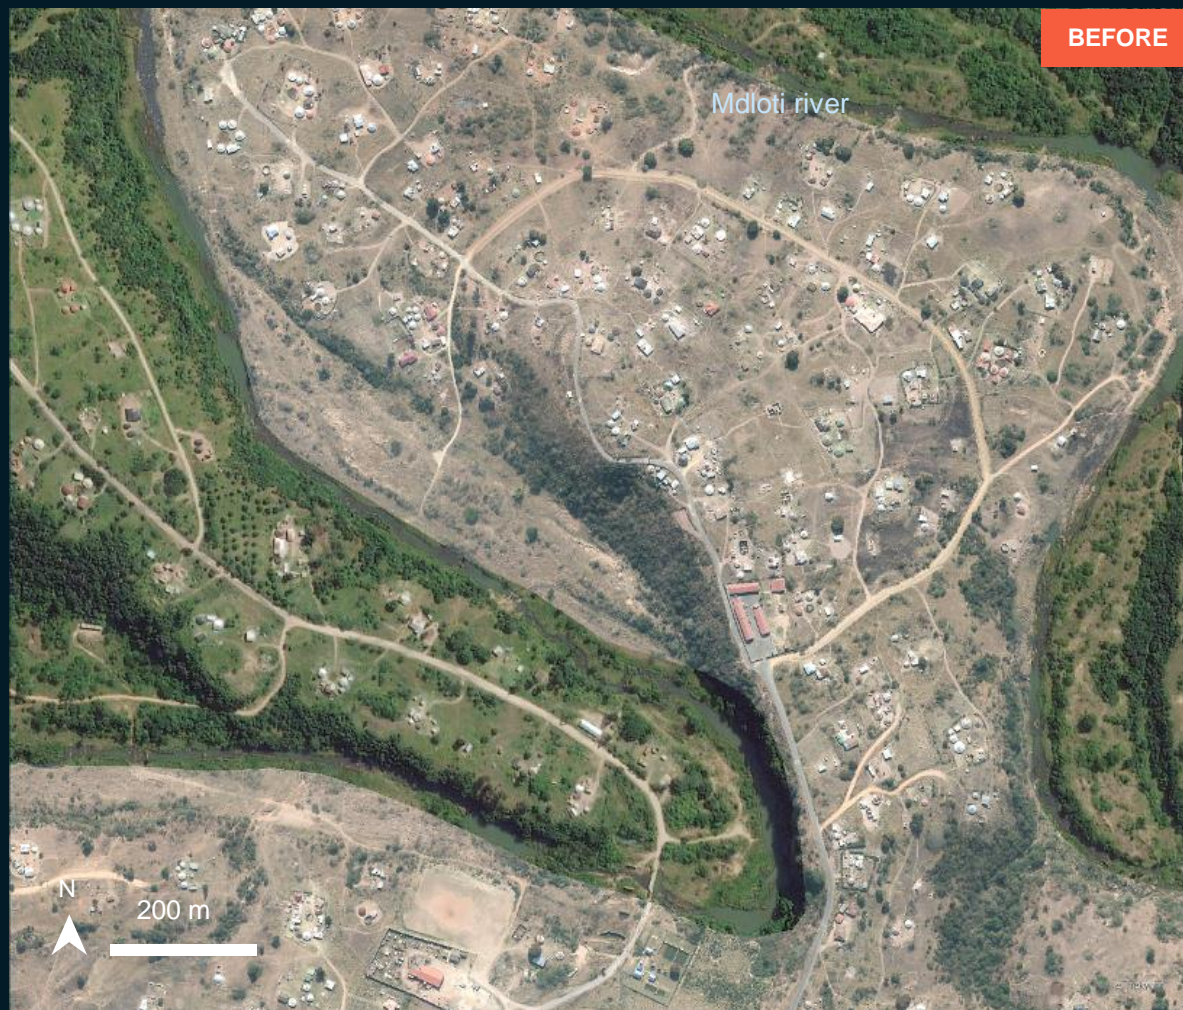
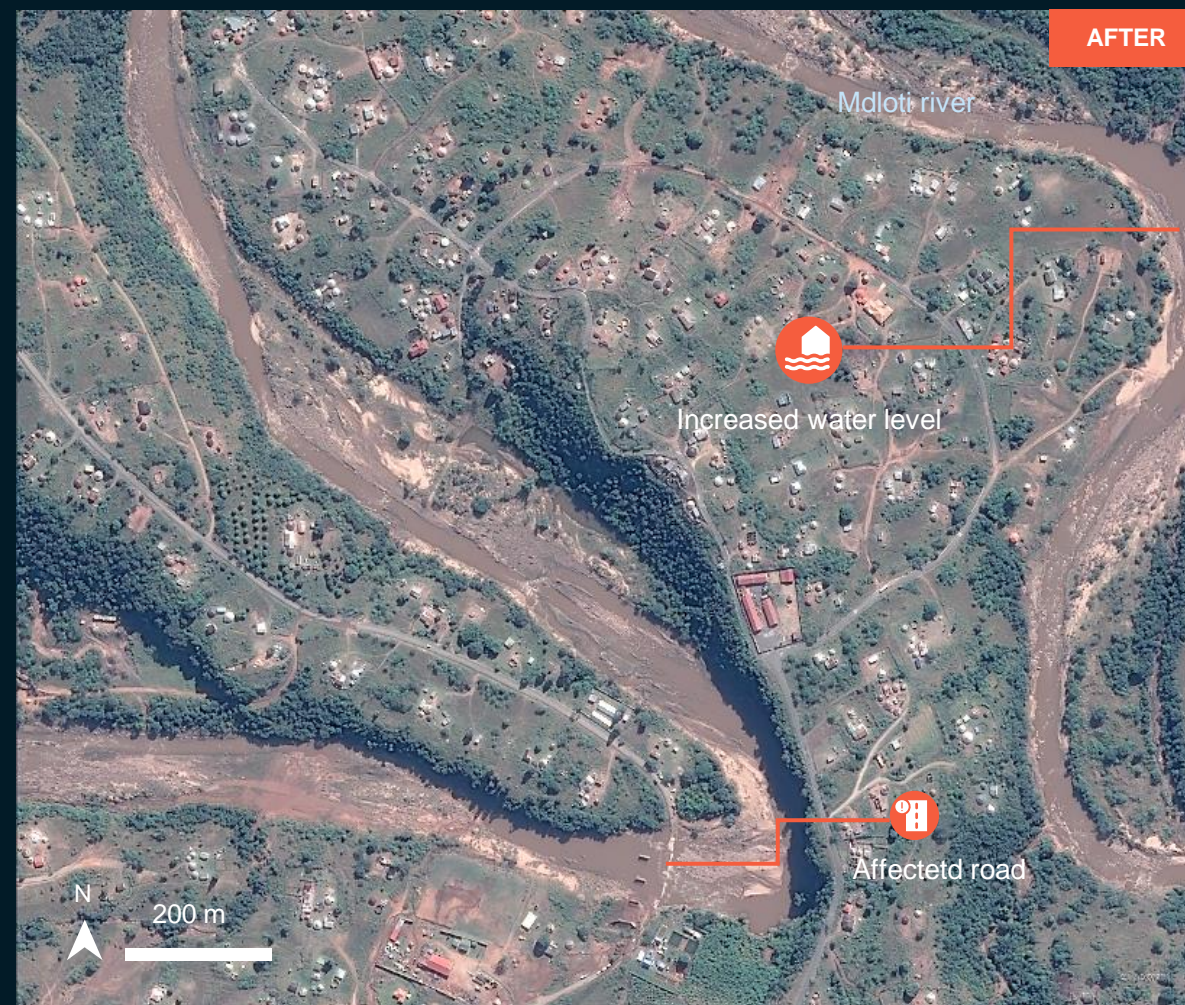
Pleiades / 25 May 2022

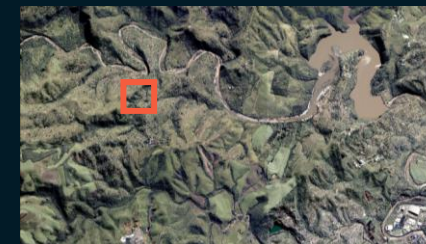
# AOI 1-2 NORTHERN ETHEKWINI MUNICIPALITY, KWAZULU-NATAL PROVINCE

Mudslides and potential affected buildings

Esri Basemap / 15 Jan. 2020

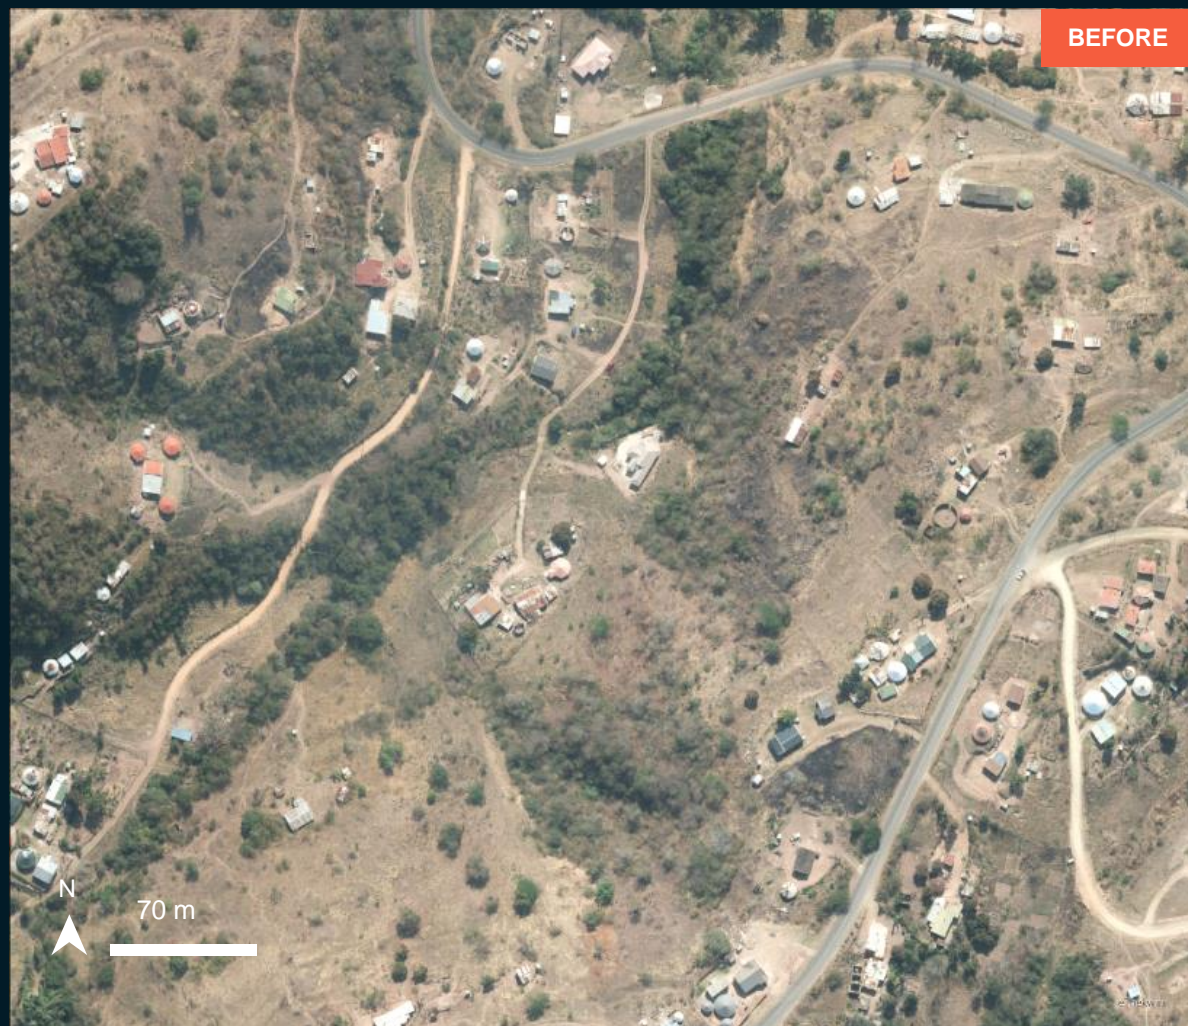
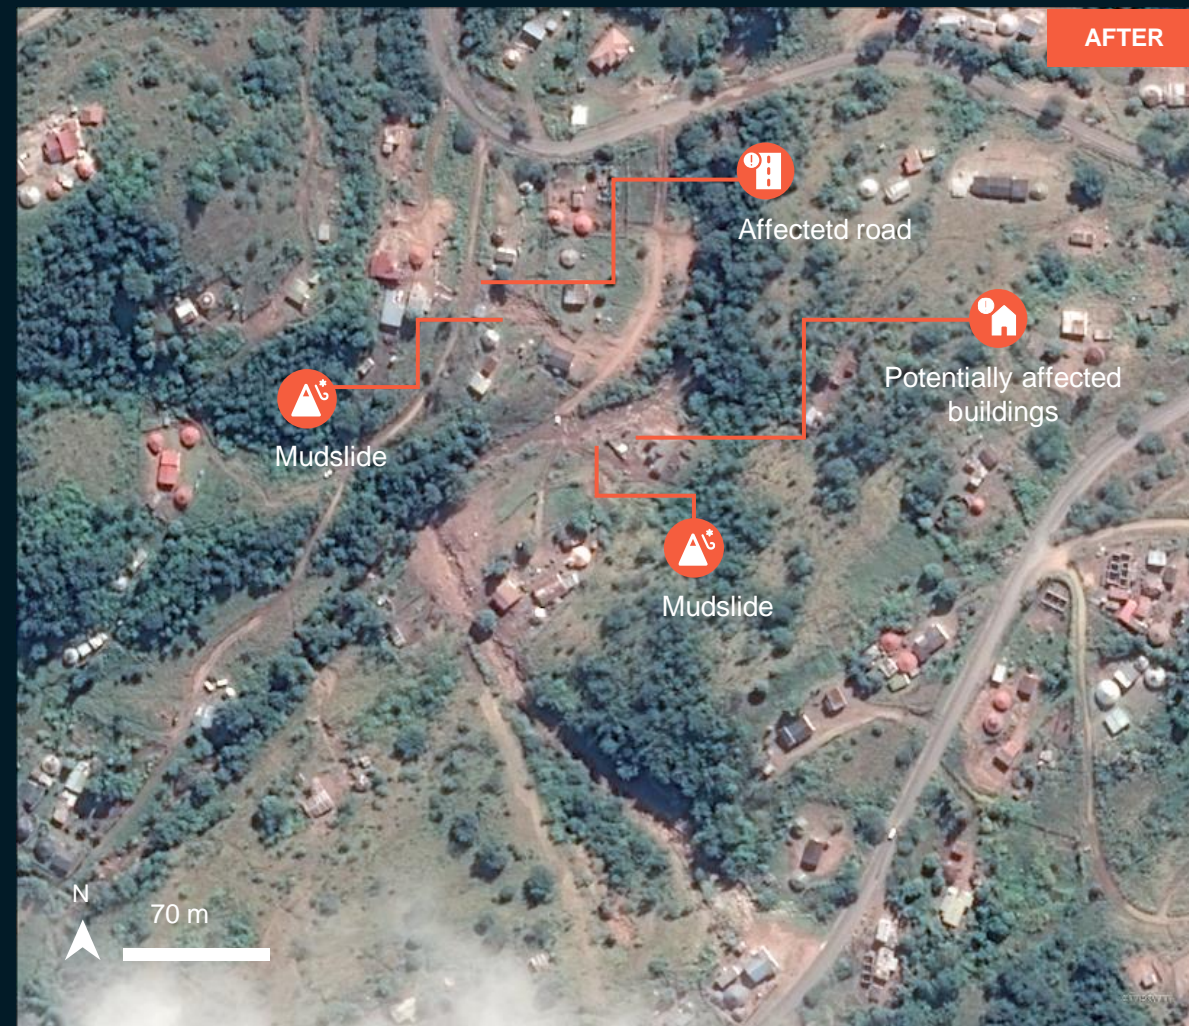
Pleiades / 25 May 2022

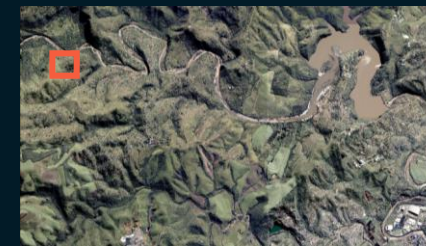
# AOI 1-3 NORTHERN ETHEKWINI MUNICIPALITY, KWAZULU-NATAL PROVINCE

## Landslide and destroyed buildings

Esri Basemap / 15 Jan. 2020

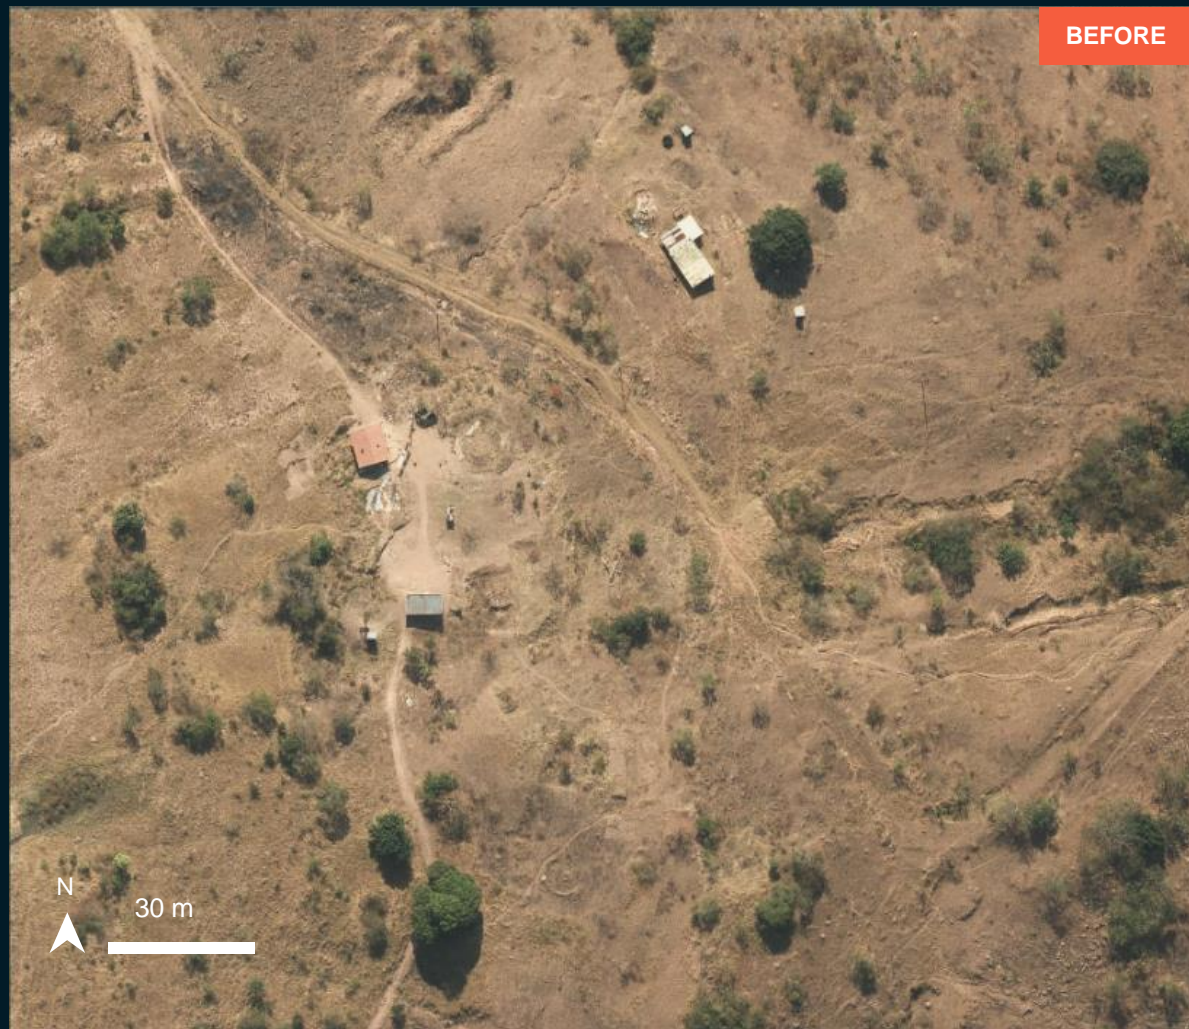
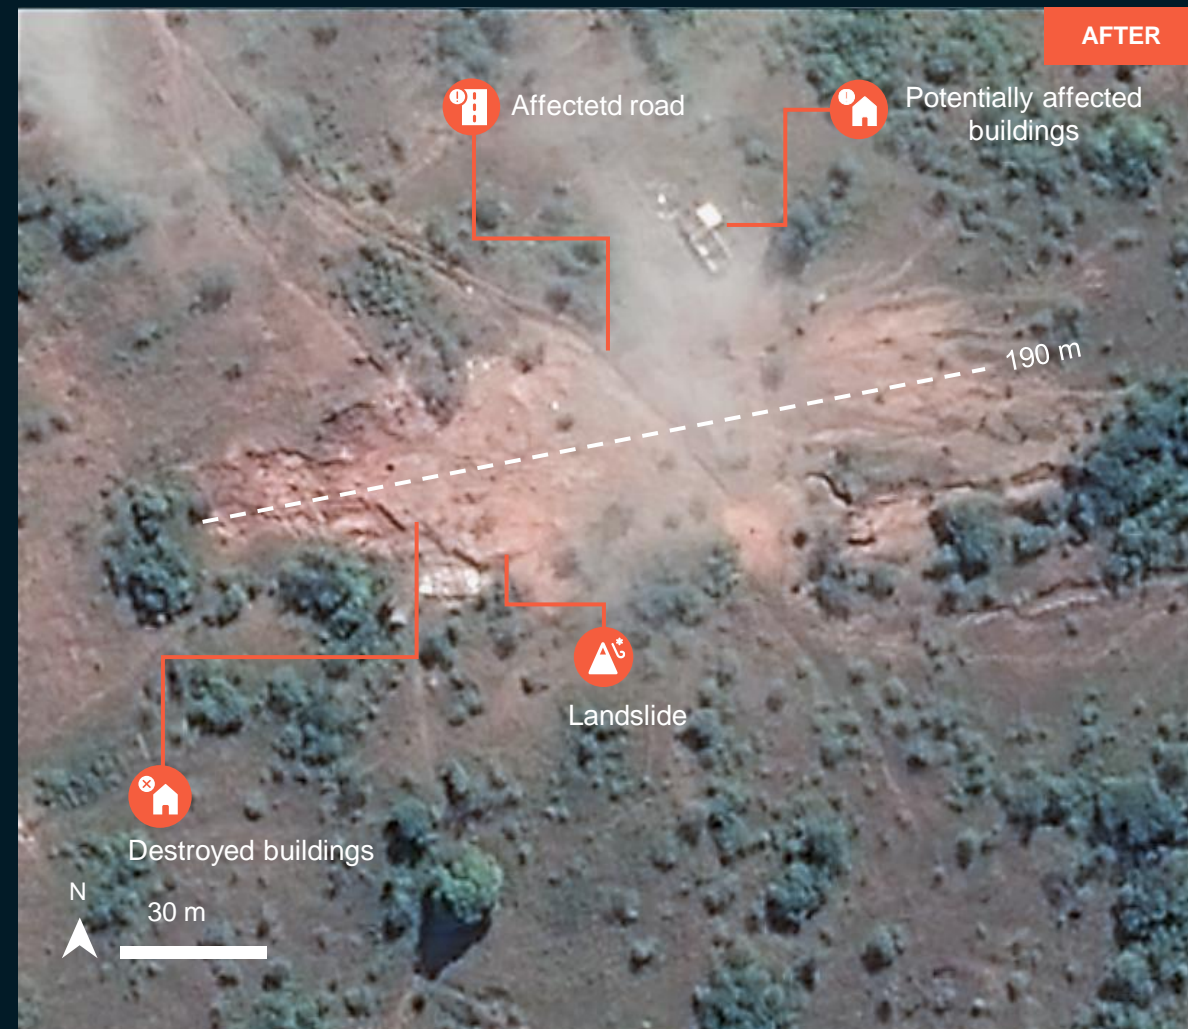
Pleiades / 25 May 2022

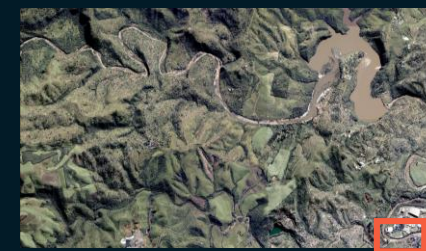
# AOI 1-4 NORTHERN ETHEKWINI MUNICIPALITY, KWAZULU-NATAL PROVINCE

Flooded areas and potentially affected buildings

Esri Basemap / 15 Jan. 2020

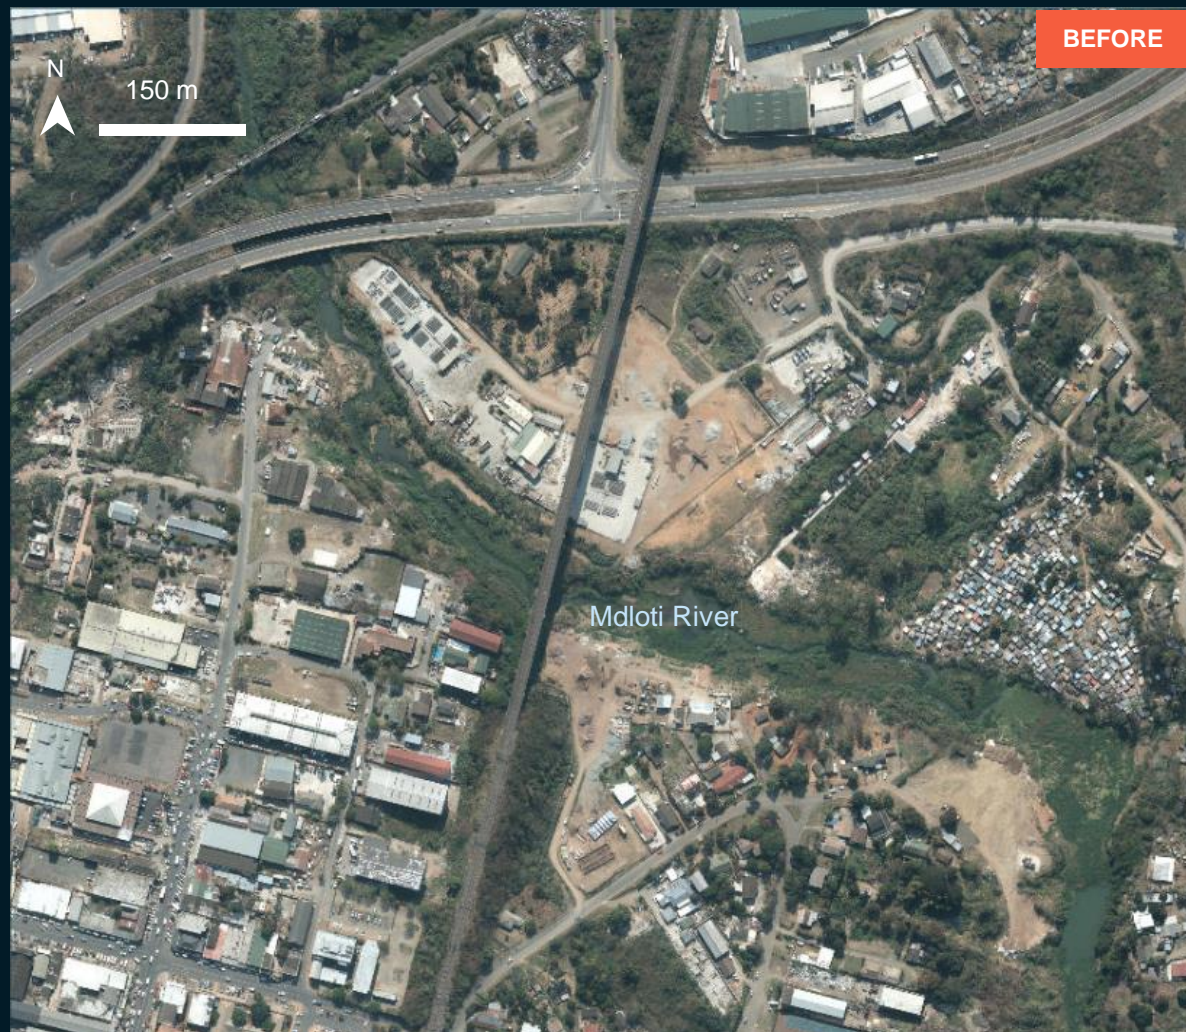
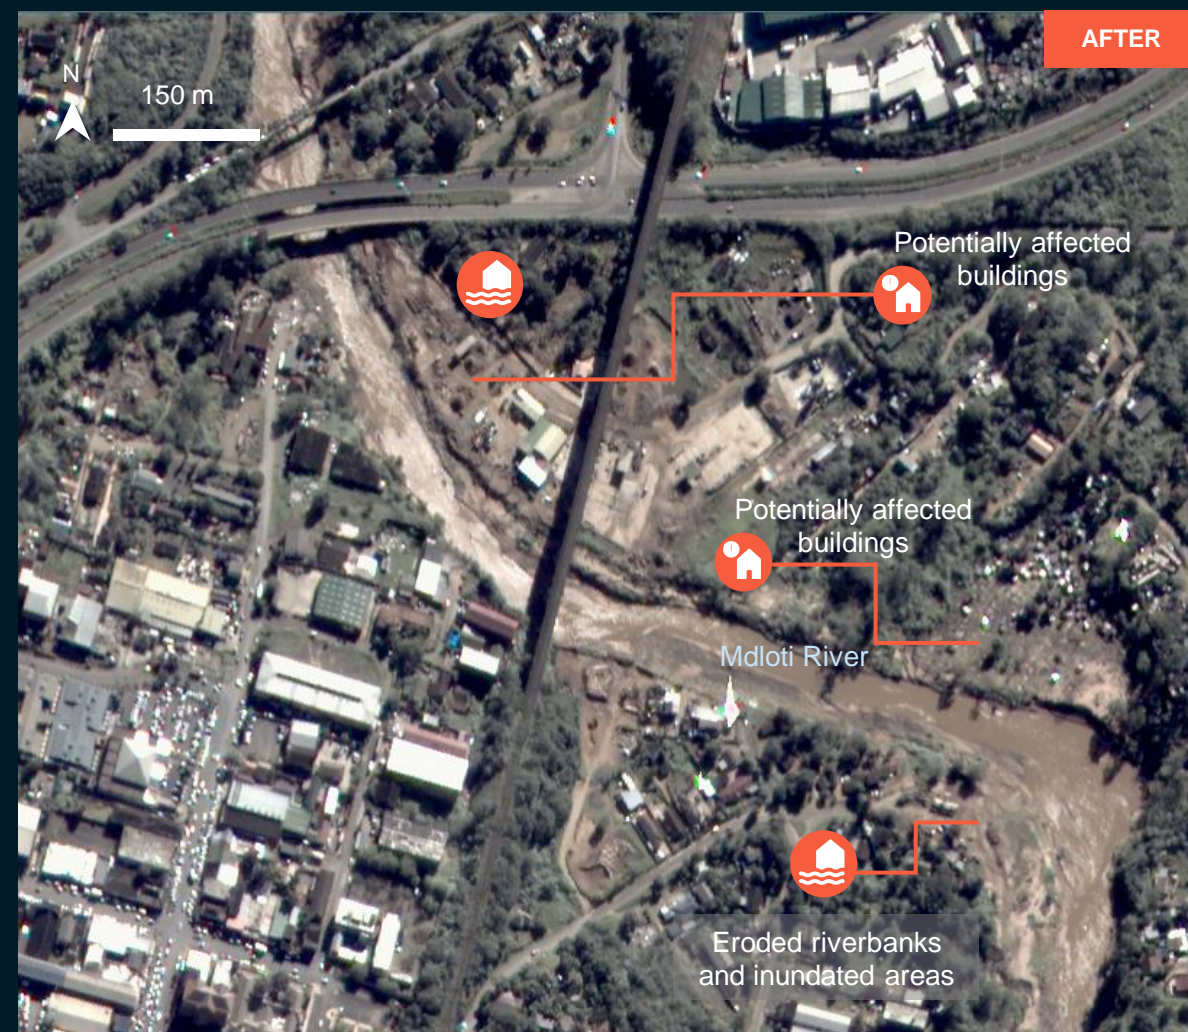
Worldview-2 / 28 May 2022

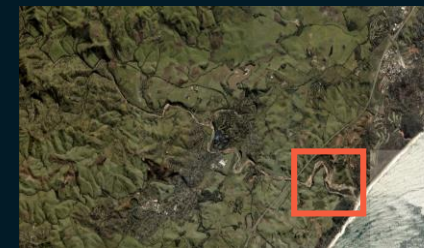
# AOI 2-1 ETHEKWINI METROPOLITAN MUNICIPALITY, KWAZULU-NATAL PROVINCE

Increased water level and inundated roads

Esri Basemap / 15 Jan. 2020

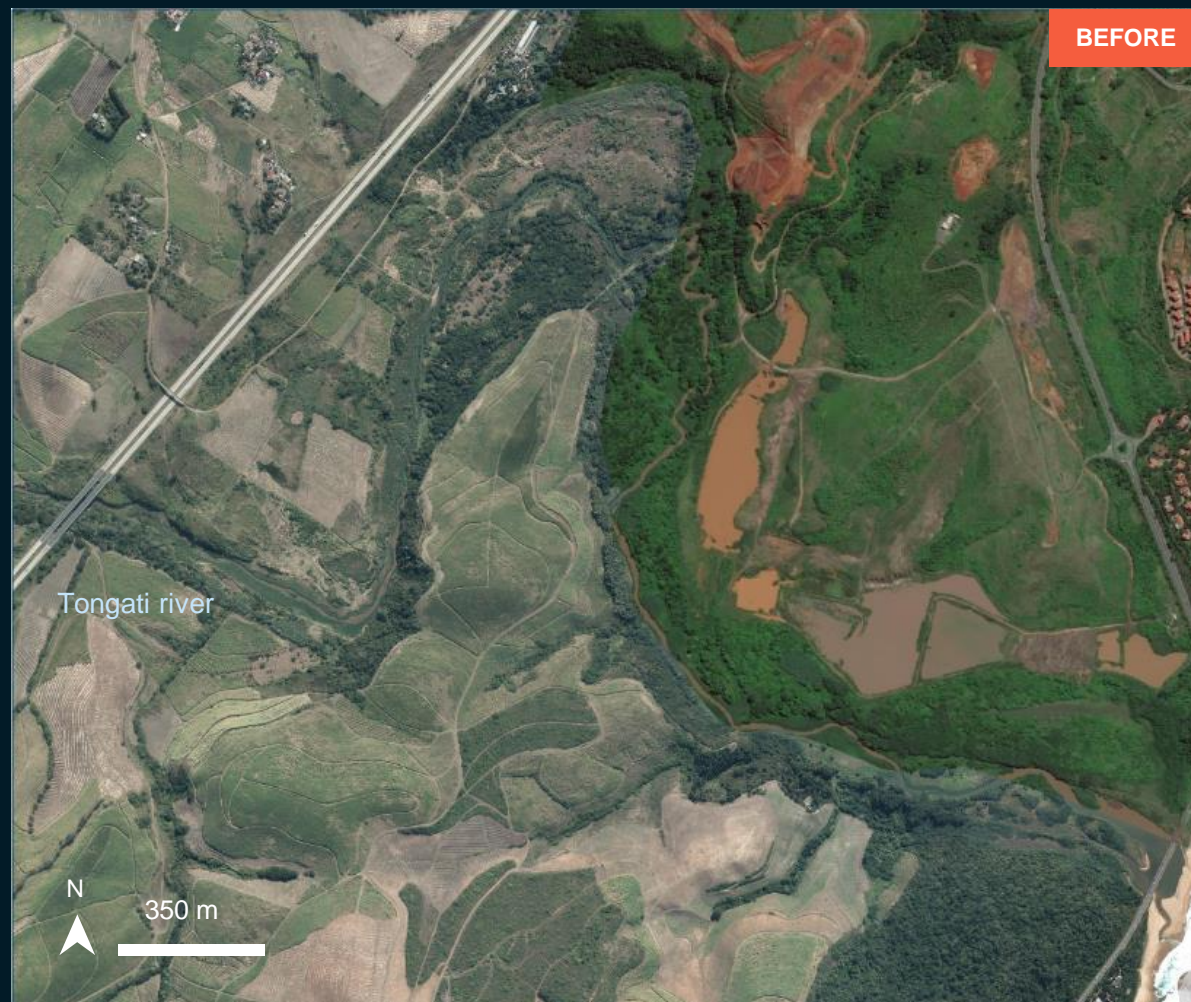
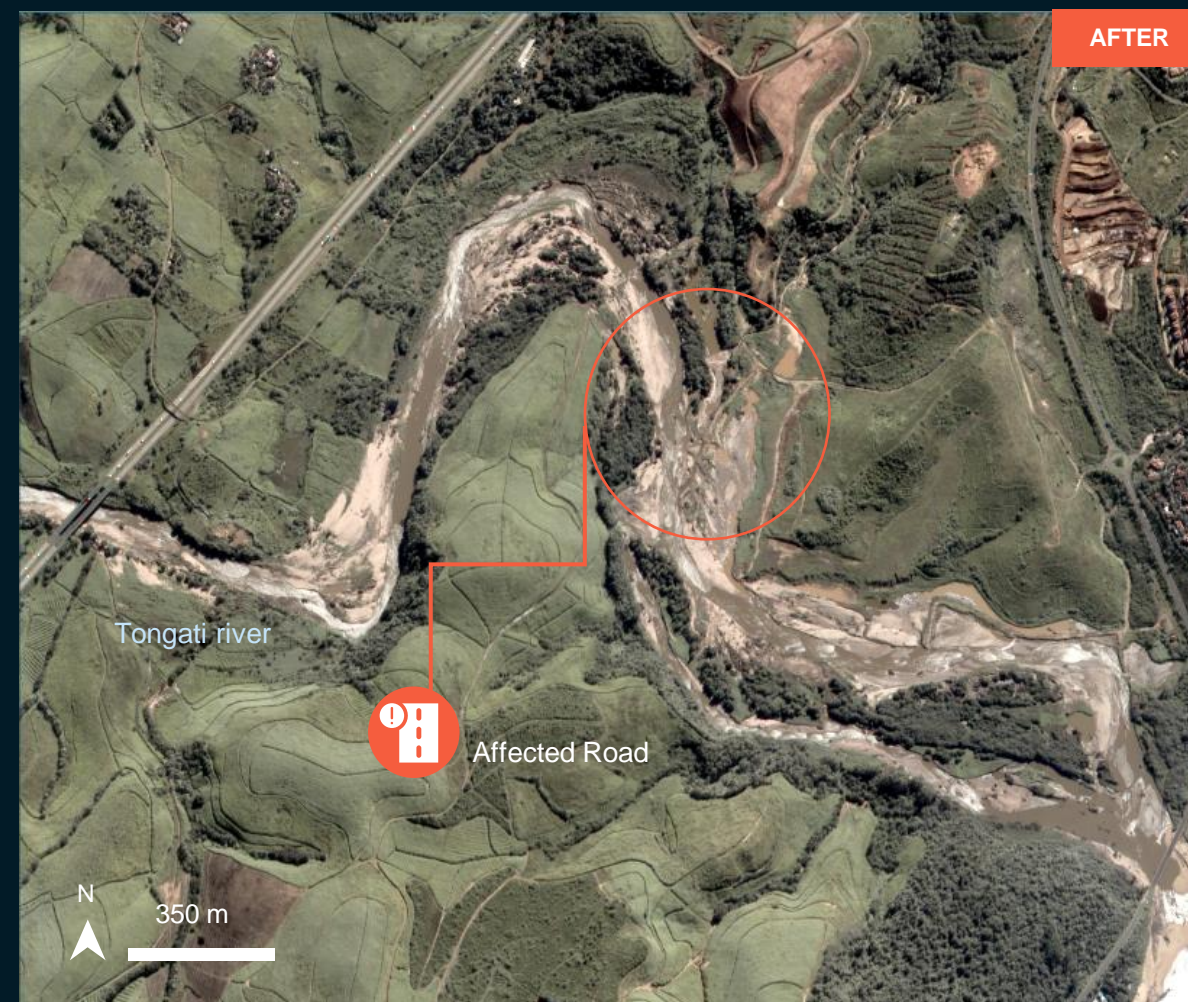
WorldView-2 / 28 May 2022

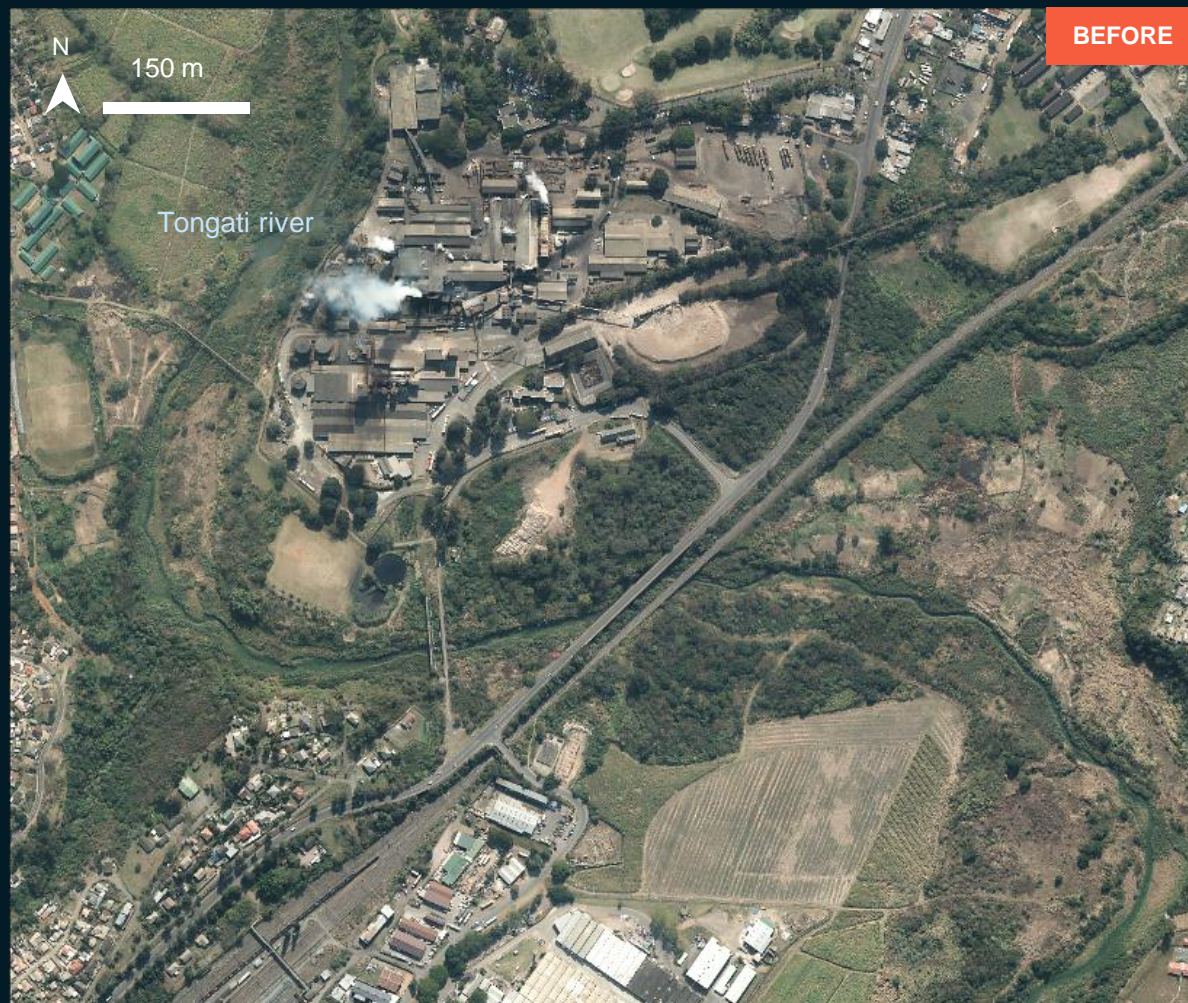
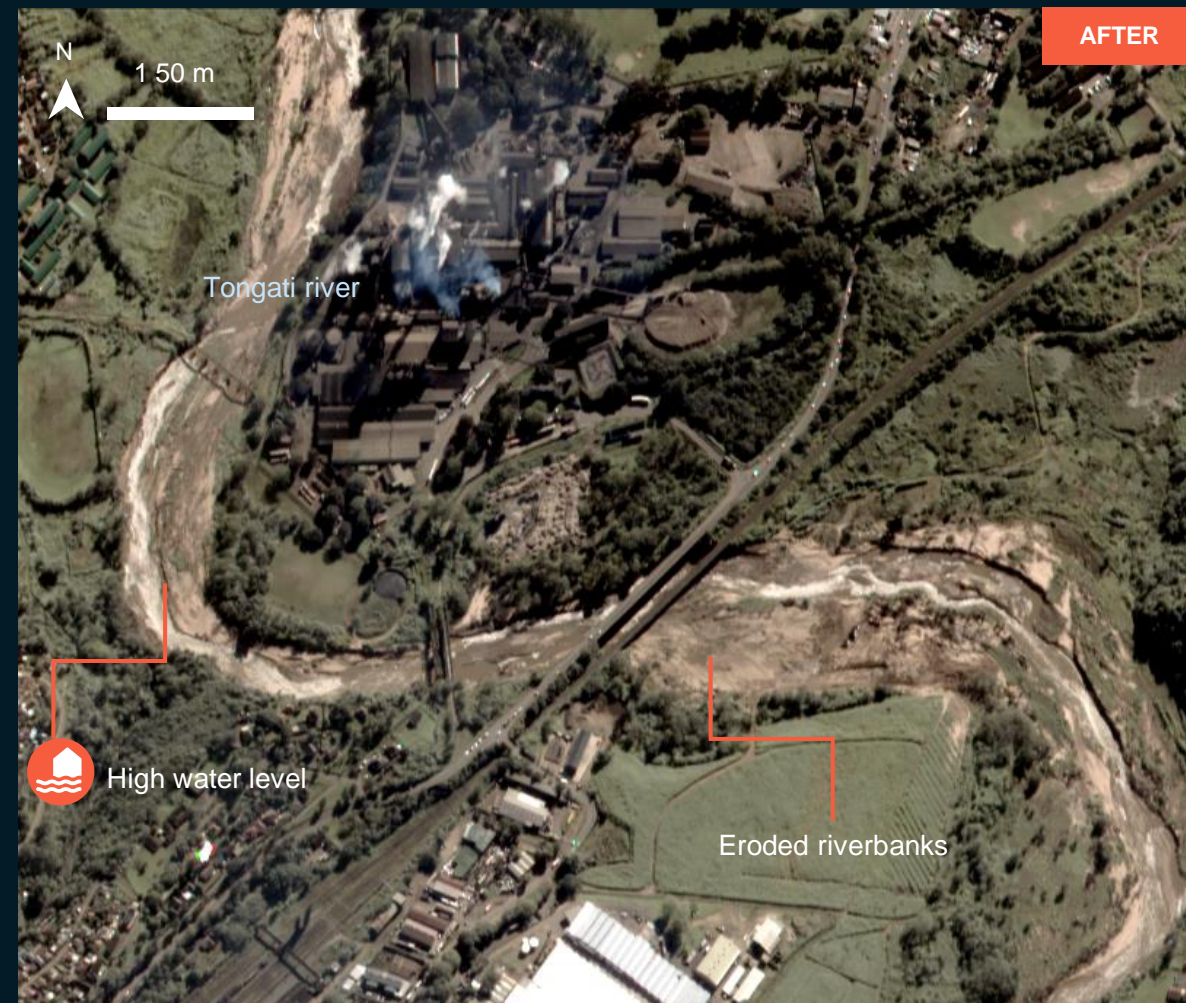
# AOI 2-1 ETHEKWINI METROPOLITAN MUNICIPALITY, KWAZULU-NATAL PROVINCE

Increased water level and eroded riverbanks along the Tongati River

WorldView-2 / 28 May 2022

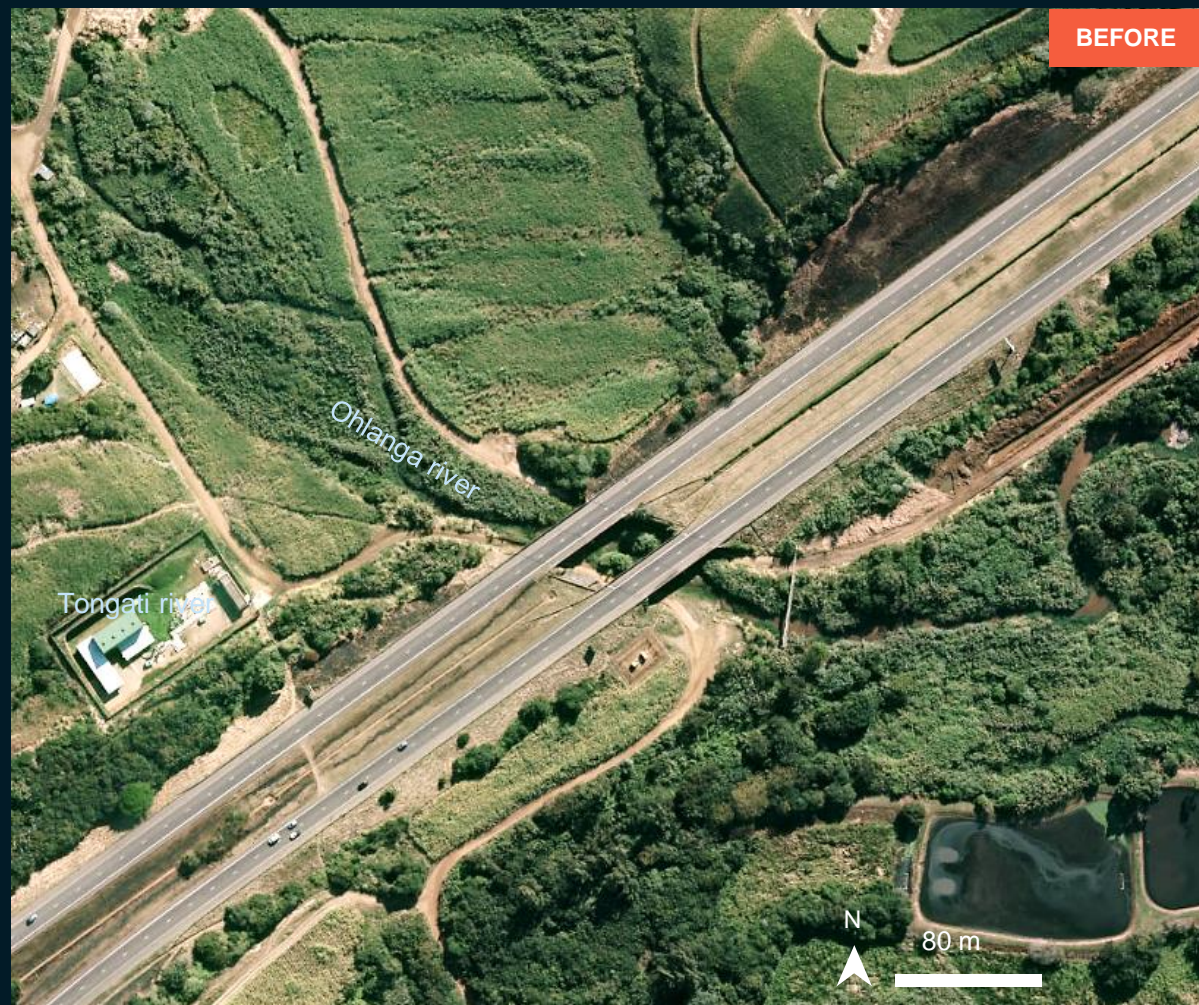
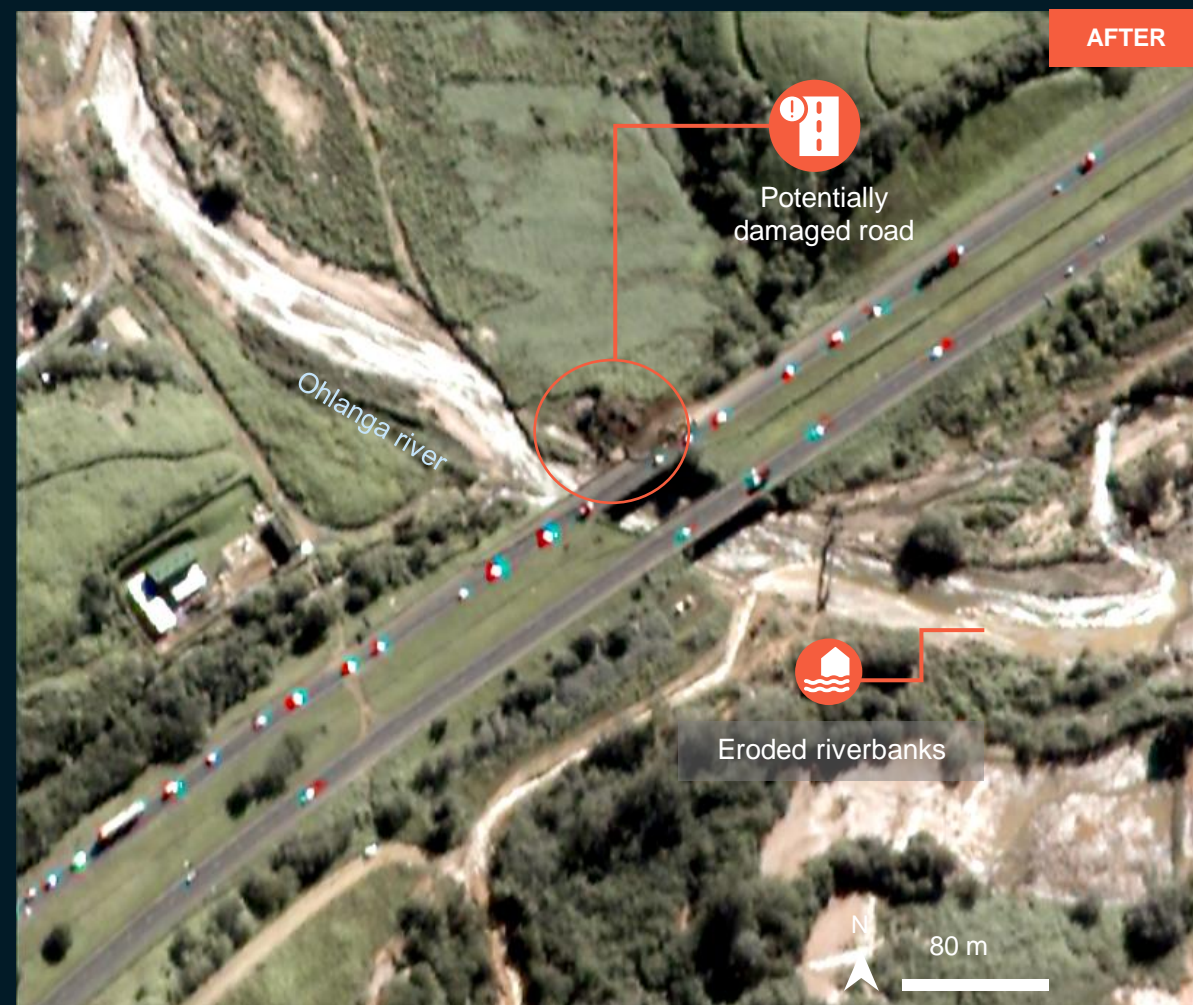
# AOI 3-1 ETHEKWINI METROPOLITAN MUNICIPALITY, KWAZULU-NATAL PROVINCE

Increased water level and potentially damaged road

WorldView-2 / 28 May 2022
