8 Jun. 2022

OIL SPILL IN GAMBIA PRELIMINARY SATELLITE-DERIVED DAMAGE ASSESSMENT

Along the River Gambia

Status: Widespread potential oil film and oil slick is observed over the River Gambia

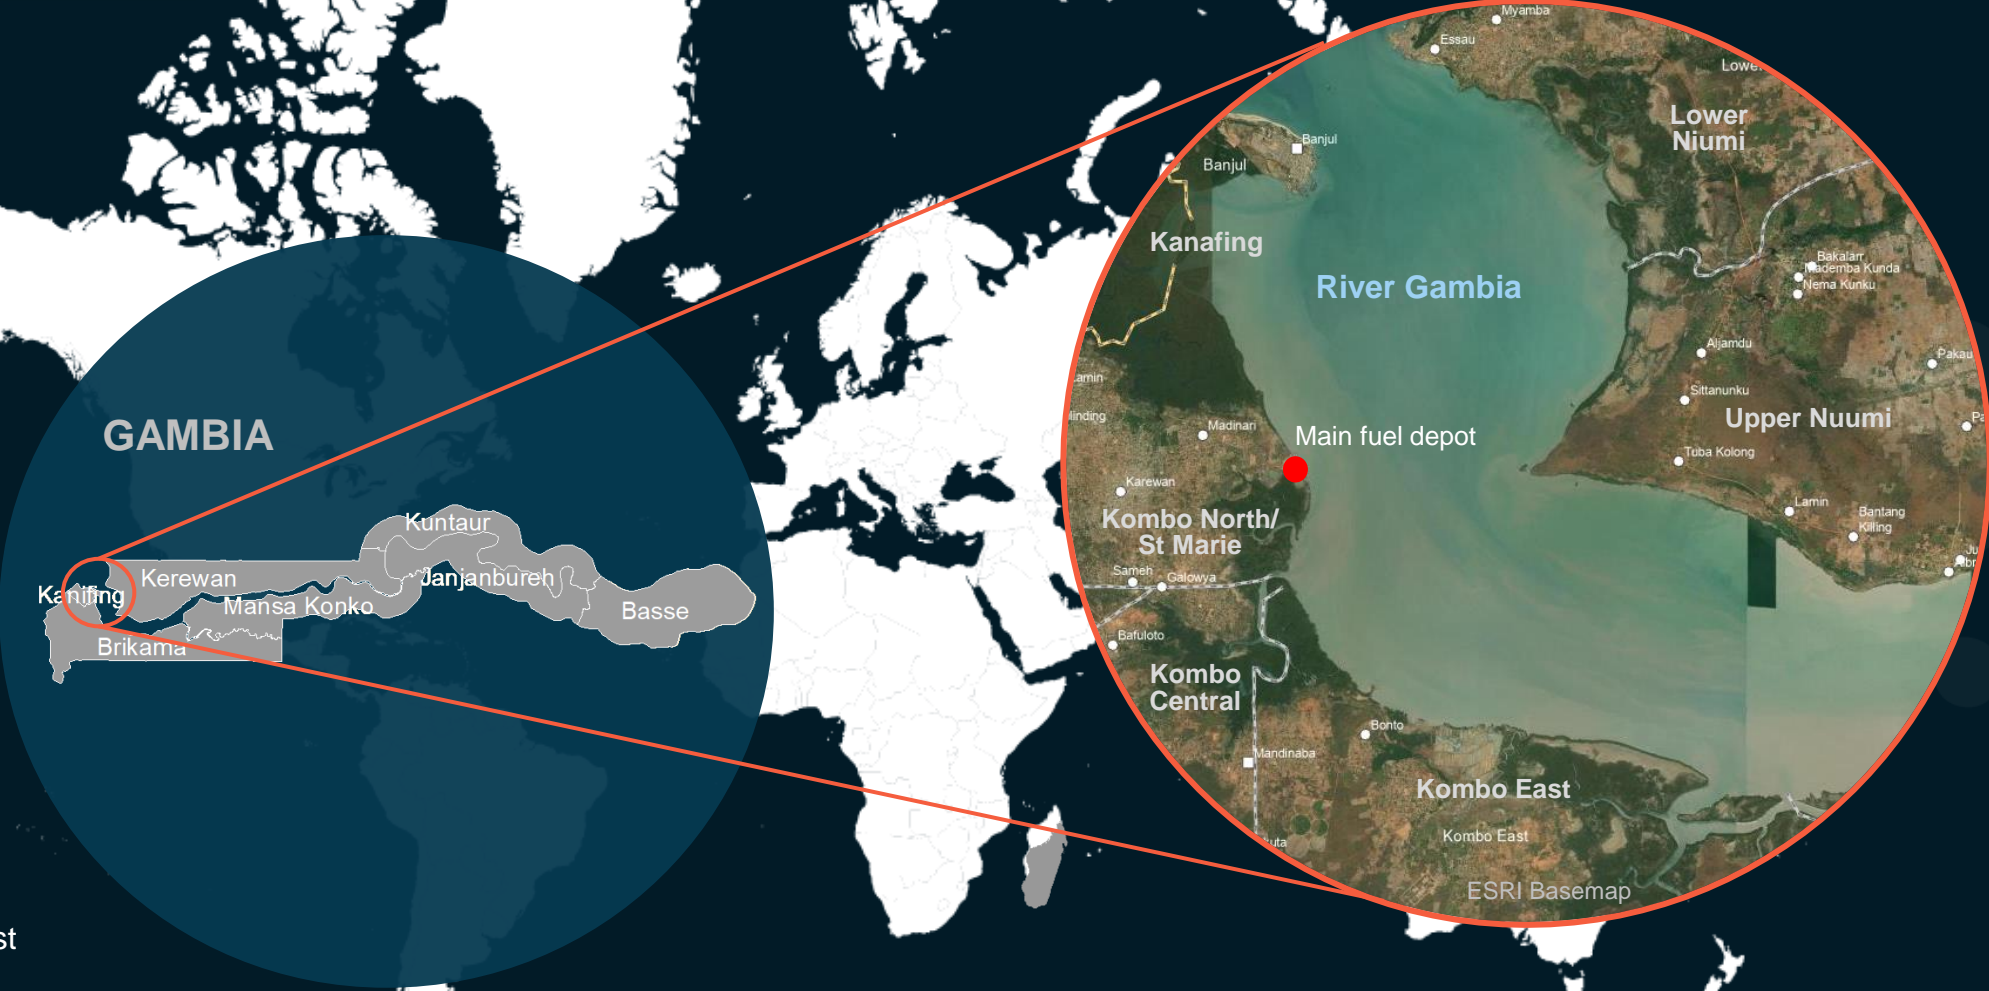
SIX AREAS OF INTEREST ALONG THE RIVER GAMBIA

AOI 1
Along the shoreline near the main fuel depot

AOI 2
Along the shoreline of southern part of Main fuel depot in Kombo East district

AOI 3
Along the shoreline of Kombo East district

AOI 4
Along the shoreline of Upper Niumi districts

AOI 5
Along the shoreline of Lower Niumi and Upper Niumi districts

AOI 6
Along the shoreline of Banjul town and Essau village

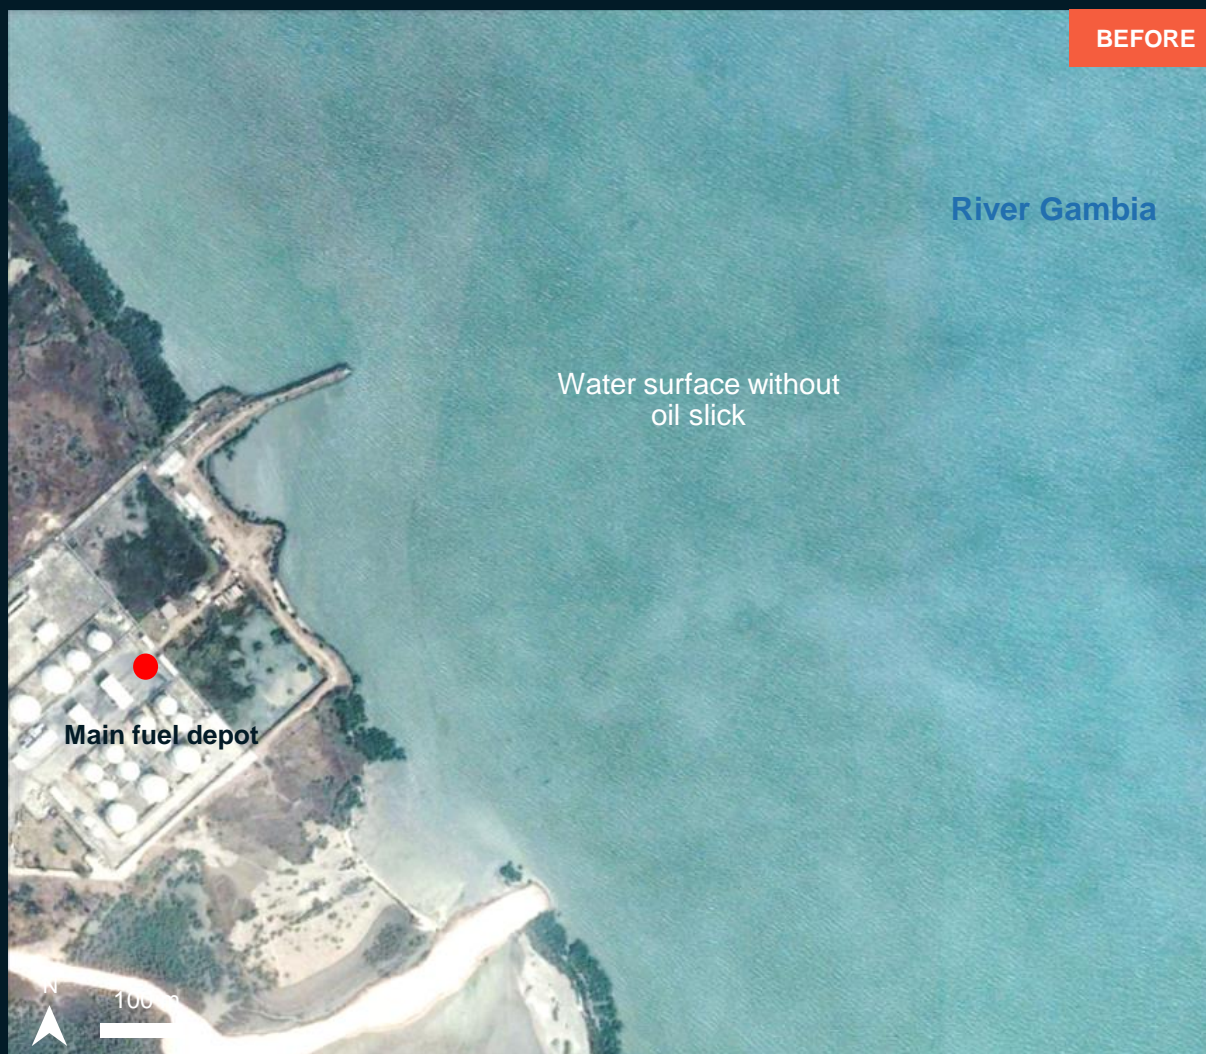
AOI 1-1 ALONG THE SHORELINE OF THE MAIN FUEL DEPOT

Potential oil film observed near the main fuel depot

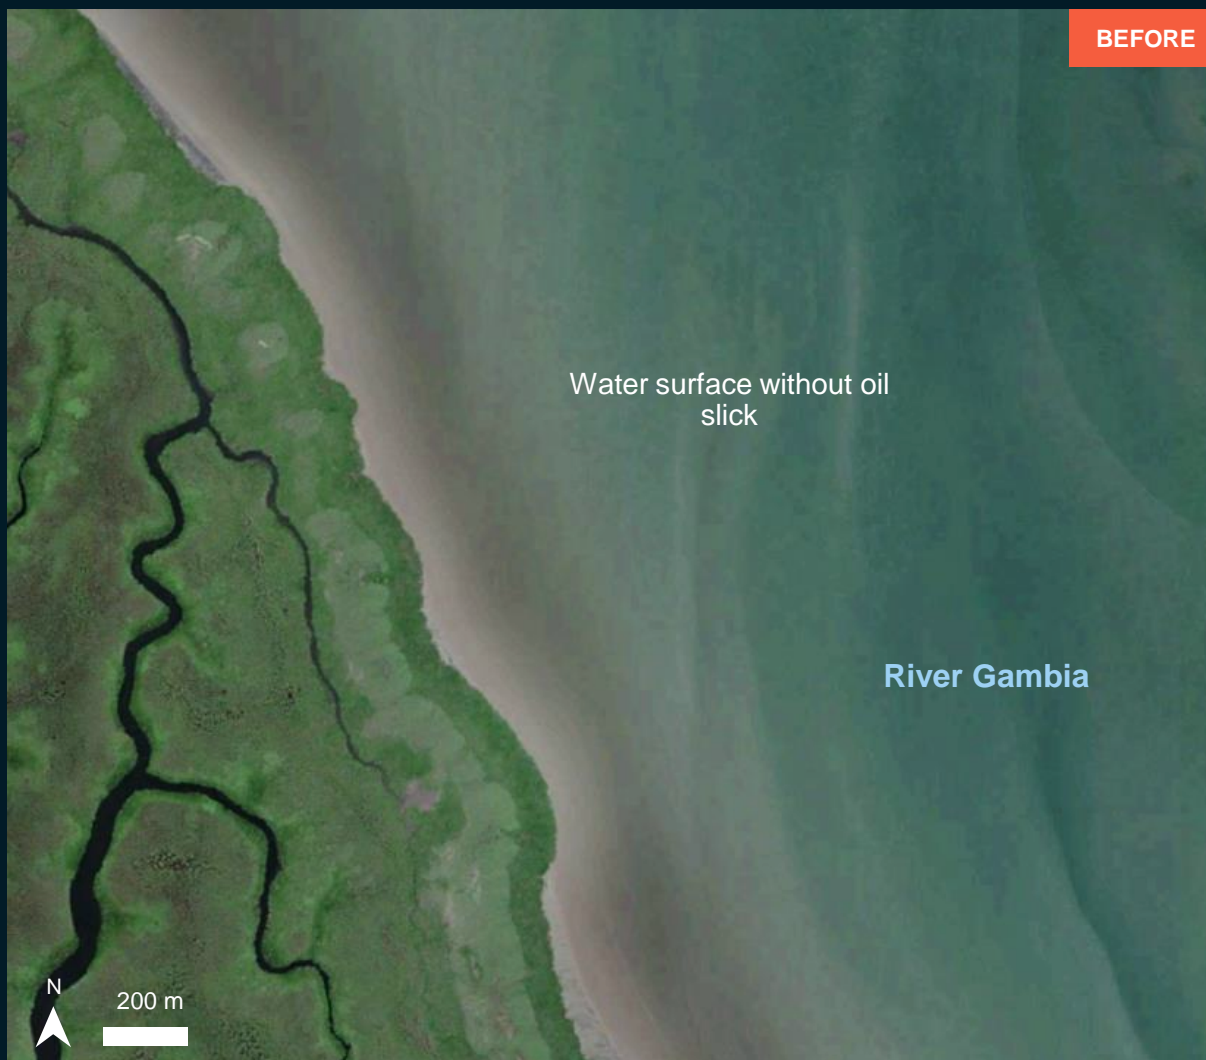
AOI 1-2 ALONG THE SHORELINE NEAR THE MAIN FUEL DEPOT 3.8 KM FROM MAIN FUEL DEPOT

Potential oil film observed along the shoreline

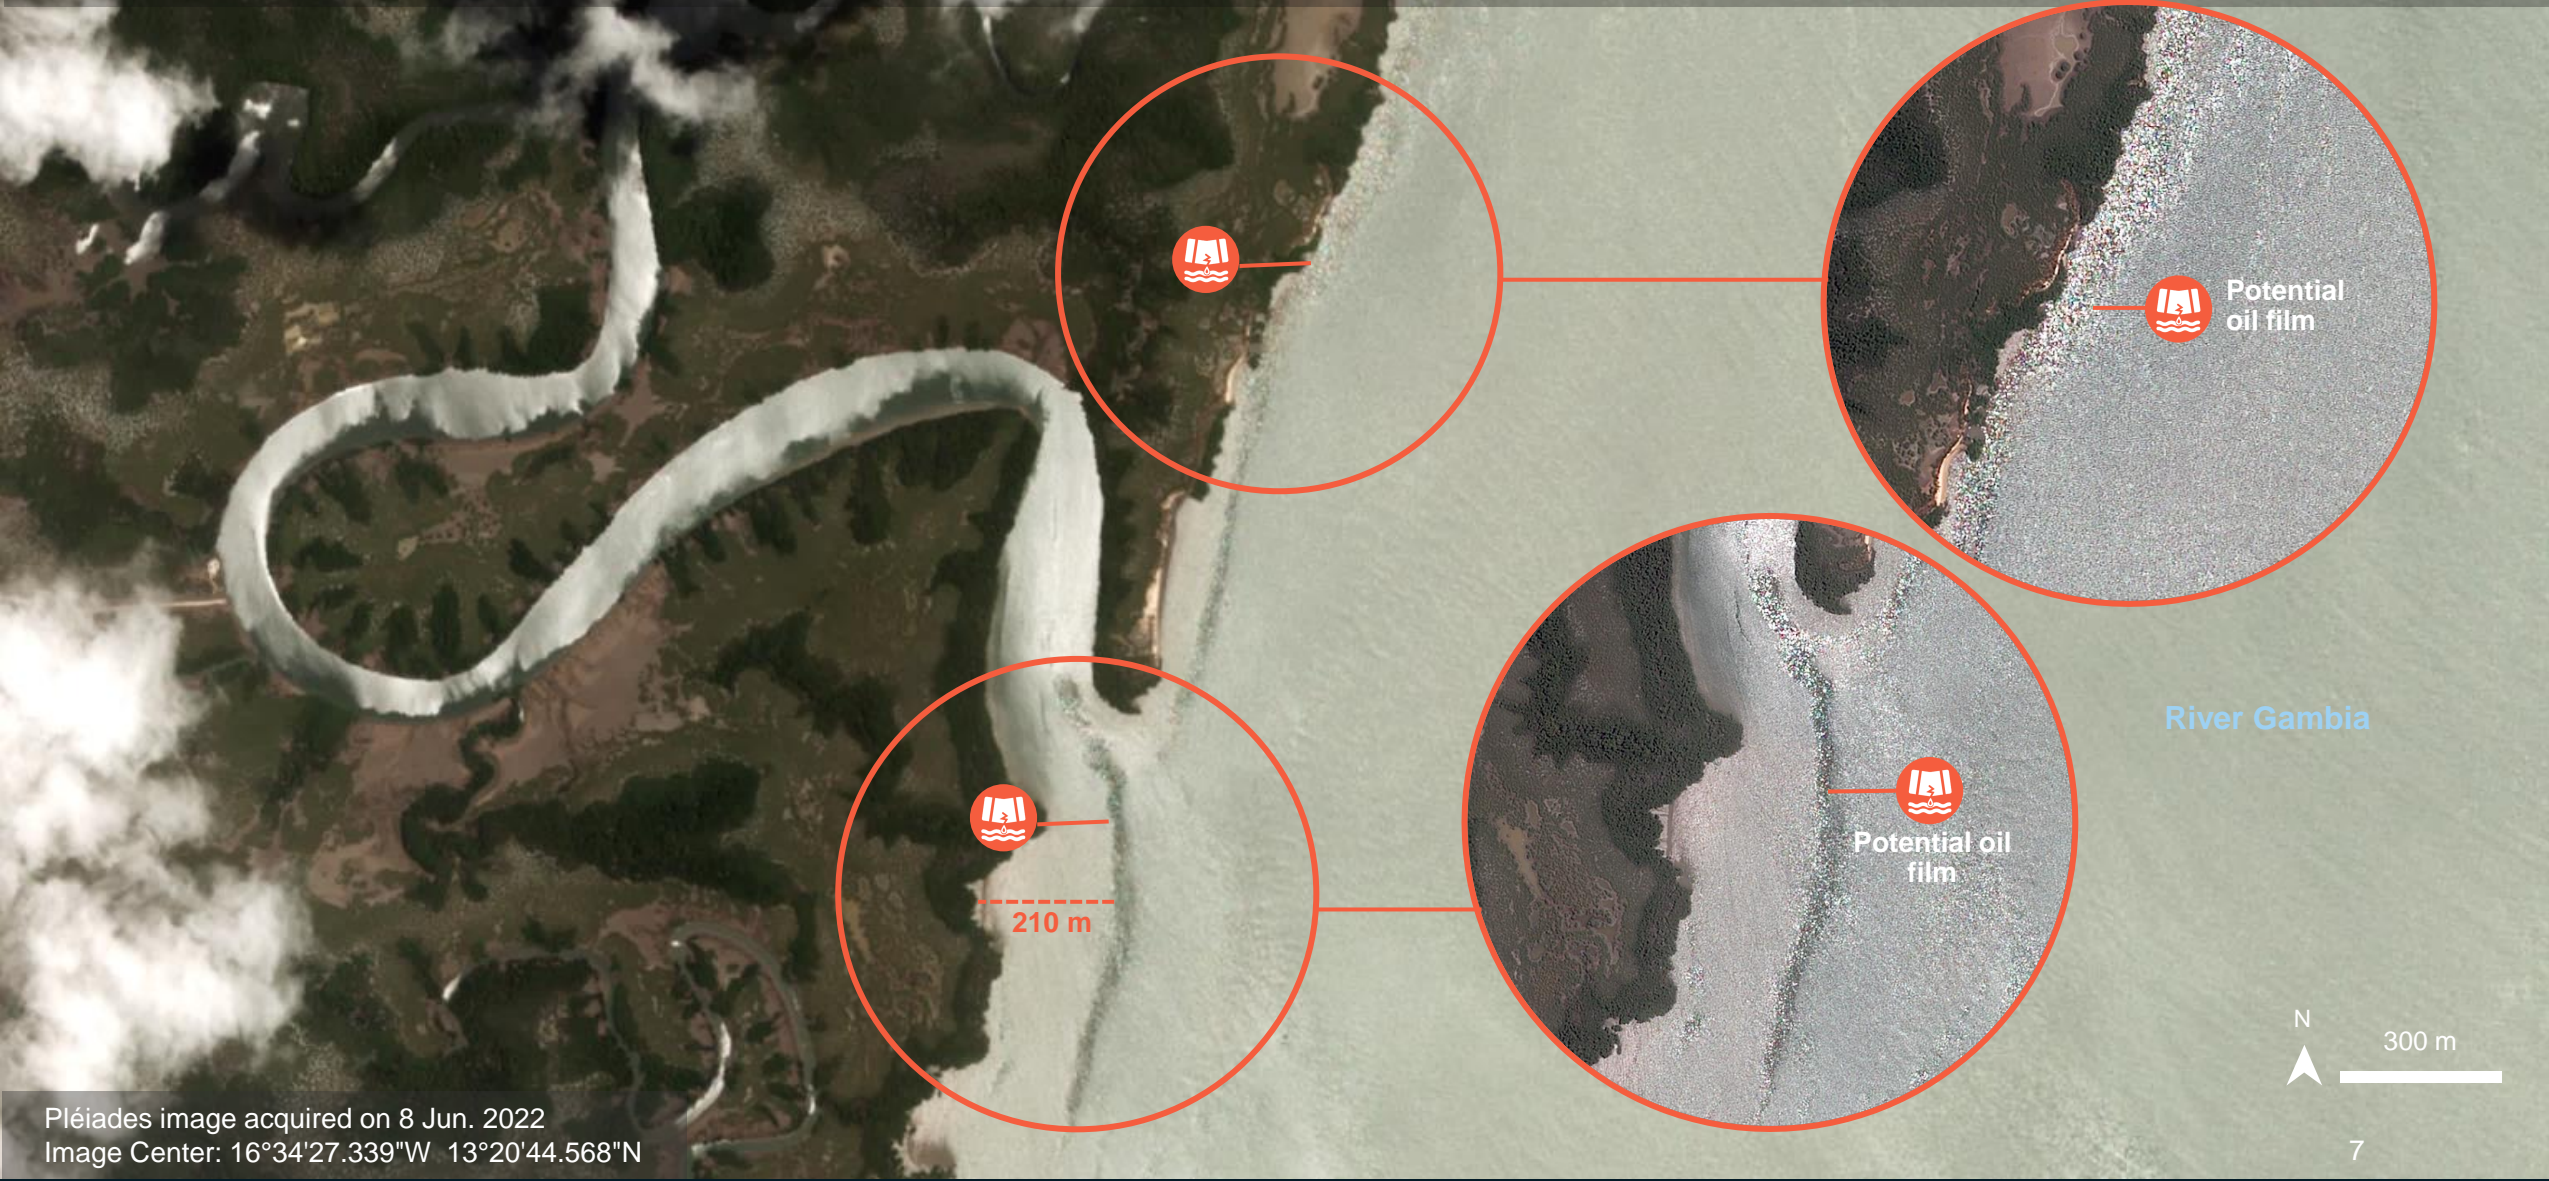
AOI 2- ALONG THE SHORELINE OF SOUTHERN PART OF MAIN FUEL DEPT IN KOMBO EAST DISTRICT

Potential oil film observed along the shoreline

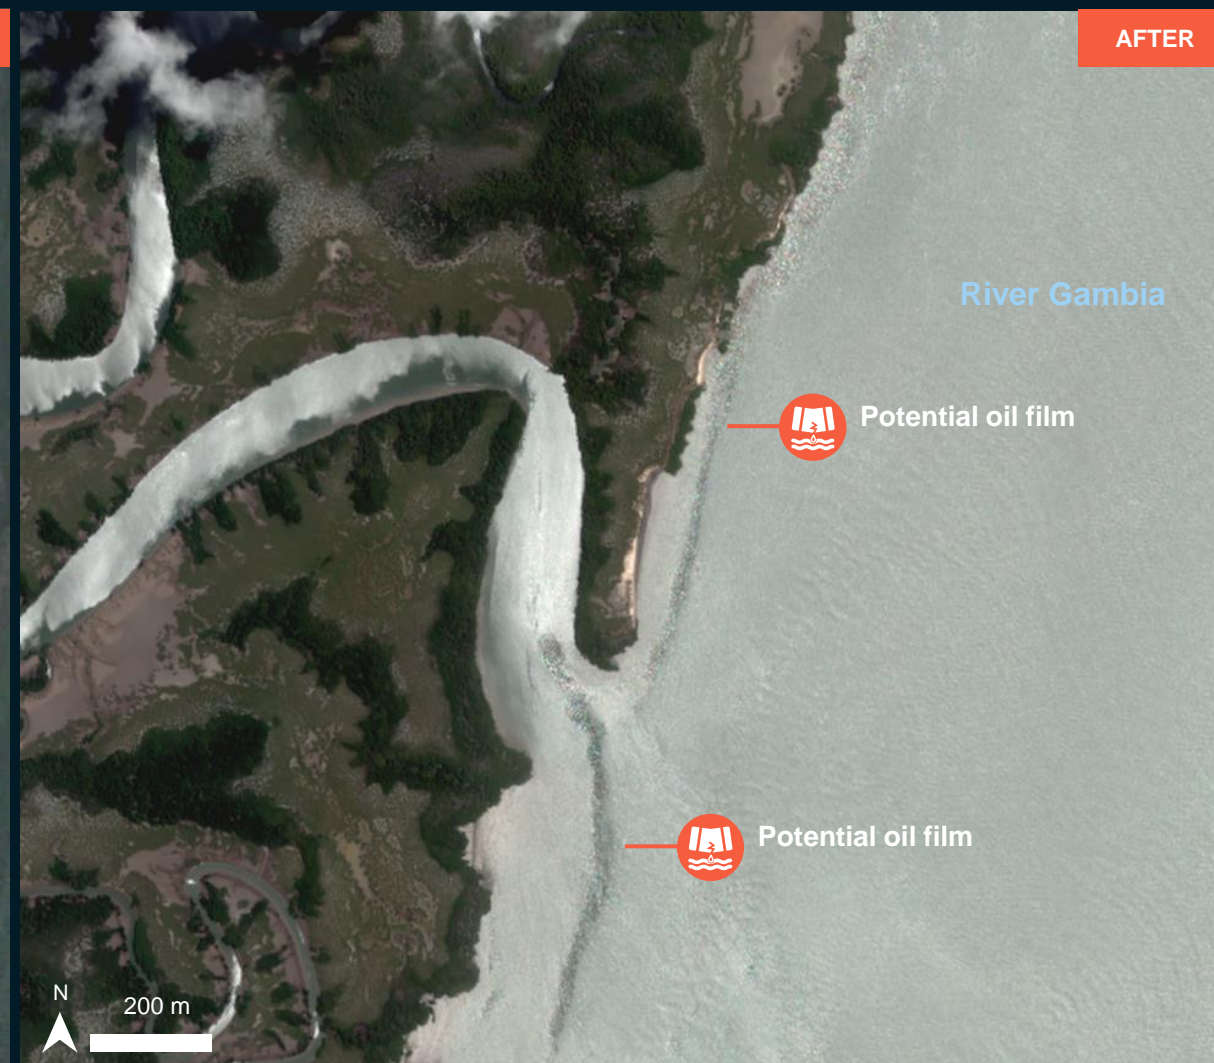
AOI 2- ALONG THE SHORELINE OF SOUTHERN PART OF MAIN FUEL DEPORT IN KOMBO EAST DISTRICT

Potential oil film observed along the shoreline

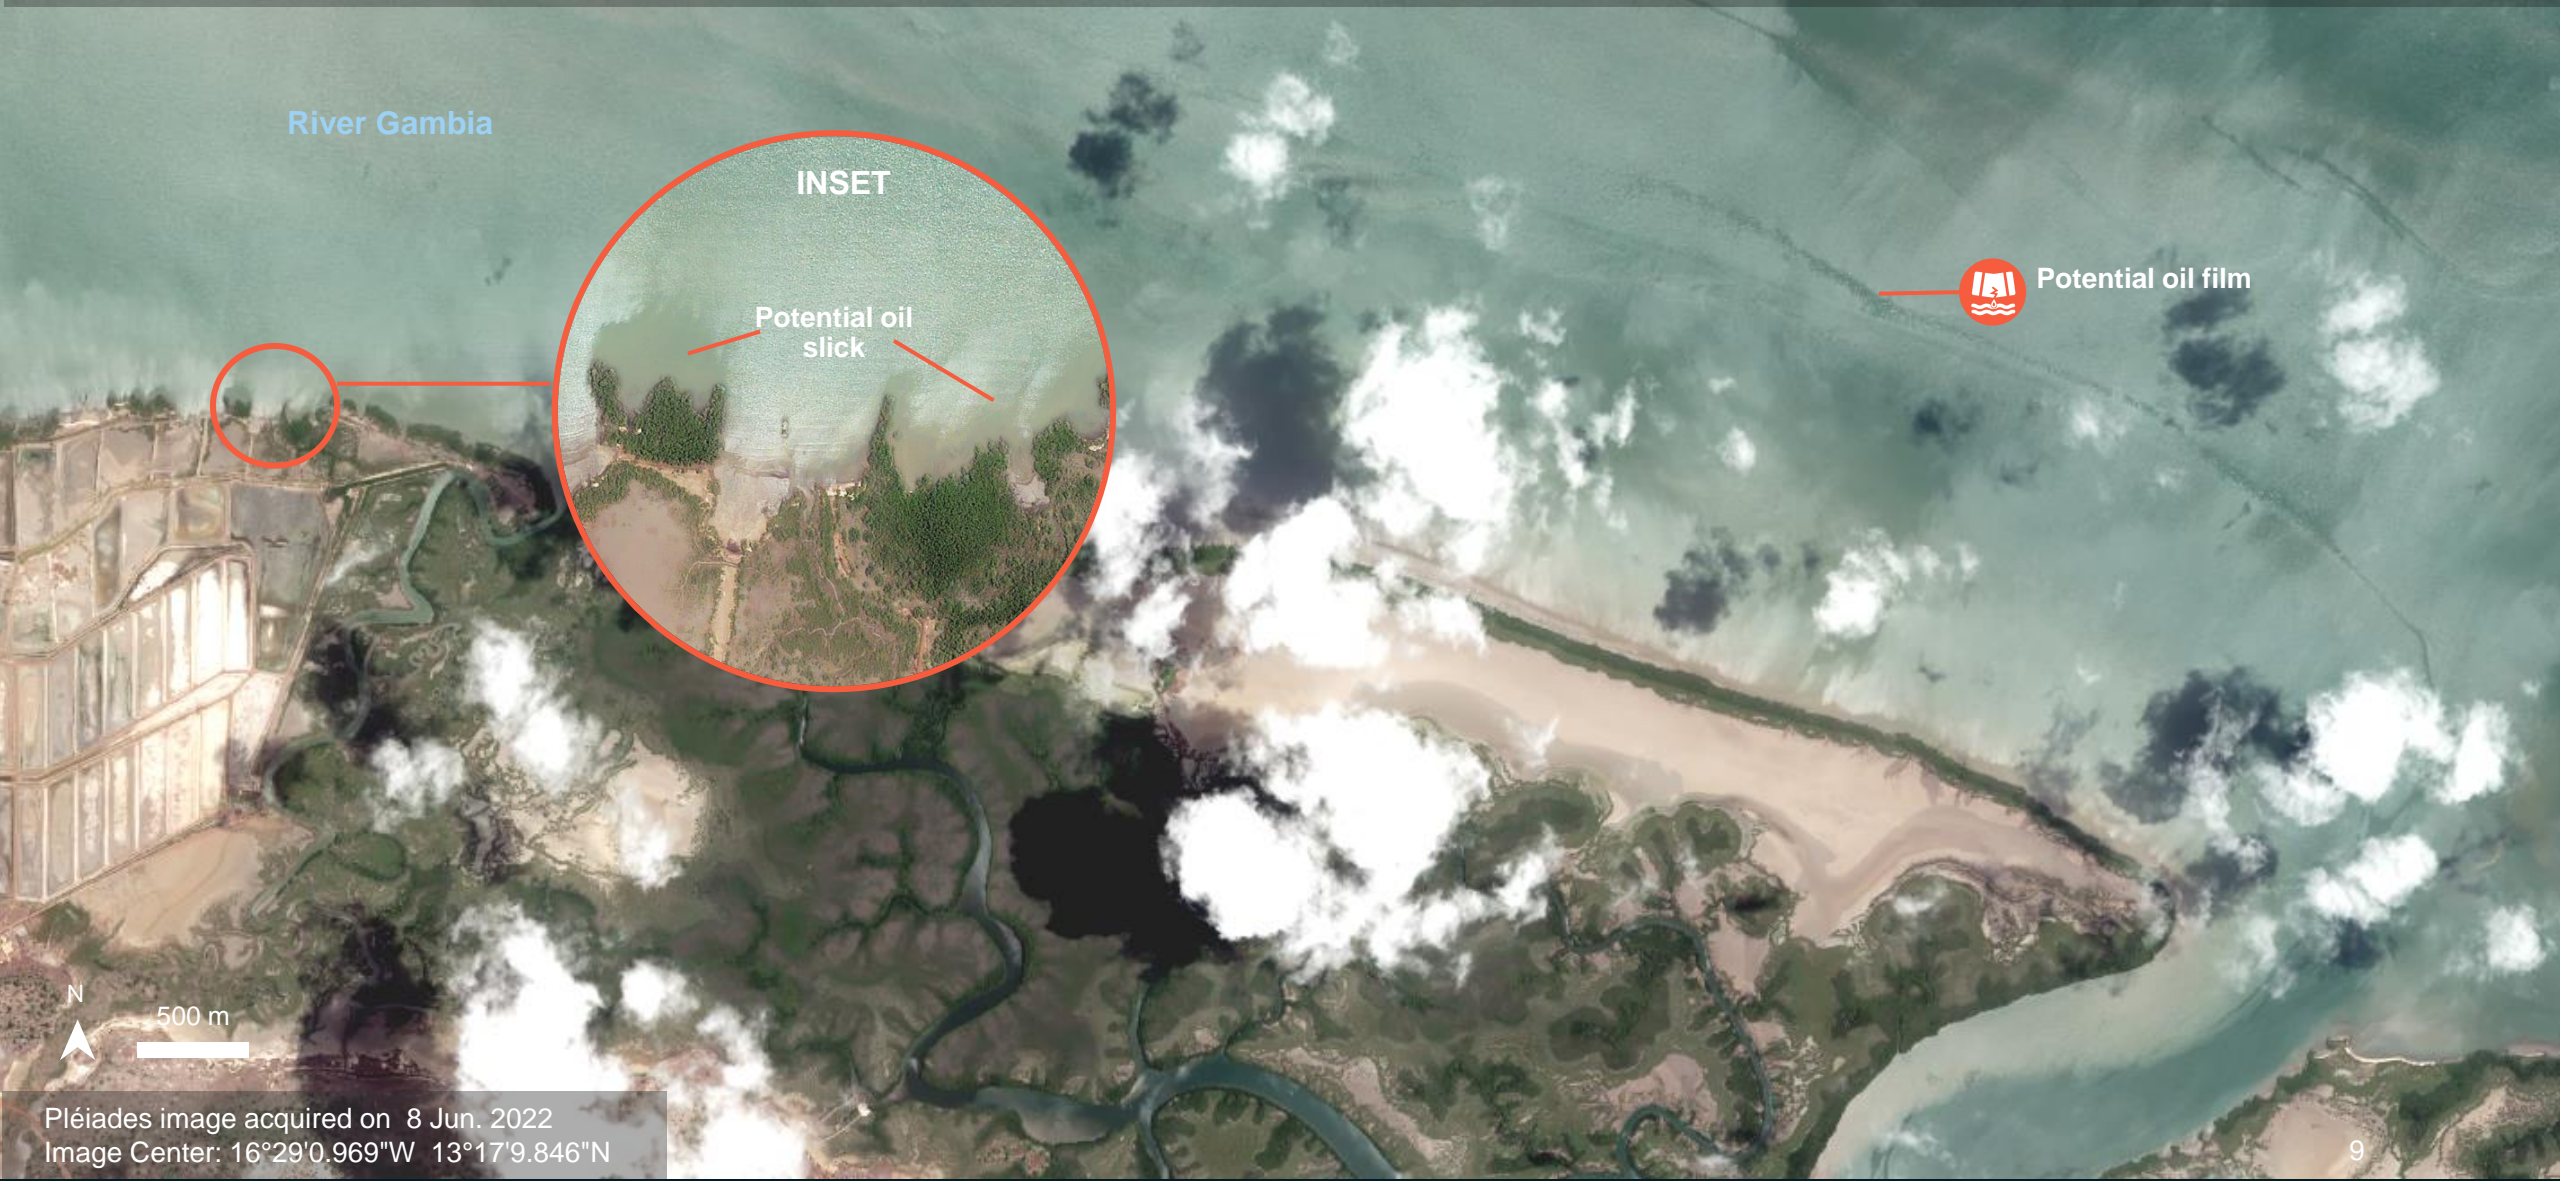
AOI 3- ALONG THE SHORELINE OF KOMBO EAST DISTRICT 14 KM FROM MAIN FUEL DEPOT

Potential oil film observed along the shoreline

Potential oil
slick

Potential oil film

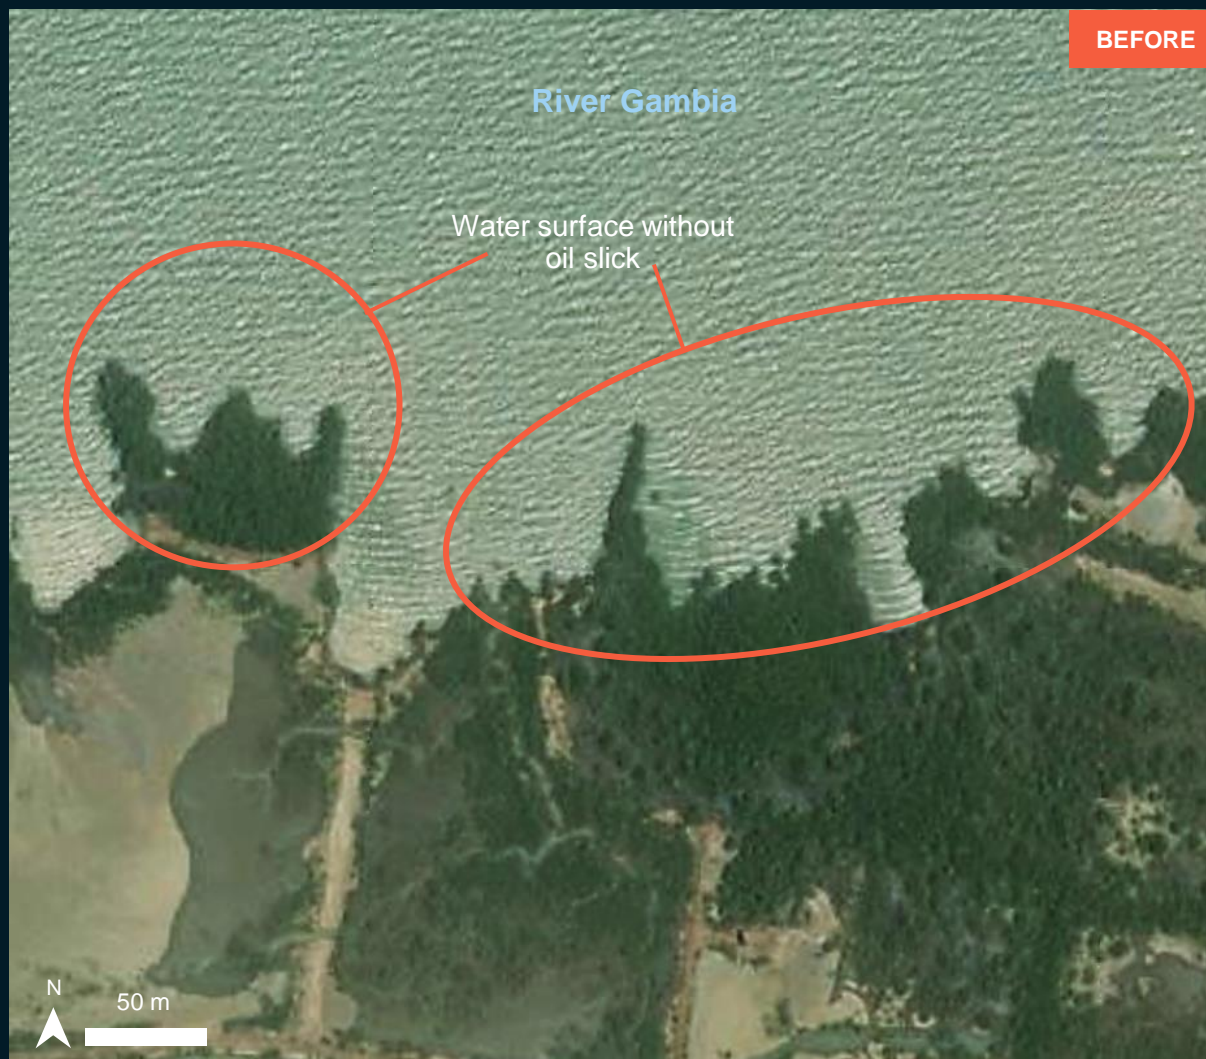
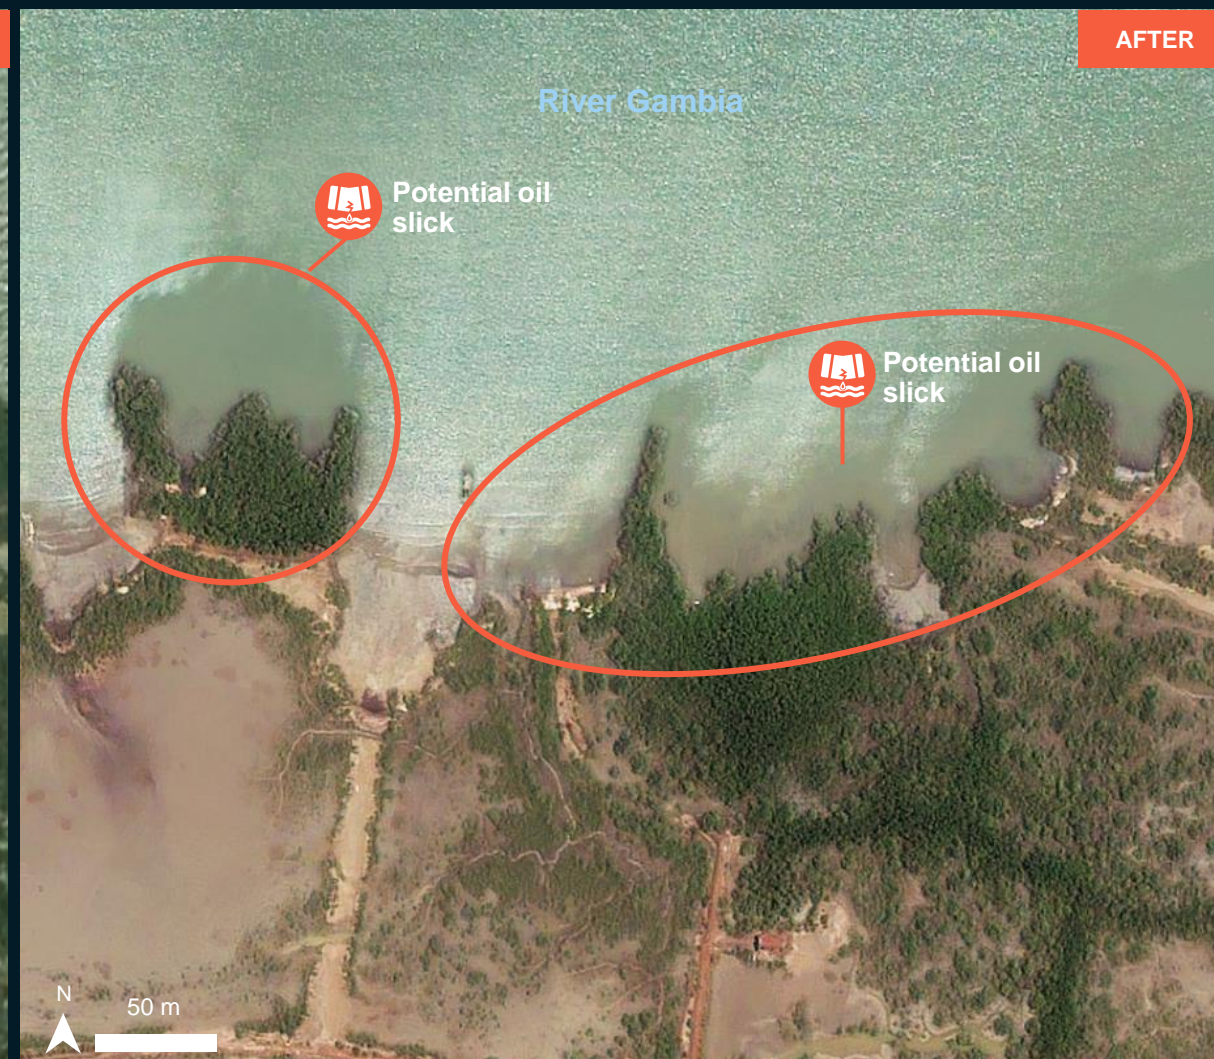
AOI 3-1 ALONG THE SHORELINE OF KOMBO EAST DISTRICT 10 KM FROM MAIN FUEL DEPOT

Potential oil slick observed along the shoreline

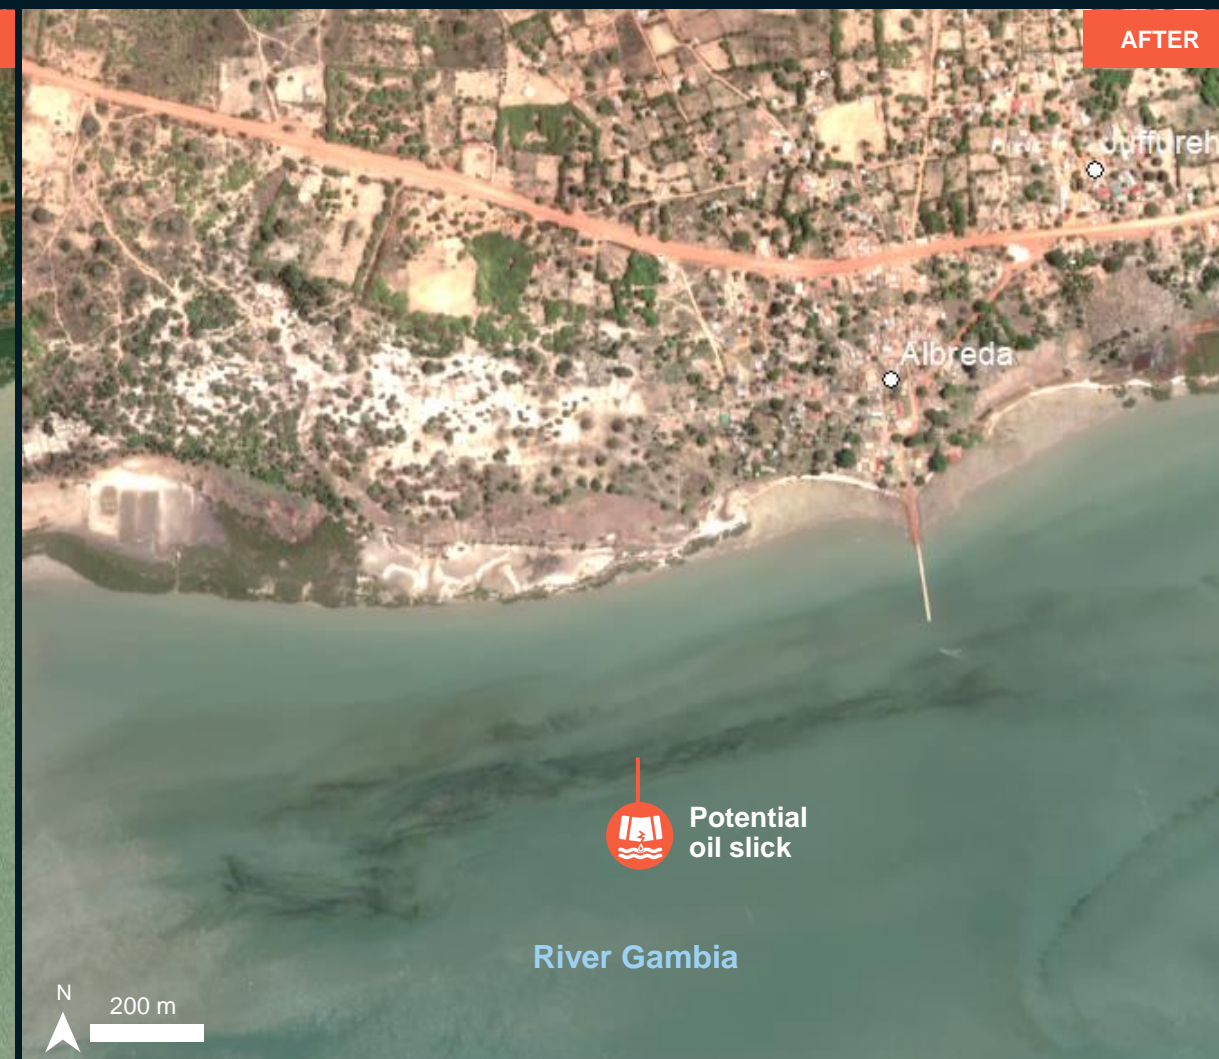
AOI 4-1 ALONG THE SHORELINE OF KOMBO EAST DISTRICT 20 KM FROM MAIN FUEL DEPOT

Potential oil slick observed along the shoreline

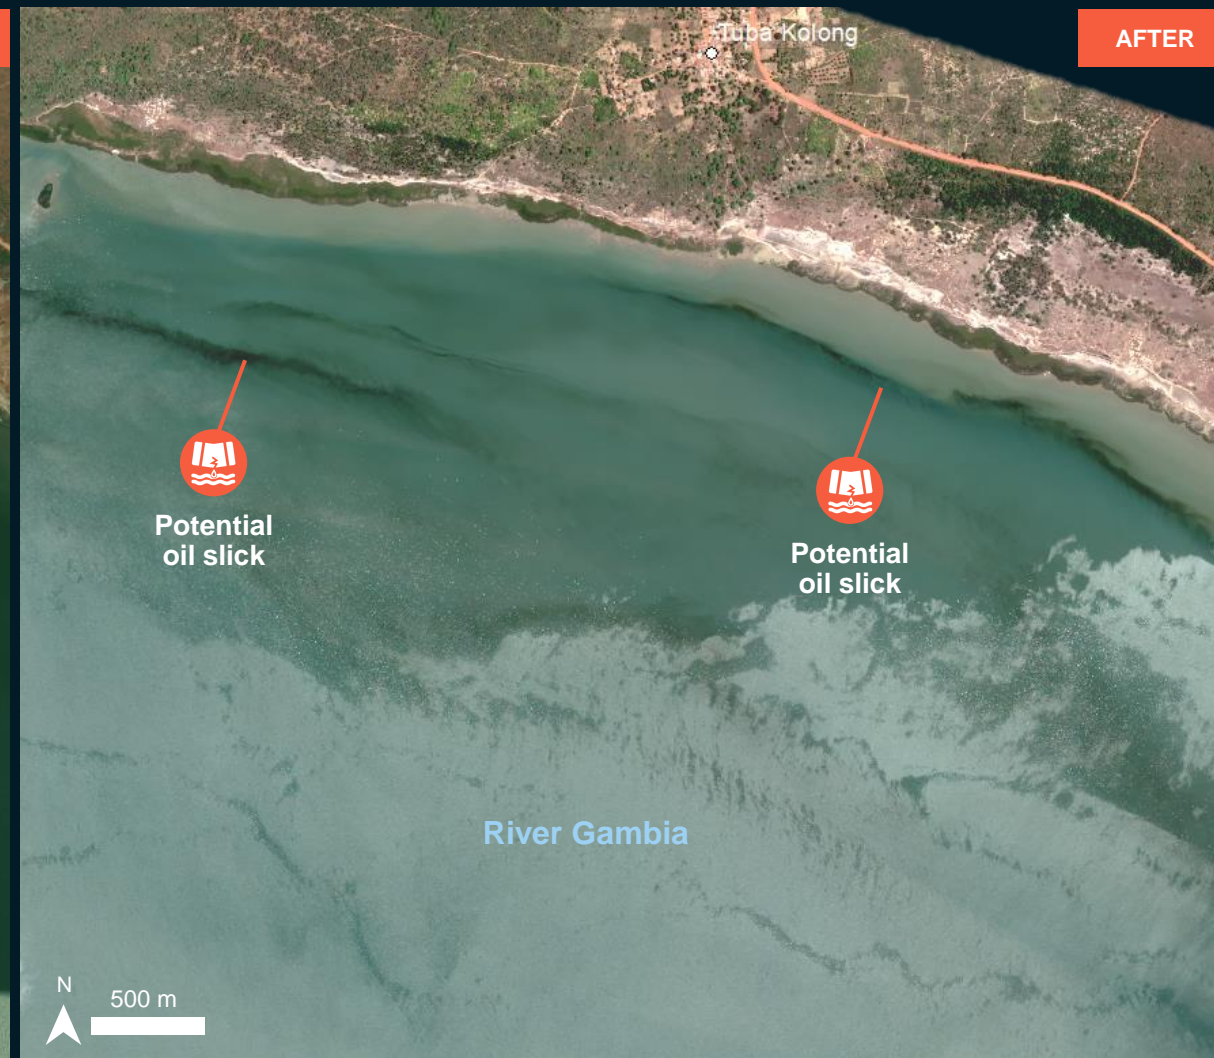
AOI 4-2 ALONG THE SHORELINE OF KOMBO EAST DISTRICT 10 KM FROM MAIN FUEL DEPOT

Potential oil slick observed along the shoreline

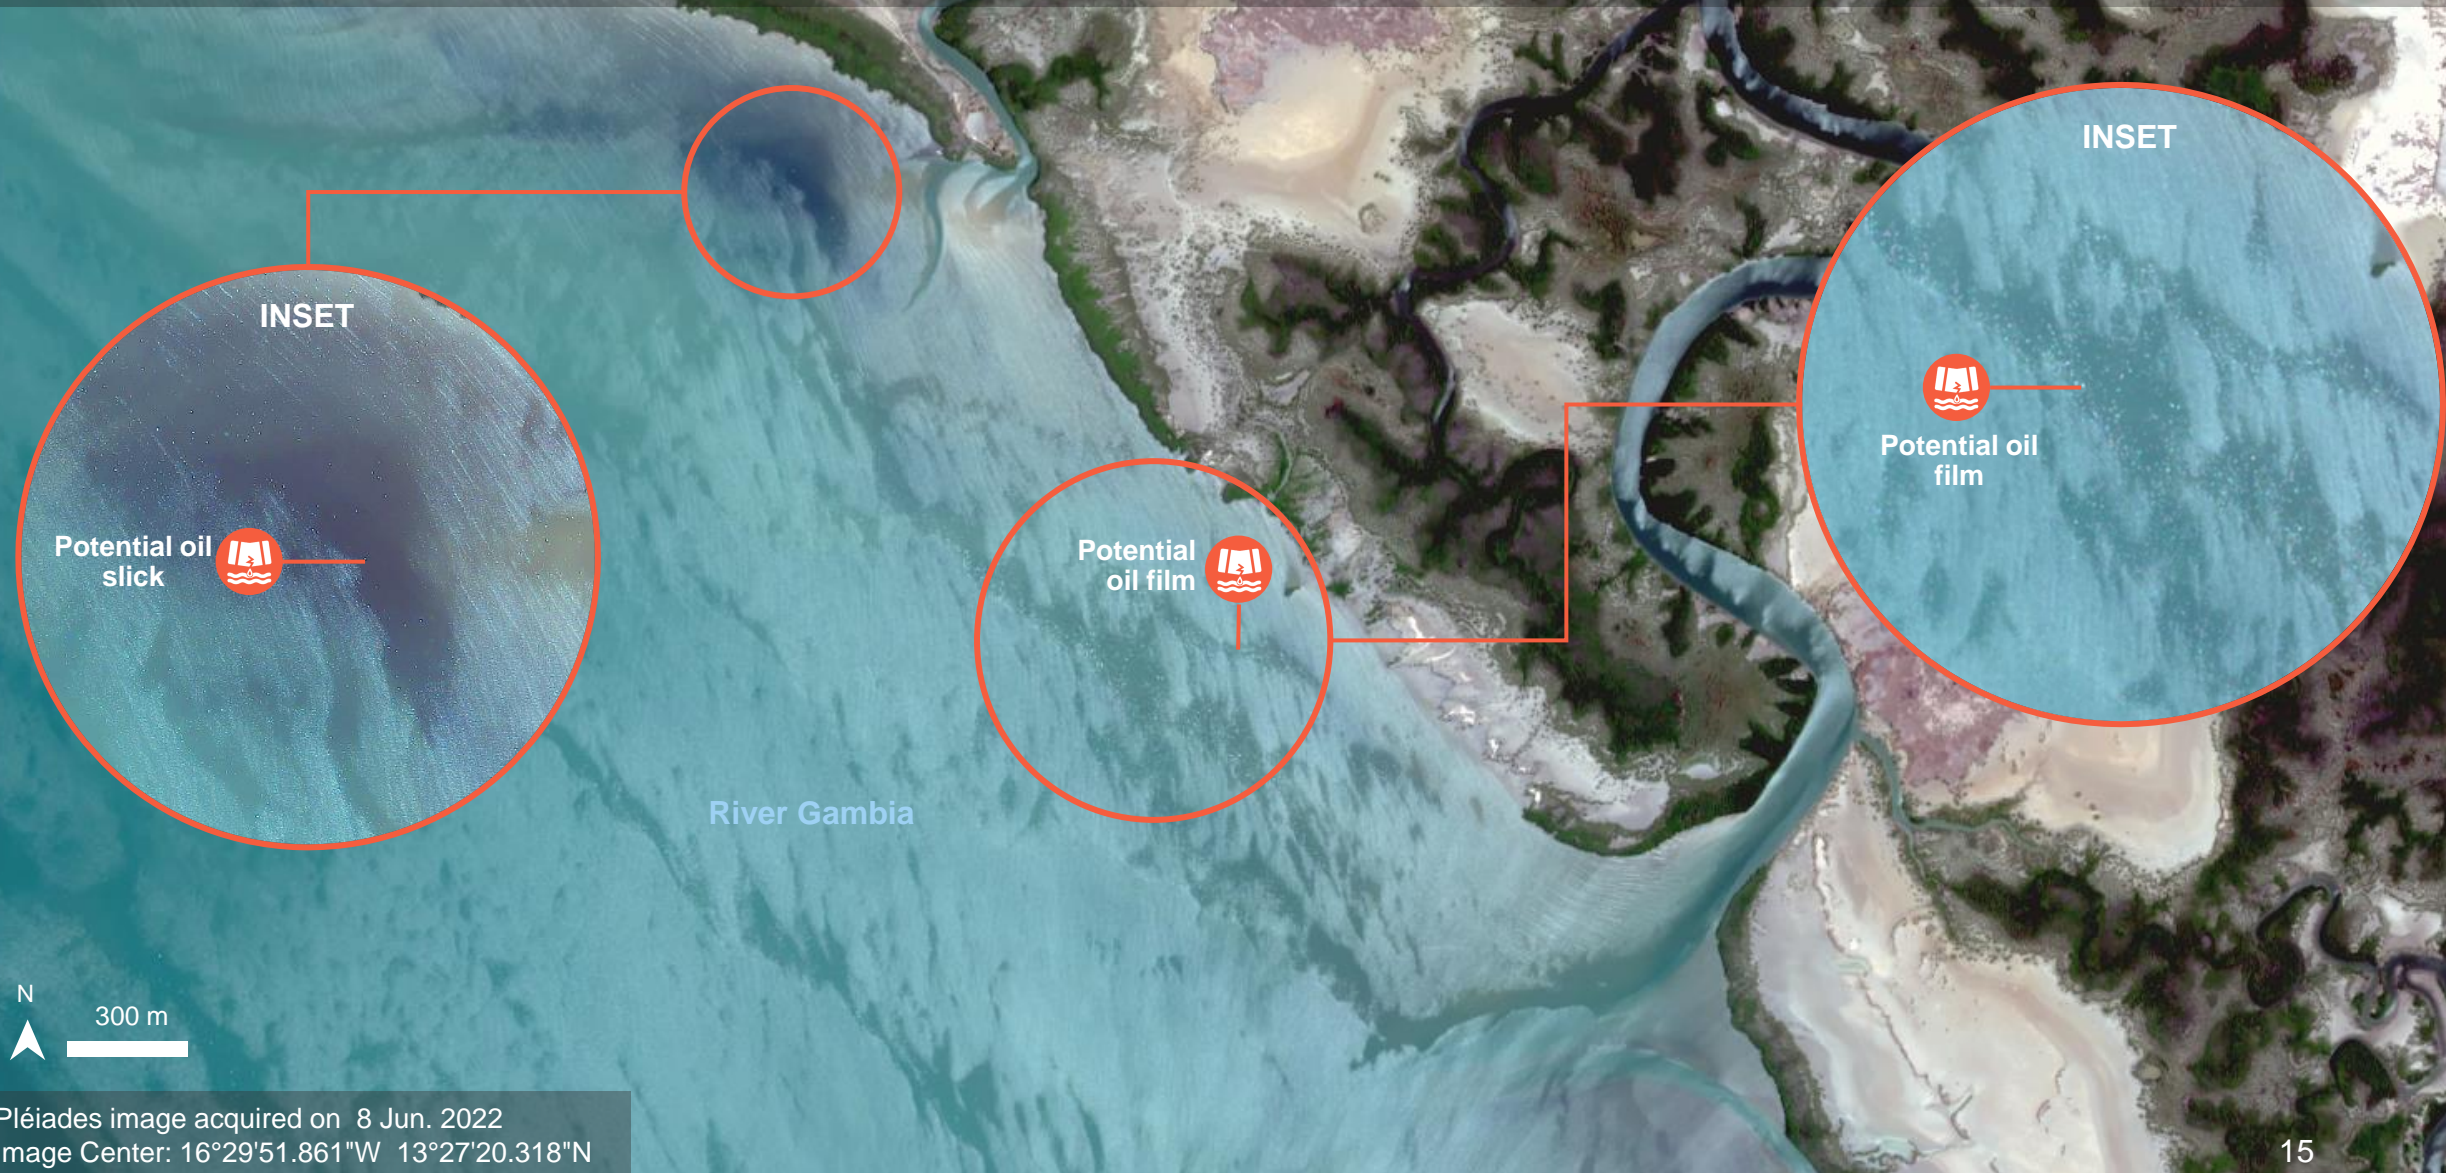
AOI 5 - ALONG THE SHORELINE OF LOWER NIUMI DISTRICT 13 KM FROM MAIN FUEL DEPOT

Widespread potential oil film and oil slick observed along the shoreline

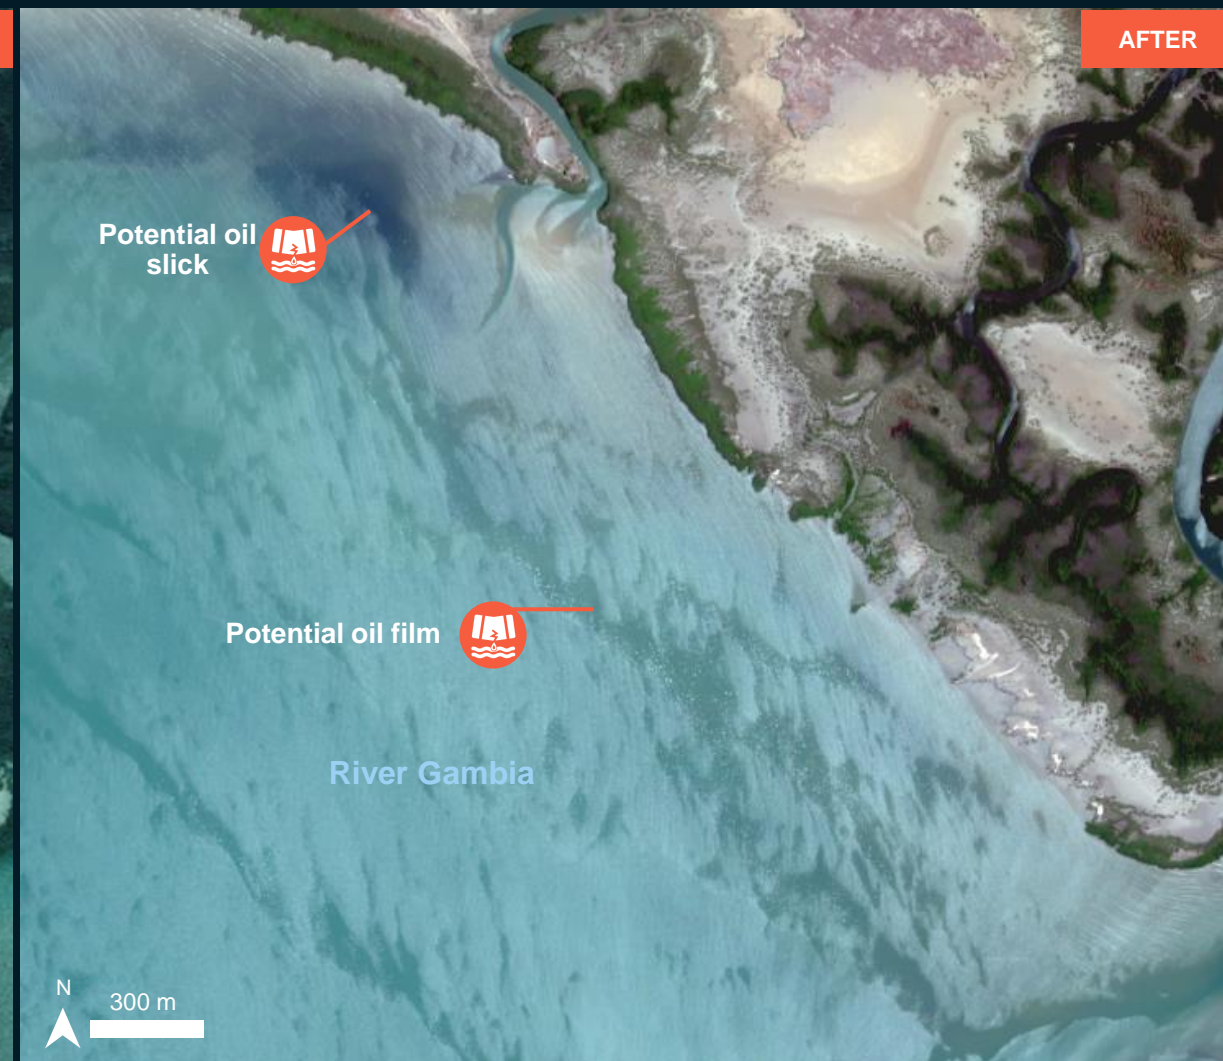
AOI 5- ALONG THE SHORELINE OF KOMBO EAST DISTRICT 13 KM FROM MAIN FUEL DEPOT

Widespread potential oil slick observed along the shoreline
