8 Jun. 2022

OIL SPILL IN GAMBIA PRELIMINARY SATELLITE-DERIVED DAMAGE ASSESSMENT

Along the River Gambia

Status: Widespread potential oil film and oil slick is observed over the River Gambia

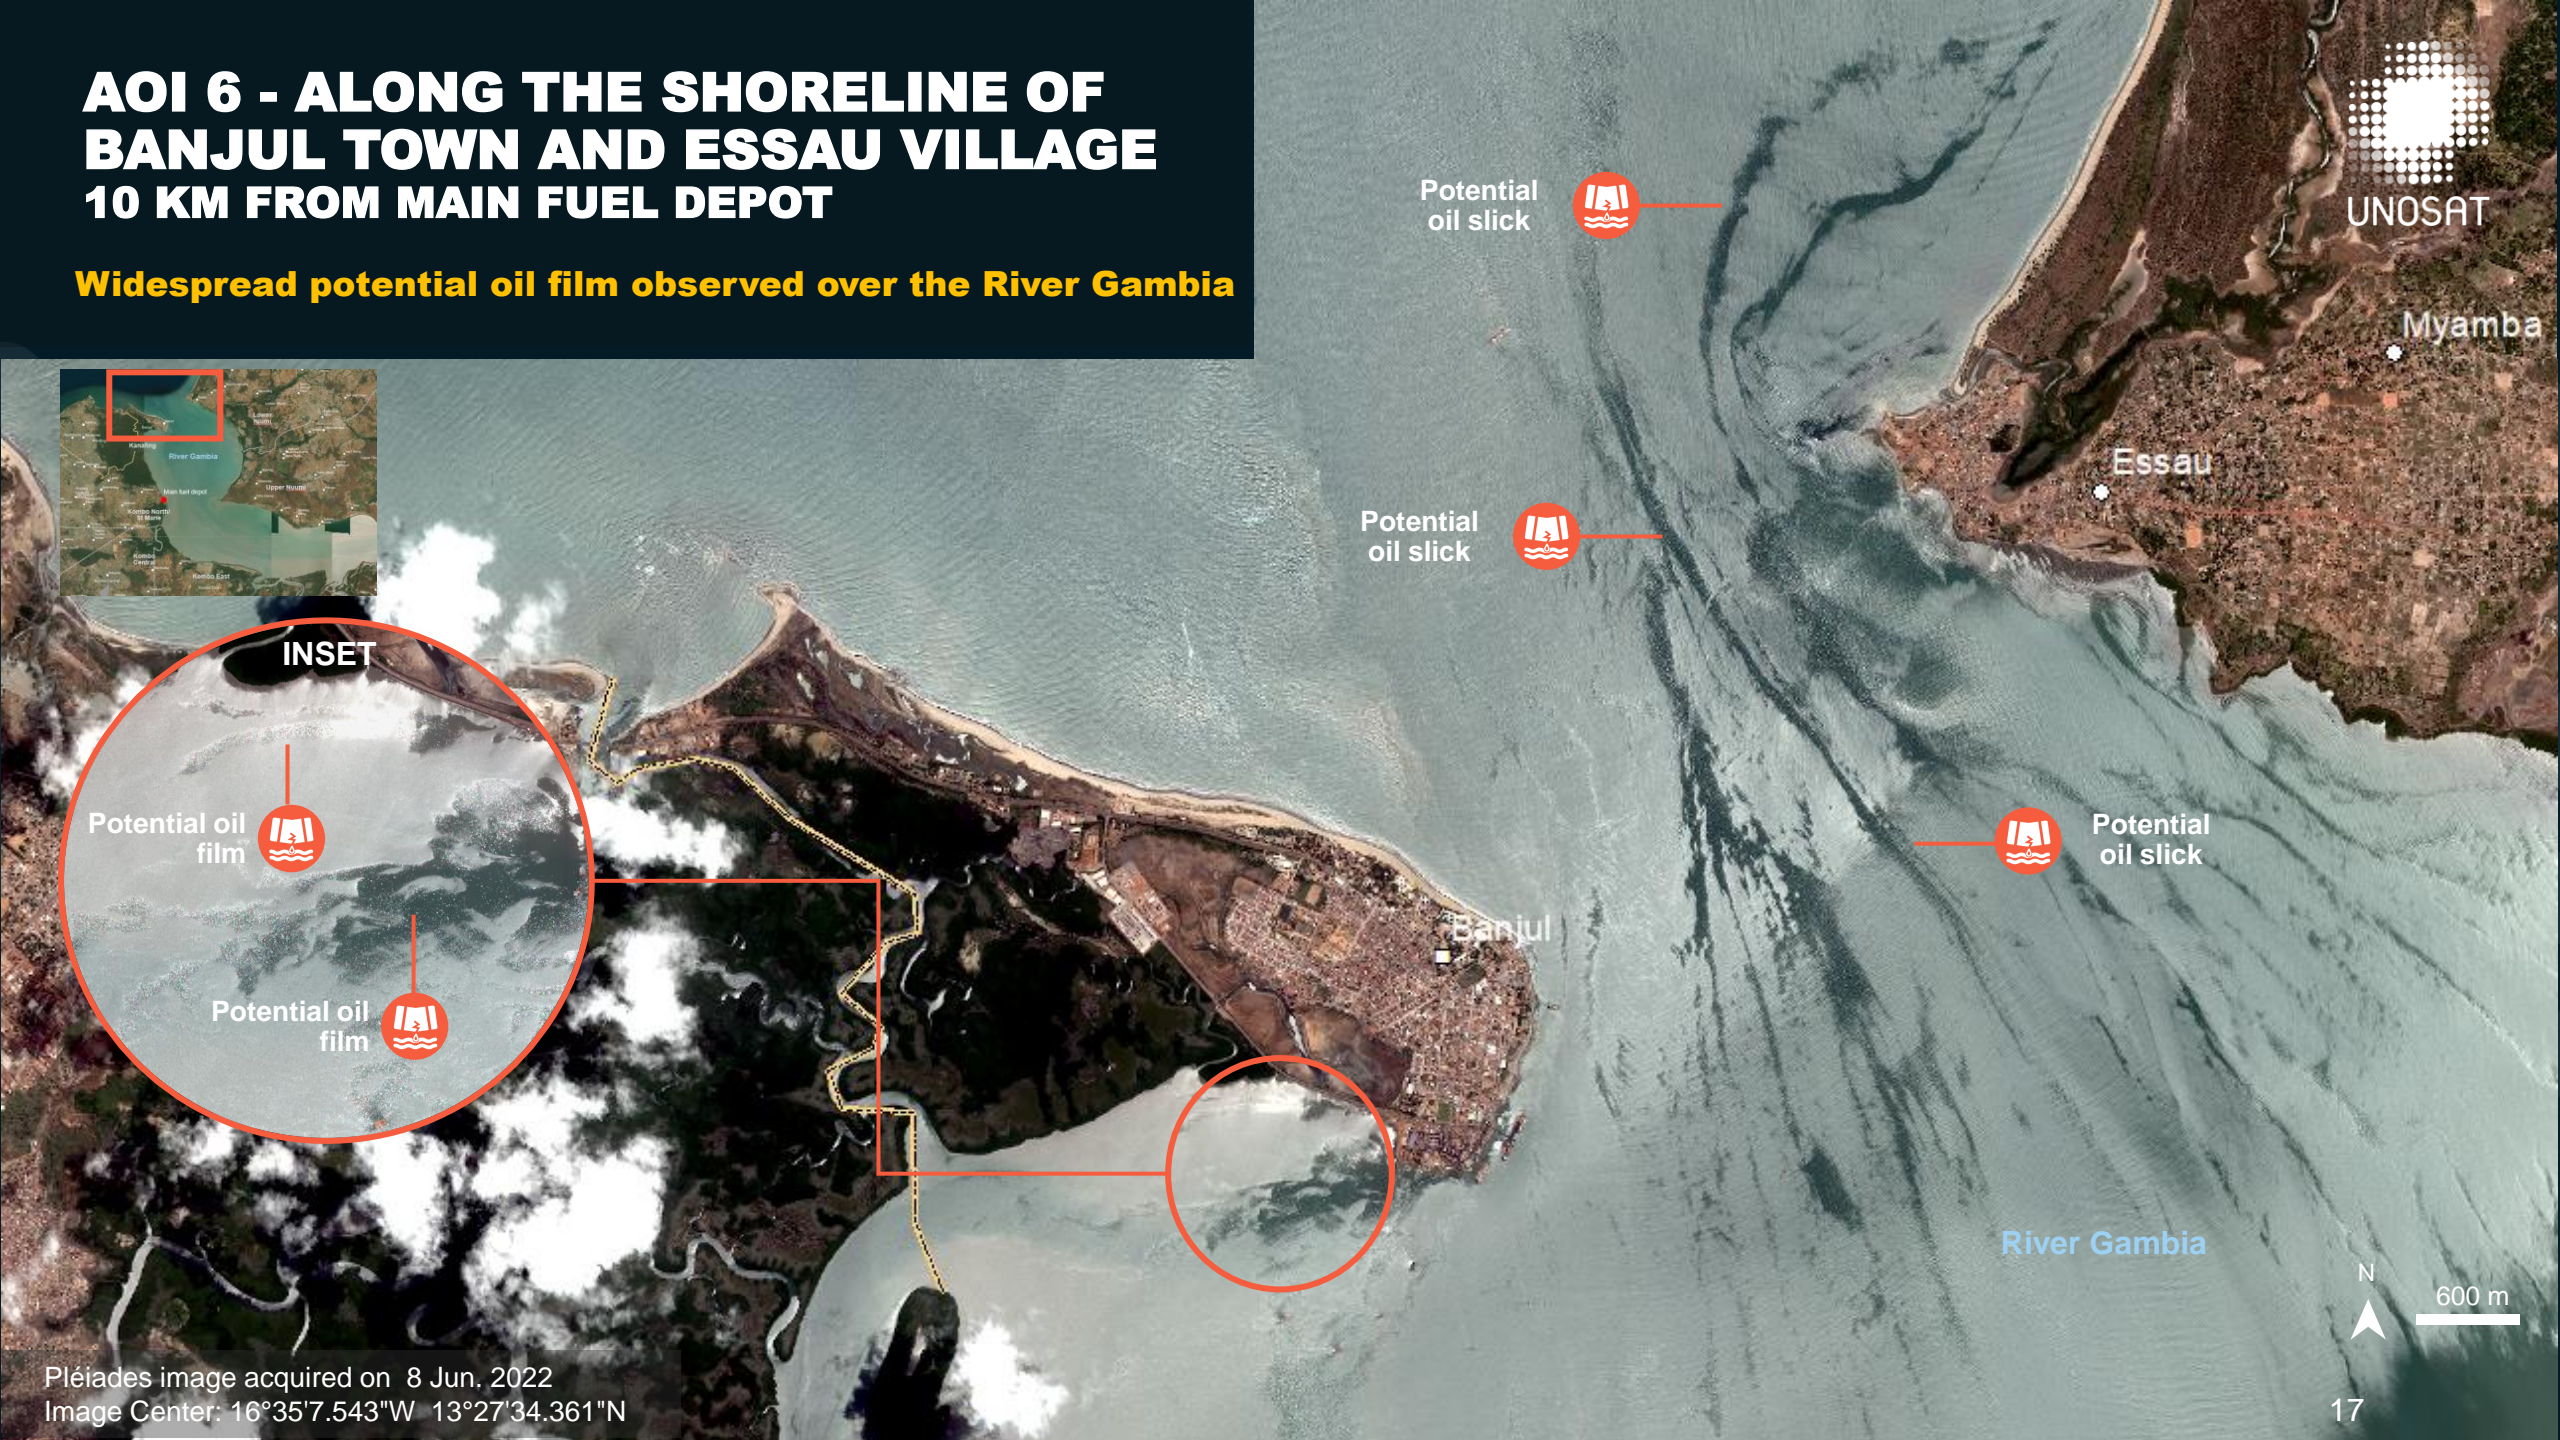
AOI 6 - ALONG THE SHORELINE OF BANJUL TOWN AND ESSAU VILLAGE 10 KM FROM MAIN FUEL DEPOT

Widespread potential oil film observed over the River Gambia

Potential oil film

Potential oil slick

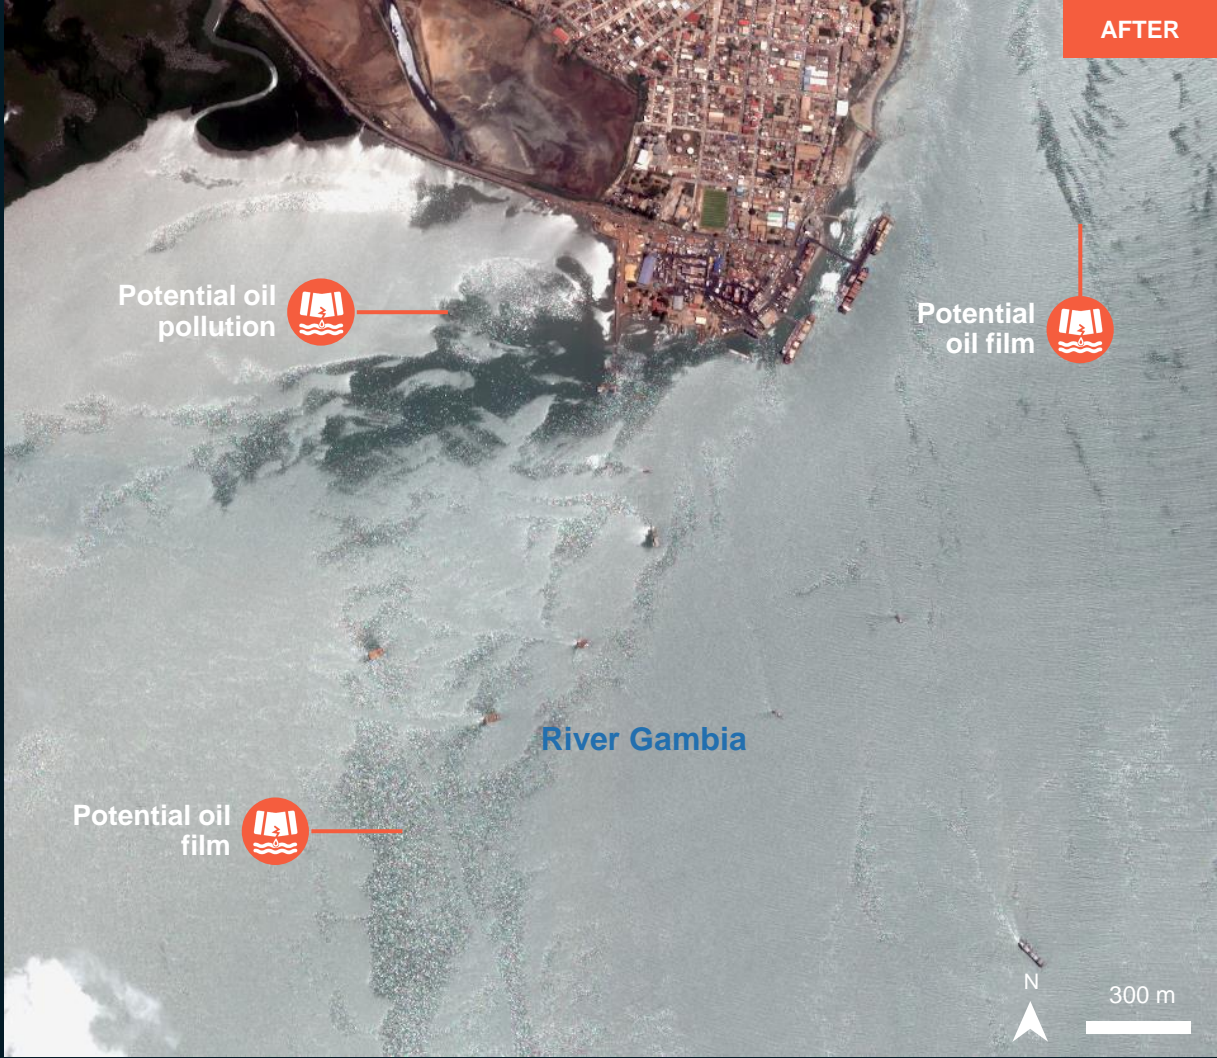
6-1- ALONG THE SHORELINE OF BANJUL TOWN 10 KM FROM MAIN FUEL DEPOT

Widespread potential oil film observed along the shoreline of Banjul town

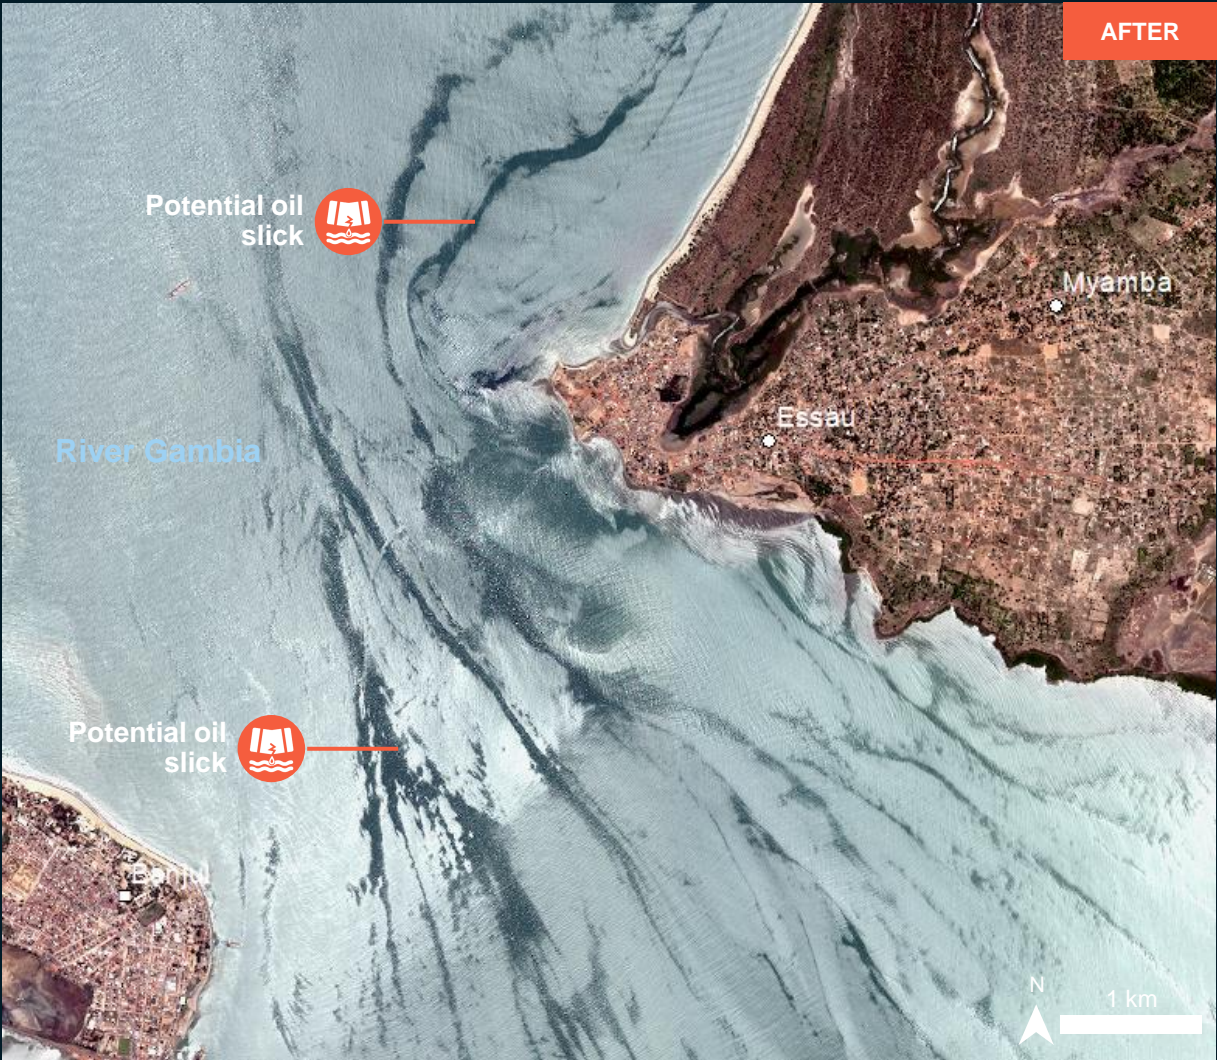
6-2- ALONG THE SHORELINE OF BANJUL TOWN 13 KM FROM MAIN FUEL DEPOT

Widespread potential oil slicks observed over the River Gambia

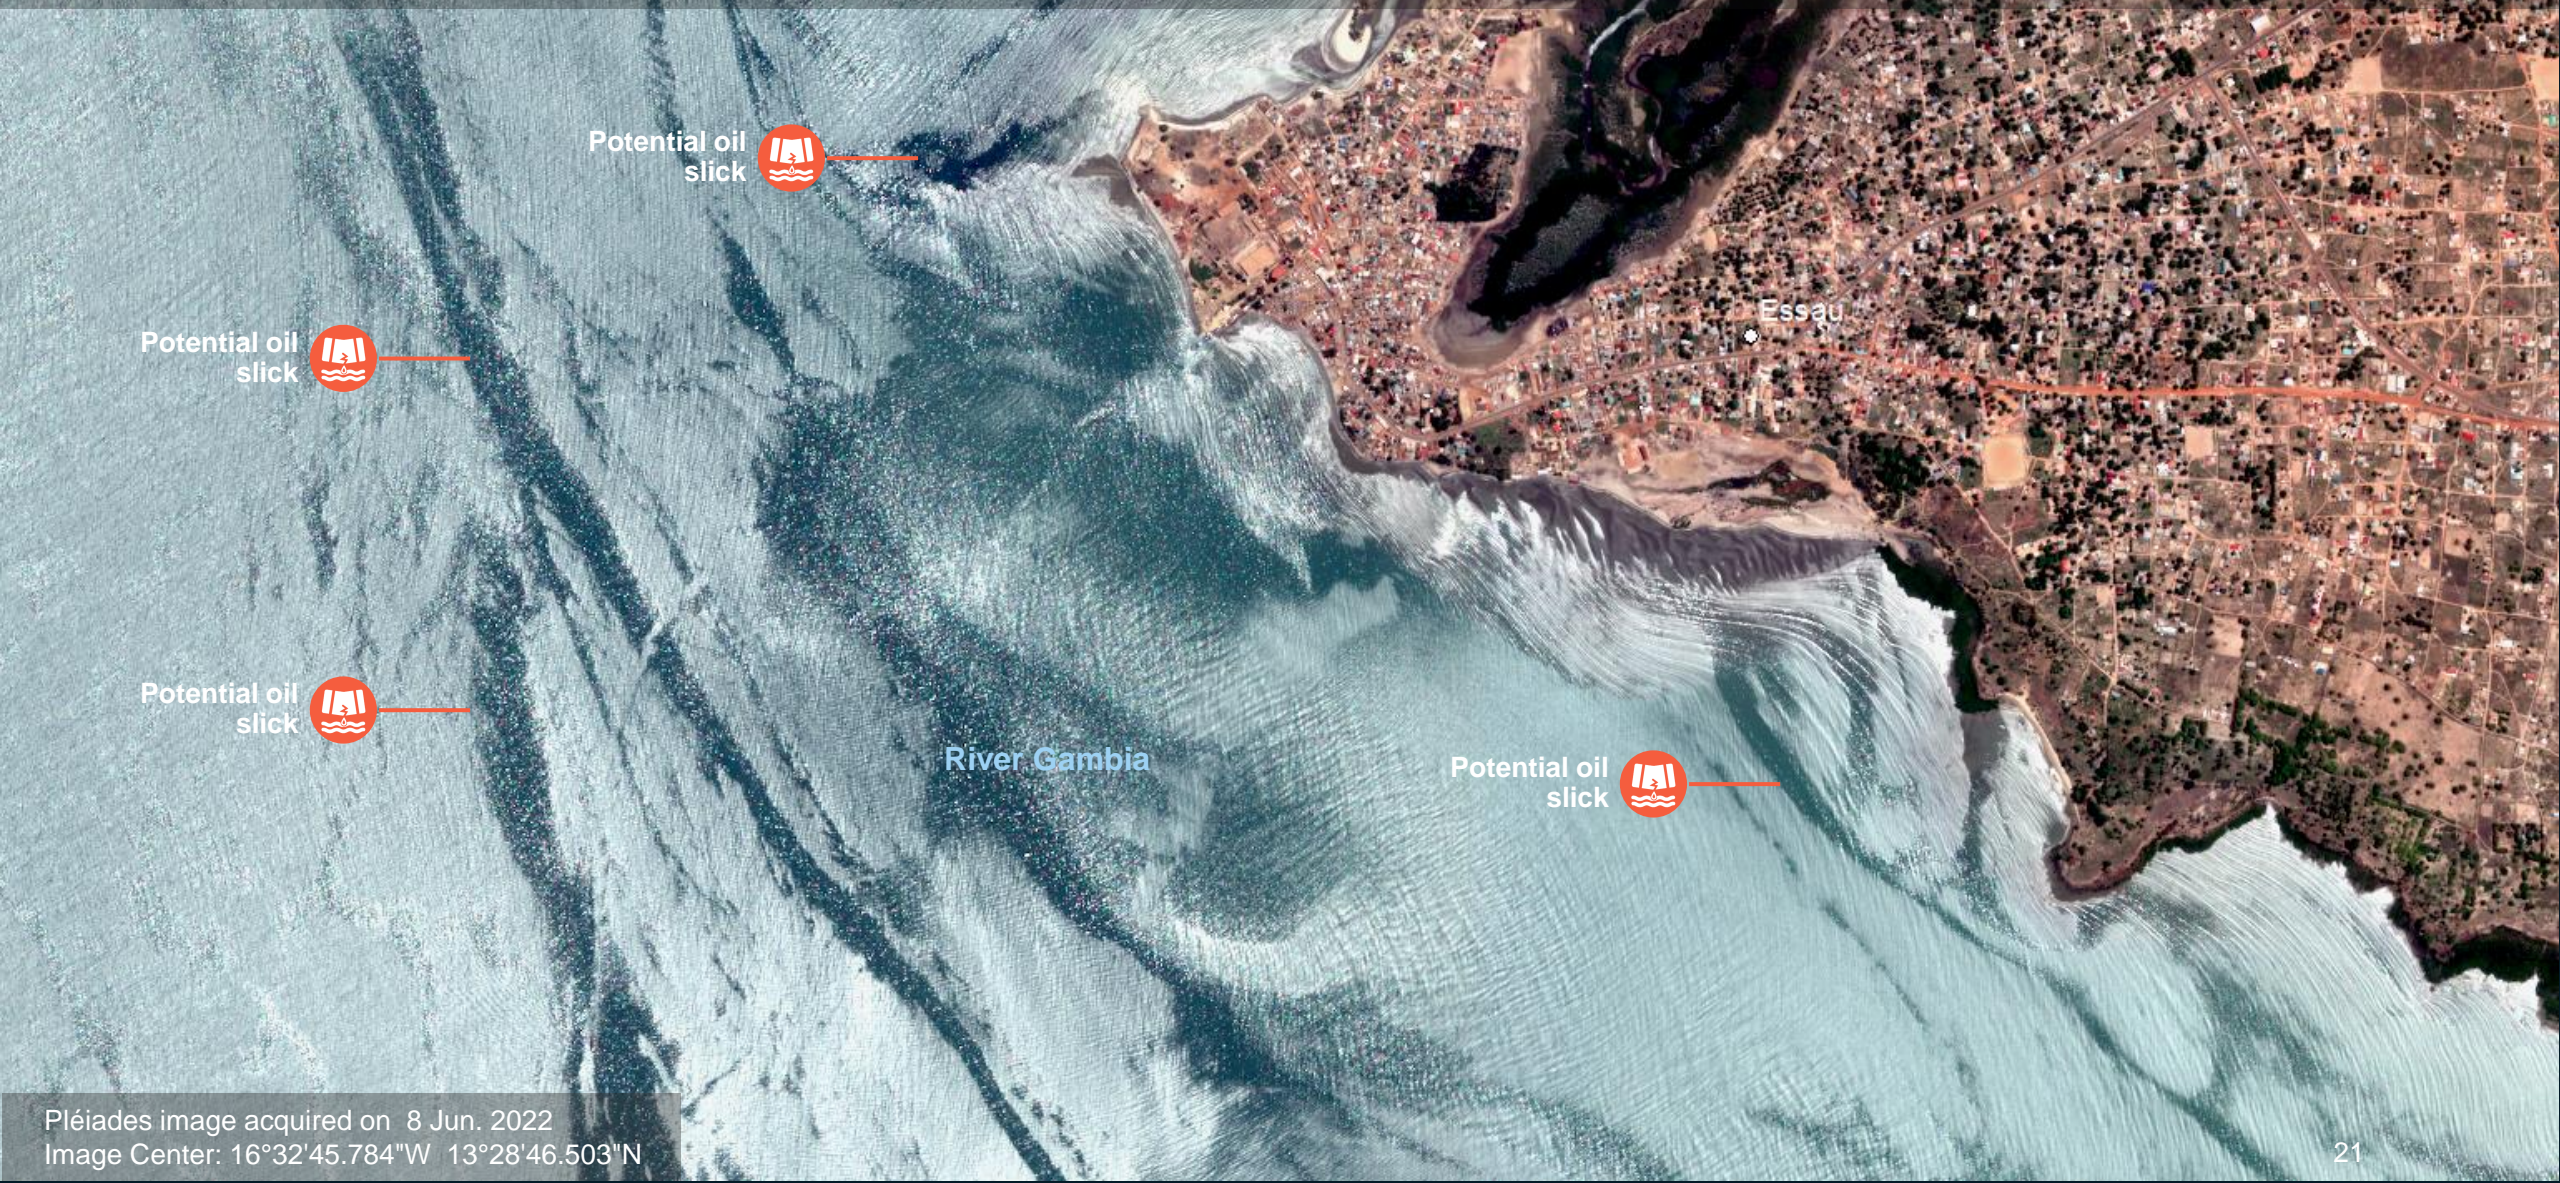
AOI 6-2- ALONG THE SHORELINE OF BANJUL TOWN 13 KM FROM MAIN FUEL DEPOT

Widespread potential oil slicks observed over the River Gambia
