Production Date: 12/11/2013  
Version 1.0  
Activation Number: TC20131108PHL

## ***DESTRUCTION IN MADREDIJOS, BANTAYAN ISLAND, PHILIPPINES***

*As seen in WorldView-2 imagery collected 11 November 2013*

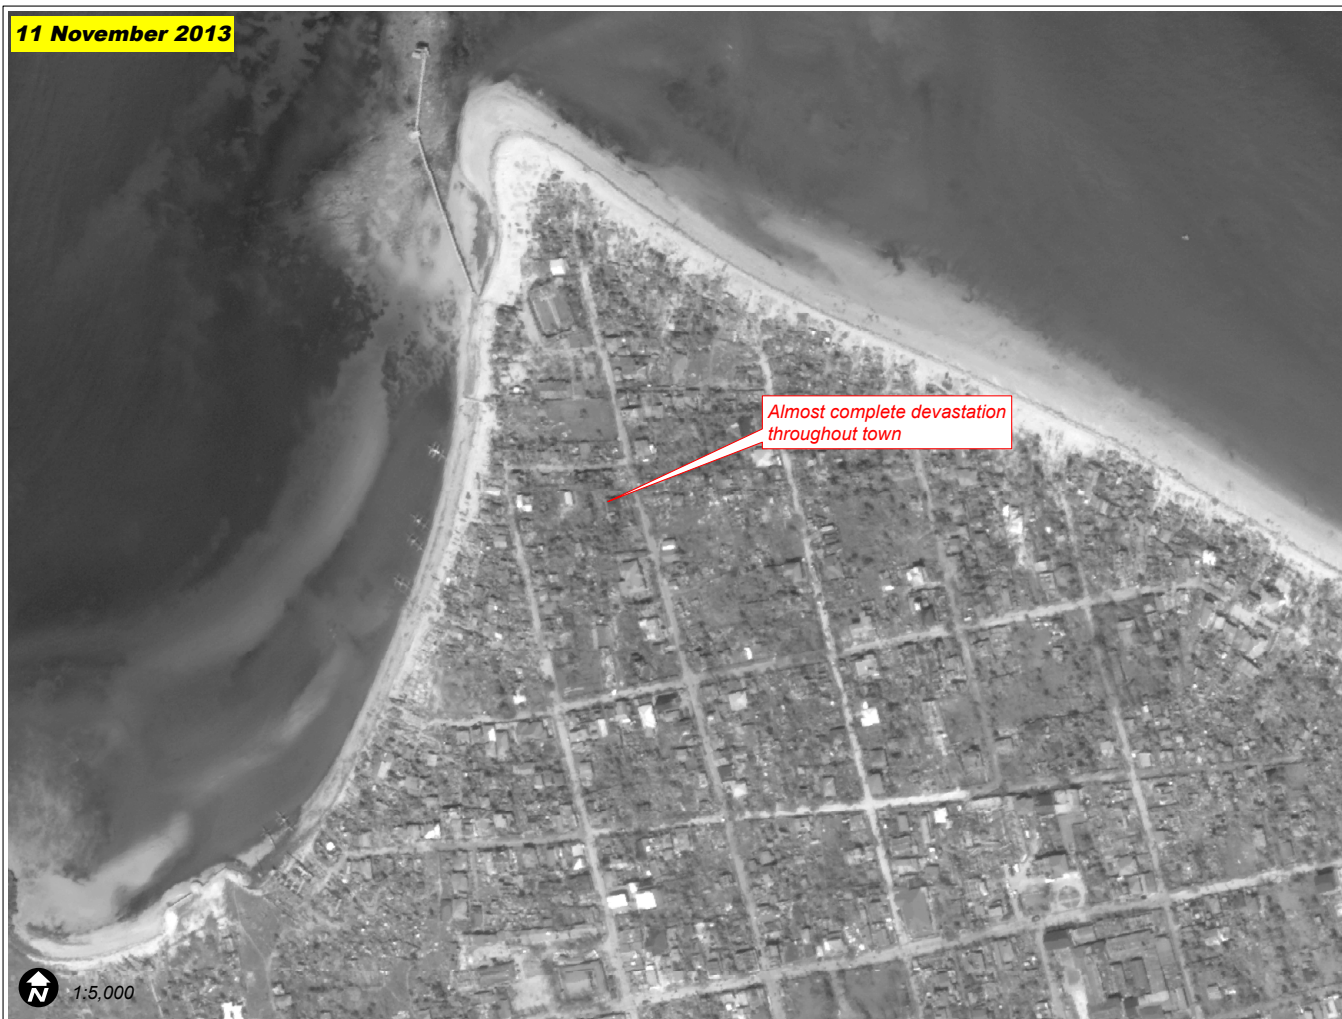
A portion of Madredijos municipality almost completely eradicated by Typhoon Haiyan. See Figure 1 (next page) for pre-disaster comparison.

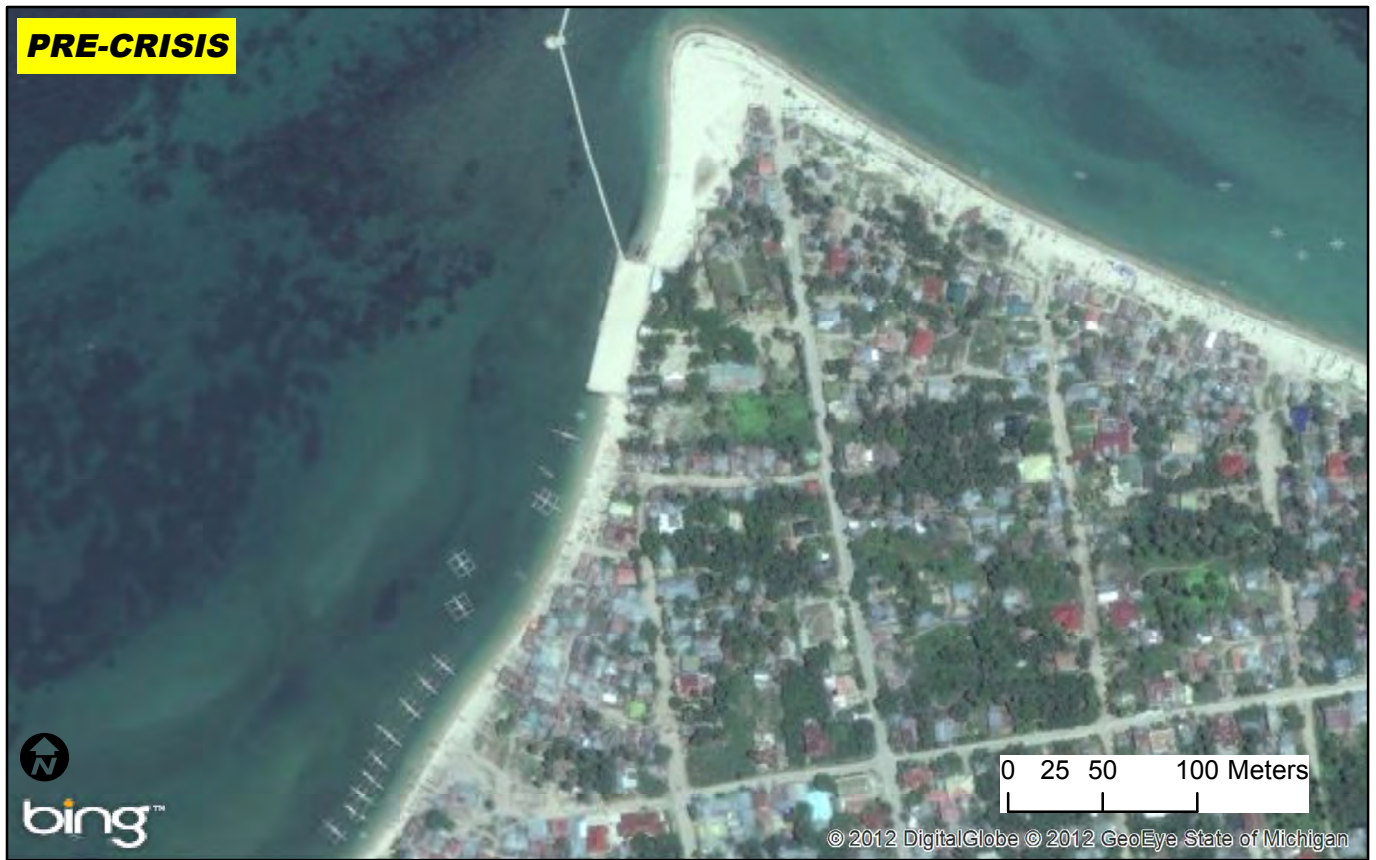
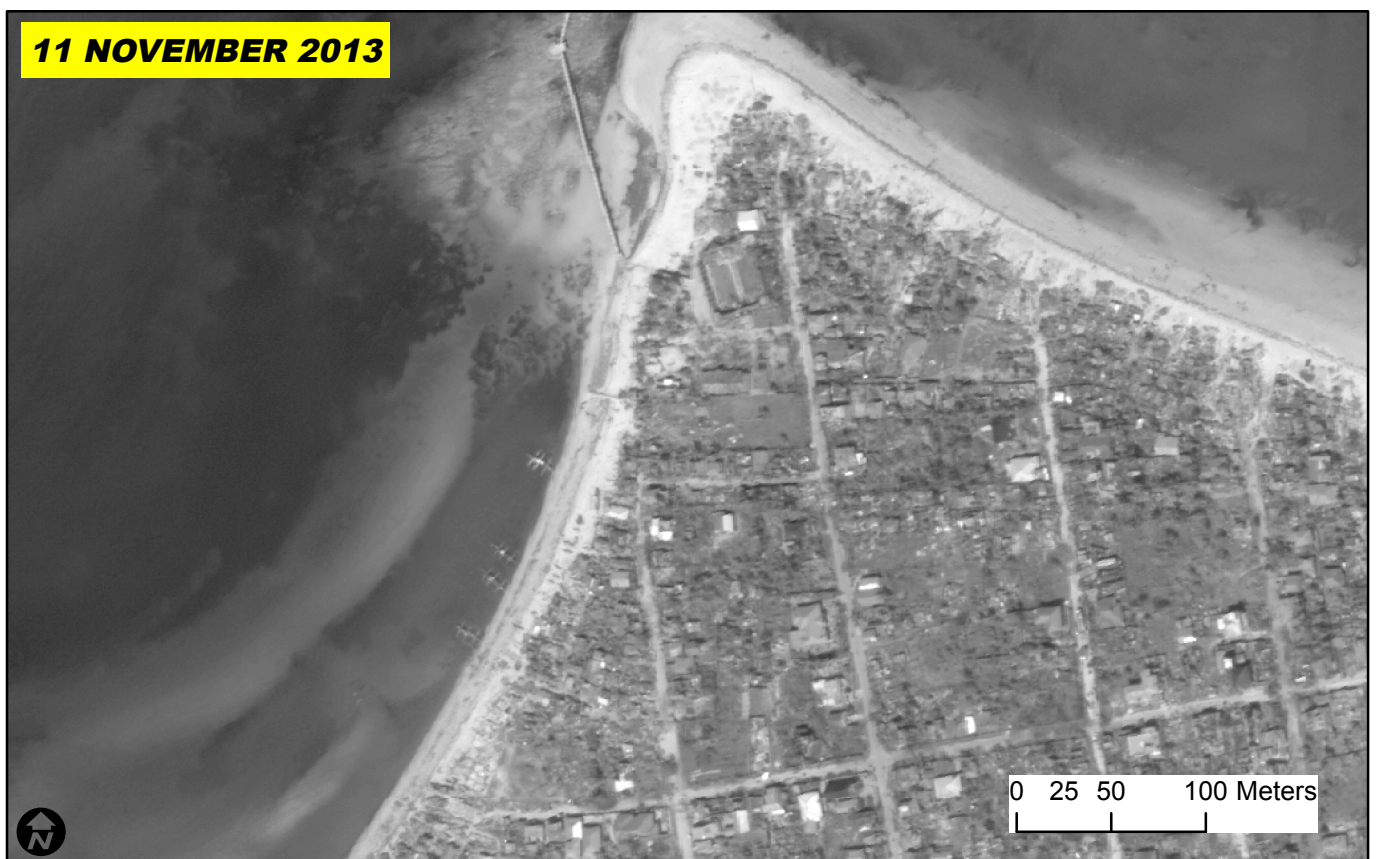
**Figure 1: Destruction in Madredijos Municipality**

*The northern end of the Madredijos municipality with multiple structures and tree cover visible intact in pre-crisis image (top) collected prior to Typhoon Haiyan. As of 11 November 2013 (bottom) most structures are gone with proximate debris indicative of complete destruction, and most tree cover likewise destroyed.*
