Activation Number: TC20131108PHL

DAMAGE TO CHINDOLAN ISLAND, PALAWAN, PHILIPPINES

As seen in Pleiades imagery collected 15 November 2013

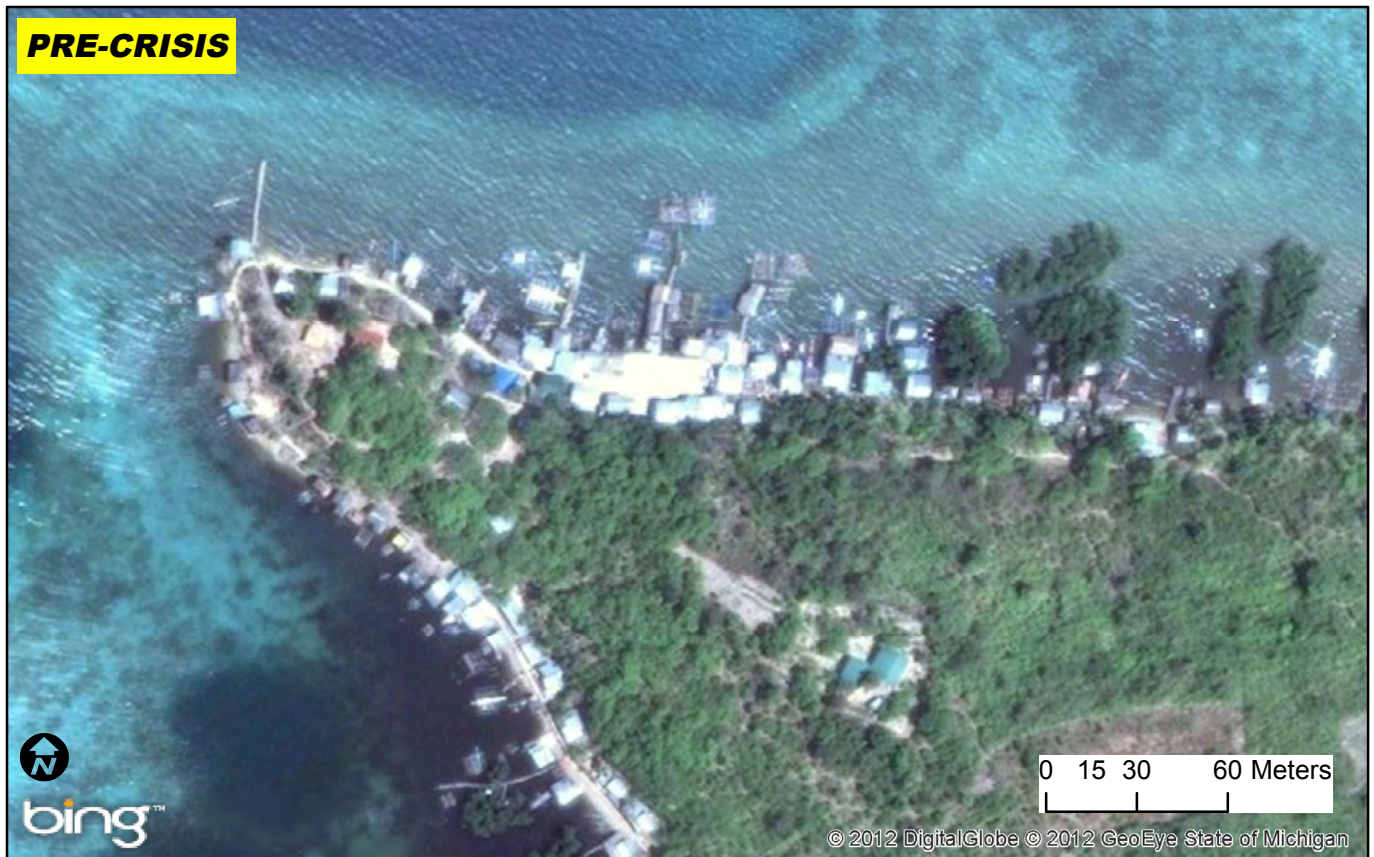
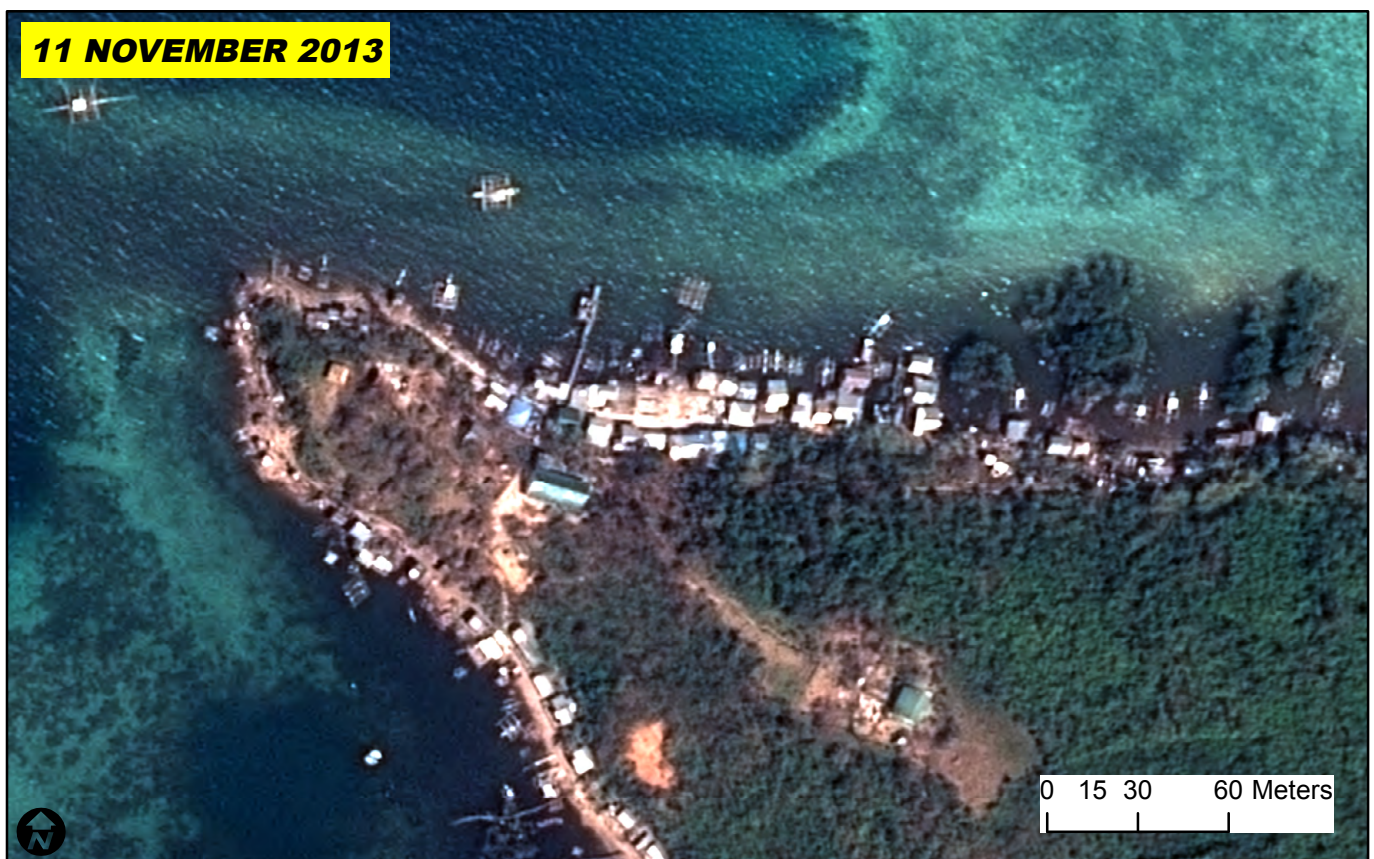
Figure 1: Damage in Chindolan Island, Palawan

A small village on Chindolan Island in Palawan in pre-crisis image (top), and as of 11 November 2013 (bottom) showing moderate signs of damage, including areas of vegetation loss, some destroyed structures, and marine debris. Conditions are similar in other areas sampled in northern Palawan, with damage apparent but no extreme losses similar to Leyte and elsewhere to the east.
