Production Date: 15/11/2013
Version 1.0
Activation Number: TC20131108PHL

DAMAGE TO TACLOBAN OIL DEPOT, TACLOBAN CITY, PHILIPPINES

As seen in WorldView-1 imagery collected 11 November 2013

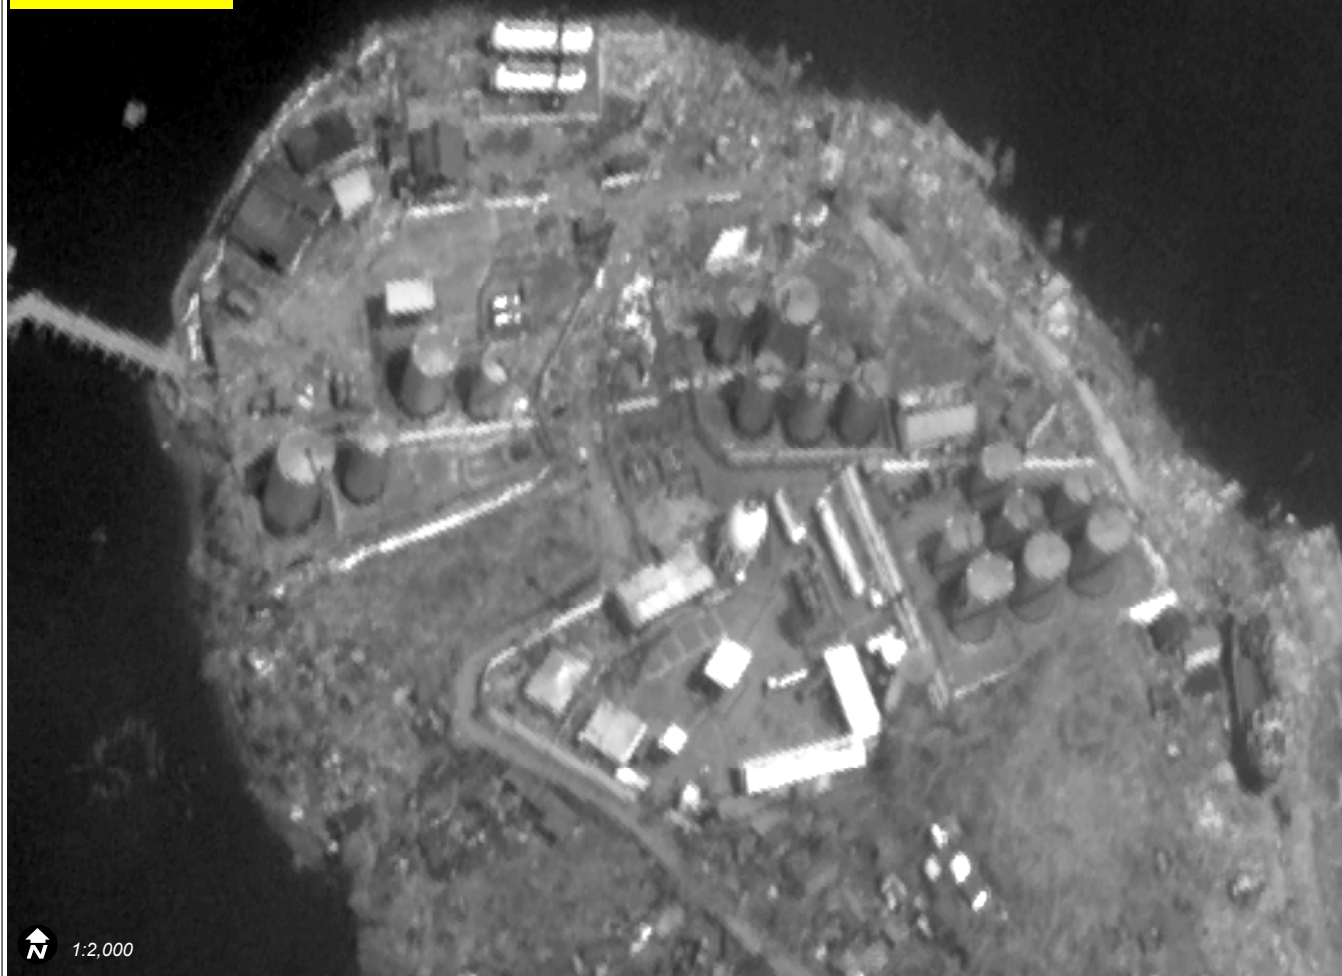
11 November 2013

The oil depot in Tacloban City on 11 November 2013. Surrounding structures and infrastructure sustained heavy damage. See Figure 1 (next page) for pre-disaster comparison.

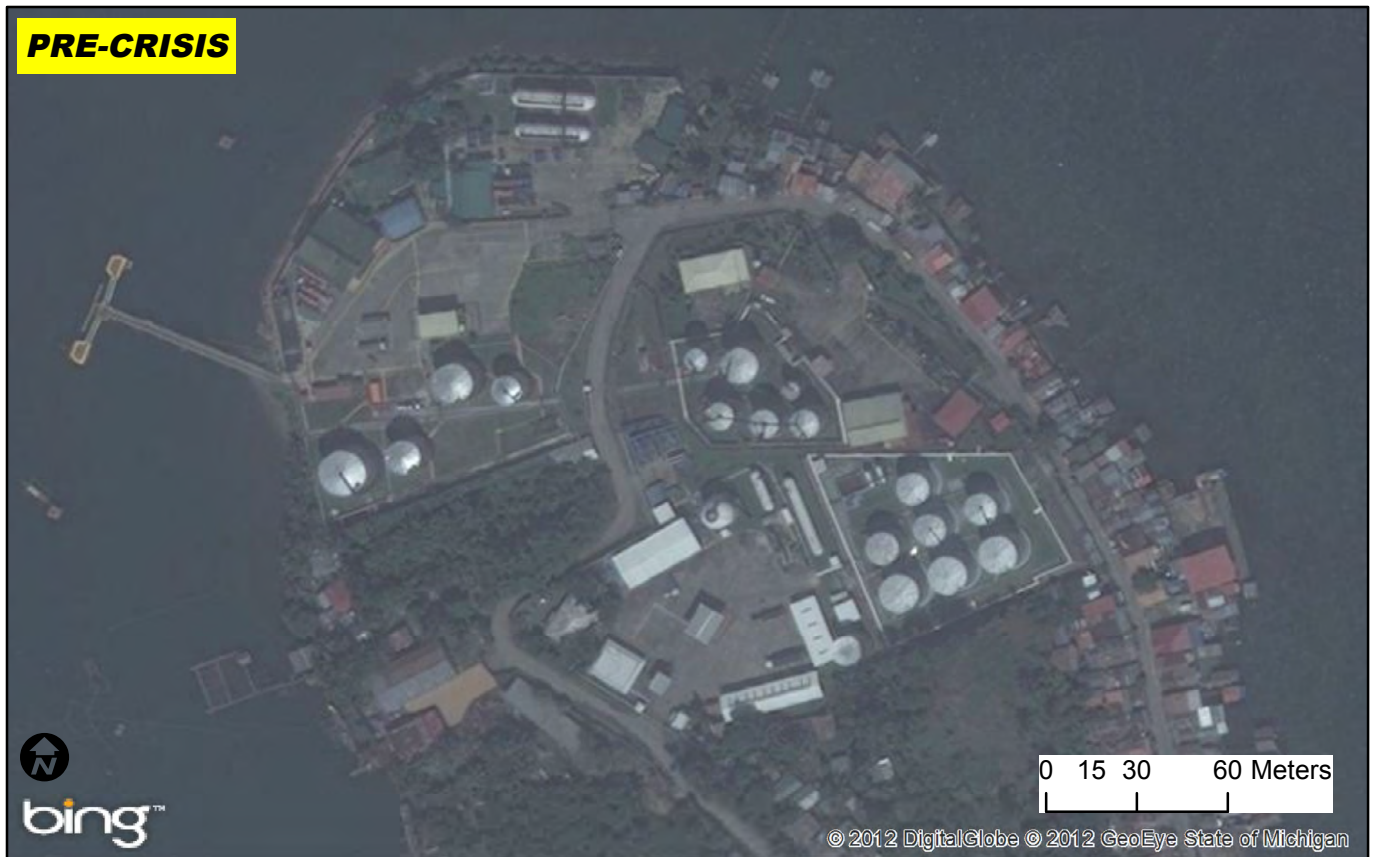
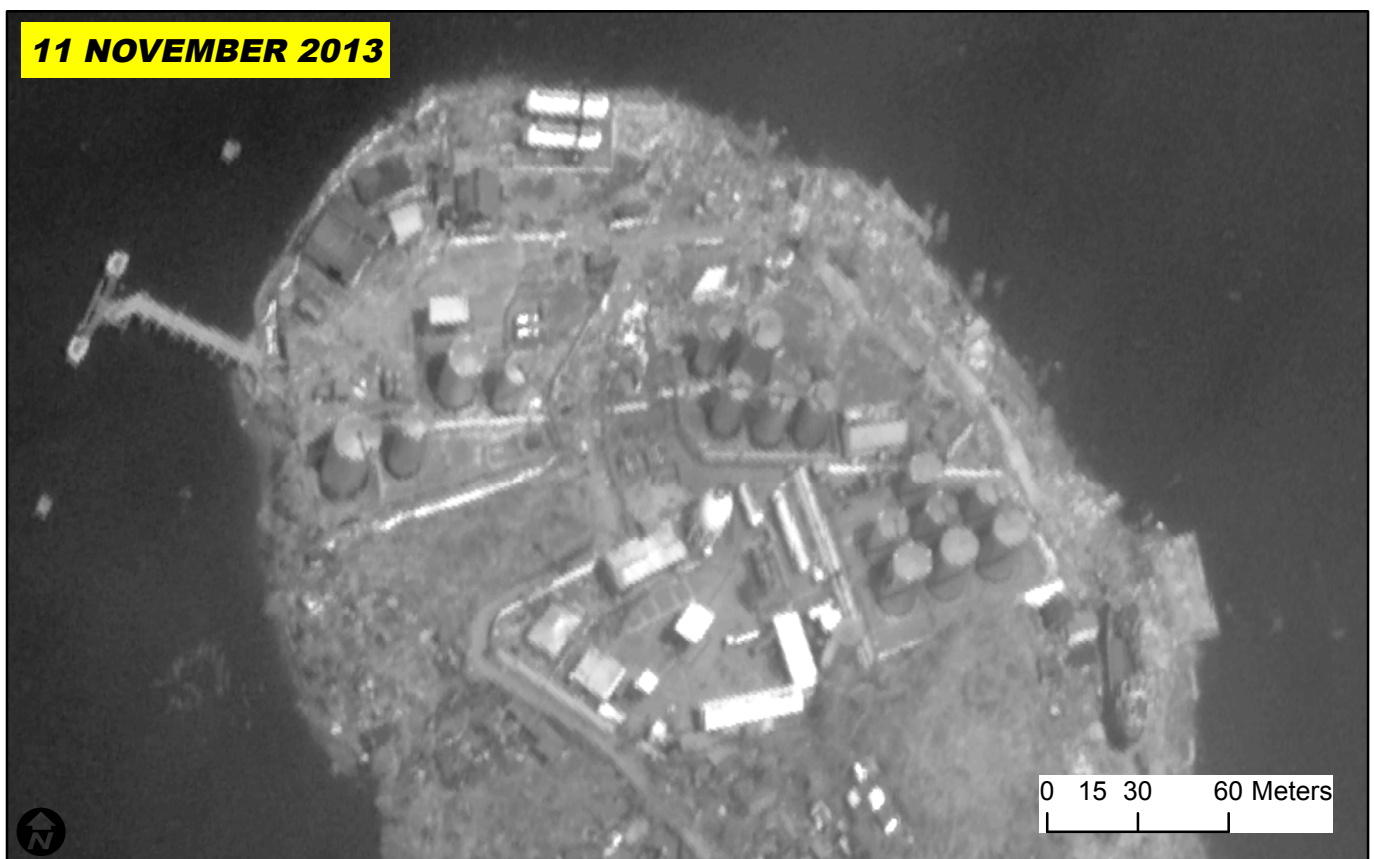
Figure 1: Destruction at Tacloban Oil Depot

The Tacloban oil depot visibly intact in pre-crisis image (top) collected prior to Typhoon Haiyan. As of 11 November 2013 (bottom) many proximate structures and docks are eradicated with proximate debris indicative of complete destruction, and areas of tree cover are likewise destroyed. Primary depot buildings and tanks seem largely intact.
