5 May 2023

# PRELIMINARY SATELLITE- FLOOD ASSESSMENT REPORT

Nyabarongo River, Western, Northern, Southern Provinces and Kigali City, Rwanda

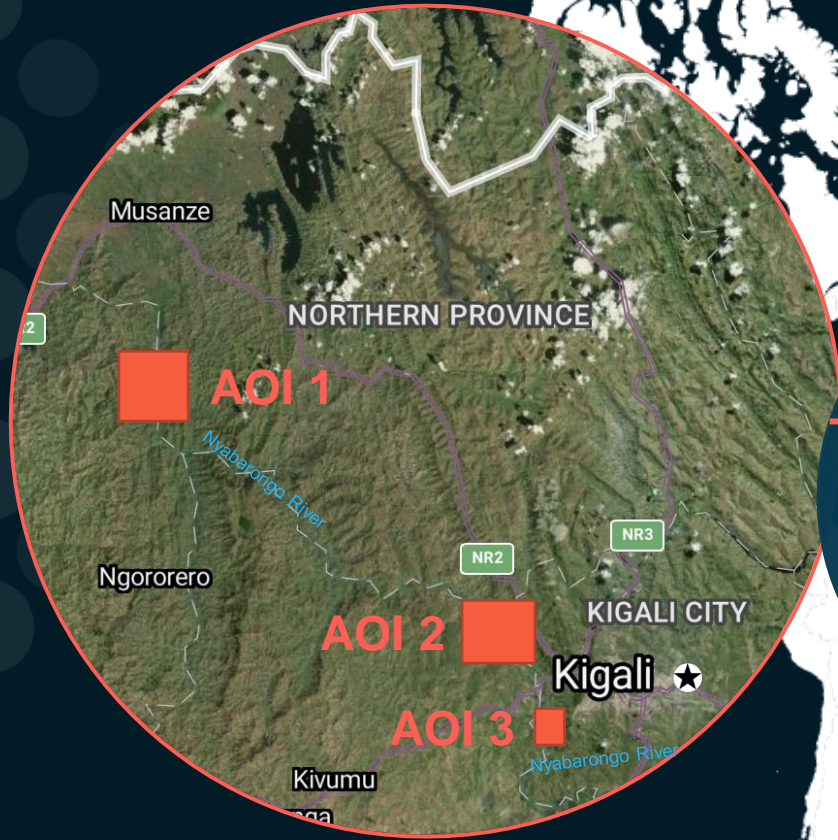
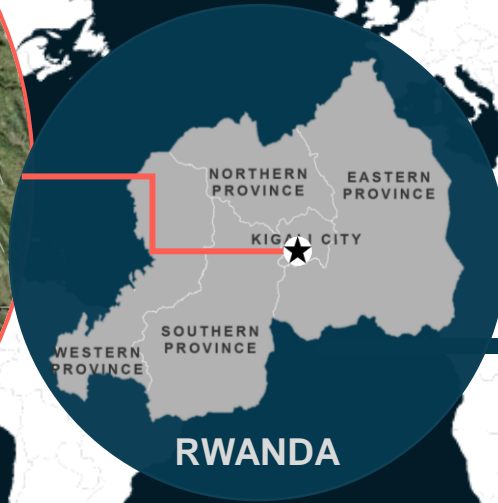
# AOI 1 – 1: VUNGA VILLAGE, NYABIHU DISTRICT, WESTERN PROVINCE, RWANDA

Increased water and washed away area along the Nyabarongo River

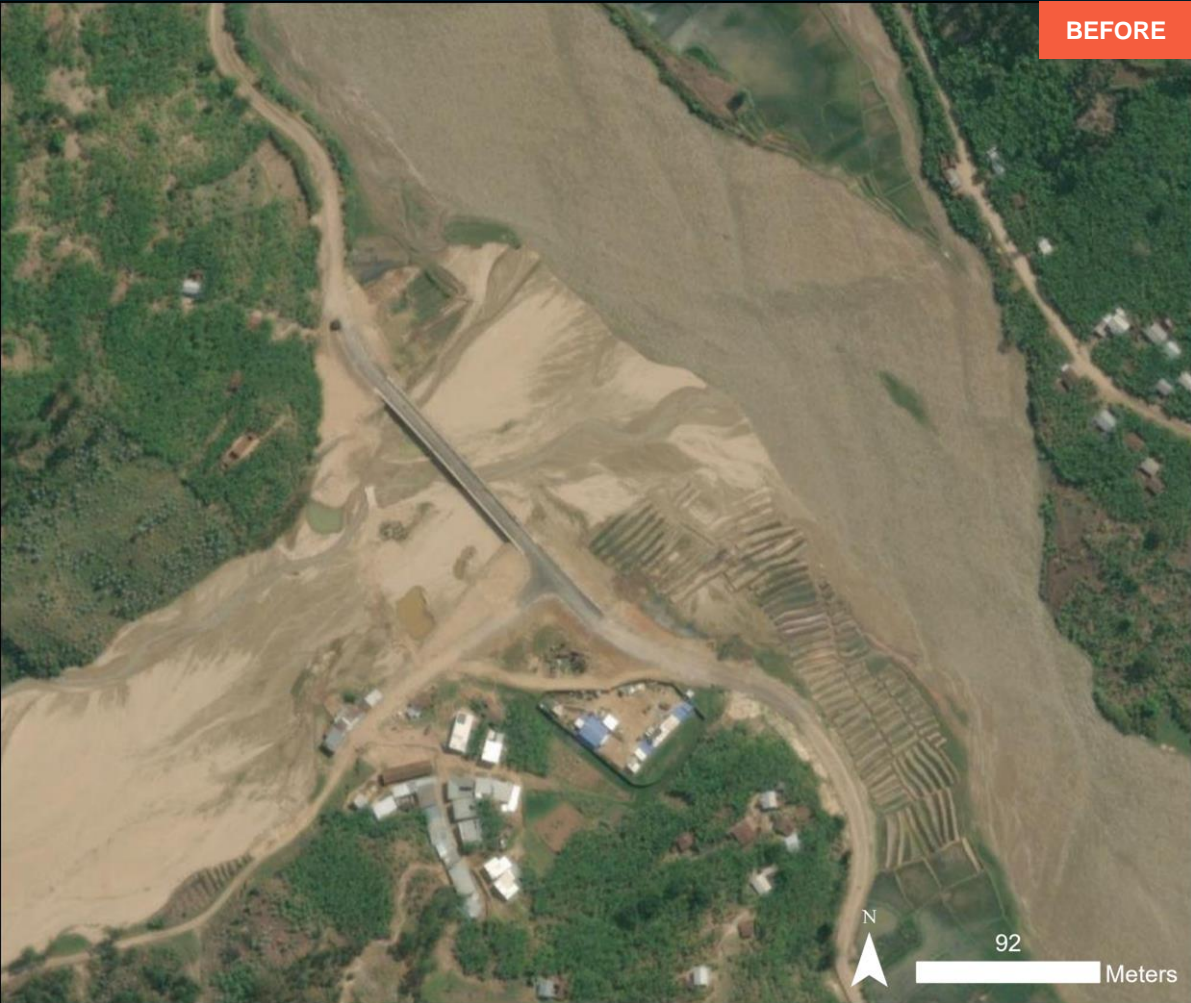
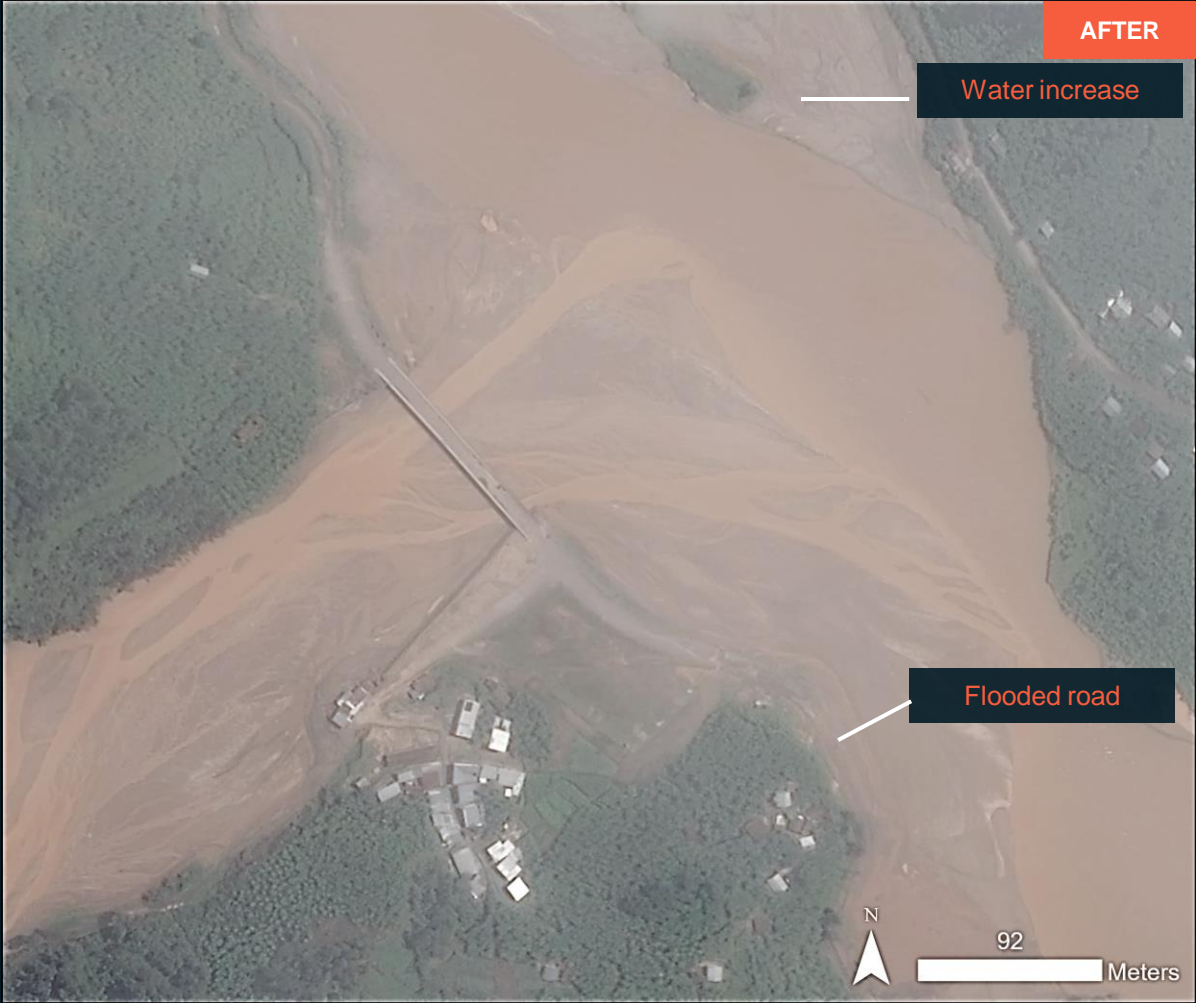
# AOI 1 – 2: NYABIHU DISTRICT, WESTERN PROVINCE, RWANDA

Increased water and flooded road along the Nyabarongo River

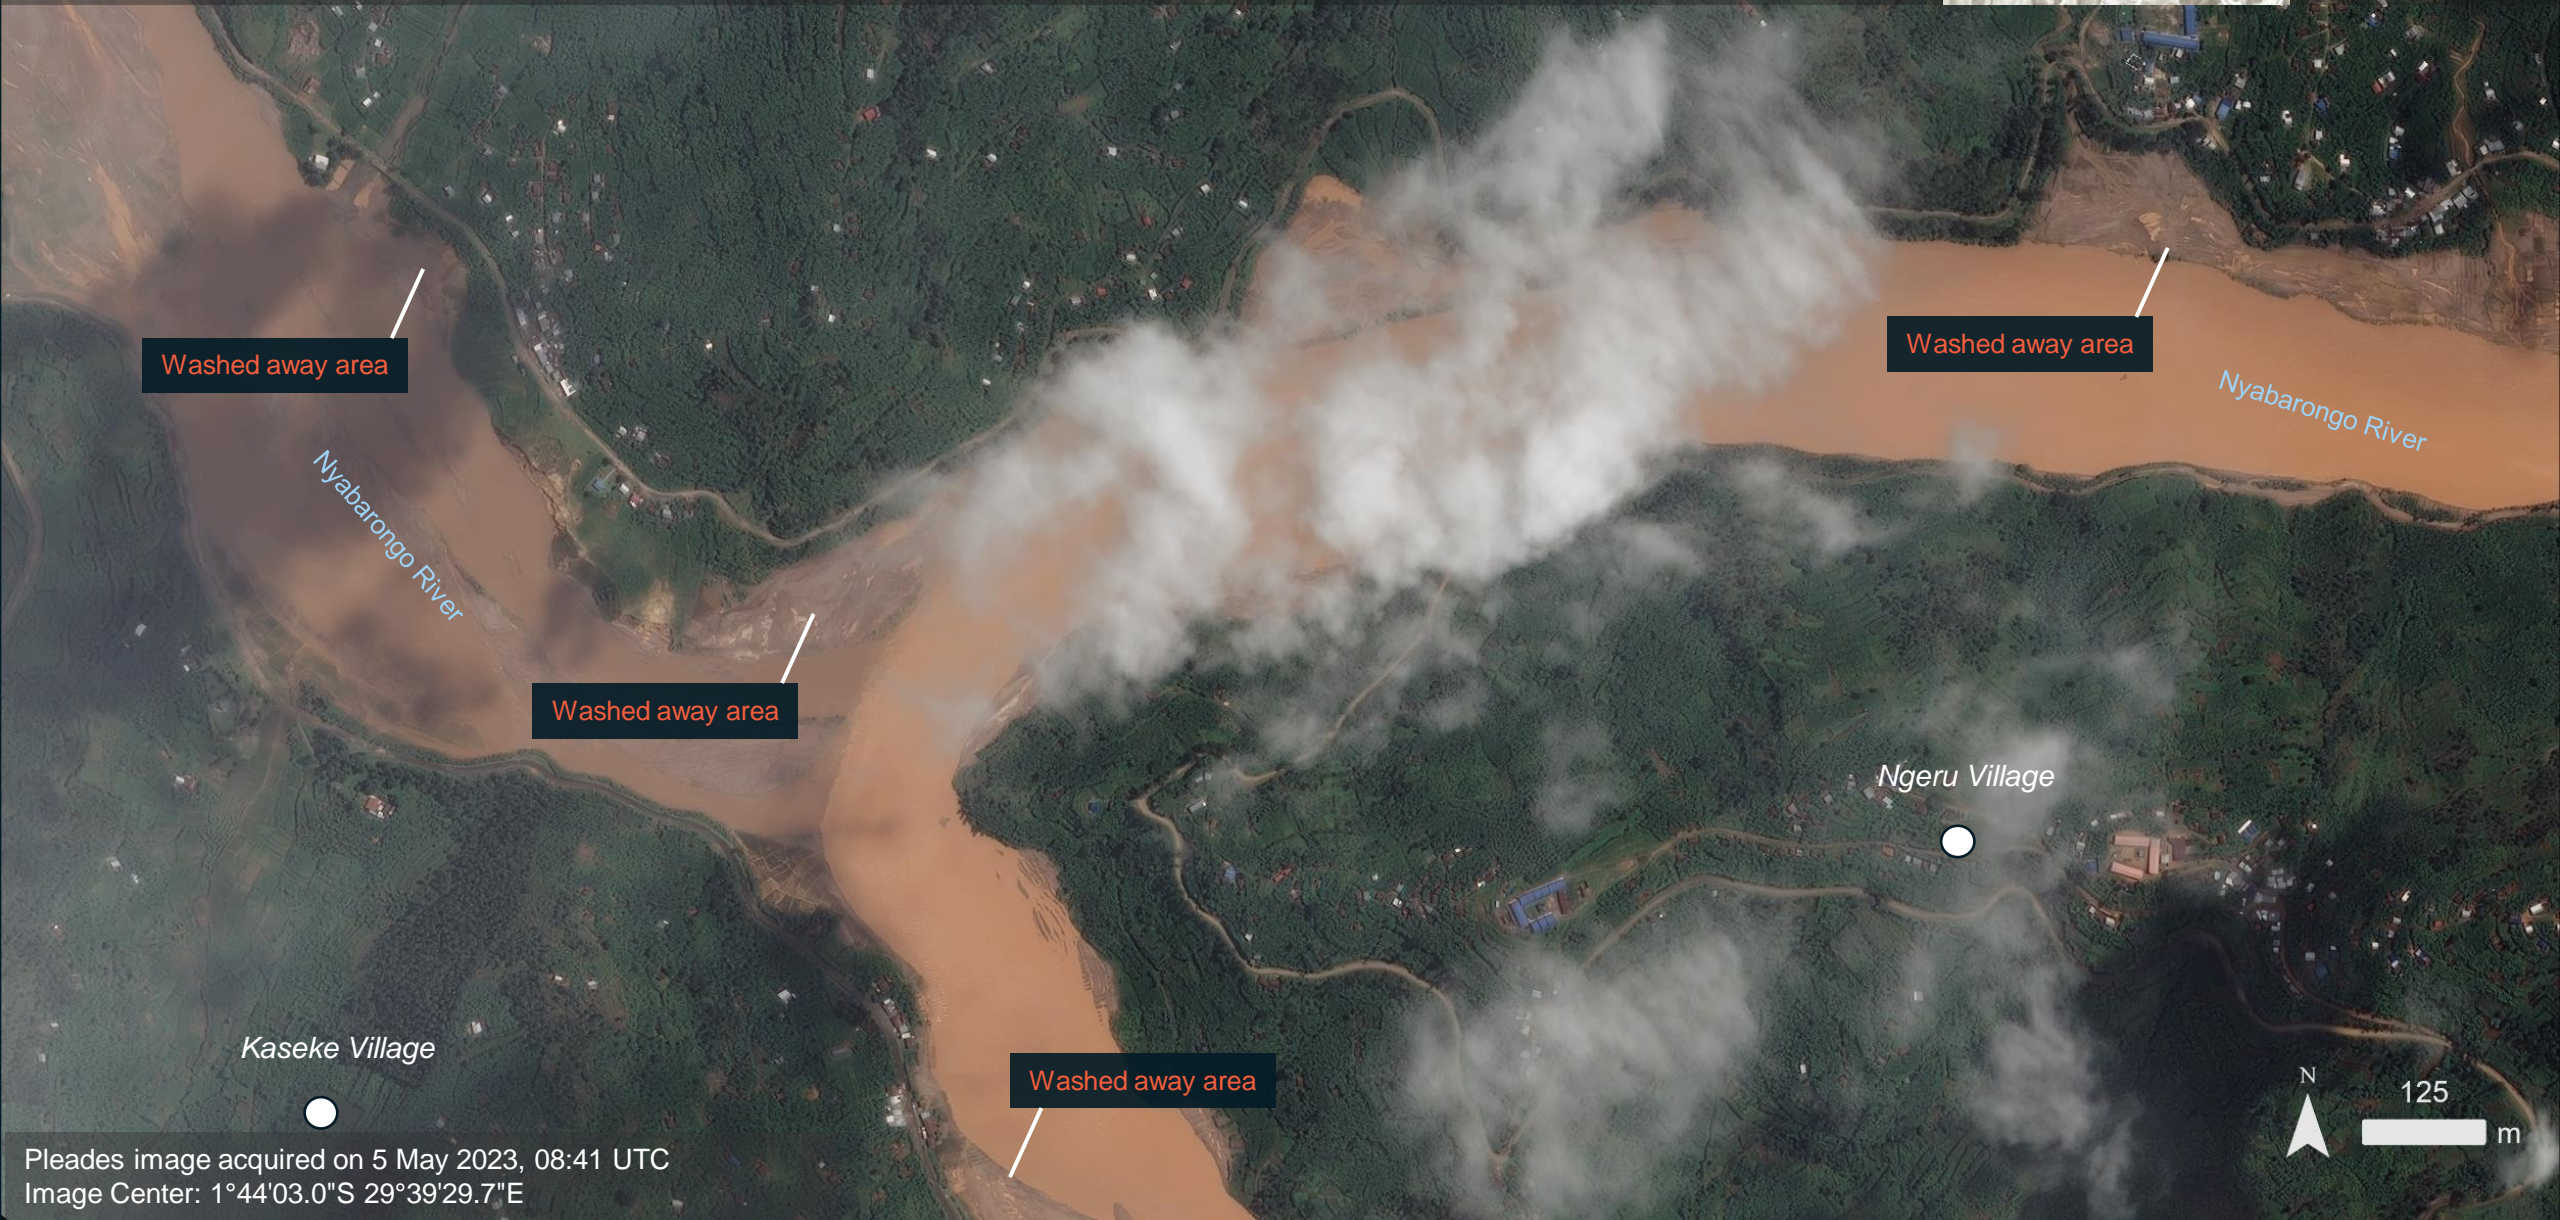
# AOI 1-3: RIVER MEETING POINT BETWEEN NORTHERN, WESTERN AND SOUTHERN PROVINCES, RWANDA

Washed away area along the Nyabarongo River

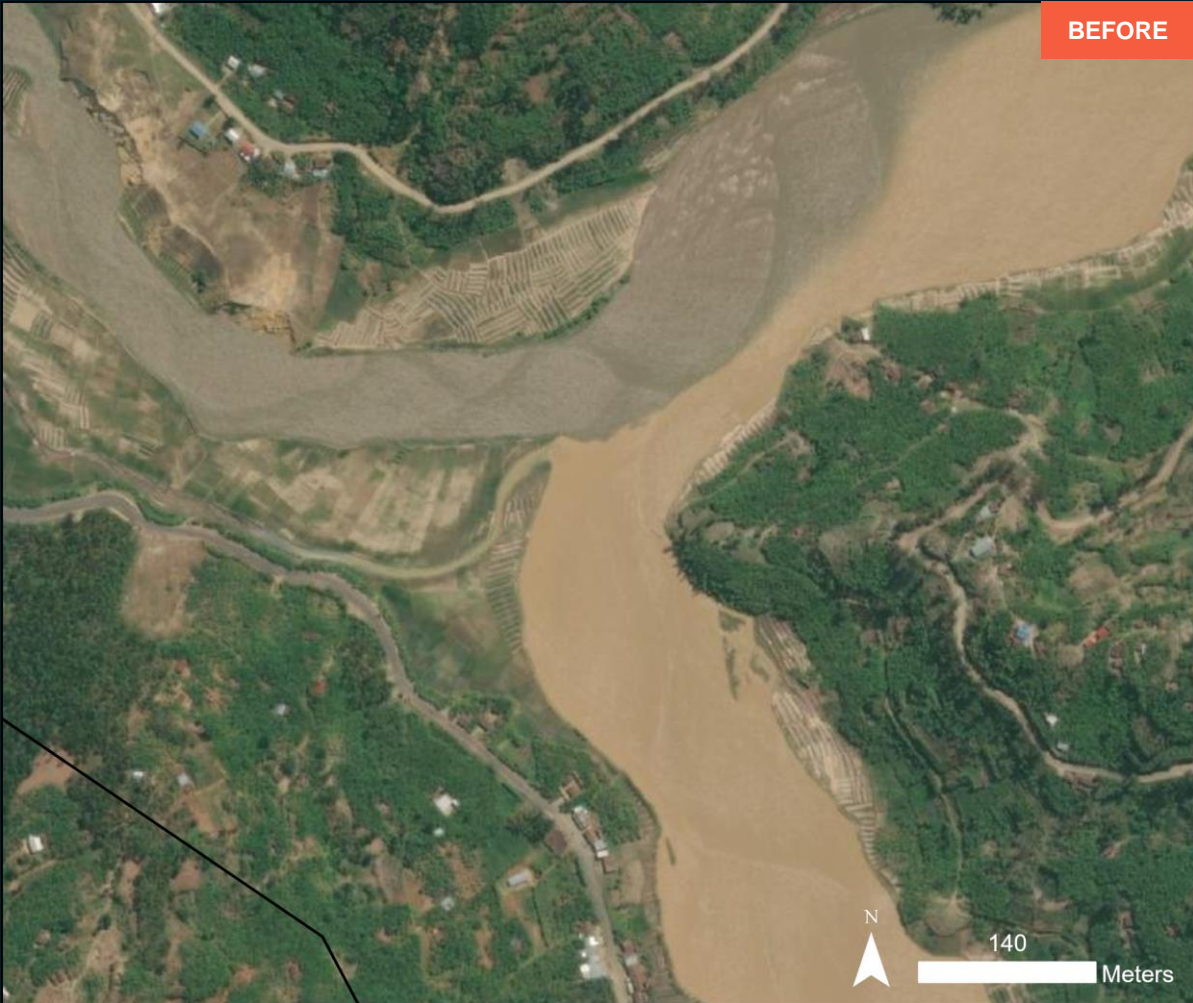
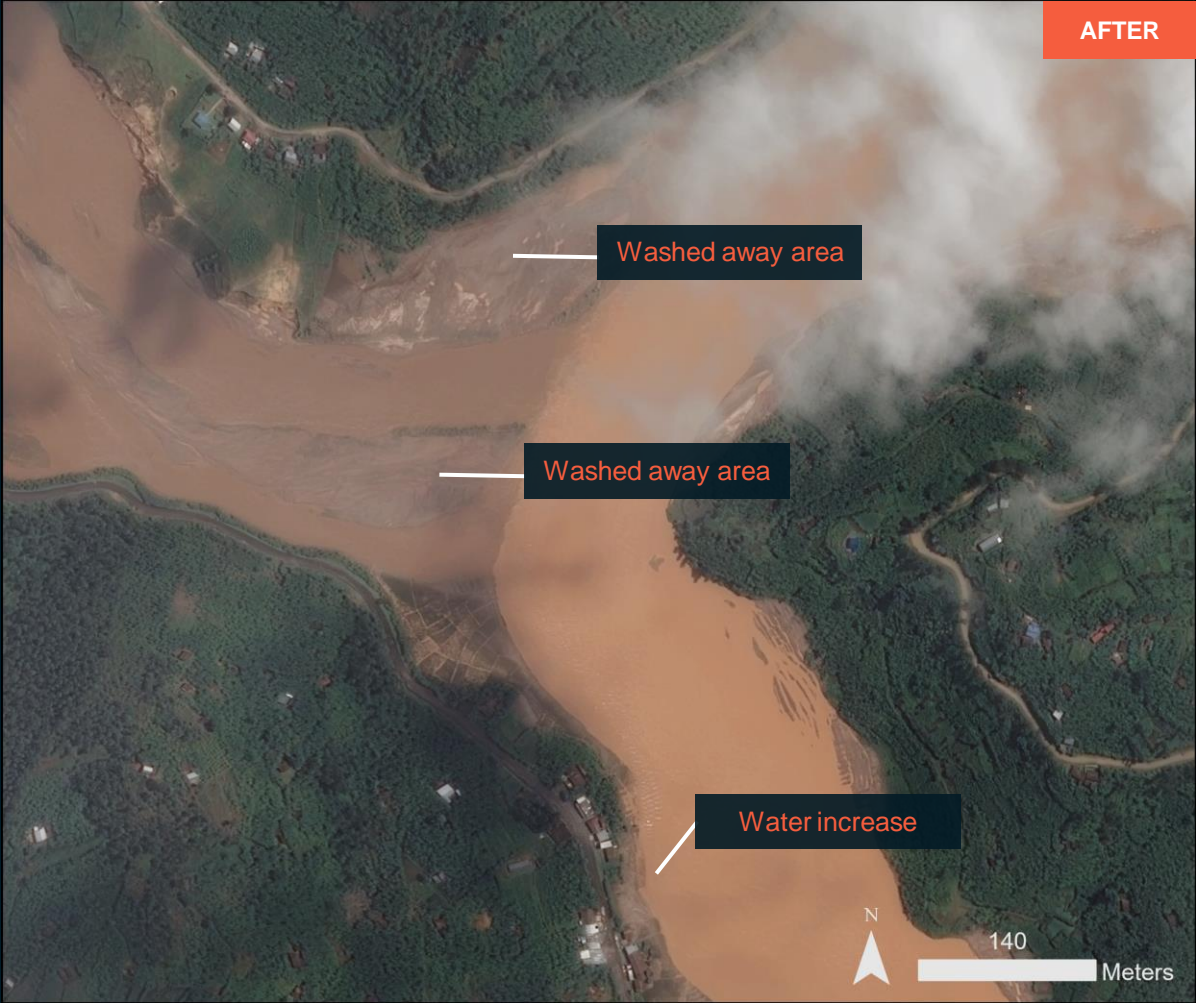
# AOI 1-3: NYABARONGO RIVER MEETING POINT BETWEEN NORTHERN, WESTERN AND SOUTHERN PROVINCES, RWANDA

Increased water and washed away area along the Nyabarongo River

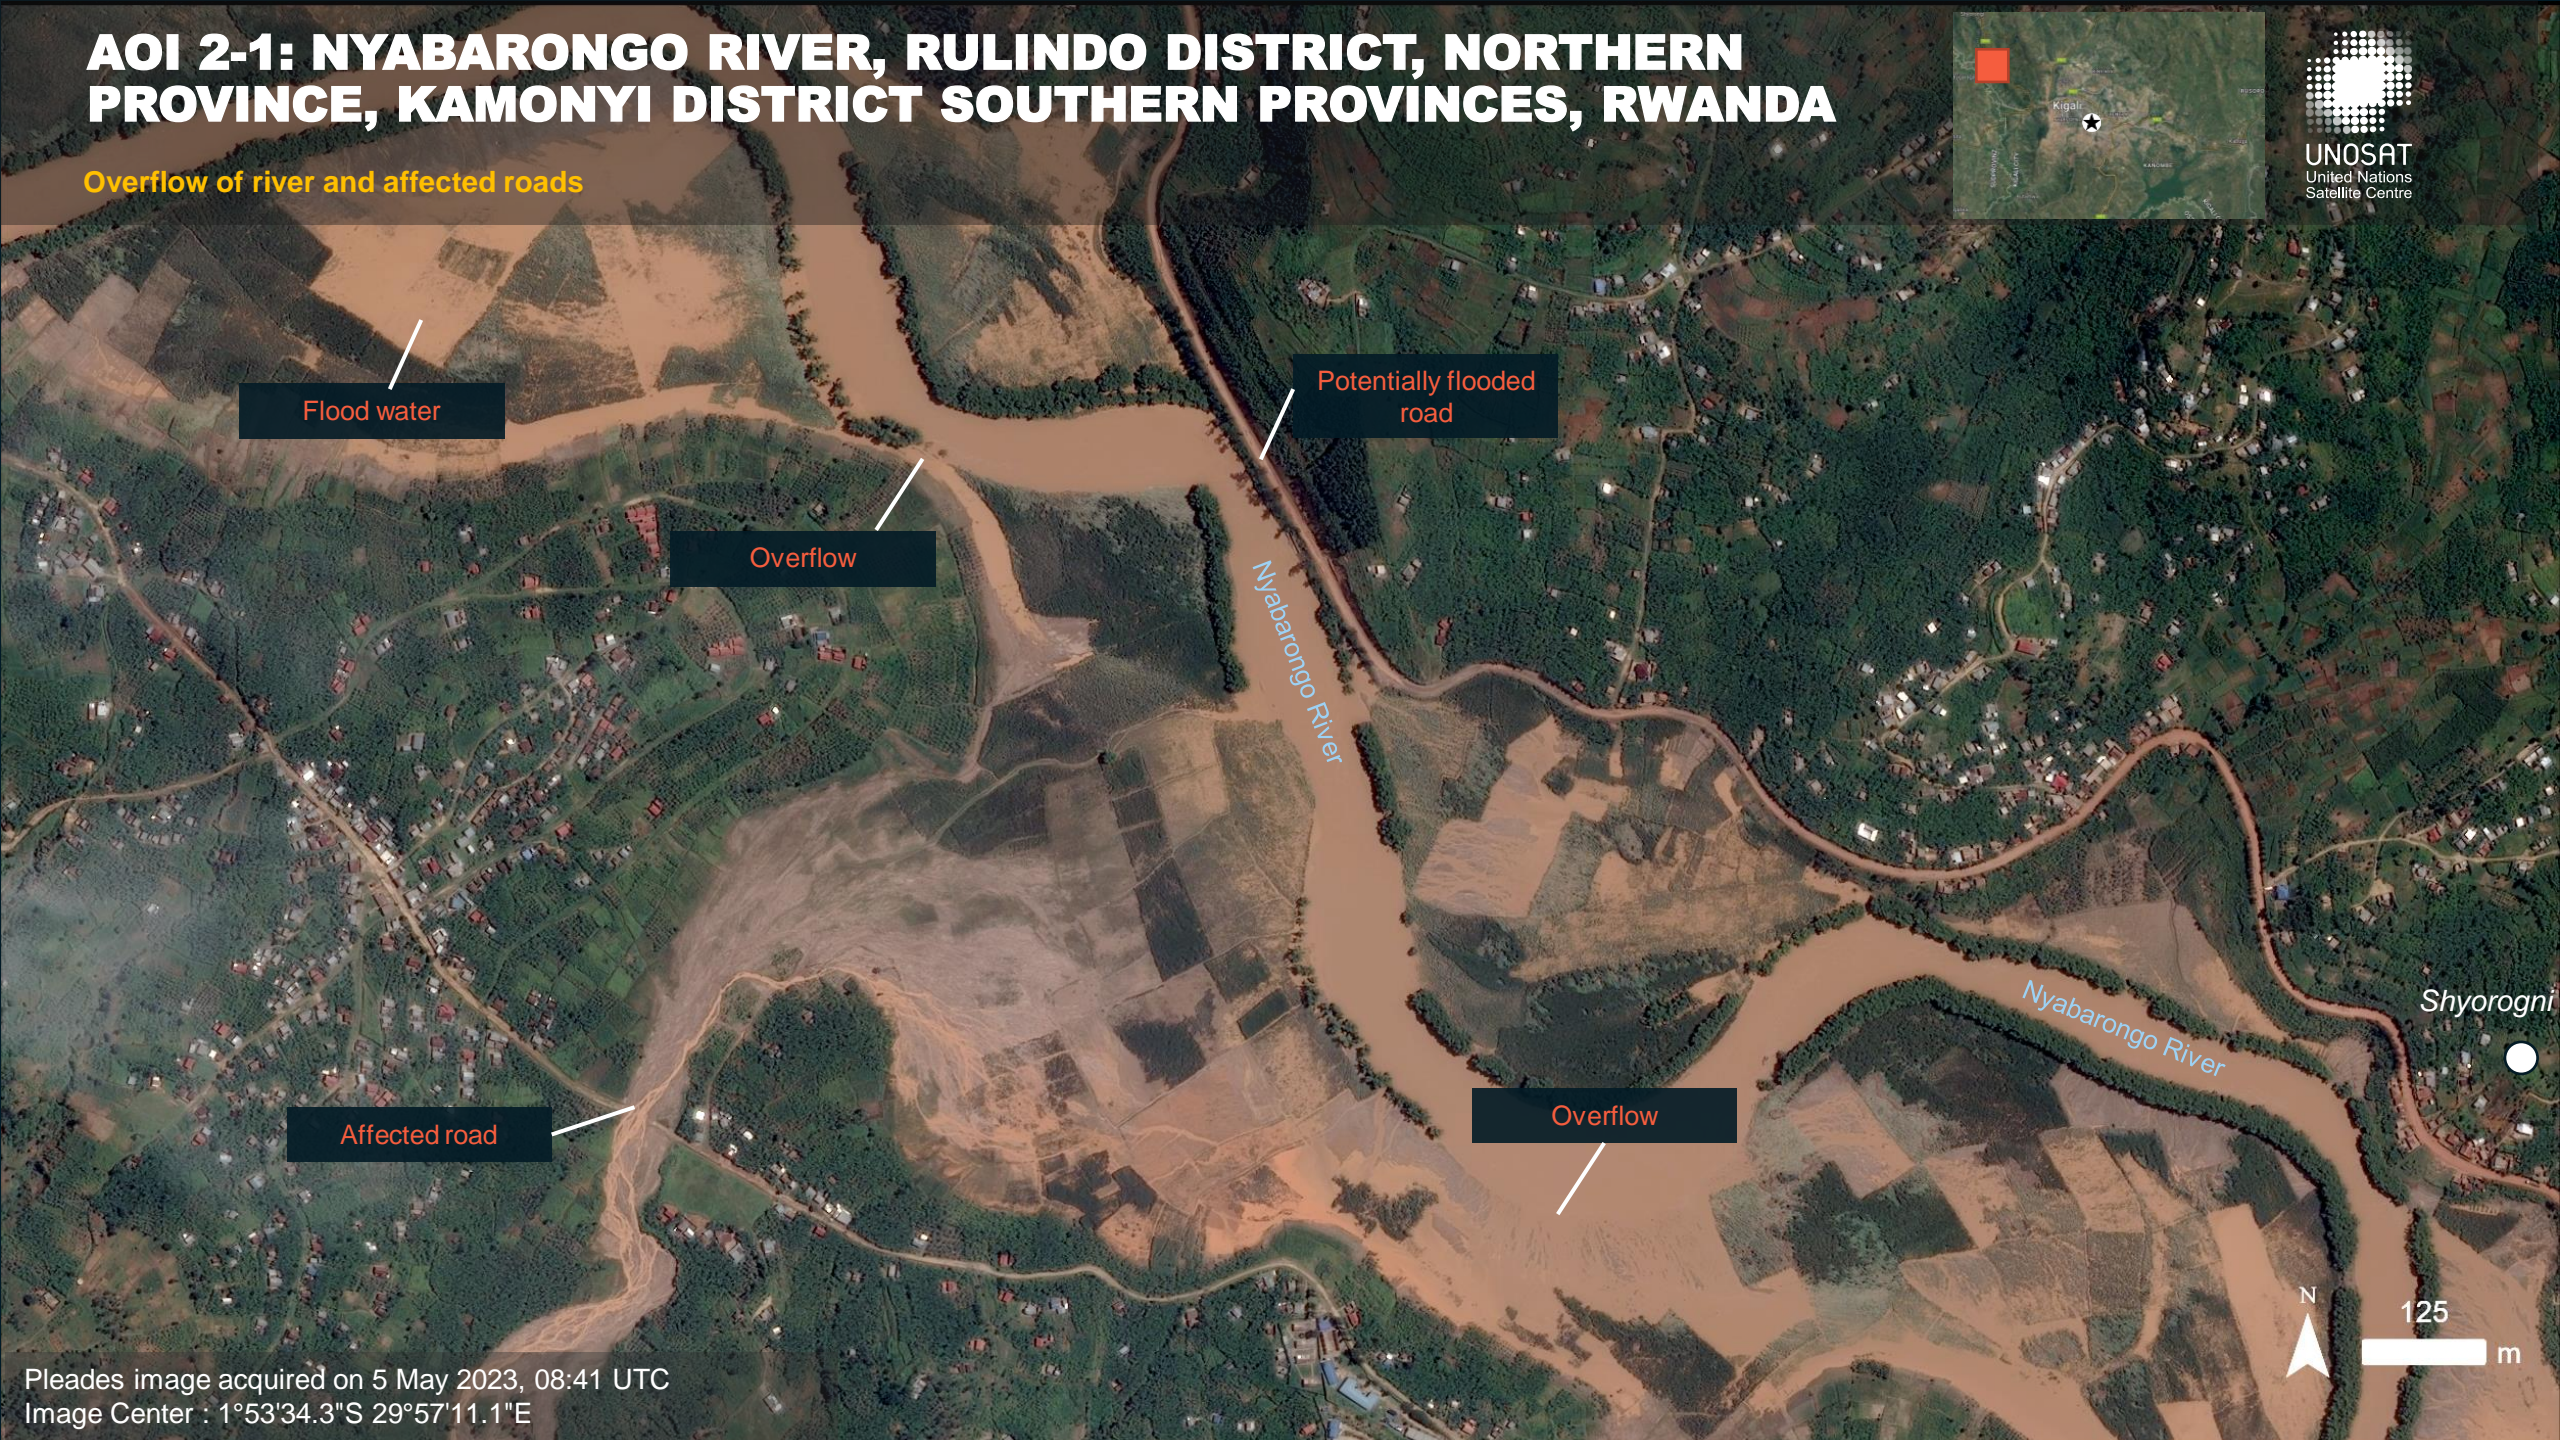
# AOI 2-1: NYABARONGO RIVER, RULINDO DISTRICT, NORTHERN PROVINCE, KAMONYI DISTRICT SOUTHERN PROVINCES, RWANDA

Overflow of river and affected roads

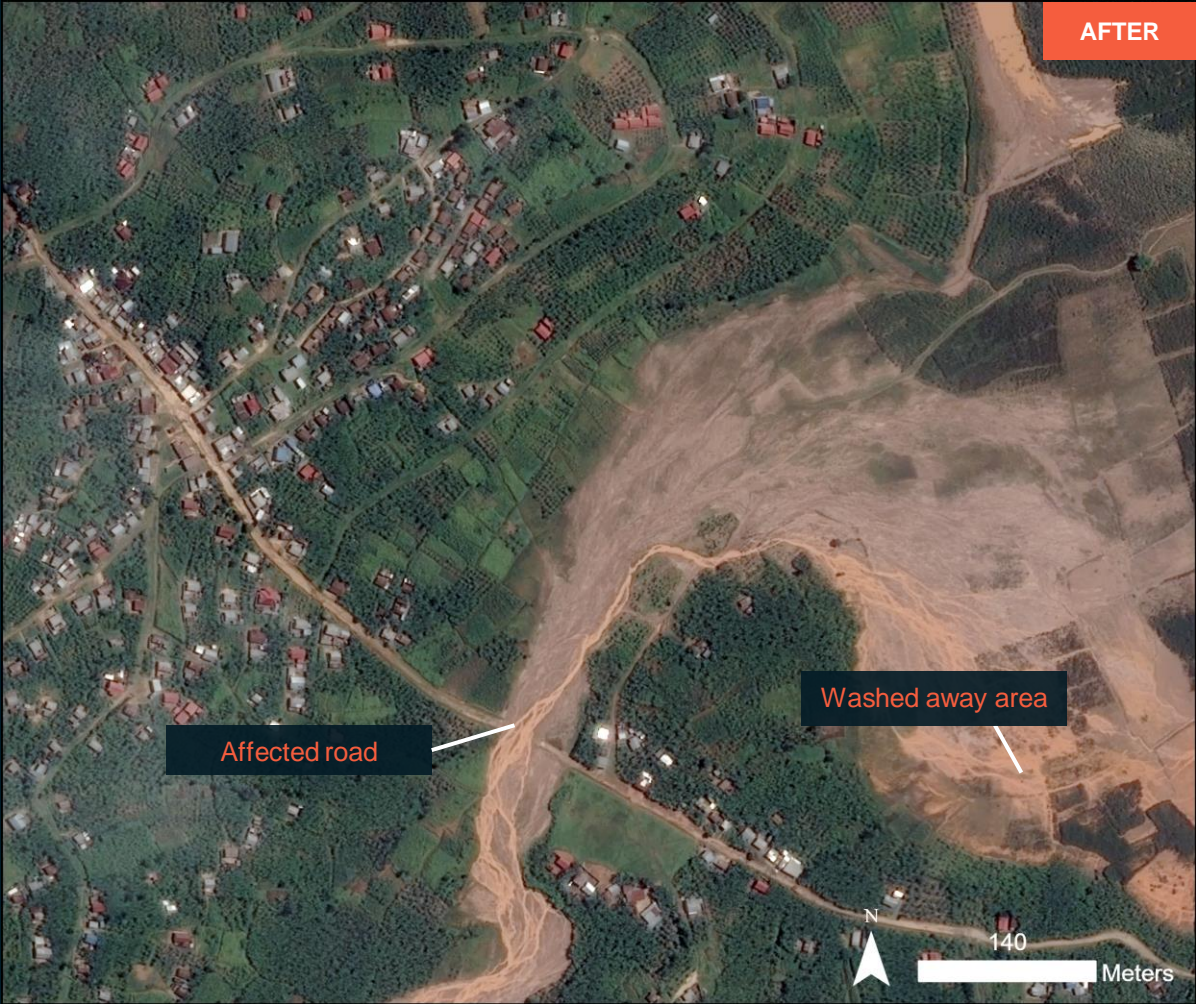
# AOI 2-1 : NYABARONGO RIVER, RULINDO DISTRICT, NORTHERN PROVINCE, KAMONYI DISTRICT SOUTHERN PROVINCES, RWANDA

Overflow of river and affected roads

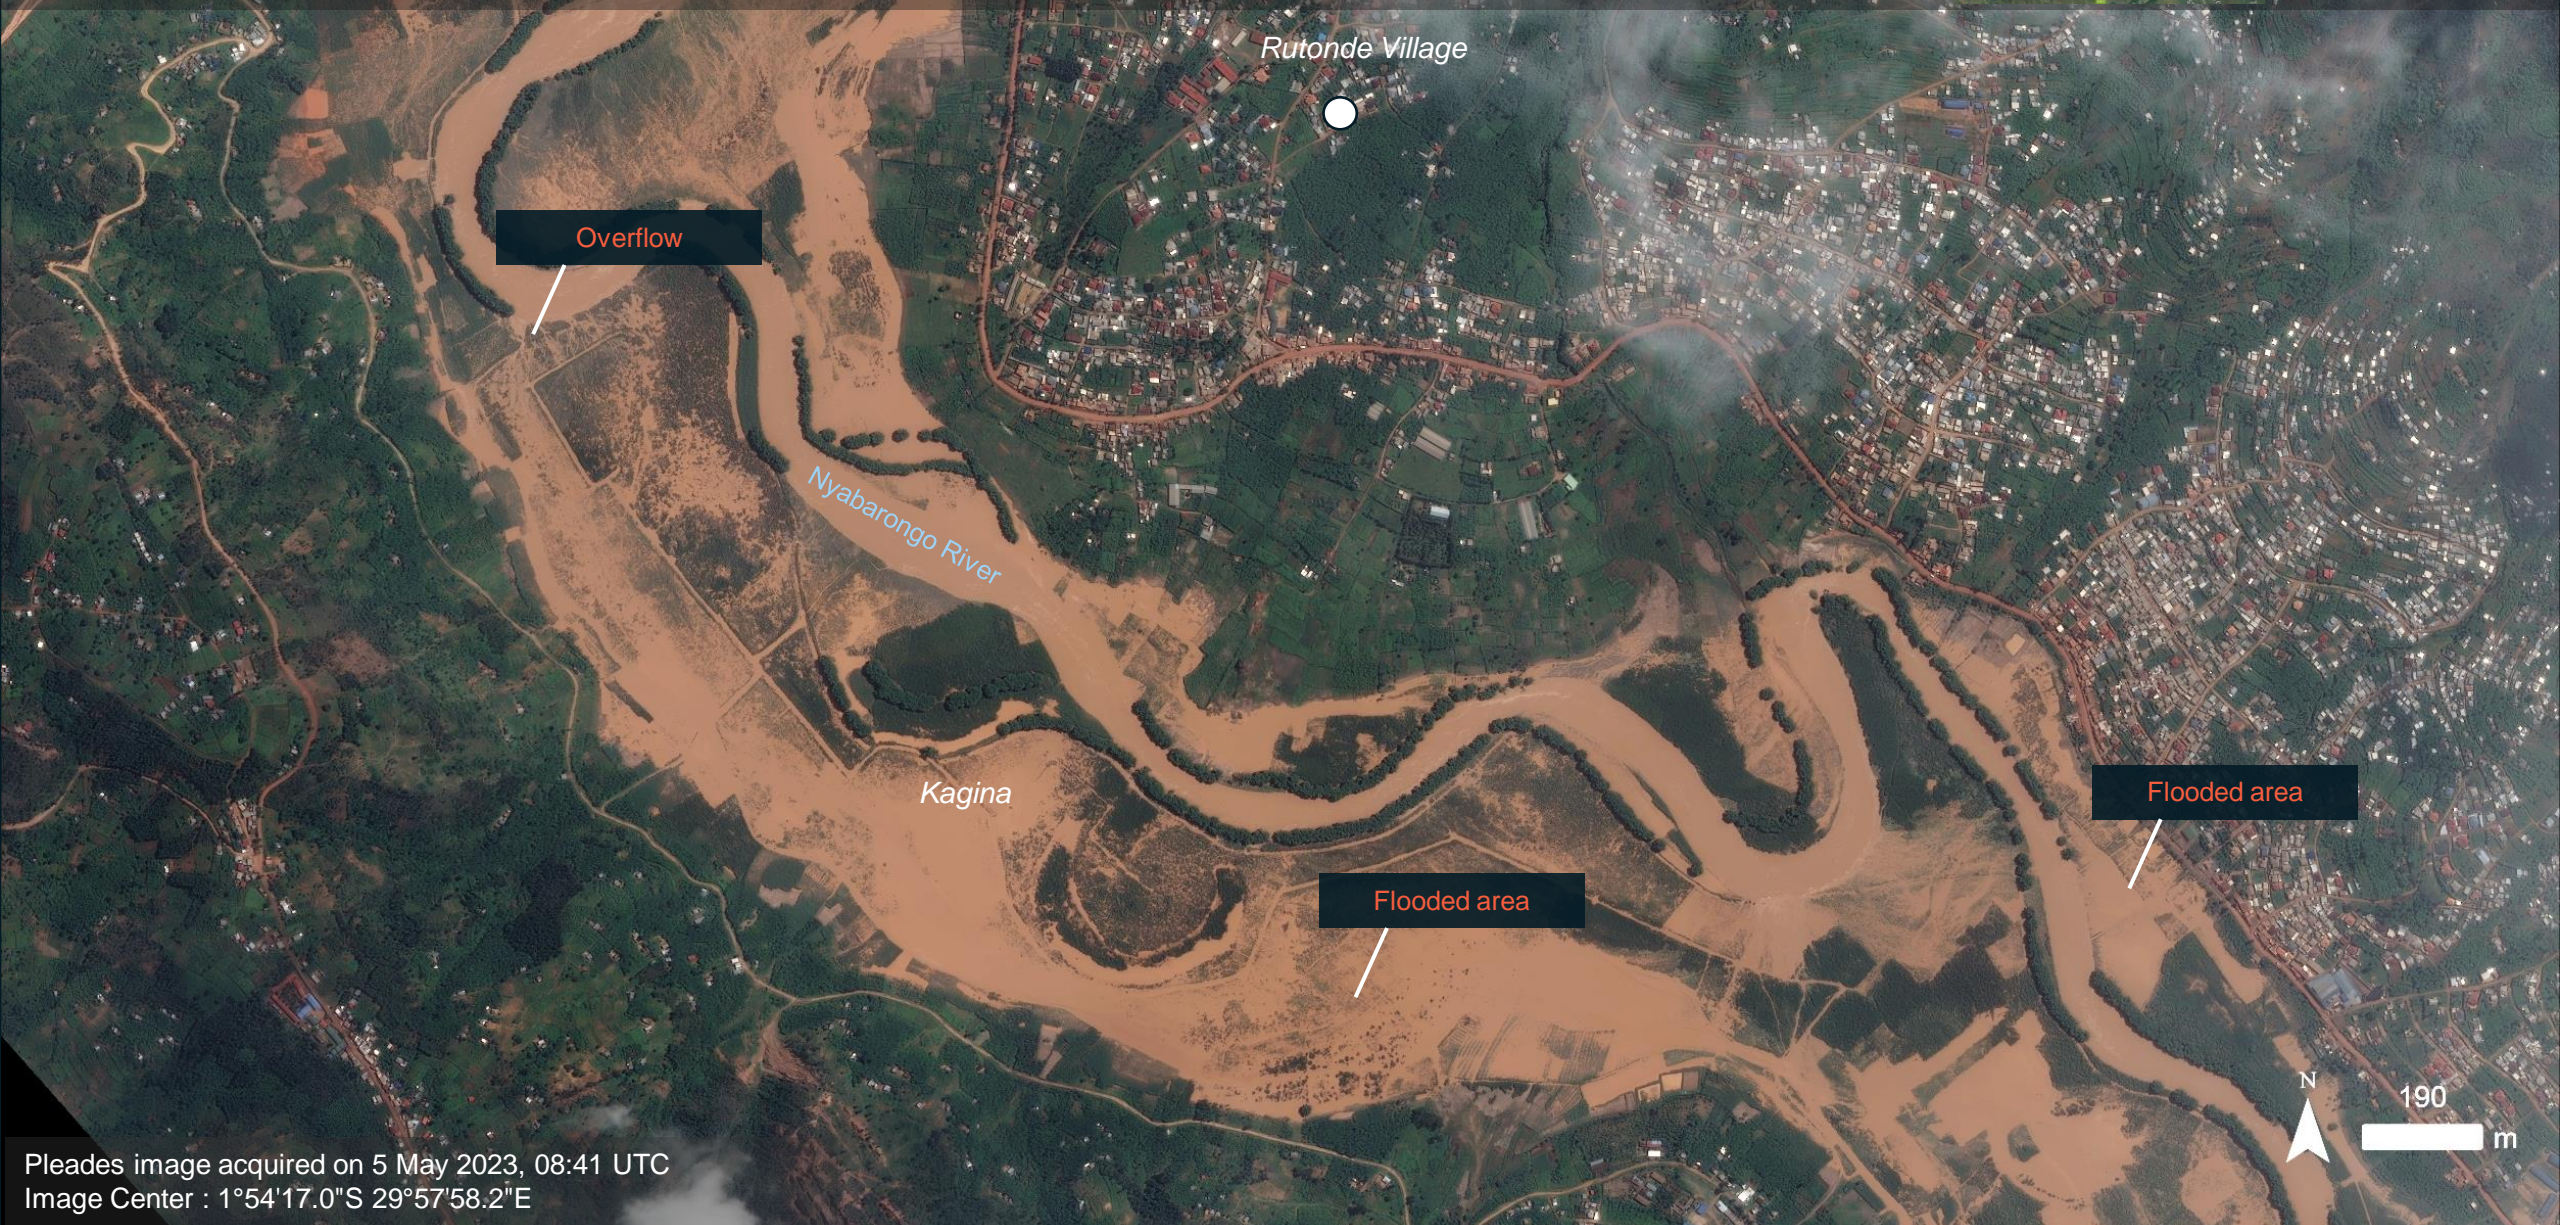
# AOI 2-2: NYABARONGO RIVER, RULINDO DISTRICT, NORTHERN PROVINCE, KAMONYI DISTRICT SOUTHERN PROVINCES, RWANDA

Flooded areas along the Nyabarongo River

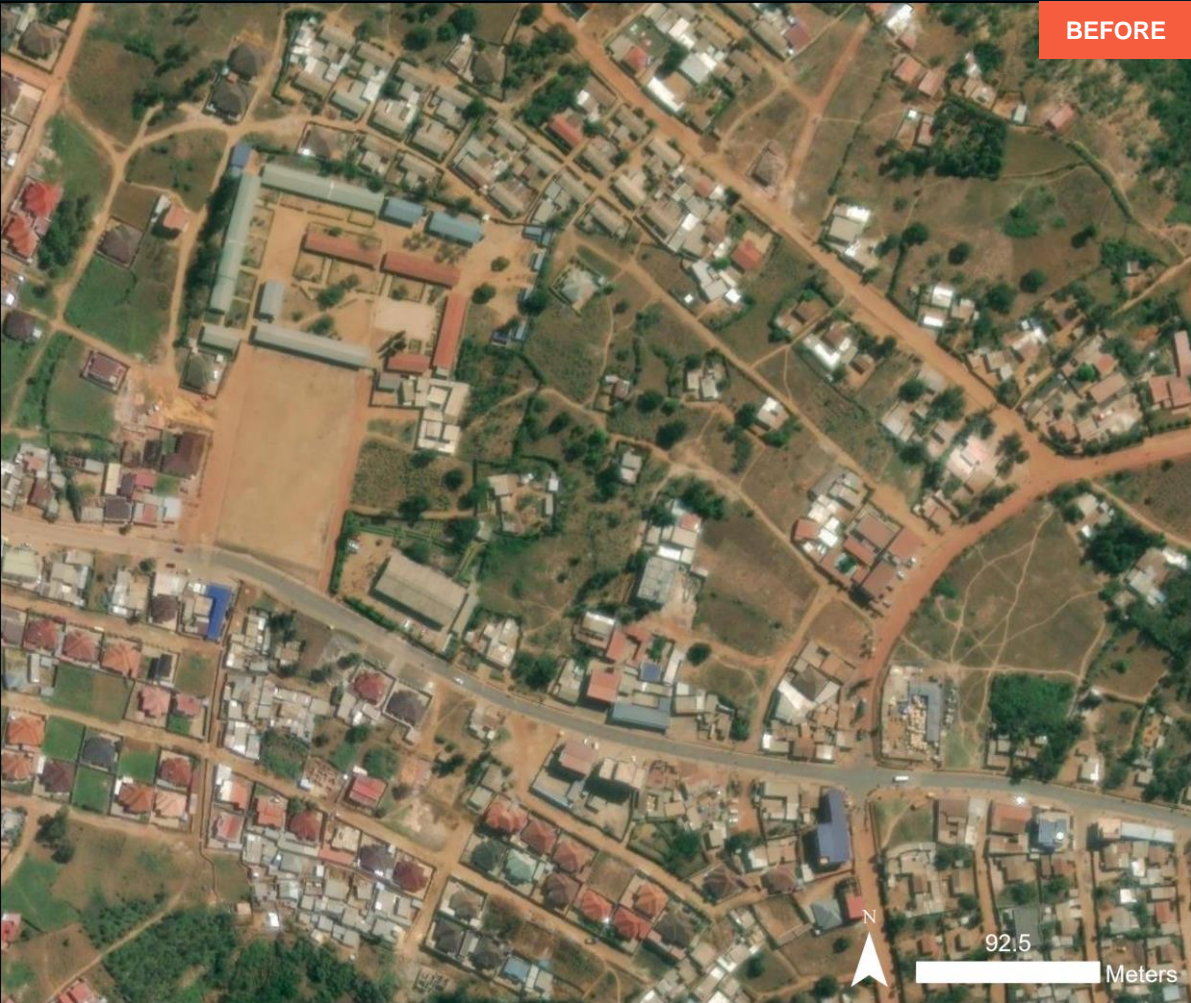
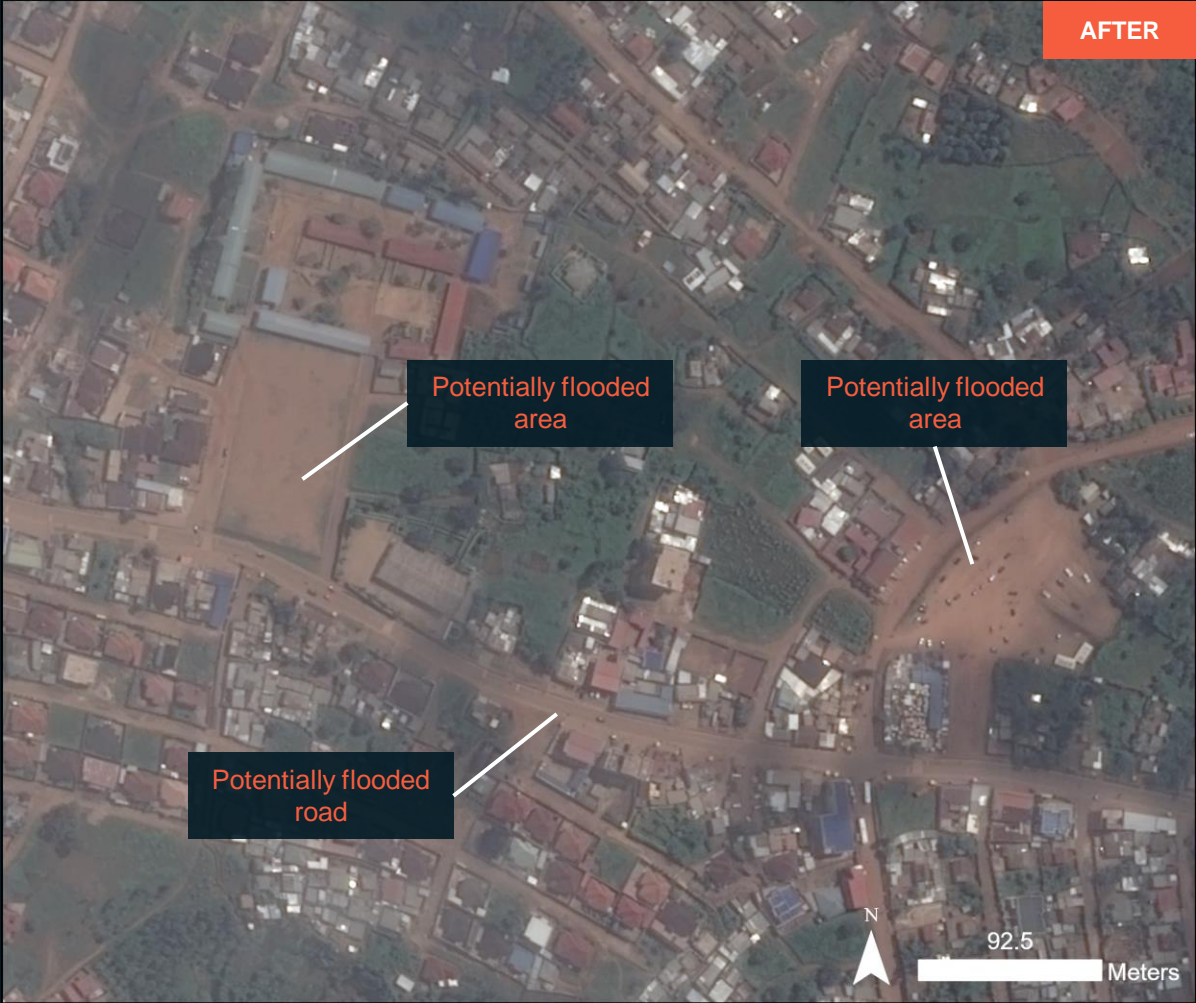
# AOI 3: NYABUGOGO, NYARUGENGE DISTRICT, KIGALI CITY, RWANDA,

Potentially flooded areas and affected road
