Analysis Results for Possible slope failure area

Miura Laboratory @ Yamaguchi University

Possible slope failure area due to earthquake, April 15, Japan (No.1)

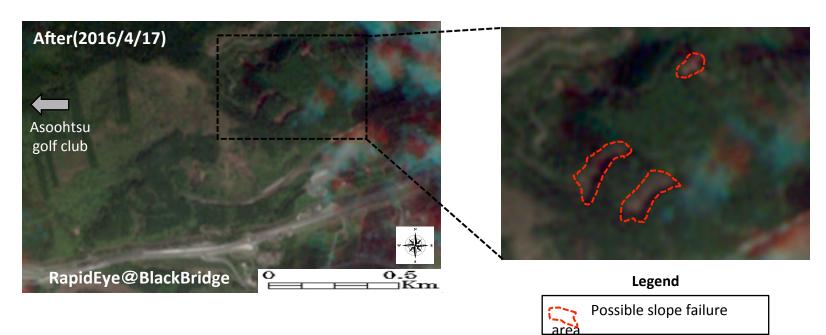
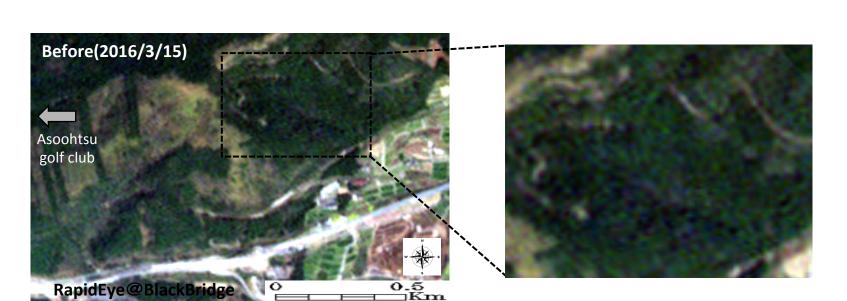
After event : RapidEye(2016/4/17) Before event : RapidEye(2016/3/15)

Red color frame shows the location where slope failure possible occurred.

There are three possible slope failure area in after event image.

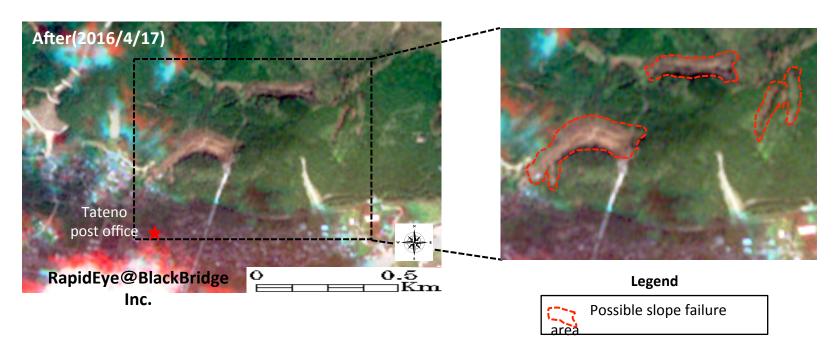
Possible slope failure area due to earthquake, April 15, Japan (No.2)

After event : RapidEye(2016/4/17) Before event: RapidEye(2016/3/15)

Red color frame shows the location where slope failure possible occurred.

There are three possible slope failure area in after event image.
