# Situation as of 10/11/2024 10:39 UTC

Grading - Overview map 01

#### EMSR773 AOI: 12 Godelleta Grading

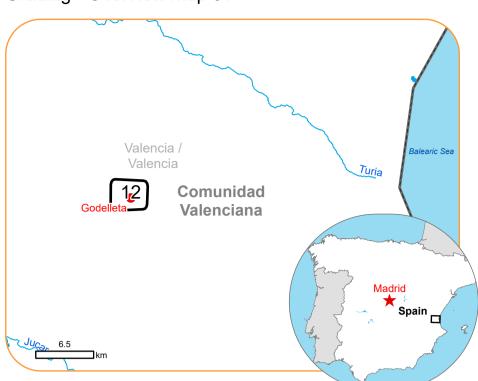
Affected Built-up and Transportations

Event: On 29 October 2024 at 14:30 UTC, an extraordinary rainfall event affected the Valencia region. High water levels in rivers caused flooding in Ribera Alta, Horta, La Plana de Utiel and Letur river. On 31 October 2024, extraordinary precipitation caused flooding in the Castellon Province area. Copernicus EMS Rapid Mapping is requested to provide emergency mapping of flood extent, Monitoring and classification damages emergency

The thematic layer has been derived from post-event satellite image by means of visual interpretation.

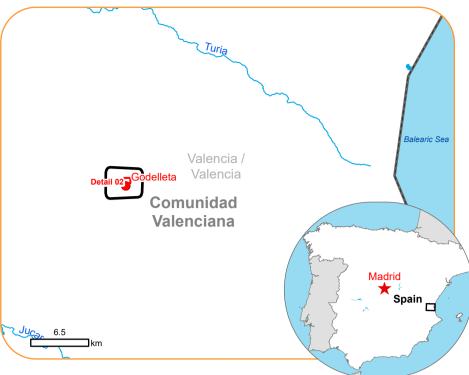
Grading - Detail map 02

Event: On 29 October 2024 at 14:30 UTC, an extraordinary rainfall event affected the Valencia region. High water levels in rivers caused flooding in Ribera Alta, Horta, La Plana de Utiel and Letur river. On 31 October 2024, extraordinary precipitation caused flooding in the Castellon Province area. Copernicus EMS Rapid Mapping is requested to provide emergency mapping of flood extent, Monitoring and classification damages emergency mapping.

The thematic layer has been derived from post-event satellite image by means of visual interpretation.
