9 June 2021

PRELIMINARY SATELLITE- DERIVED FLOOD ASSESSMENT

Guyana

FLOODS OVER GUYANA

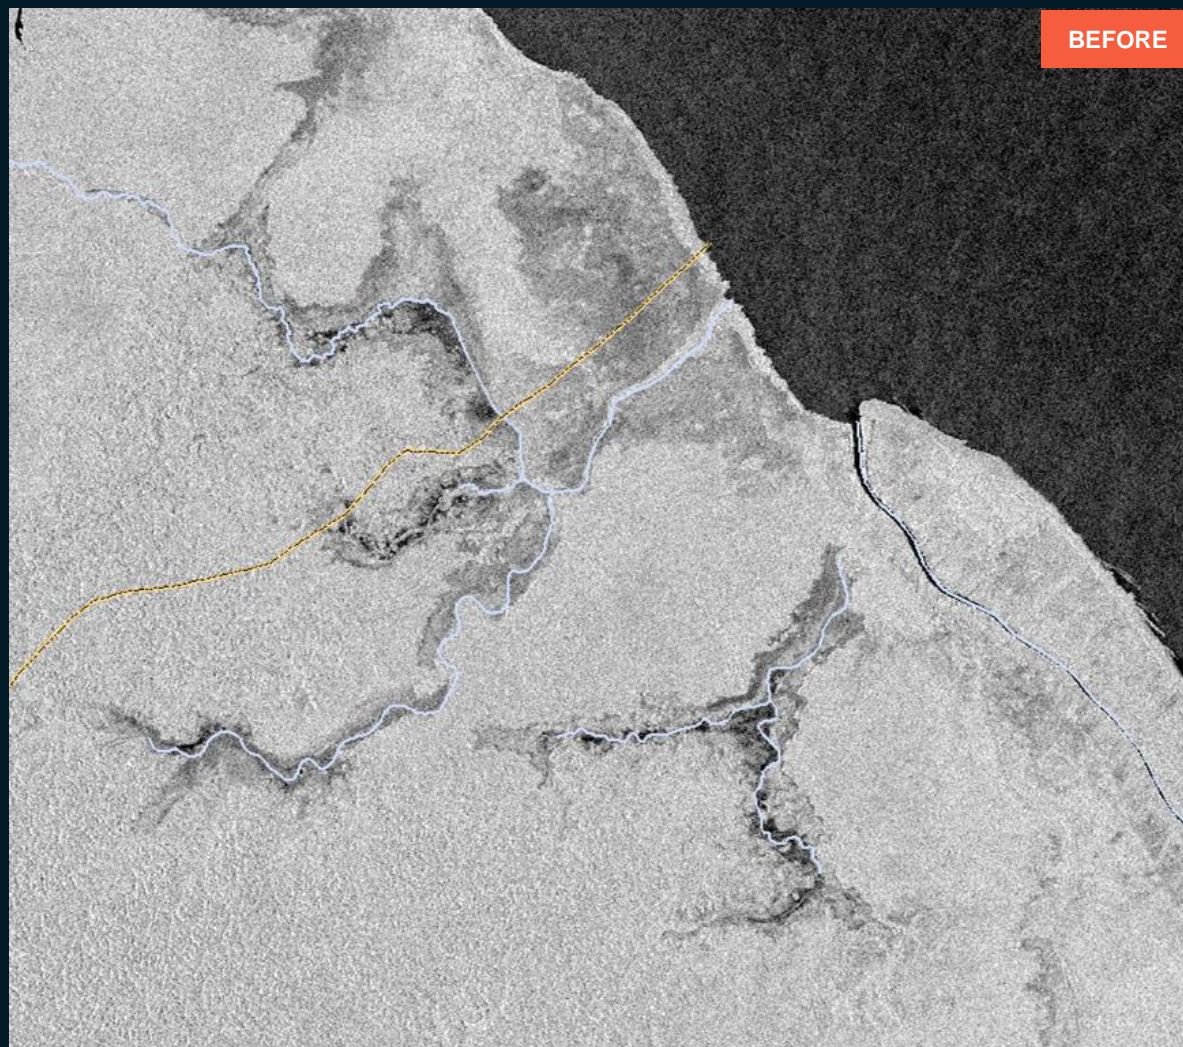
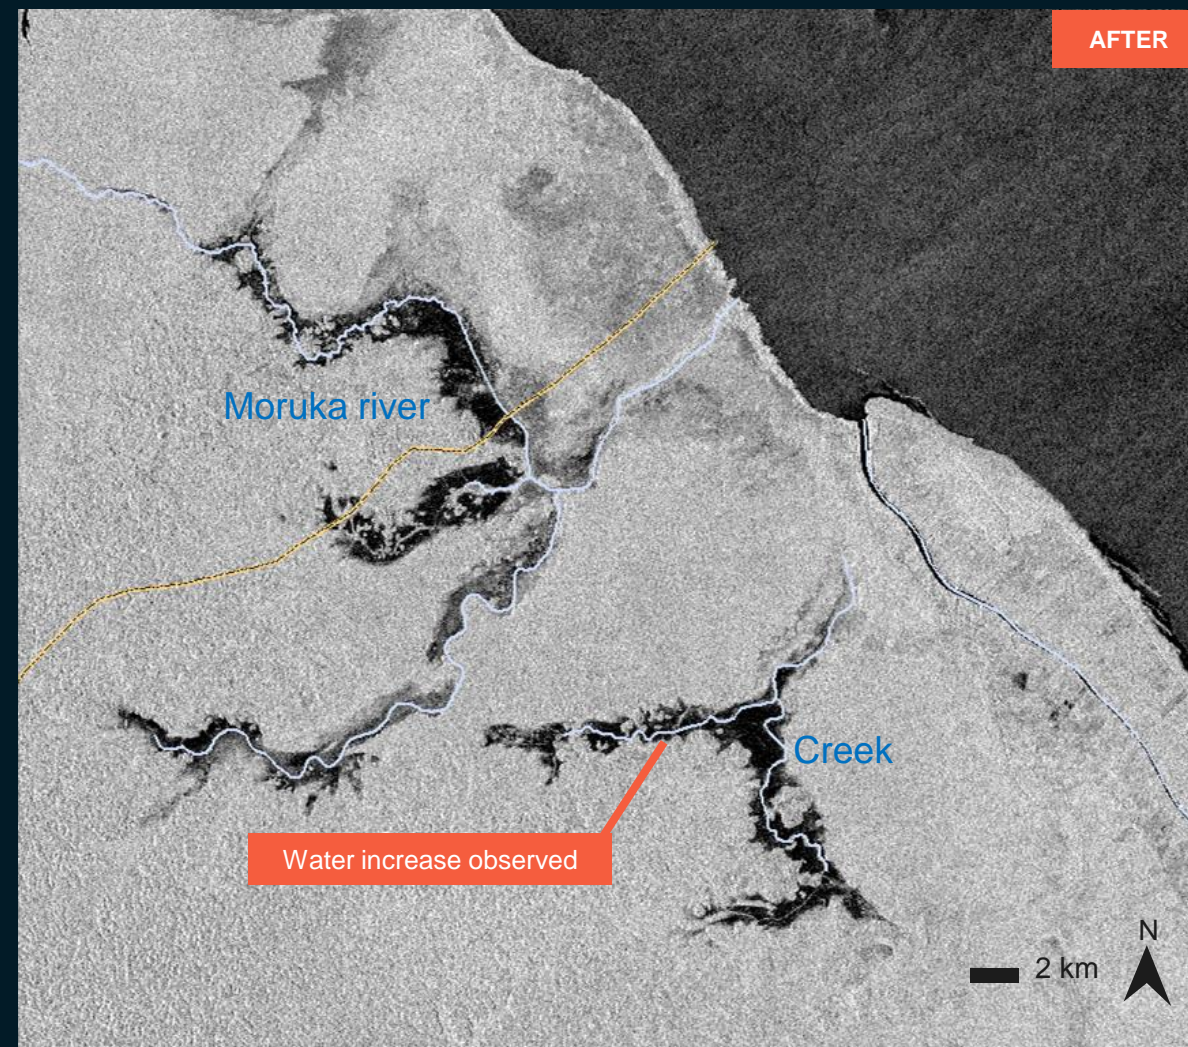
AOI 1-1 Region 2 / Pomeroon-Supenaam

Water increase along the Moruka river

Sentinel-1 / 1 May 2021

Sentinel-1 / 6 June 2021

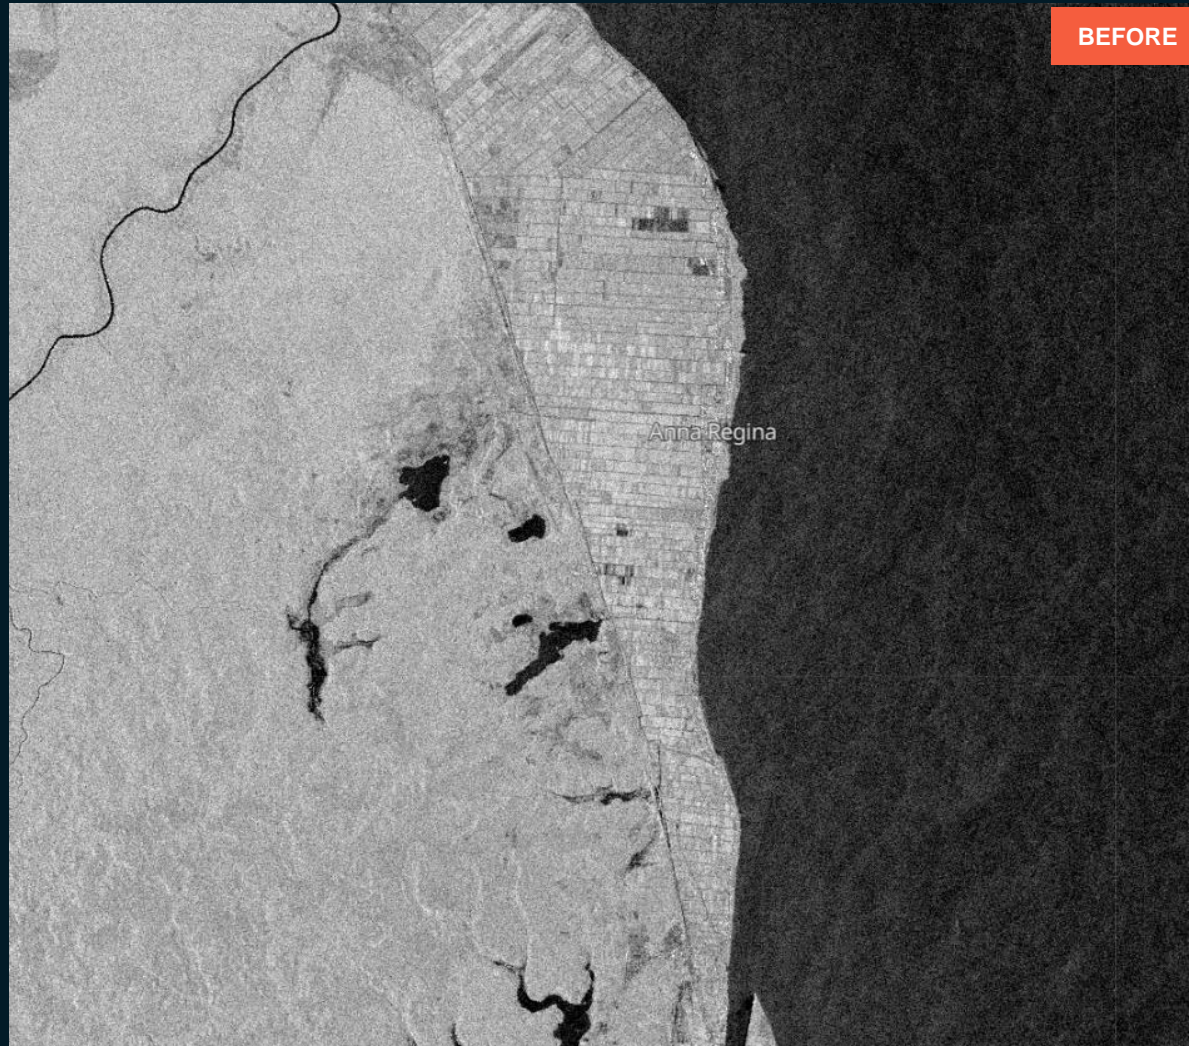
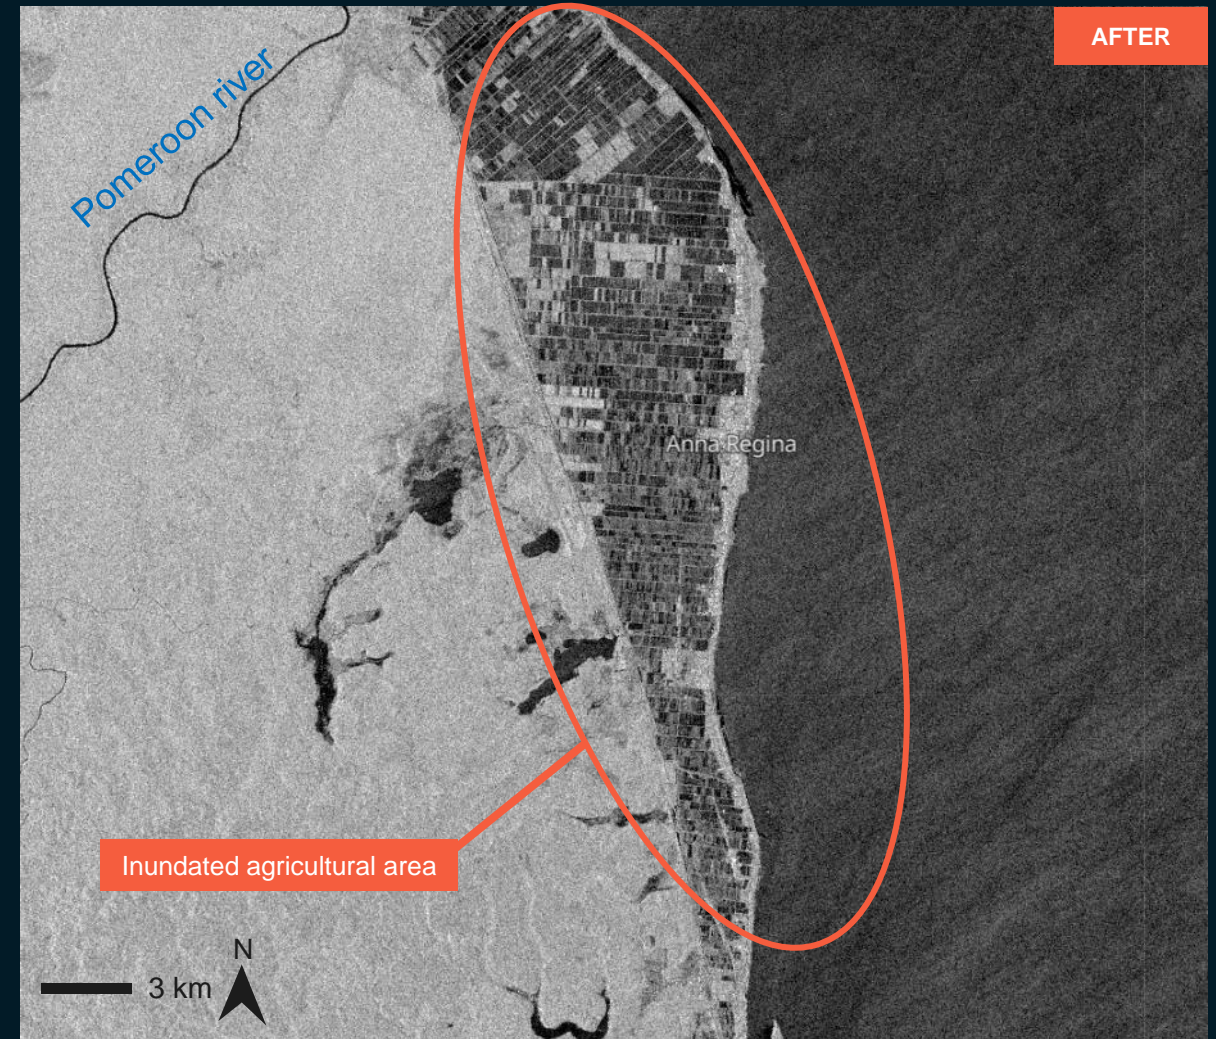
AOI 1-2 Region 2 / Pomeroon-Supenaam

Inundated agricultural area

Sentinel-1 / 1 May 2021

Sentinel-1 / 6 June 2021

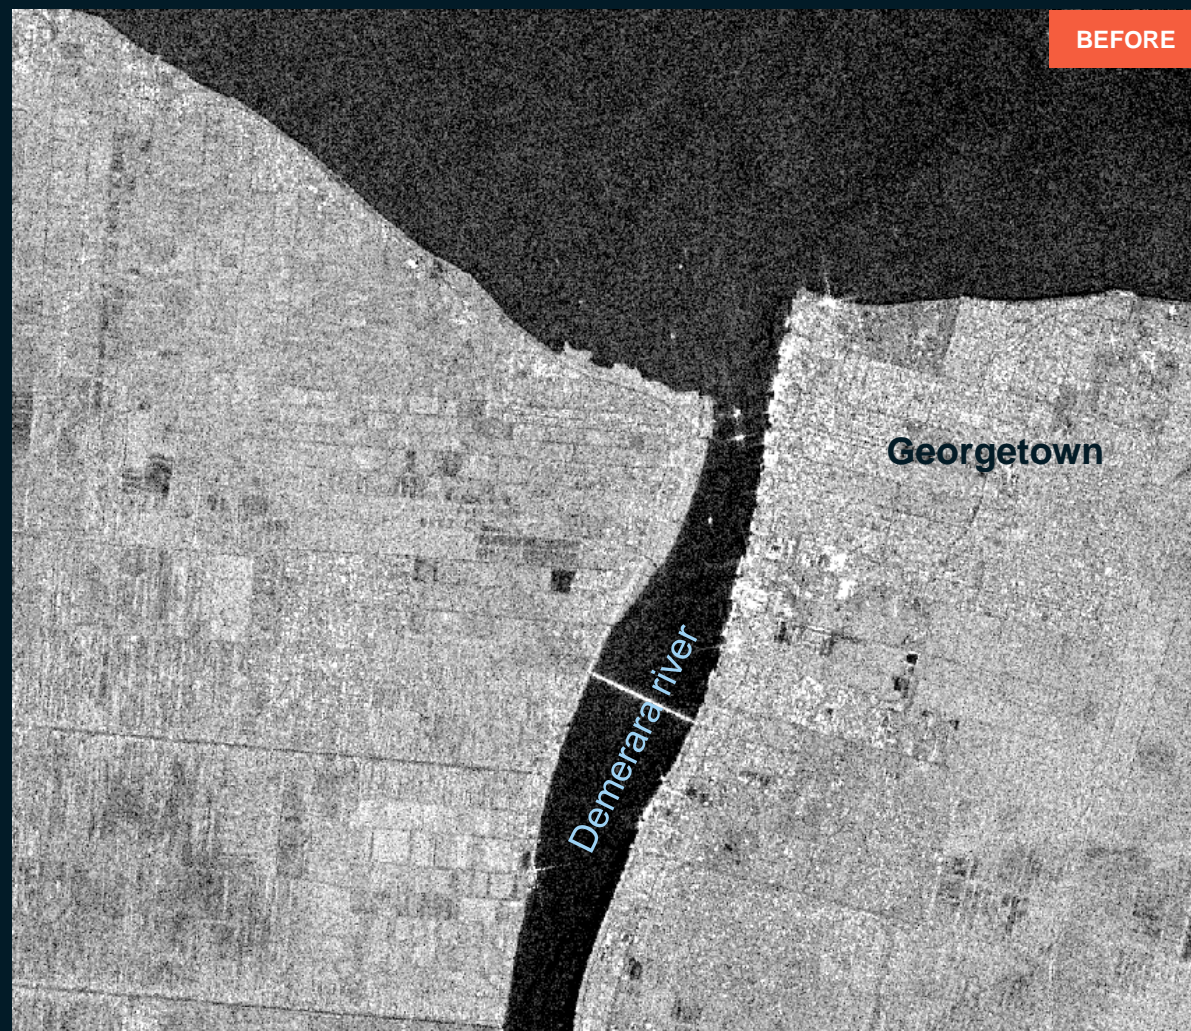
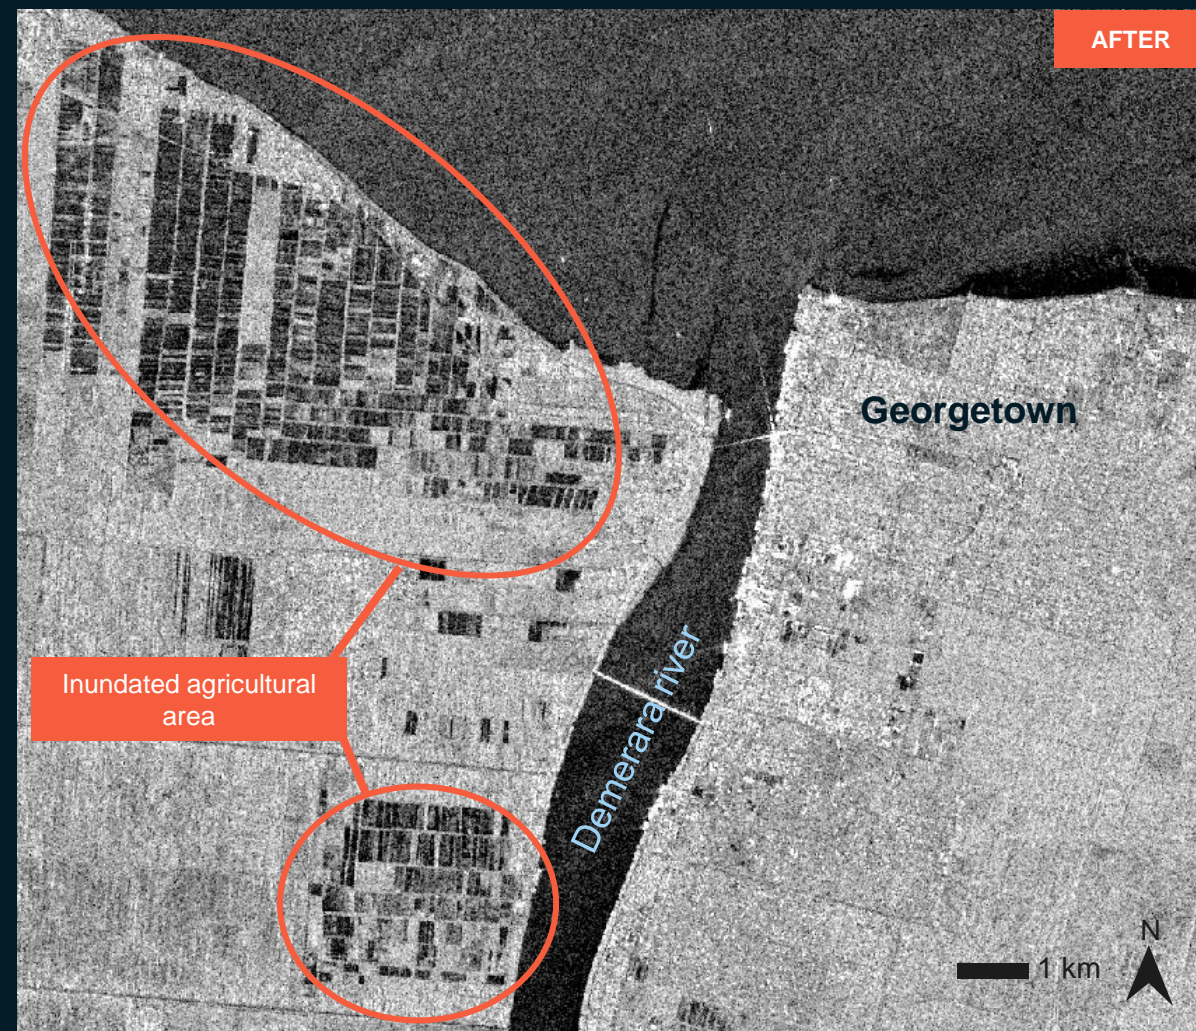
AOI 2-1 Region 3 / Essequibo Islands-West Demerara

Inundated agricultural area

Sentinel-1 / 1 May 2021

Sentinel-1 / 6 June 2021

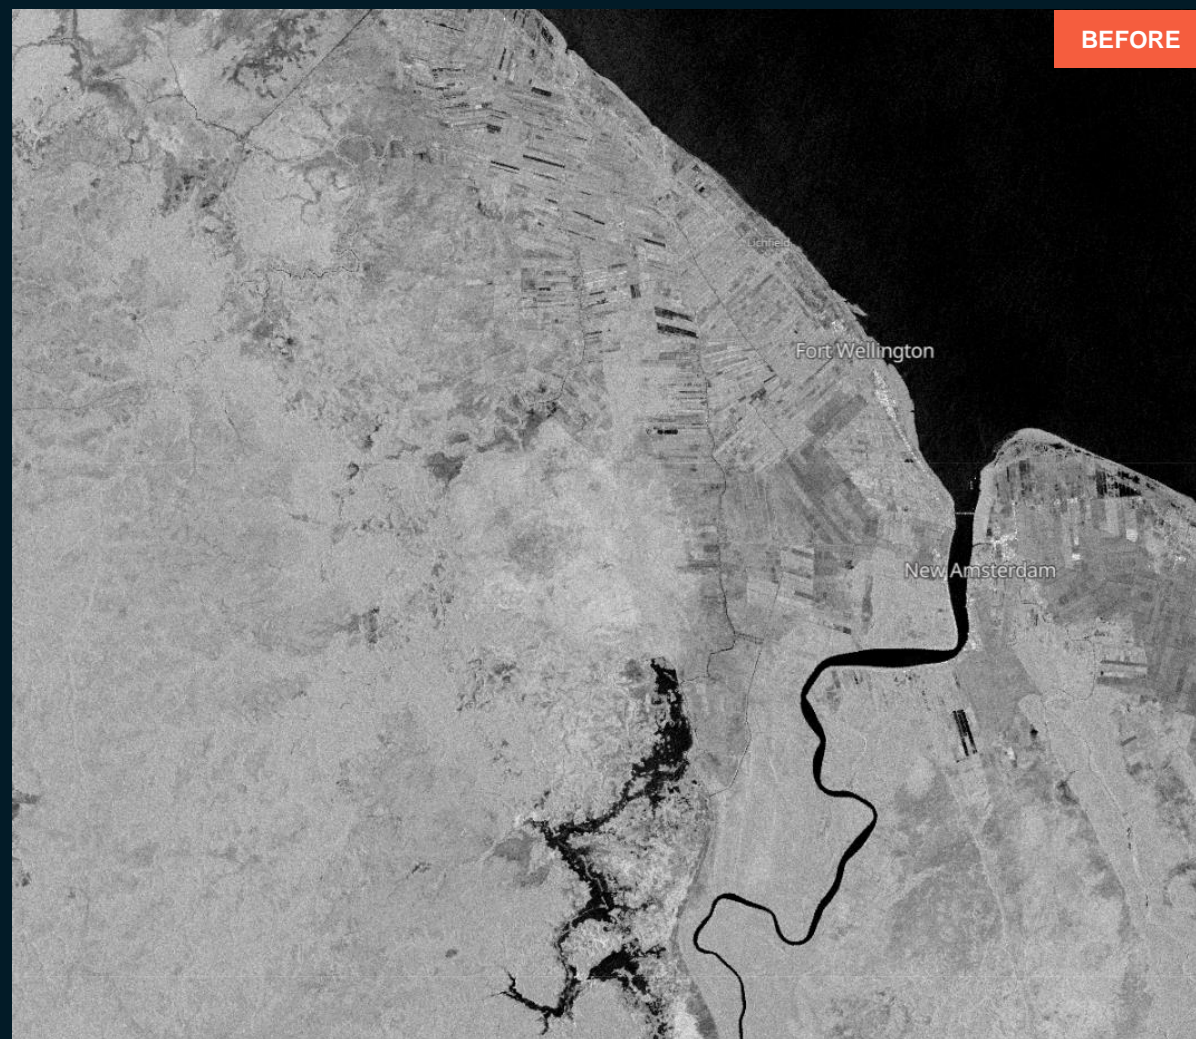
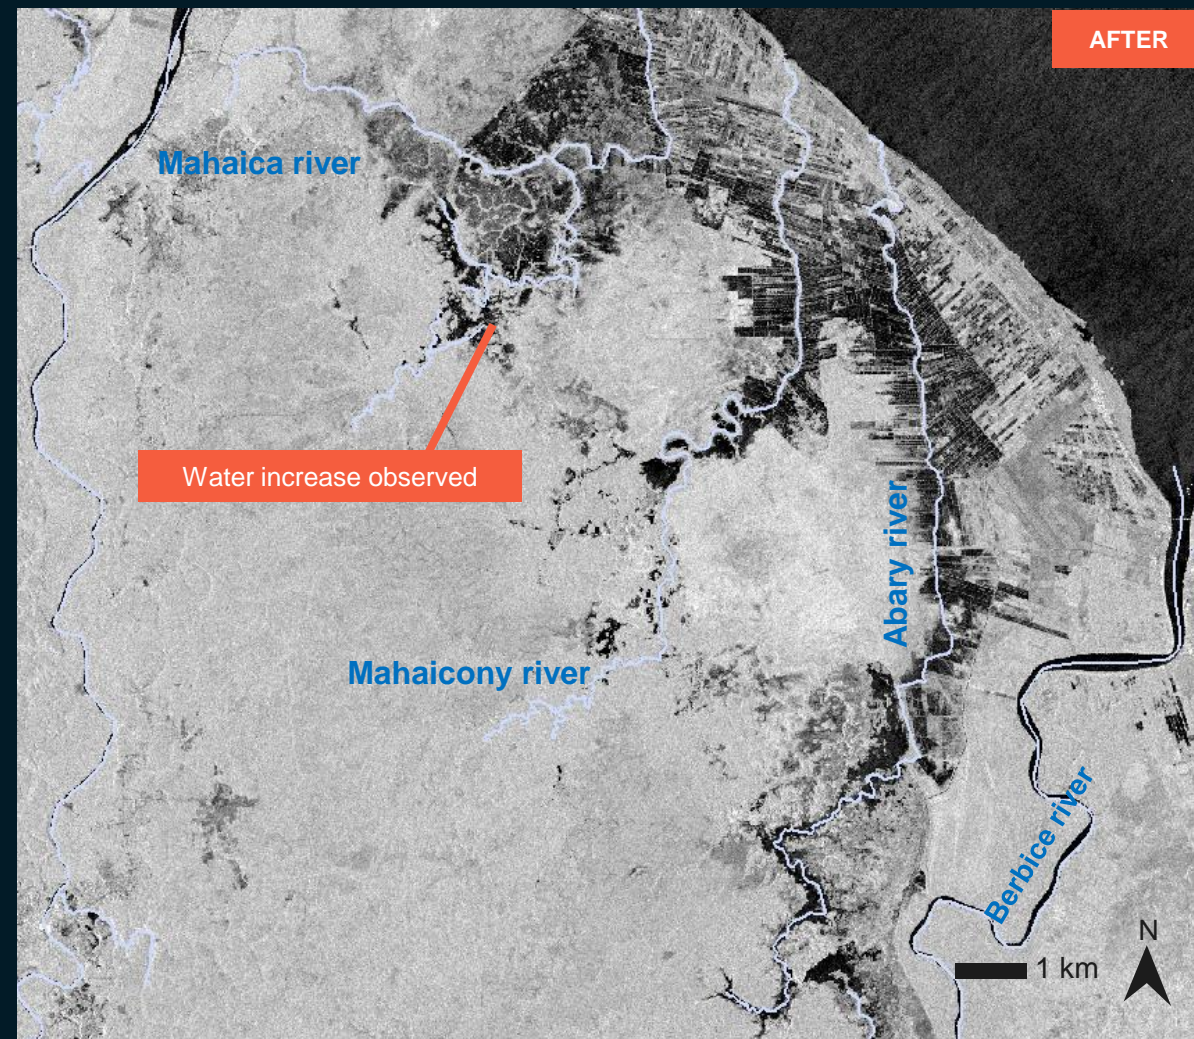
AOI 2-2 Region 4 / Demerara-Mahaica and 5 / Mahaica Berbice

Inundated agricultural area along the Mahaica, Mahaicony and Abary rivers

Sentinel-1 / 1 May 2021

Sentinel-1 / 6 June 2021

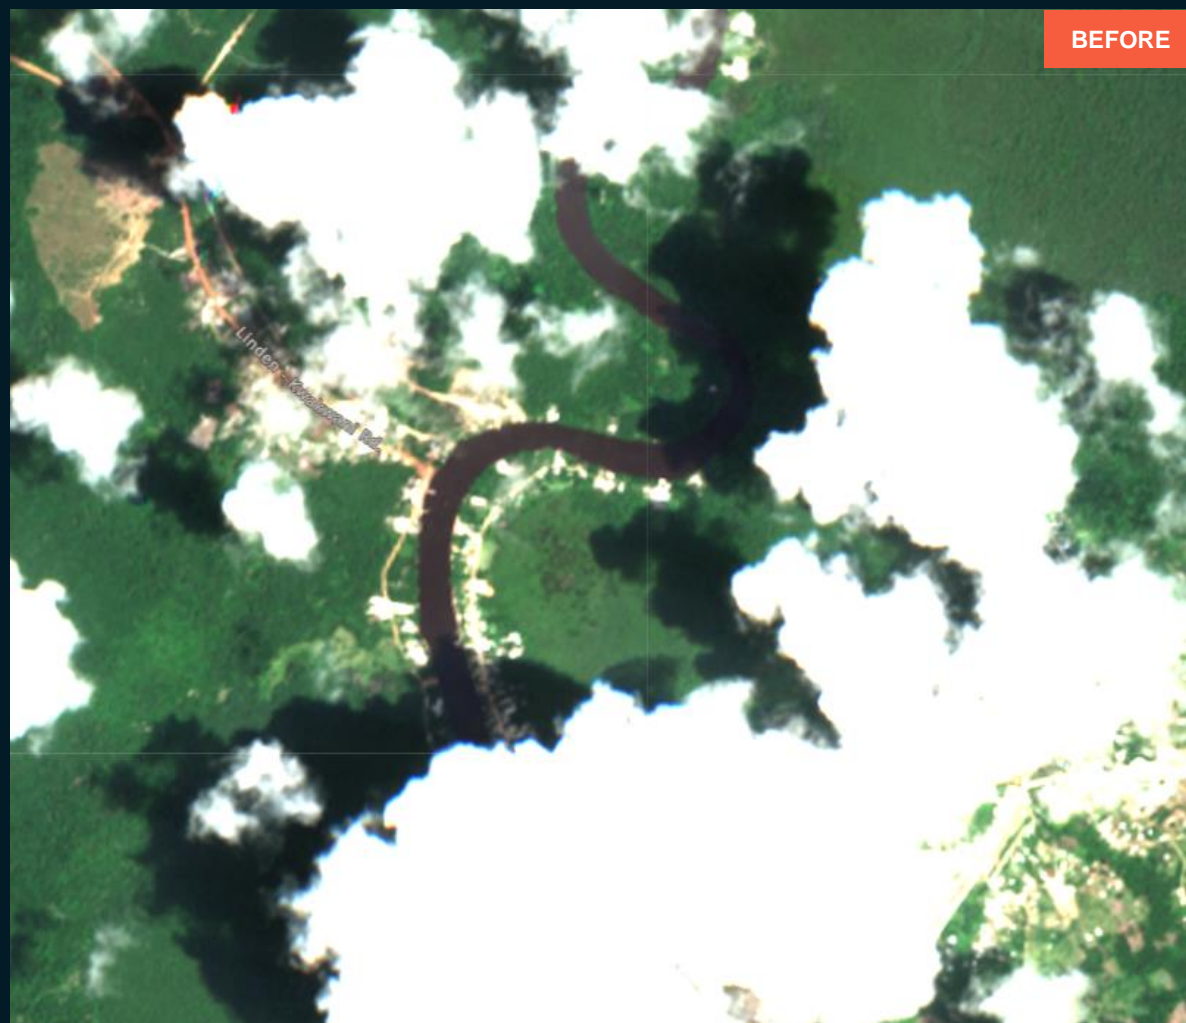
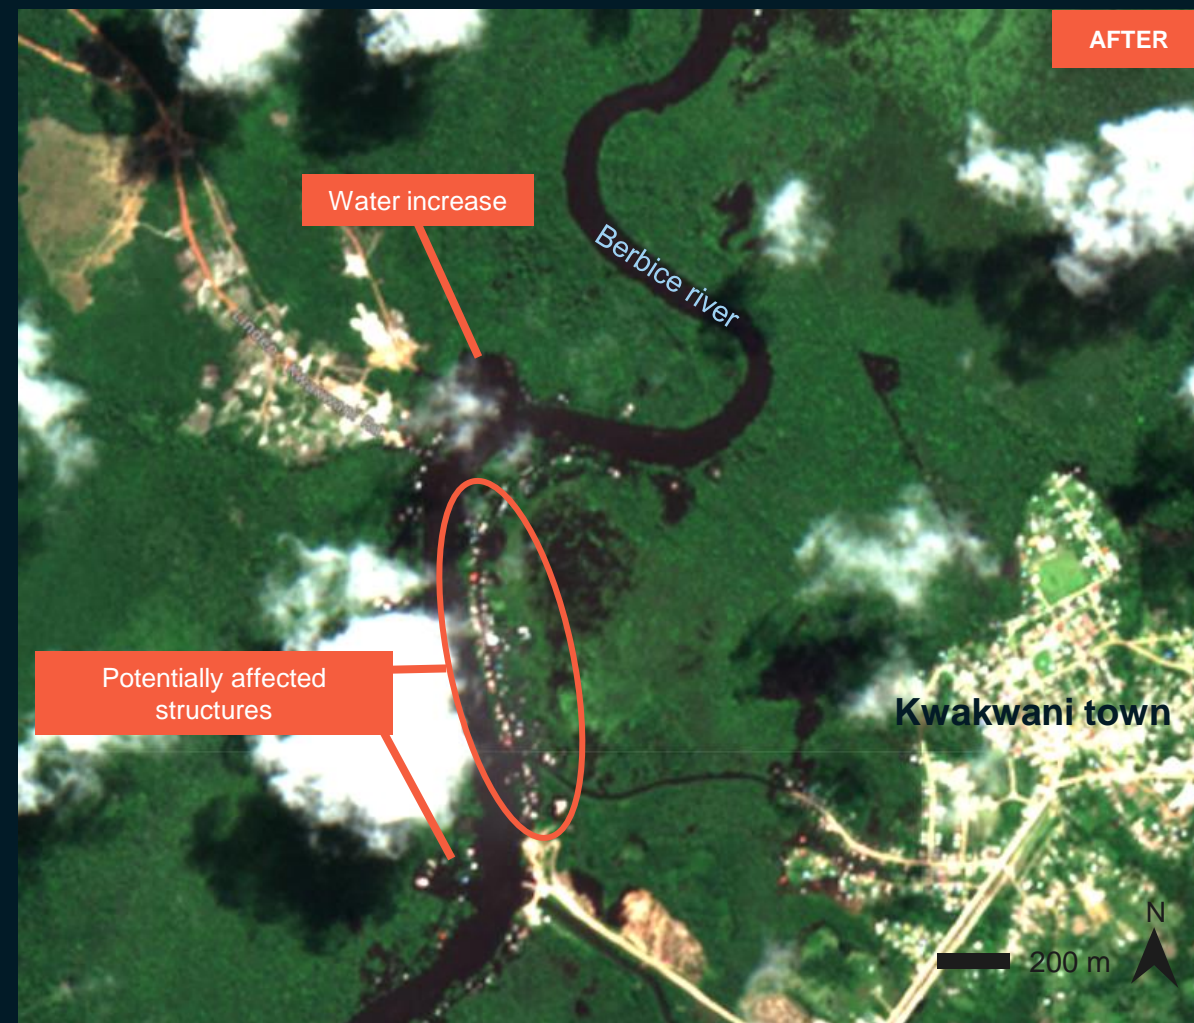
AOI 3-1 Region 10 / Upper Demerara-Berbice

Potentially affected structures observed along the Berbice river

Sentinel-2 / 18 Mar 2021

Sentinel-2 / 6 June 2021

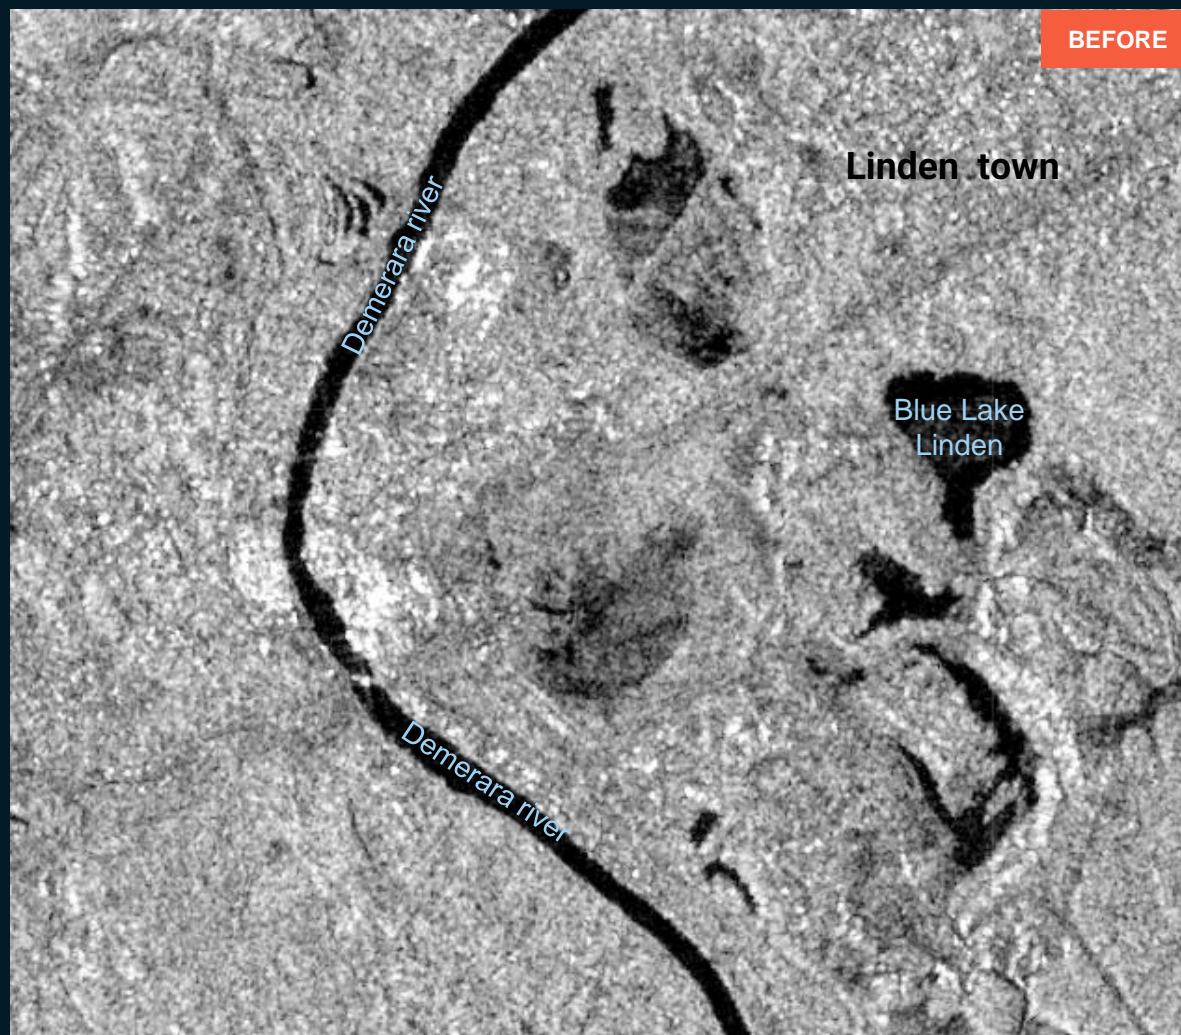
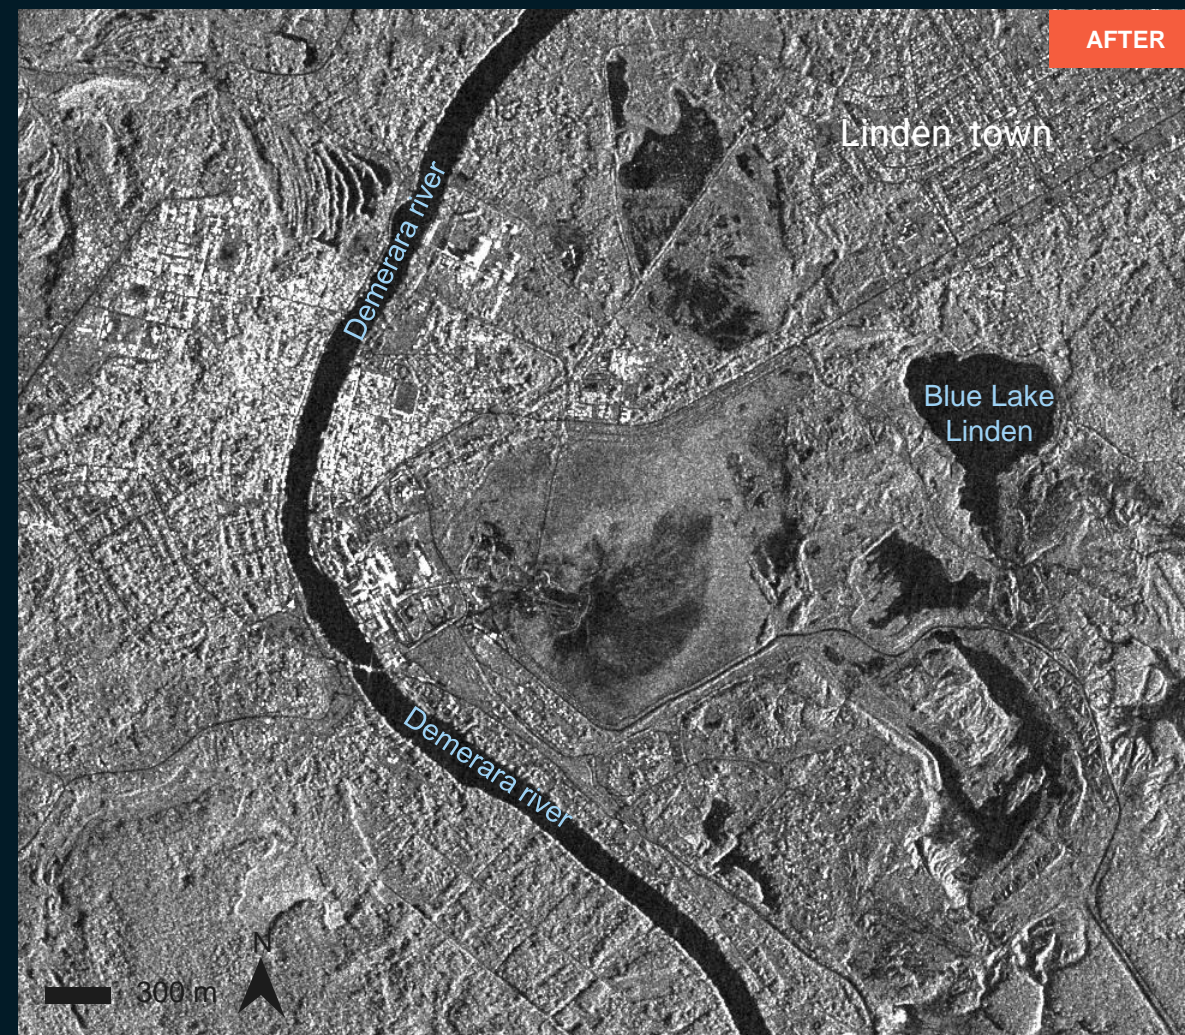
AOI 3-2 Region 10 / Upper Demerara-Berbice

No floods observed along the Demerara river

Sentinel-1 / 1 May 2021

Terra SAR-X / 8 June 2021

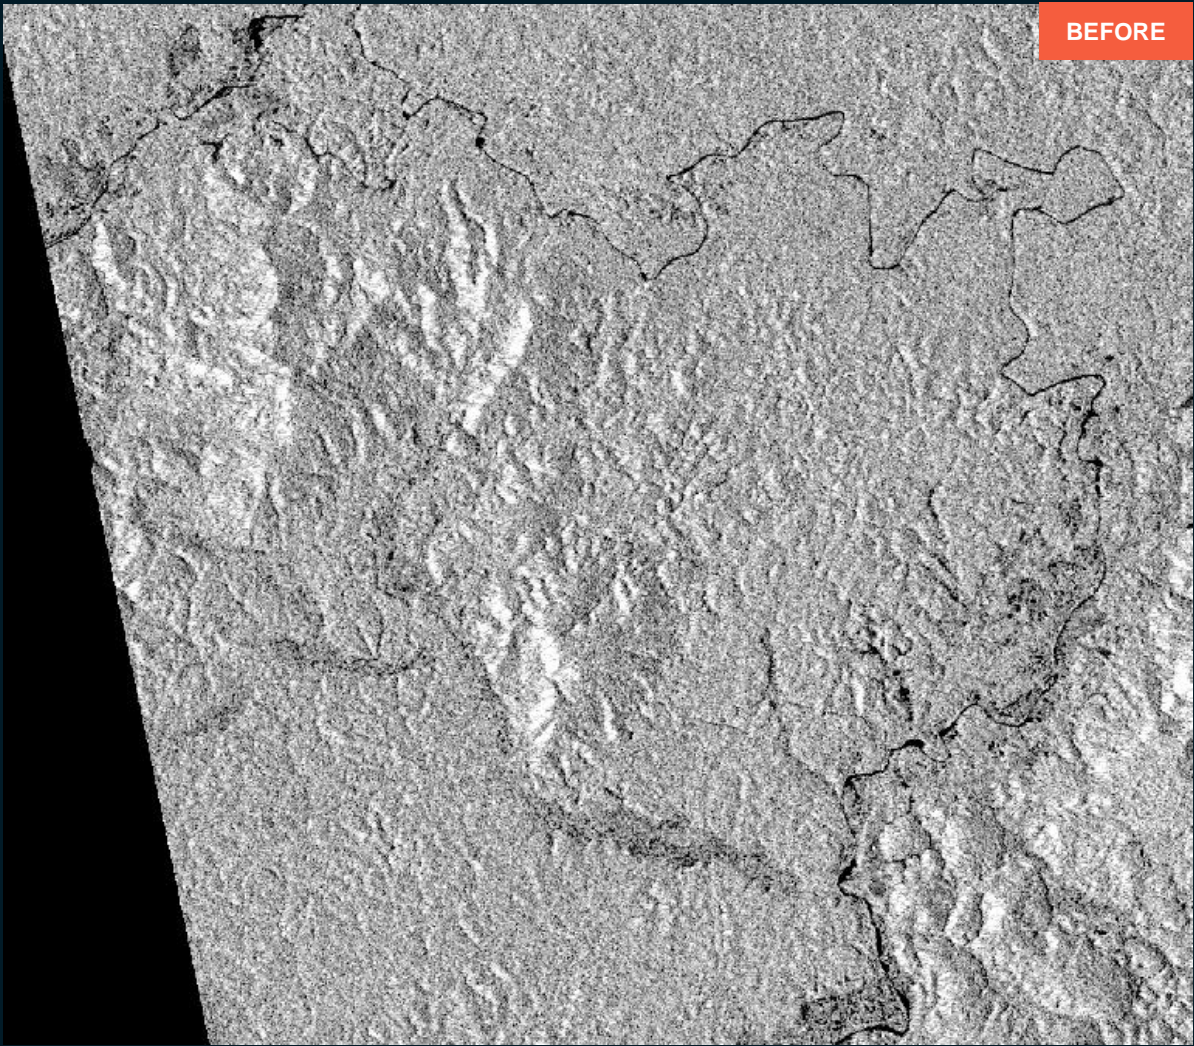
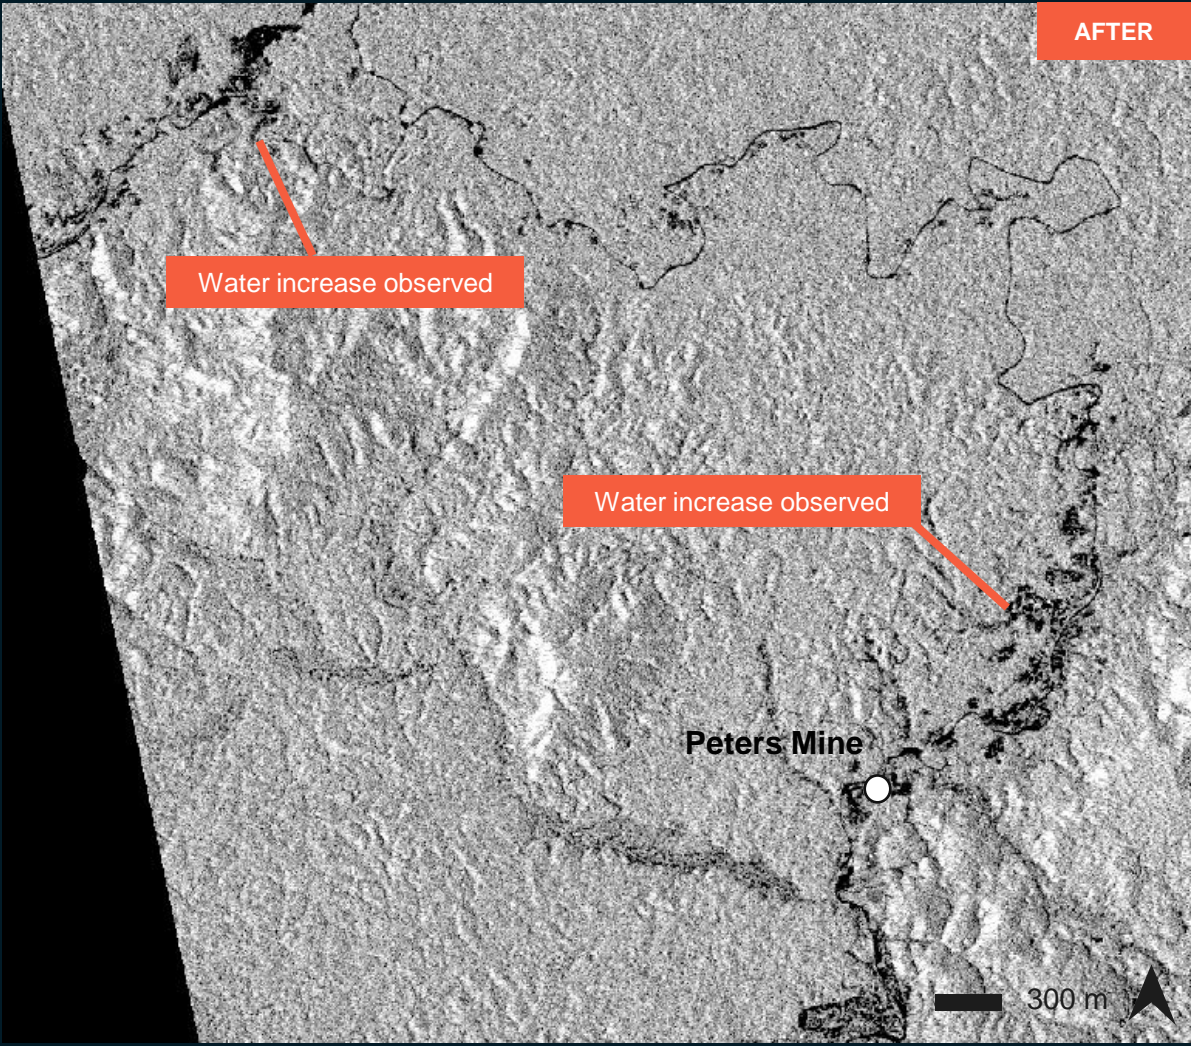
AOI 4-1 Region 7 / Cuyuni-Mazaruni

Floods observed upstream of Peters Mine hamlet

Sentinel-1 / 1 May 2021

Sentinel-1 / 6 June 2021

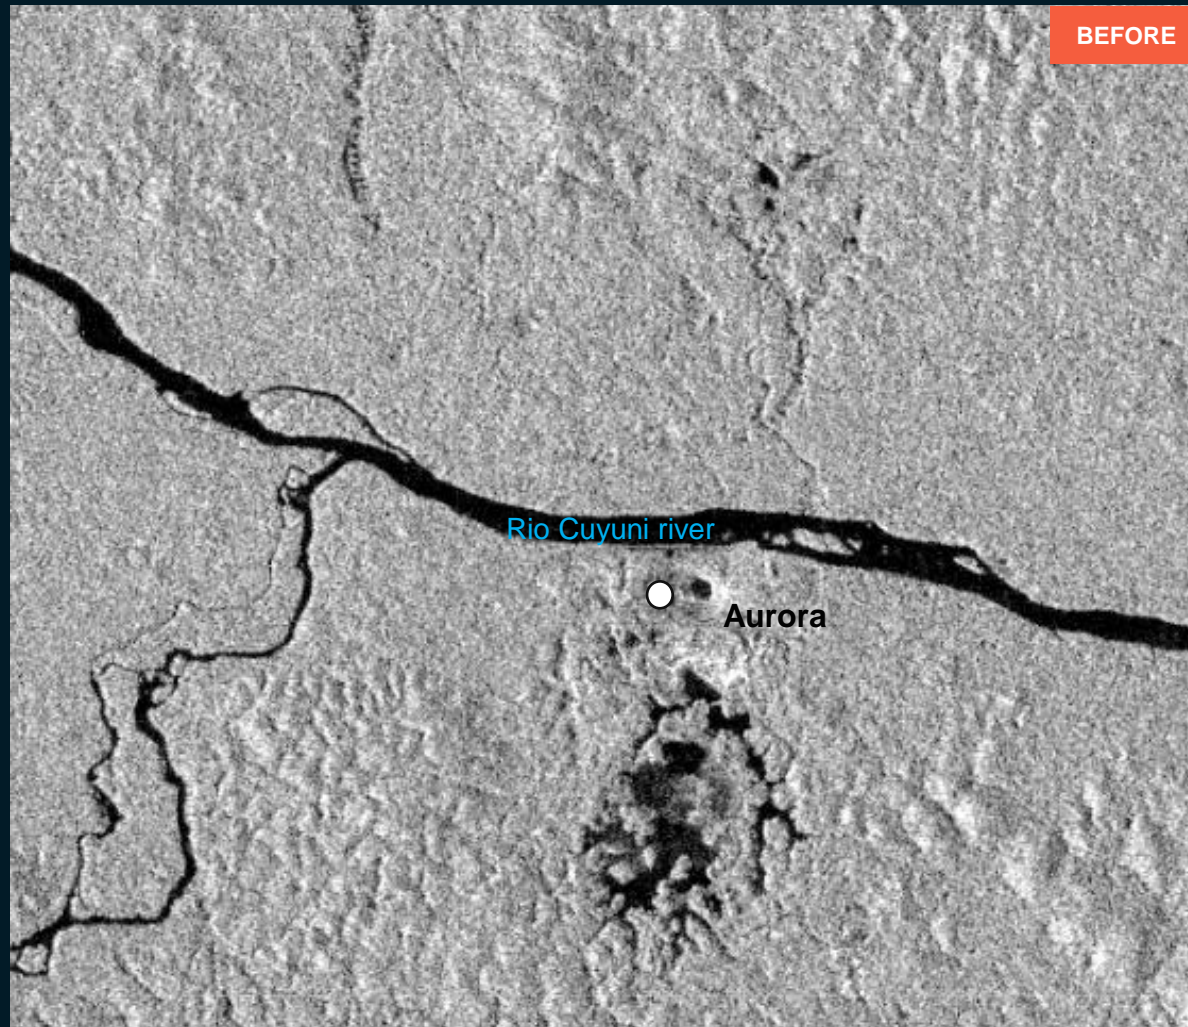
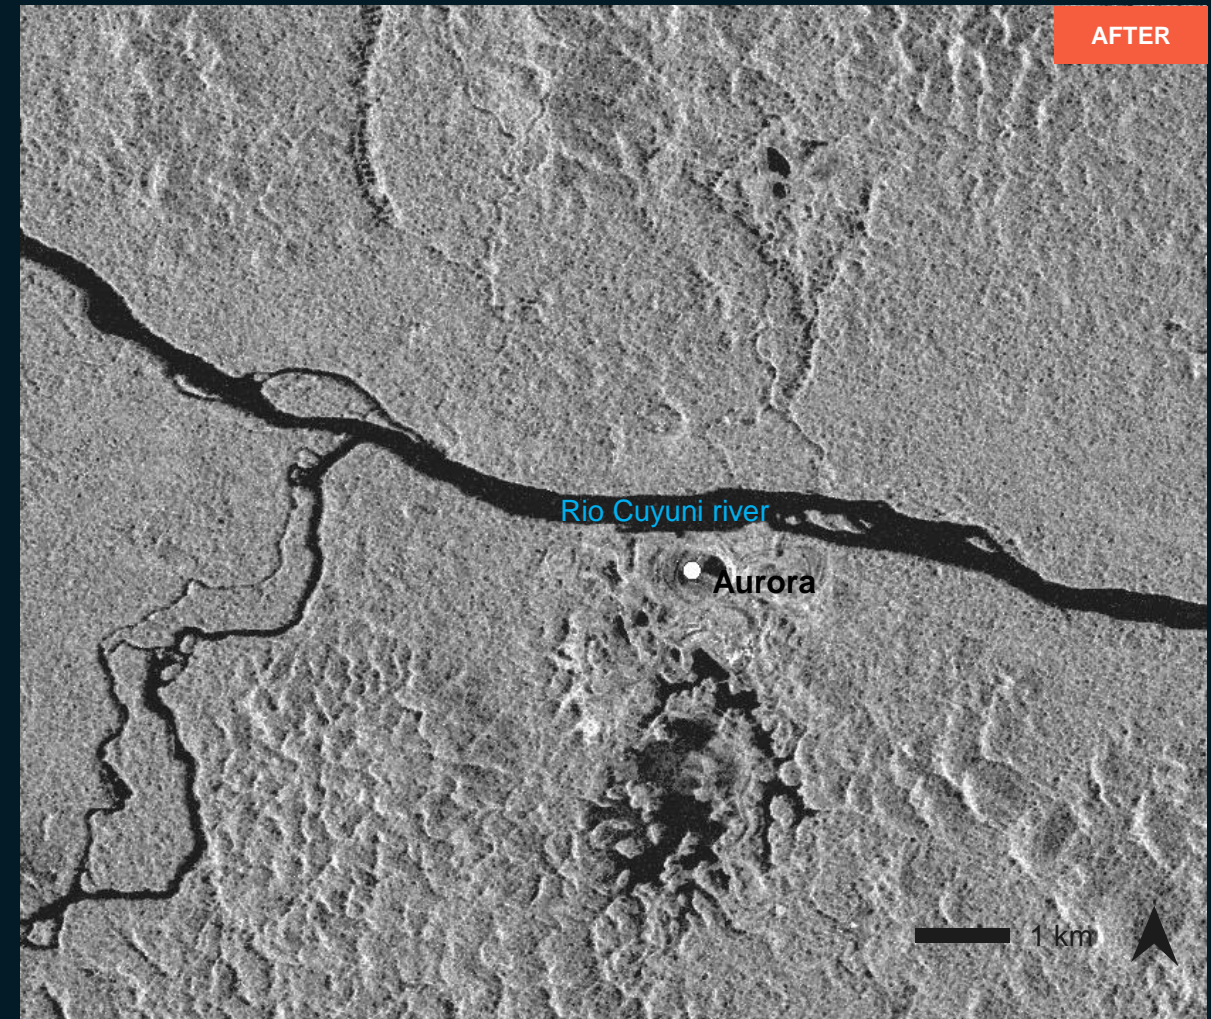
AOI 4-2 Region 7 / Cuyuni-Mazaruni

No floods observed along the Rio Cuyuni river

Sentinel-1 / 6 May 2021

RCM-2/ 8 June 2021
