27 December 2021

TROPICAL CYCLONE RAI-21

PRELIMINARY SATELLITE-DERIVED INDUSTRIAL SITES IMPACT ANALYSIS IN CEBU & NAGA

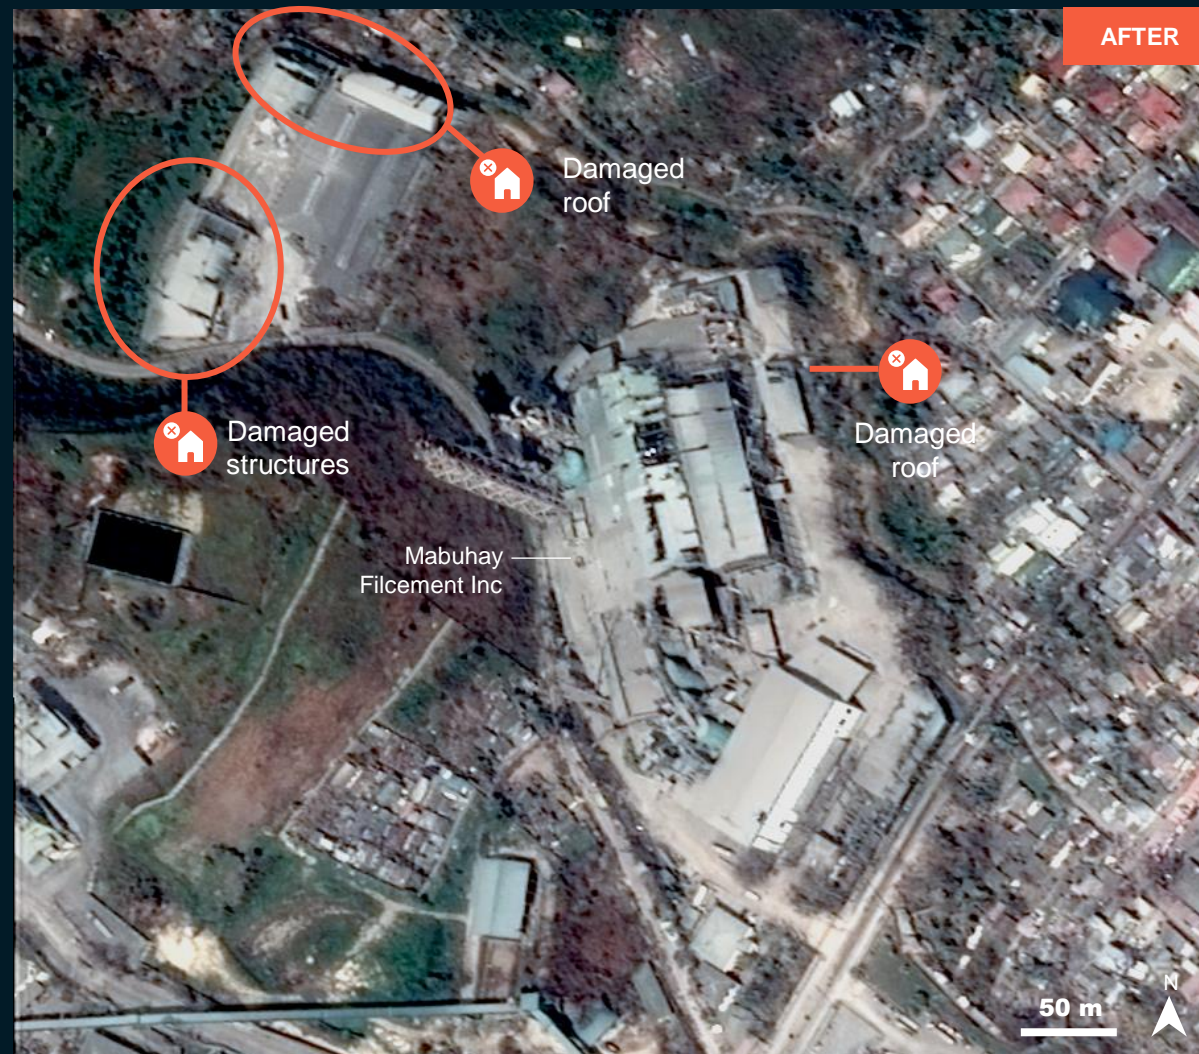
Pléiades / 21 December 2021

AOI 1-6: MABUHAY FILCEMENT INC SAN FERNANDO, CEBU, REGION VII (CENTRAL VISAYAS)

Damaged structures and roof in the industrial factory
