UNOSAT

Production Date: 11/11/2013

DESTRUCTION IN DULAG TOWN, LEYTE PROVINCE, PHILIPPINES

As seen in WorldView-2 imagery collected 10 November 2013

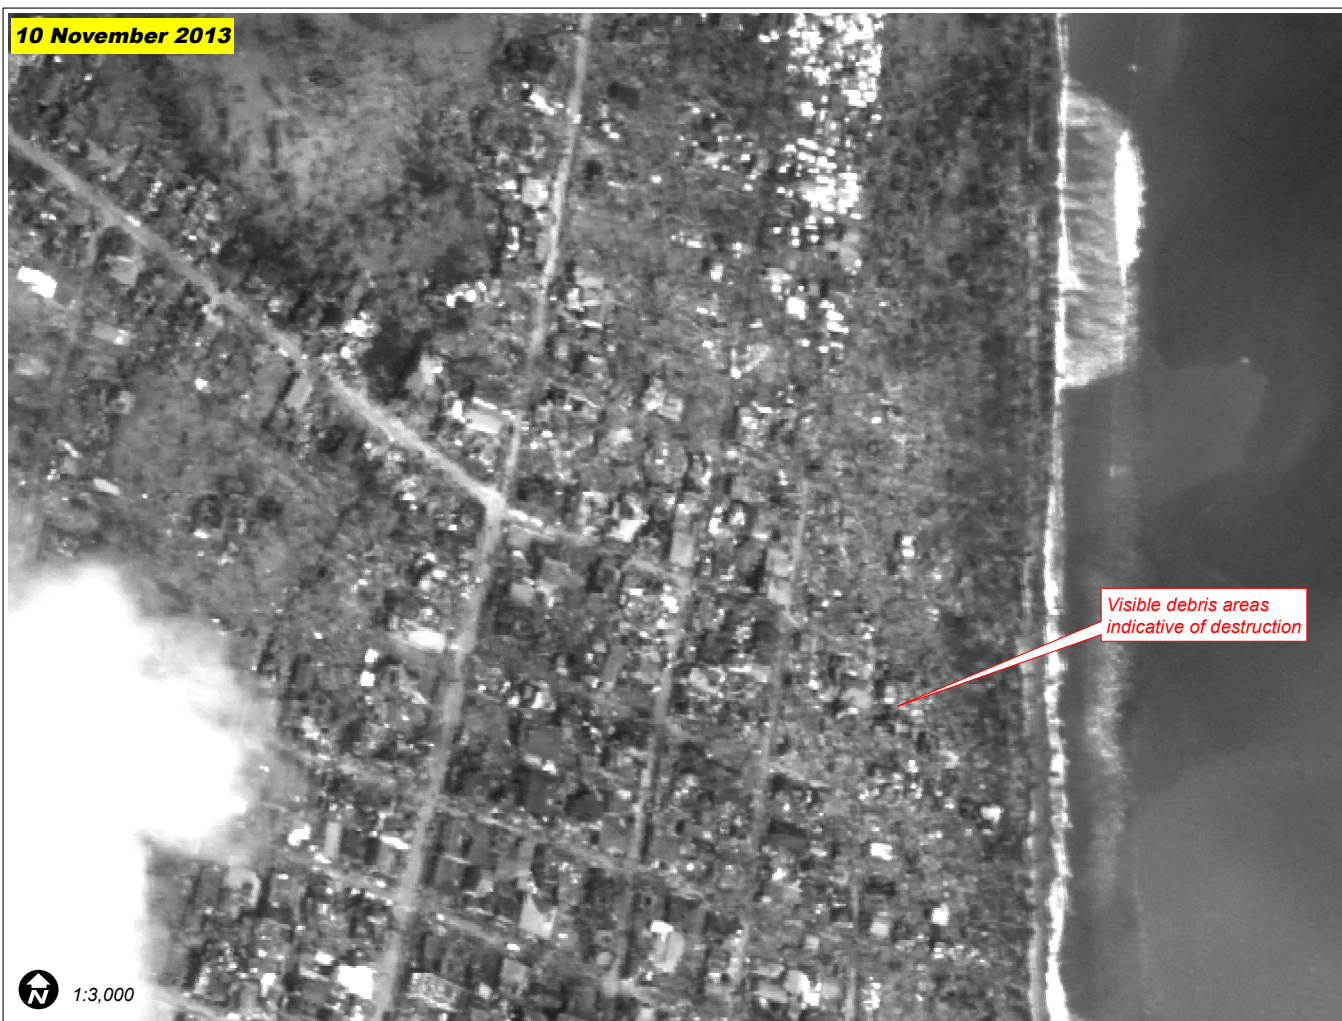
A portion of central Dulag town almost completely eradicated by Typhoon Haiyan. See Figure 1 (next page) for pre-disaster comparison.

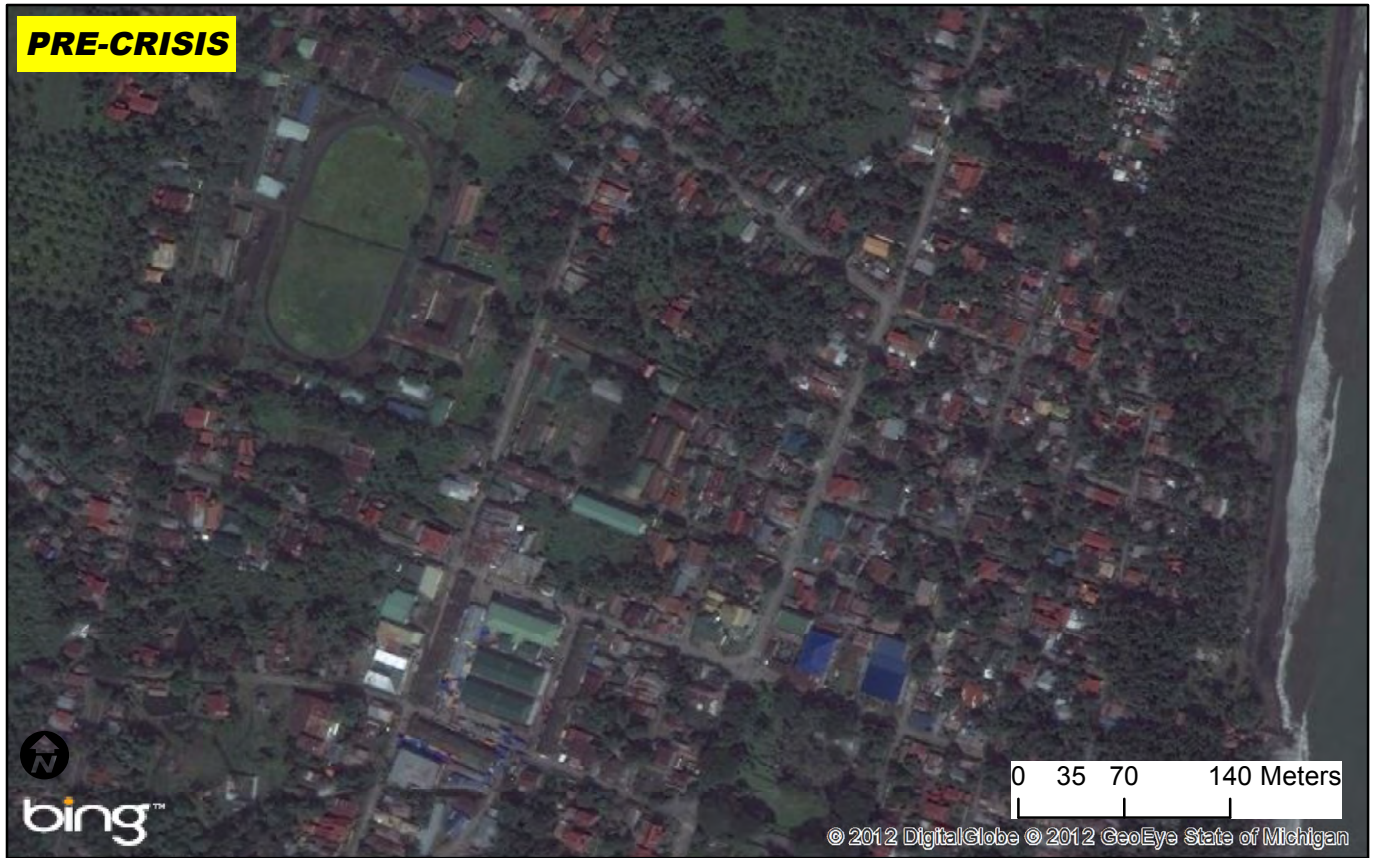
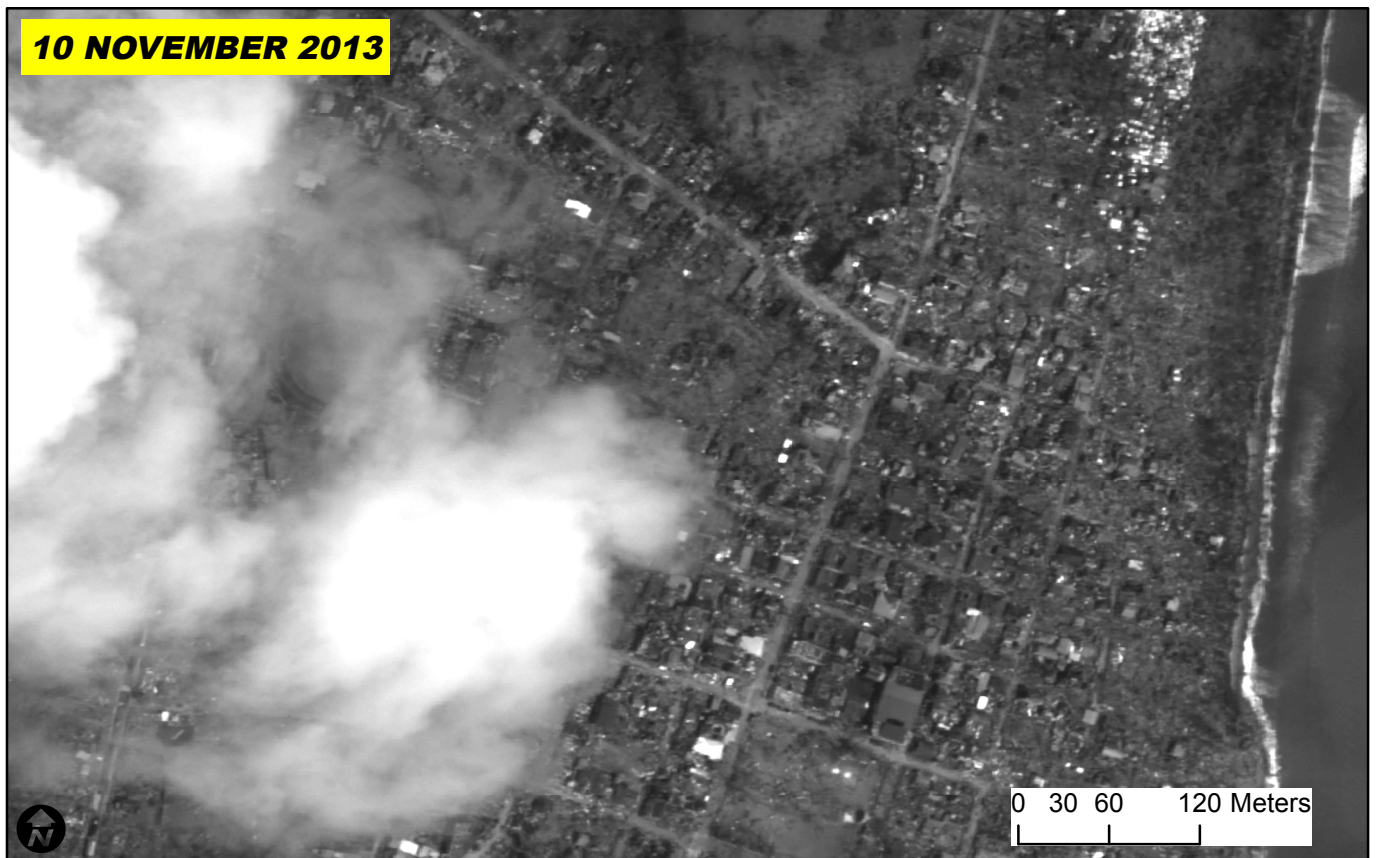
Figure 1: Destruction in Dulag Town

The central portion of the town of Dulag with multiple structures and tree cover visible intact in pre-crisis image (top) collected prior to Typhoon Haiyan. As of 10 November 2013 (bottom) most structures are gone with proximate debris indicative of complete destruction, and most tree cover likewise destroyed.
