UNOSAT

Production Date: 11/11/2013

DESTRUCTION IN TABONTABON TOWN, LEYTE PROVINCE, PHILIPPINES

As seen in WorldView-2 imagery collected 10 November 2013

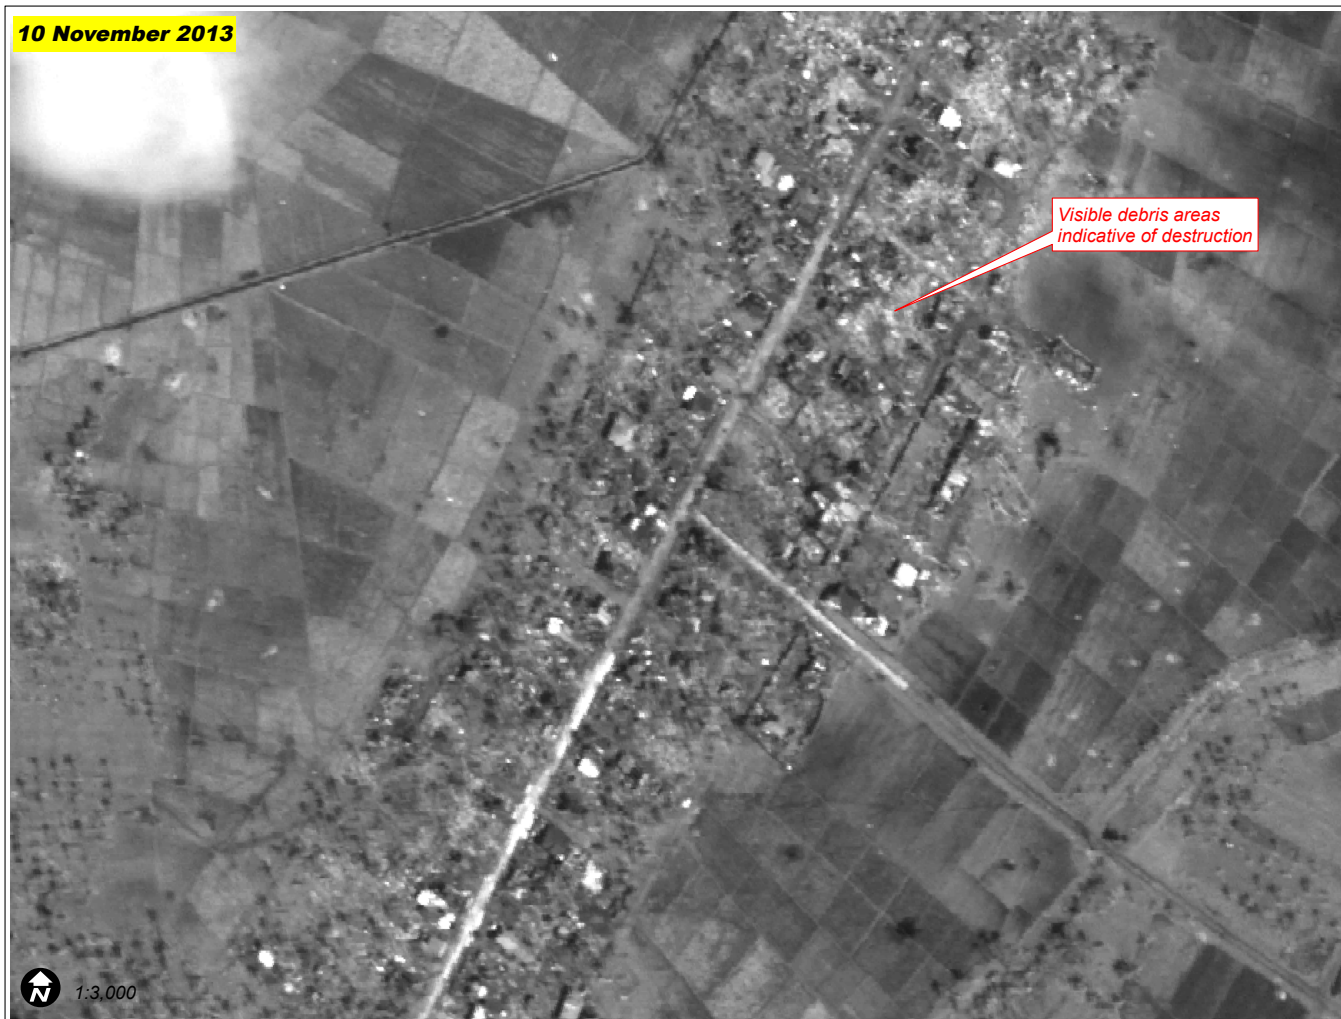
A portion of northern Tabontabon town almost completely eradicated by Typhoon Haiyan. See Figure 1 (next page) for pre-disaster comparison.

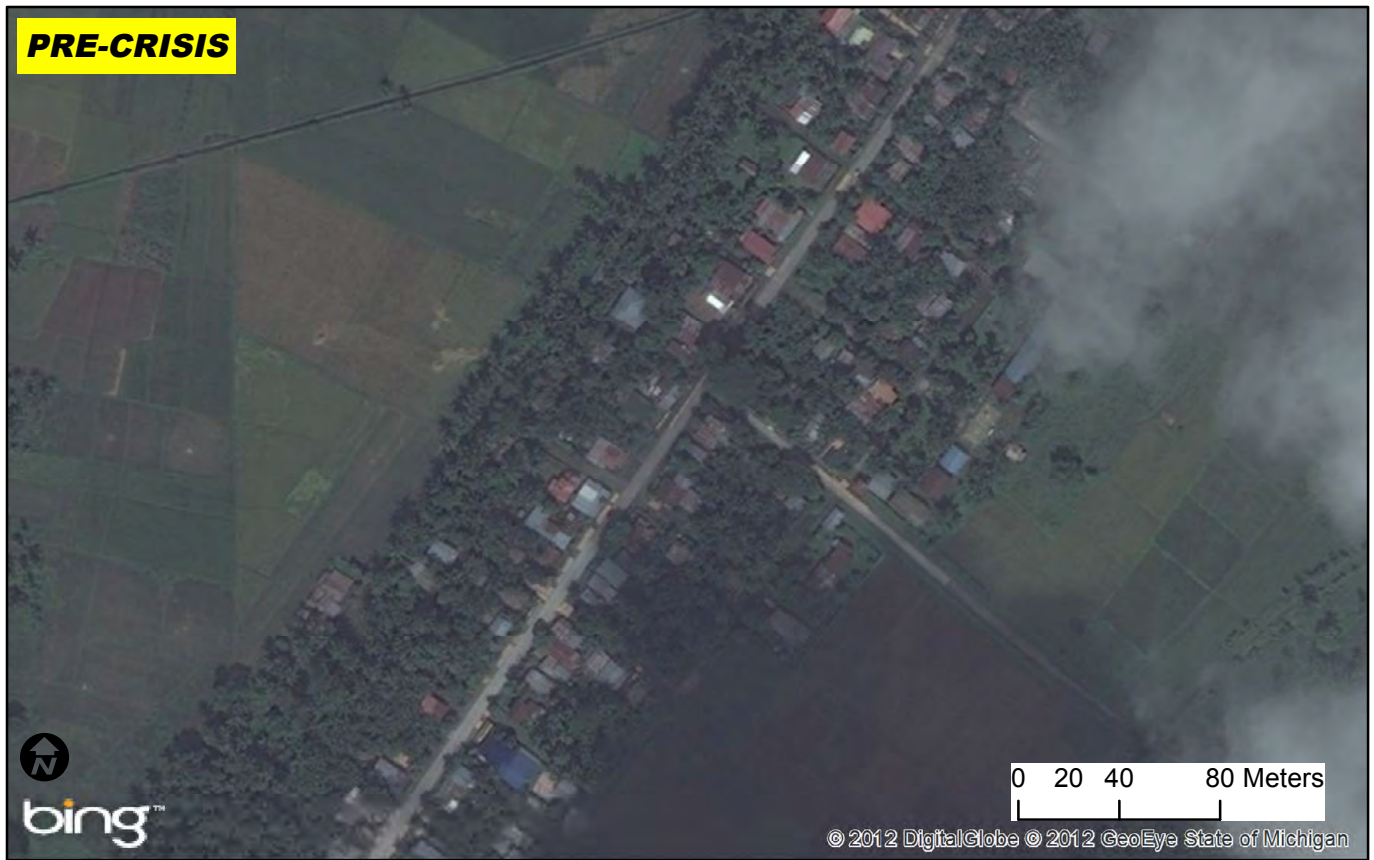
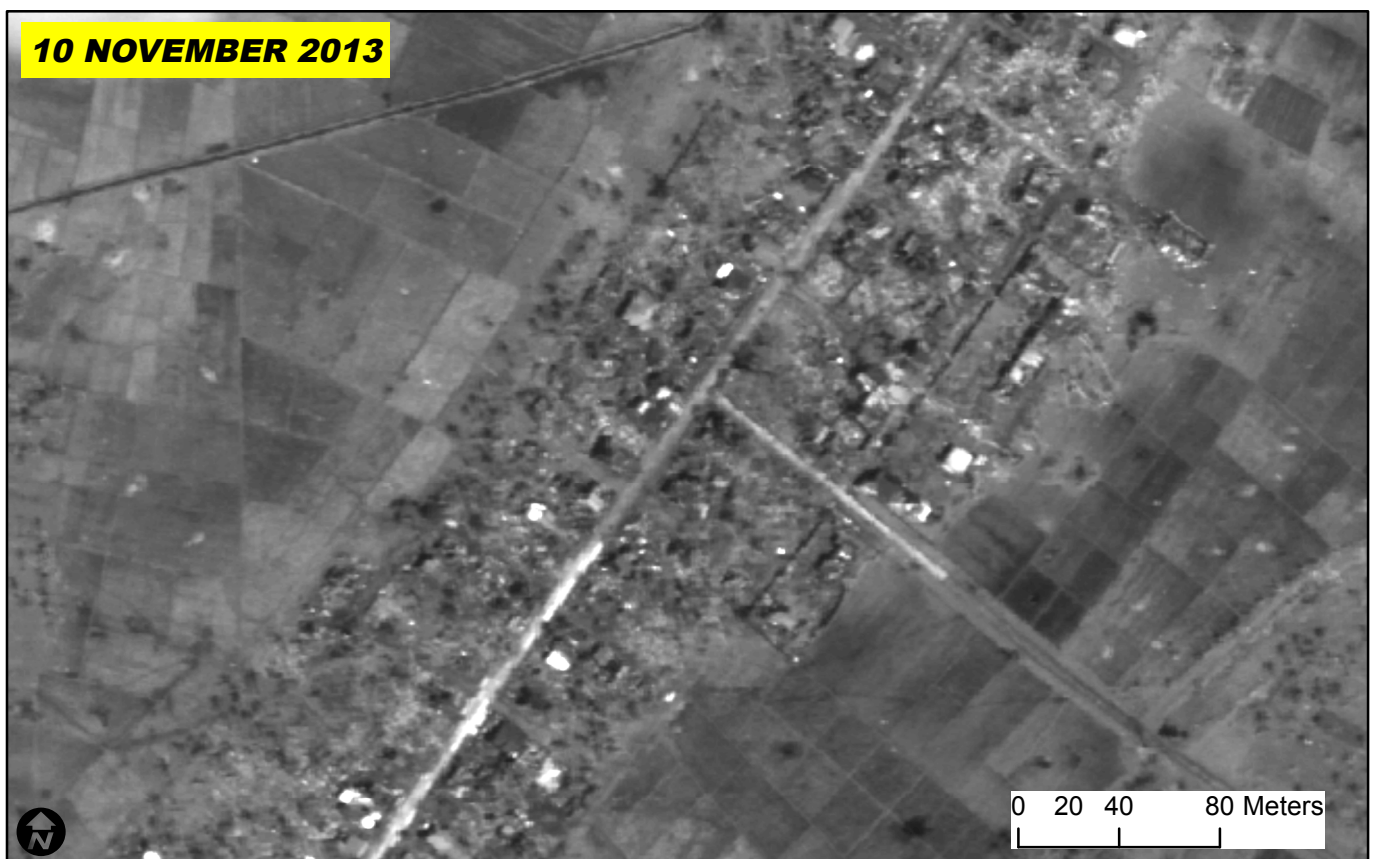
Figure 1: Destruction in Tabontabon Town

A northern portion of the town of Tabontabon with multiple structures and tree cover visible intact in pre-crisis image (top) collected prior to Typhoon Haiyan. As of 10 November 2013 (bottom) most structures are gone with proximate debris indicative of complete destruction, and most tree cover likewise destroyed.
