Hurricane Matthew Preliminary Satellite Based Damage Assessment Report: Grand South departments (Grand'Anse, South and Nippes), Haiti

Update 1 (as of 18 Oct. 2016): Area 1 & Area 2

Prepared By
UNITAR-UNOSAT

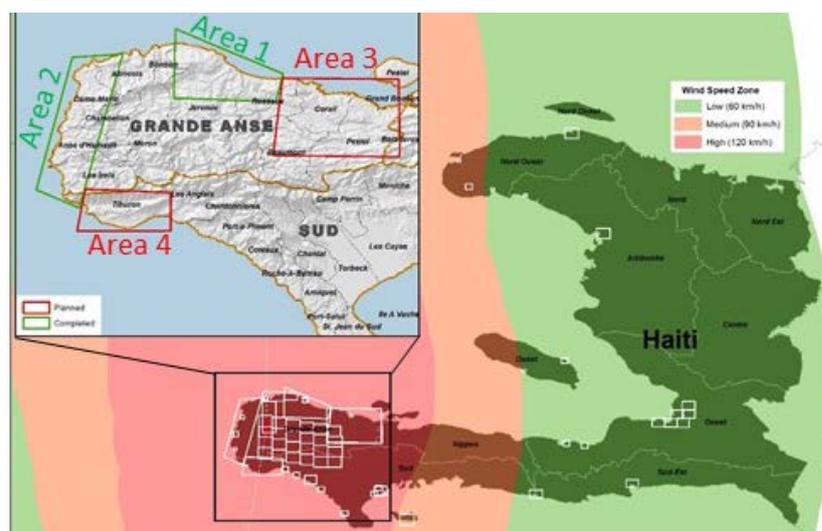
Overview Map showing areas covered with satellite analysis by all organizations along with Hurricane wind speed; Inset map shows the Areas of Interest (AOIs) completed and in-progress by UNOSAT.

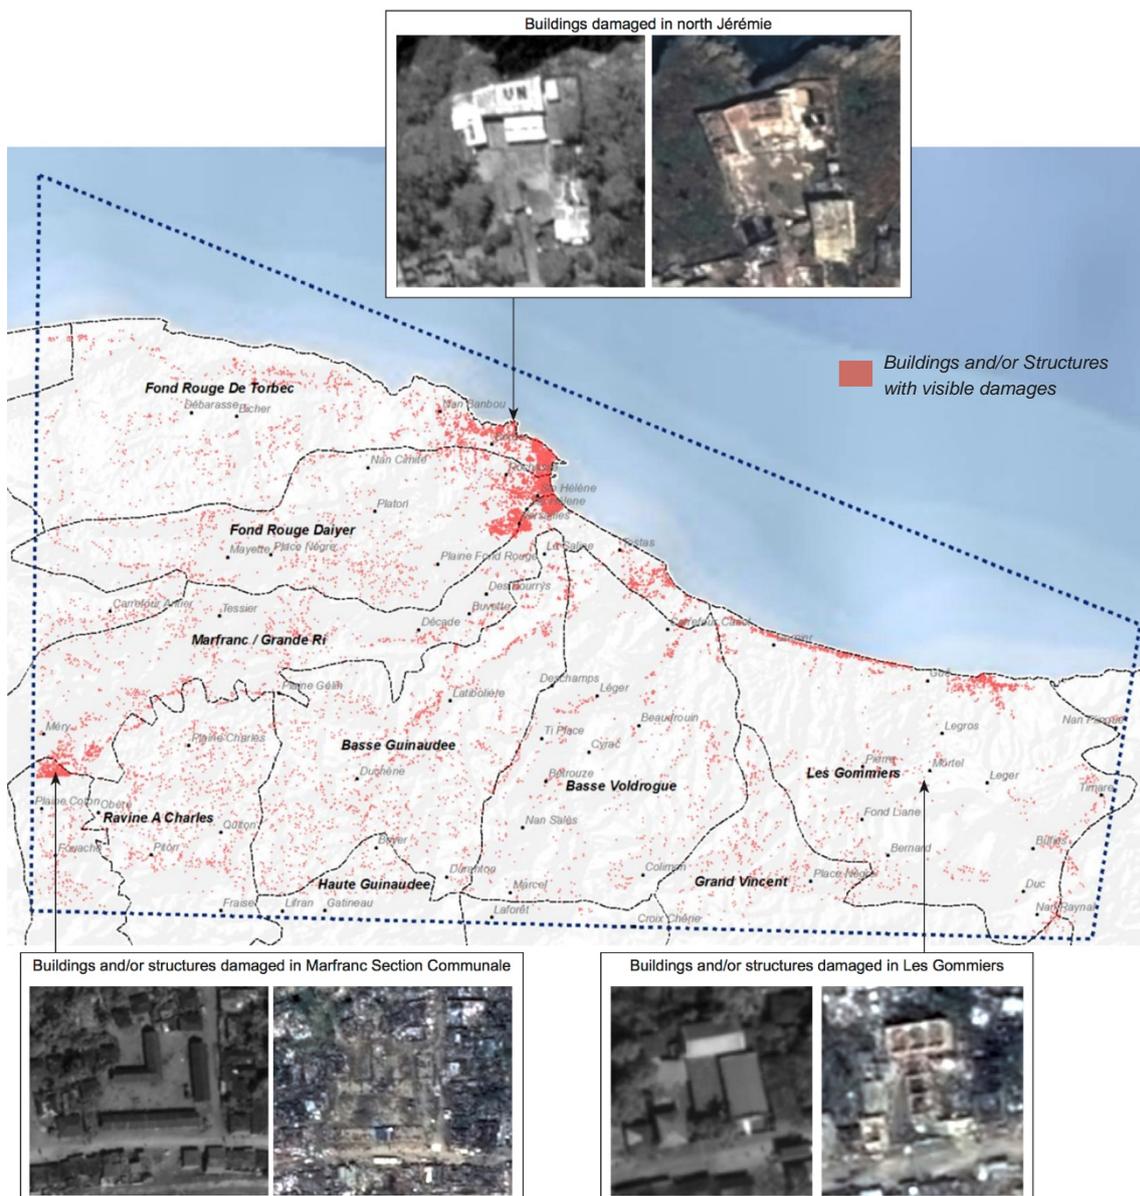
A total of 13,753 buildings were identified to have suffered prominent visual damages within the analyzed areas. Marfranc (section communale) has been identified to have the highest number of affected buildings with over 2,700 detected damaged buildings.

Map showing the buildings/structures identified (red dots) with visual damage using pre- and post- satellite imageries

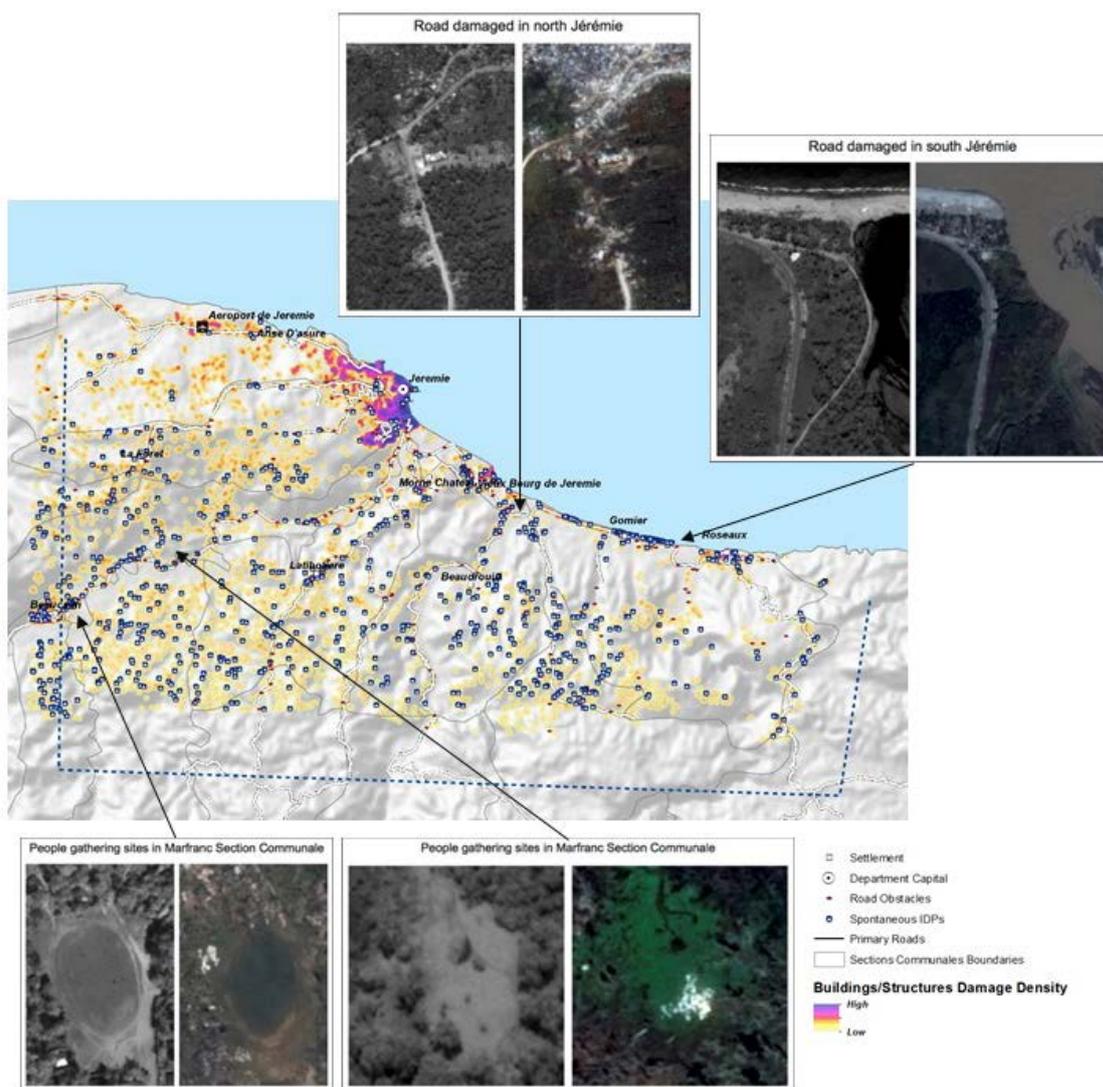
Within Area 1, a total of 141 locations with visible roads obstacles and/or access constraints have been identified with most affected Section Communale being Ravine A Charles in Jérémie Commune.

According to a recent UN OCHA report (12/10/2016), at least 175,500 have been evacuated or displaced and housed in 224 temporary shelters across Haiti. Within the analyzed extent in the Communes of Jérémie, Bonbon and Roseaux, UNOSAT has identified a total of 995 temporary people gathering sites.

Map depicts the location of road blocks and people gathering sites overlaid on building damage density within Area 1. Note the increase in the number of temporary people gathering sites where the level of damage is high.

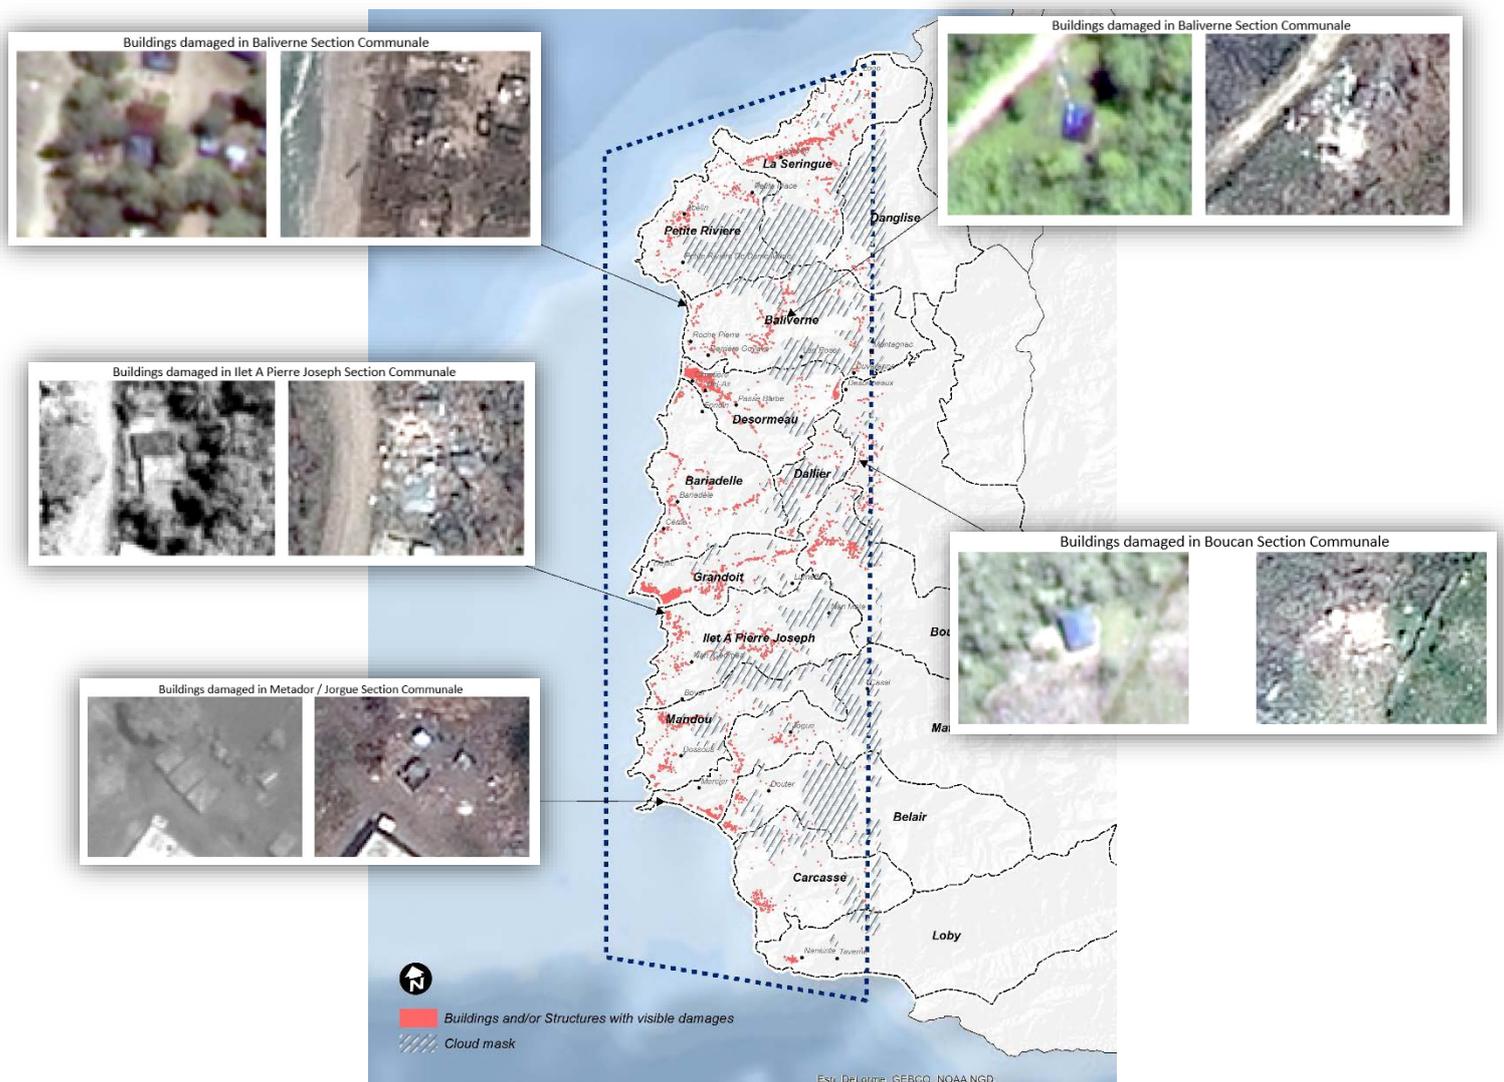
A total of 9,173 buildings were identified to have suffered prominent visual damages within Area 2.

Grandoit (section communale) has been identified to have the highest number of affected buildings with over 1,650 detected damaged buildings.

Map showing the buildings/structures identified (red dots) with visual damage using pre- and post- satellite imageries. Note that due to cloud cover in post-disaster satellite imagery (~20%) not all buildings/structures in Area 2 have been assessed.

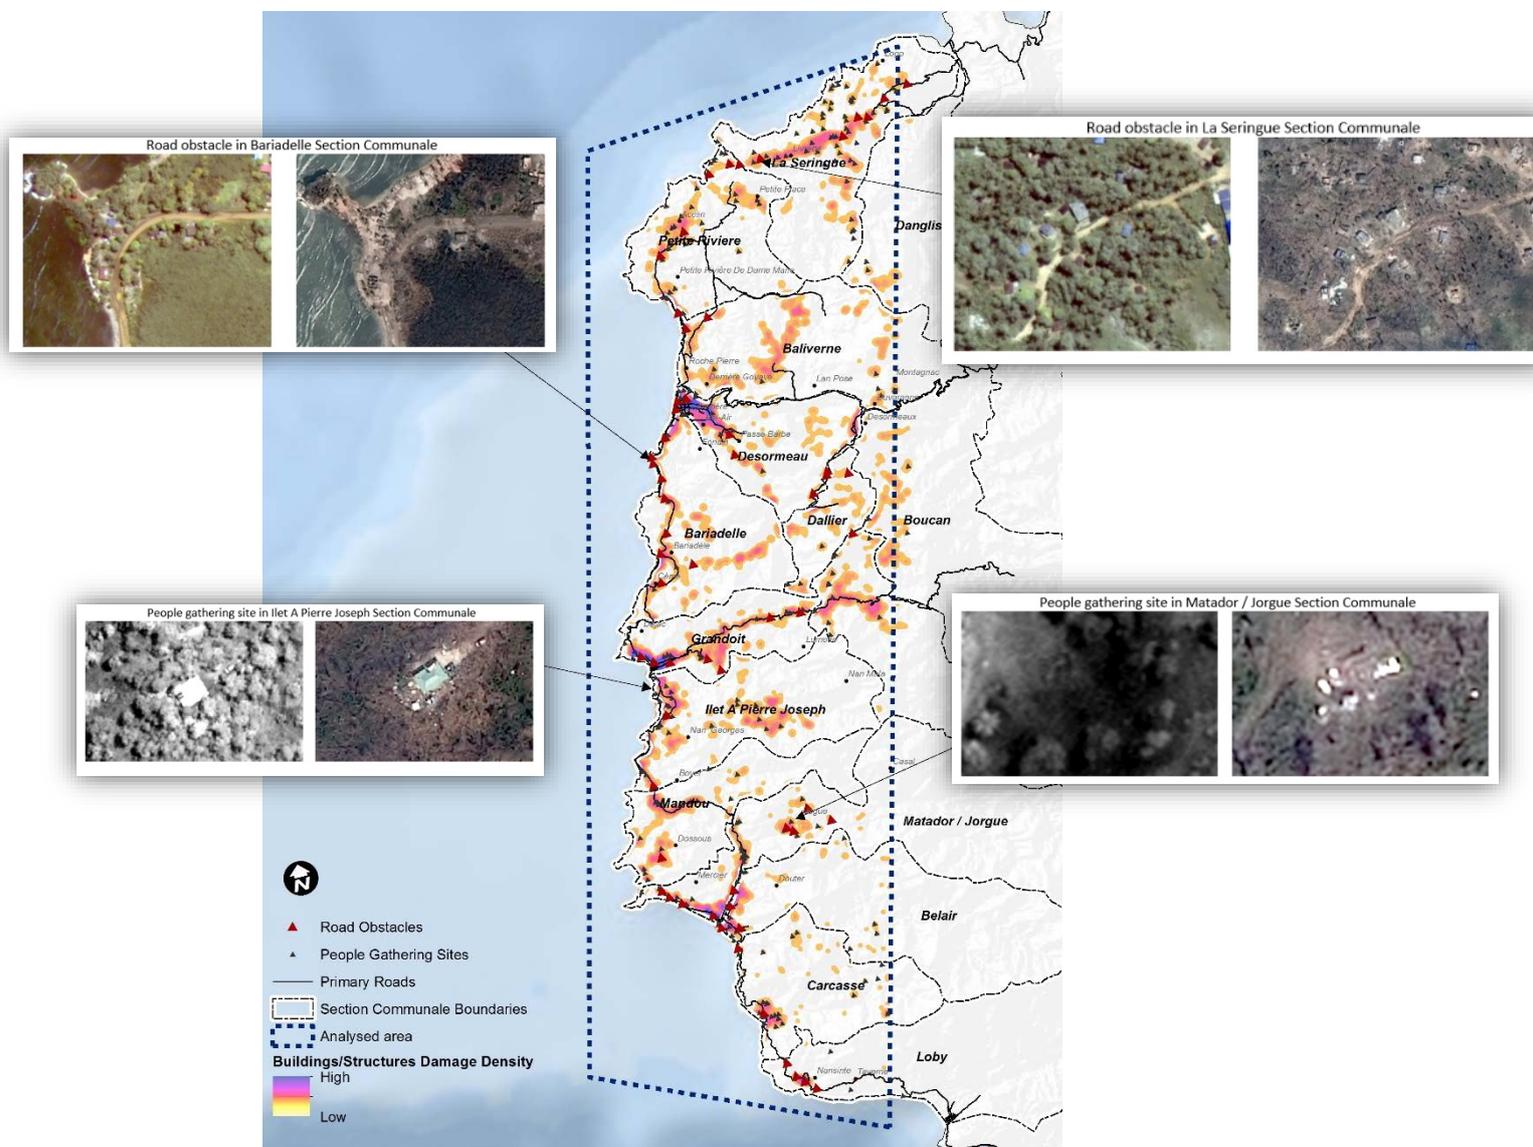
Within the Area 2, a total of 123 locations with visible roads obstacles and/or access constraints have been identified. Most affected Section Commune is Matador / Jorgue in Les Irois Commune. Also, within the analysed Area 2, UNITAR-UNOSAT has identified a total of 255 temporary people gathering sites.

Map depicts the location of road blocks and people gathering sites overlaid on building damage density within the analysed area. Note the increase in the number of temporary people gathering sites where the level of damage is high.
